**Flood Control Project Maintenance
Levee Inspections**

Fall 2015 Levee Maintenance Deficiency Summary Report

Sacramento Maintenance Yard Cache Creek

Fall 2015 Levee Inspection Results

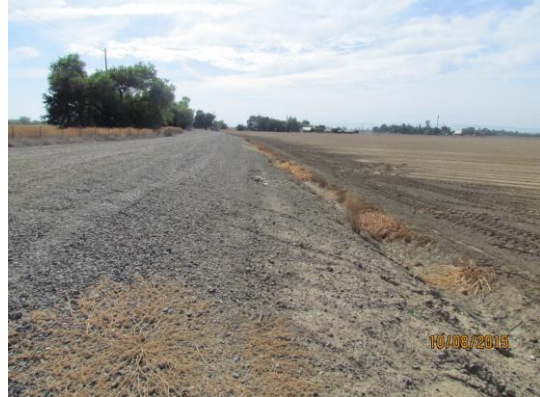
Photo 1 of 1 : FA_2015_ST0001_259_48_20151012_00080.jpg

View of the ditch on the landward side of the levee looking upstream.
Fall 2015.

LM Start	0.19	Rating **	M	Issue No.	66
LM End	0.19	Issue Type +	Ma	Location *	WS
Category	Earthen Levee			GPS Latitude/Longitude	
				Start	End
Item	Slope Stability			38.716904 °	38.716904 °
				-121.823218 °	-121.823218 °
DWR ID	DWR_ST0001_01_f_2015_66				
Action/Comments					
Repair the levee slope damaged by vehicle traffic and prevent access where possible.

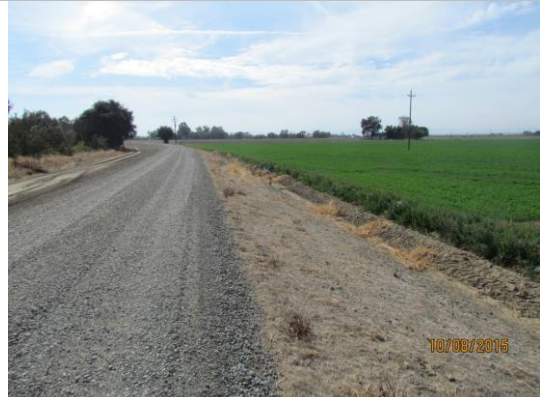
Photo 1 of 1 : FA_2015_ST0001_259_47_20151012_00079.jpg

View of the ditch on the landward side of the levee looking upstream.
Fall 2015.

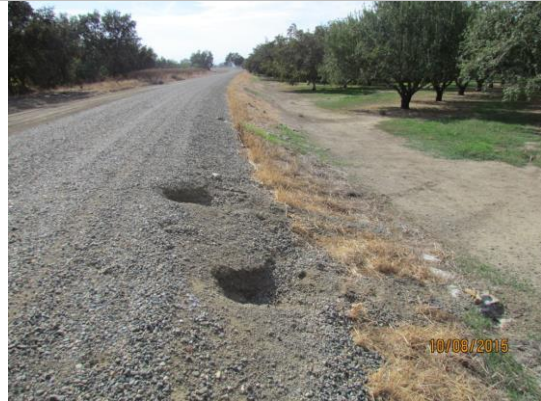
Photo 1 of 1 : FA_2015_ST0001_259_63_20151012_00078.jpg

LM Start	1.33	Rating **	M	Issue No.	63
LM End	1.33	Issue Type +	Ma	Location *	LS
Category	Earthen Levee			GPS Latitude/Longitude	
				Start	End
Item	Slope Stability			38.722302 °	38.722302 °
				-121.809424 °	-121.809424 °
DWR ID	DWR_ST0001_01_f_2015_63				
Action/Comments					
Repair the levee slope damaged by vehicle traffic and prevent access where possible.

View of the potholes created by vehicles on the landward side of the levee looking upstream. Fall 2015.

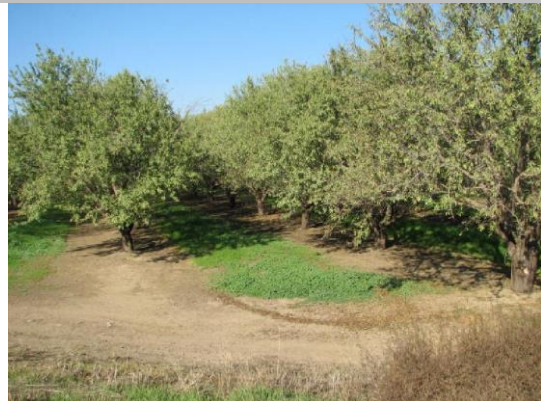
Photo 1 of 3 : UCIP_FA_2015_3832.jpg

LM Start	1.37	Rating **	M	Issue No.	67
LM End	1.37	Issue Type +	En	Location *	LS
Category	Supplemental			GPS Latitude/Longitude	
				Start	End
Item	DWR UCIP Field Study			38.722669 °	38.722669 °
				-121.808792 °	-121.808792 °
DWR ID					
Action/Comments					
Inspector Comments: FS_ID:46679					
DS_ID:16270					
EP_NO: 6790					
FS_HLM: 1.364					
Repair Type: Non-Urgent					
Crossing Status: Indicator Found					
UCIP Comments: May need additional signs on LS of levee.					
FIELD_STRUCT_DESC: 6-inch gas line through the levee at an					
unknown elevation and under channel. Gasline marker on WS slope					
(Permit No. 6790 - PG&E)					
FS Date: 10/05/2015

Landside view: no gasline marker

Inspector Comments: FS_ID:46679
 DS_ID:16270
 EP_NO: 6790
 FS_HLM: 1.364
 Repair Type: Non-Urgent
 Crossing Status: Indicator Found
 UCIP Comments: May need additional signs on LS of levee.
 FIELD_STRUCT_DESC: 6-inch gas line through the levee at an unknown elevation and under channel. Gasline marker on WS slope (Permit No. 6790 - PG&E)
 FS Date: 10/05/2015

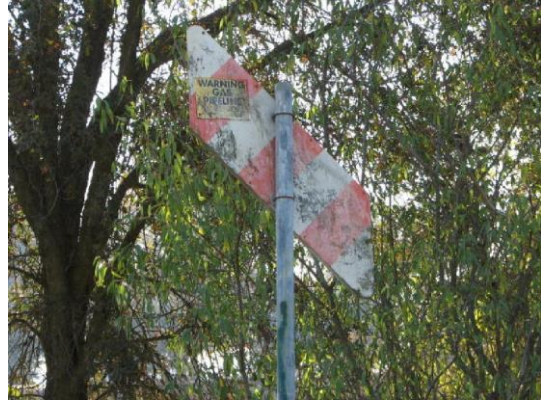
Photo 2 of 3 : UCIP_FA_2015_3833.jpg

Waterside view: closer look at gasline marker

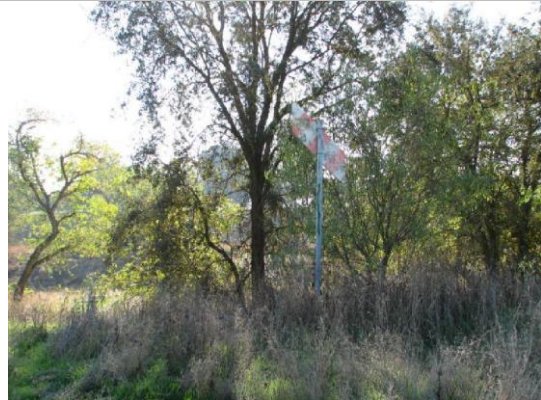
Photo 3 of 3 : UCIP_FA_2015_3834.jpg

Waterside view: gasline marker

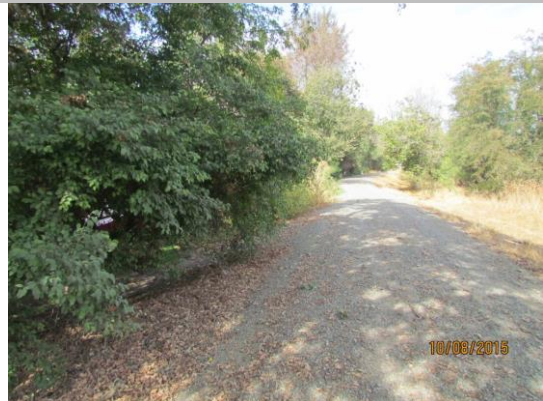
Photo 2 of 2 : FA_2015_ST0001_259_3_20151012_00076.jpg

View of the landscaping that needs to be trimmed on the landward side of the levee looking downstream. Fall 2015.

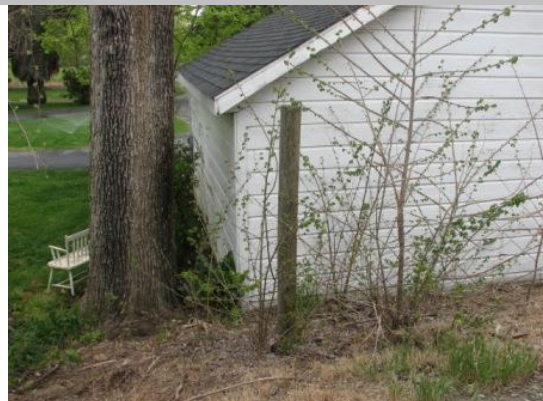
Photo 1 of 1 : FA_2015_ST0001_259_4_20150914_00003.jpg

LM Start	1.94	Rating **	M	Issue No.	4
LM End	1.94	Issue Type +	En	Location *	LS
Category	Earthen Levee			GPS Latitude/Longitude	
				Start	End
Item	Encroachments			38.730528 °	38.730528 °
				-121.806485 °	-121.806485 °
DWR ID	DWR_ST0001_01_s _ 2012_4				
Action/Comments					
Building

The building backs up to the landside levee toe of the levee.

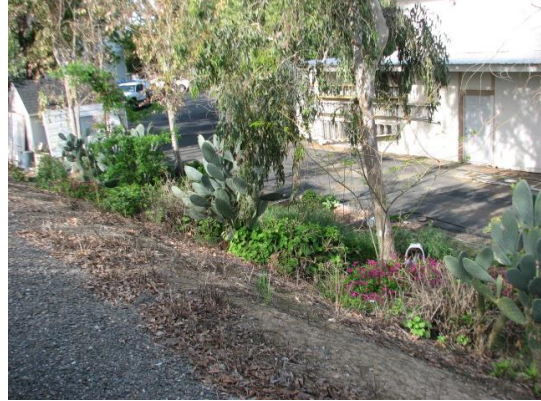
Photo 1 of 1 : FA_2015_ST0001_259_28_20150914_00023.jpg

The property owner has planted cactus along the toe of the levee.
Spring 2014

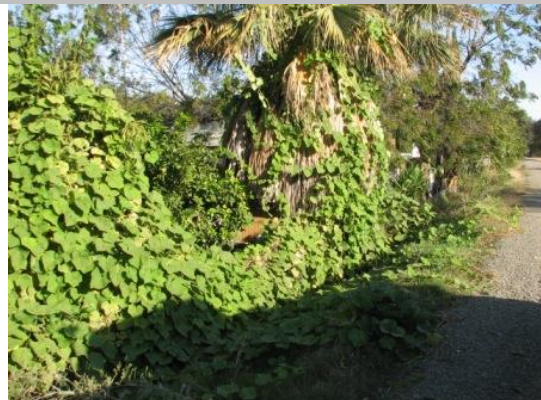
Photo 1 of 2 : FA_2015_ST0001_259_7_20150914_00006.jpg

Wild grape and other plants are obstructing the view for inspection. Fall
2011

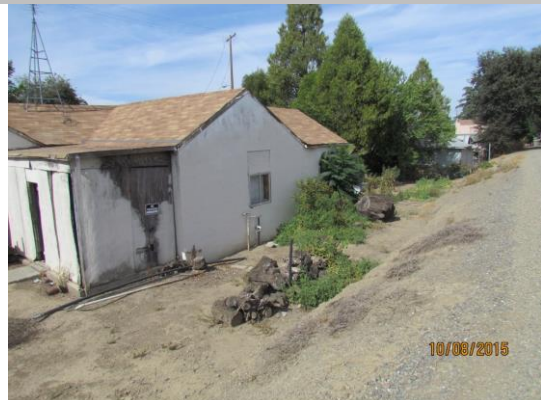
Photo 1 of 1 : FA_2015_ST0001_259_9_20151012_00072.jpg

View of the house in the town of Yolo on the landward side of the levee looking downstream. Fall 2015.

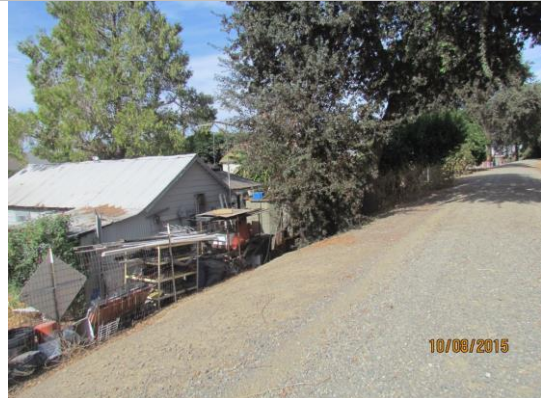
Photo 1 of 1 : FA_2015_ST0001_259_11_20151012_00070.jpg

View of the building on the landward side of the levee looking downstream. Fall 2015.

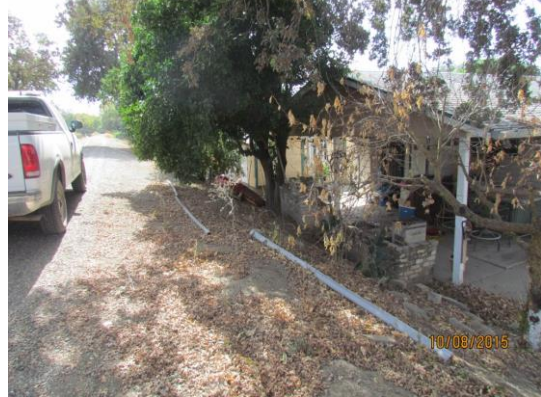
Photo 1 of 1 : FA_2015_ST0001_259_13_20151012_00069.jpg

View of the building on the landward side of the levee looking upstream.
Fall 2015.

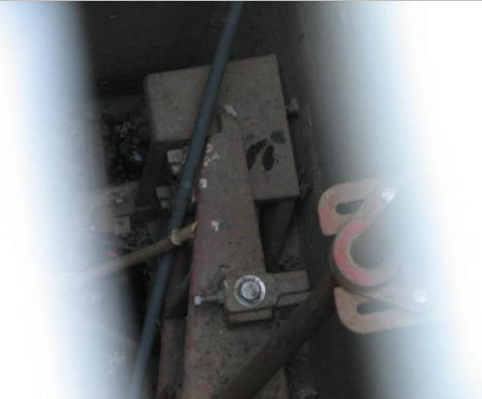
Photo 1 of 2 : UCIP_FA_2015_3998.jpg

LM Start	2.09	Rating **	M	Issue No.	68
LM End	2.09	Issue Type +	En	Location *	LS
Category	Supplemental			GPS Latitude/Longitude	
				Start	End
Item	DWR UCIP Field Study			38.732665 °	38.732665 °
				-121.805604 °	-121.805604 °
DWR ID					
Action/Comments					
Inspector Comments: FS_ID:46680 DS_ID:16269 EP_NO: 13077A FS_HLM: 2.084 Repair Type: Non-Urgent Crossing Status: Found UCIP Comments: A pump house located LS across the road. A debris is blocking the outlet channel of the pipe. It needs to be removed (an abandoned sofa). removed debris summer of 2013 FIELD_STRUCT_DESC: Pipe through the levee, screw gate on waterward slope. One of two pipes (30" diameter and 10" diameter) of a storm drainage system. A gate riser structure approximately 4 ft waterward of the waterside levee shoulder. A flap gate on the pipeline at the discharge structure. FS Date: 10/05/2015

Waterside view: inside the control box

Inspector Comments: FS_ID:46680
DS_ID:16269
EP_NO: 13077A
FS_HLM: 2.084
Repair Type: Non-Urgent
Crossing Status: Found
UCIP Comments: A pump house located LS across the road. A debris is blocking the outlet channel of the pipe. It needs to be removed (an abandoned sofa). removed debris summer of 2013
FIELD_STRUCT_DESC: Pipe through the levee, screw gate on waterward slope. One of two pipes (30" diameter and 10" diameter) of a storm drainage system. A gate riser structure approximately 4 ft waterward of the waterside levee shoulder. A flap gate on the pipeline at the discharge structure.
FS Date: 10/05/2015

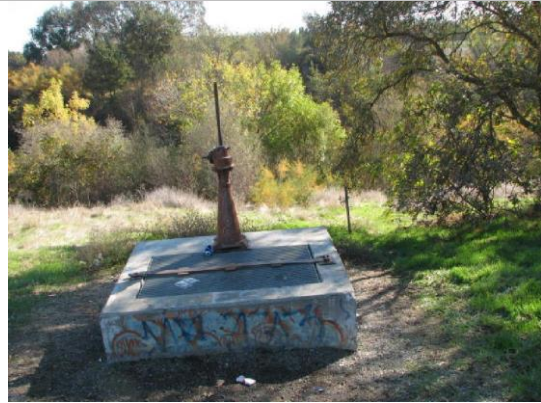
Photo 2 of 2 : UCIP_FA_2015_3999.jpg

Waterside view: a concrete control box with slide gate

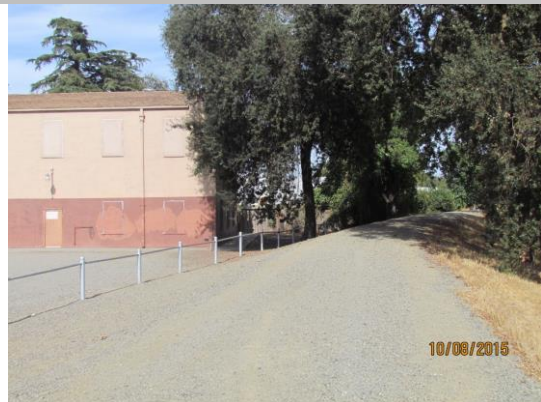
Photo 1 of 1 : FA_2015_ST0001_259_12_20151012_00068.jpg

View of the building on the landward side of the levee looking downstream. Fall 2015.

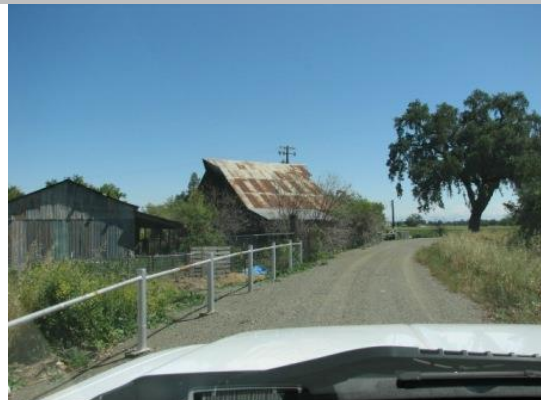
Photo 1 of 2 : FA_2015_ST0001_259_16_20150914_00015.jpg

Horse barn and corral are within the easement of the levee.

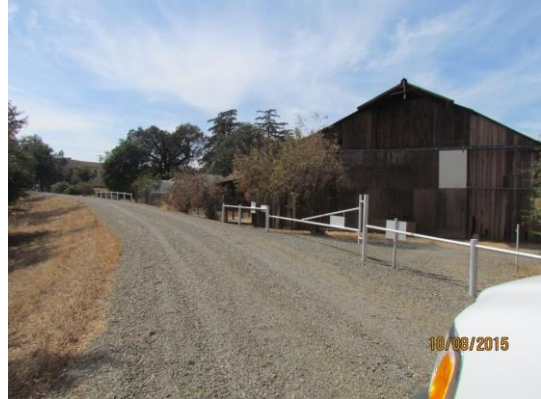
Photo 2 of 2 : FA_2015_ST0001_259_16_20151012_00065.jpg

View of the horse barn on the landward side of the levee looking upstream. Fall 2015.

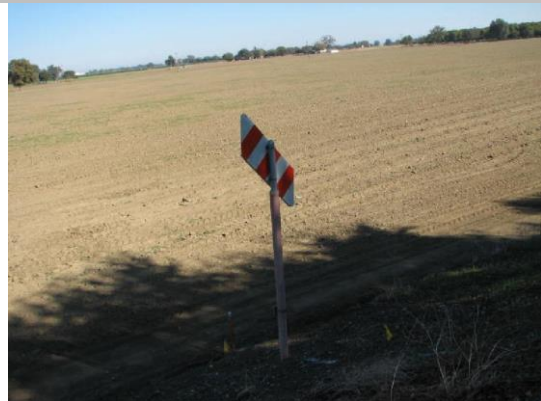
Photo 1 of 2 : UCIP_FA_2015_3835.jpg

LM Start	2.26	Rating **	M	Issue No.	69
LM End	2.26	Issue Type +	En	Location *	LS
Category	Supplemental			GPS Latitude/Longitude	
				Start	End
Item	DWR UCIP Field Study			38.733675 °	38.733675 °
				-121.803009 °	-121.803009 °
DWR ID					
Action/Comments					
Inspector Comments: FS_ID:46681 DS_ID:16268 EP_NO: 2415 FS_HLM: 2.257 Repair Type: Non-Urgent Crossing Status: Indicator Found UCIP Comments: May need to install gasoline marker on WS slope. FIELD_STRUCT_DESC: 20-inch gas line through the levee 4.0 feet below the crown. Two cutoff walls. Gasline indicator found on landside of the levee (Permit No. 2415 - PG&E) FS Date: 10/05/2015

Landside view: gasline indicator

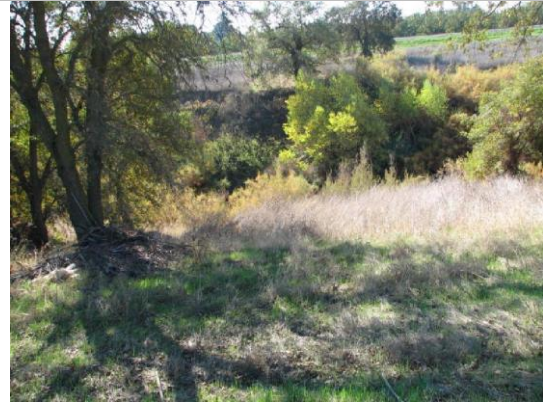
Photo 2 of 2 : UCIP_FA_2015_3836.jpg

LM Start	2.26	Rating **	M	Issue No.	69 (cont)
LM End	2.26	Issue Type +	En	Location *	LS
Category	Supplemental			GPS Latitude/Longitude	
				Start	End
Item	DWR UCIP Field Study			38.733675 °	38.733675 °
				-121.803009 °	-121.803009 °
DWR ID					
Action/Comments					
Inspector Comments: FS_ID:46681 DS_ID:16268 EP_NO: 2415 FS_HLM: 2.257 Repair Type: Non-Urgent Crossing Status: Indicator Found UCIP Comments: May need to install gasoline marker on WS slope. FIELD_STRUCT_DESC: 20-inch gas line through the levee 4.0 feet below the crown. Two cutoff walls. Gasline indicator found on landside of the levee (Permit No. 2415 - PG&E) FS Date: 10/05/2015

Waterside view: no indicators found

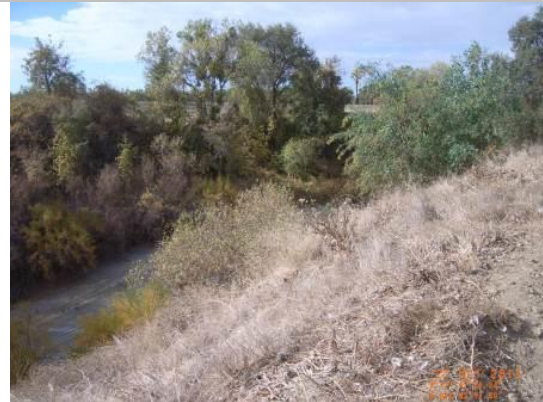
Photo 1 of 1 : USACE2013A_CHC_2-4_L_2.jpg

LM Start	2.57	Rating **	U	Issue No.	17
LM End	2.61	Issue Type +	Ma	Location *	WS
Category	Supplemental			GPS Latitude/Longitude	
				Start	End
Item	2015 USACE Erosion Survey, DRAFT			38.732836 °	38.732685 °
				-121.797893 °	-121.797154 °
DWR ID					
Action/Comments					
Inspector Comments: Site identified as CRITICAL in 2002. 2006 - Currently constructing a setback levee. New failures present and extensive. Downstream end of the setback levee did not extend far enough. Upstream end was repaired. 2007 - DWR repaired with a setback levee, but the levee did not go far enough downstream. 2012 - New cracks observed. 2013 - Fresh erosion on upper bank. 2015: No observed changes. [2015 Site ID: CHC_2-4_L]

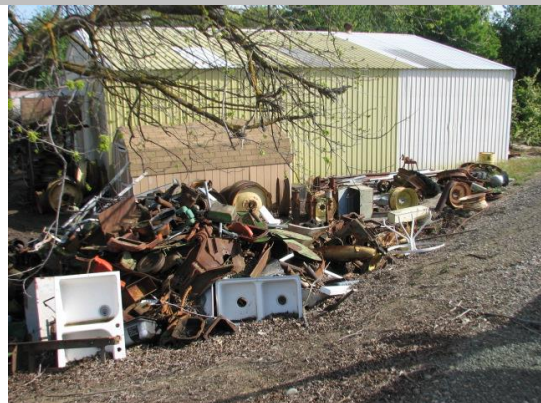
Photo 2 of 2 : FA_2015_ST0001_259_19_20150914_00018.jpg

Equipment and parts stacked along the levee toe and slope. Spring 2014

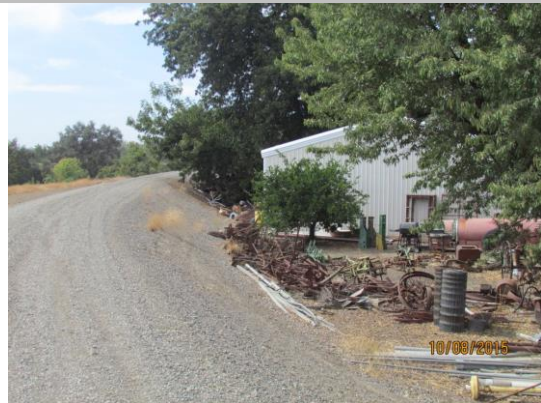
Photo 2 of 2 : FA_2015_ST0001_259_20_20151012_00064.jpg

View of the building on the landward side of the levee looking upstream. Fall 2015.

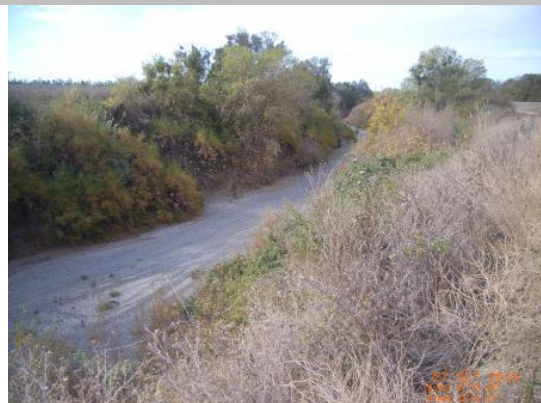
Photo 1 of 1 : USACE2013A_CHC_2-8_L_2.jpg

LM Start	2.82	Rating **	M	Issue No.	38
LM End	2.86	Issue Type +	Ma	Location *	WS
Category	Supplemental			GPS Latitude/Longitude	
				Start	End
Item	2015 USACE Erosion Survey, DRAFT			38.734067 °	38.734171 °
				-121.793713 °	-121.792992 °
DWR ID					
Action/Comments					
Inspector Comments: 2006 - Large new failure. 2008 - Plans for repair currently in the design phase. 2010 - Planned setback levee by CA DWR, 60% design complete, construction planned for 2012. 2011 - Construction delayed to 2013 - 2014. 2015: No observed changes. [2015 Site ID: CHC_2-8_L]

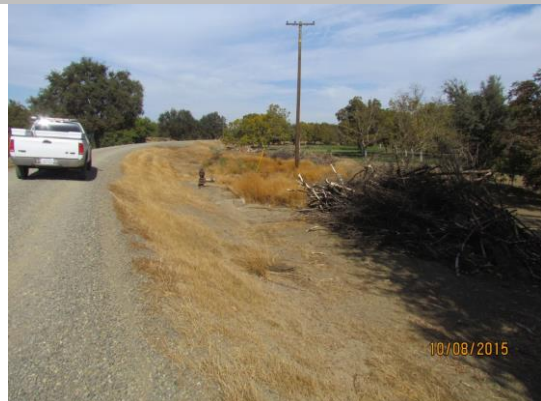
Photo 1 of 1 : FA_2015_ST0001_259_43_20151012_00061.jpg

View of the pruning pile on the landward side of the levee looking upstream. Fall 2015.

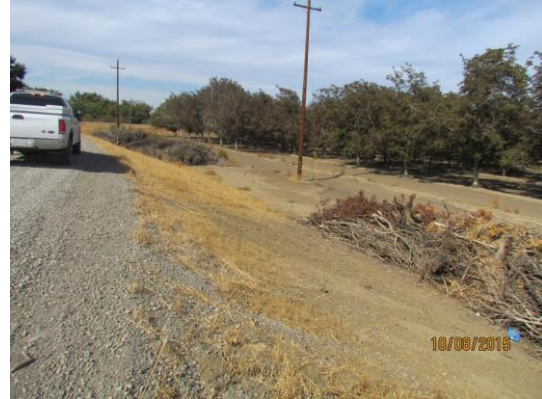
Photo 1 of 1 : FA_2015_ST0001_259_42_20151012_00060.jpg

View of the pruning pile on the landward side of the levee looking upstream. Fall 2015.

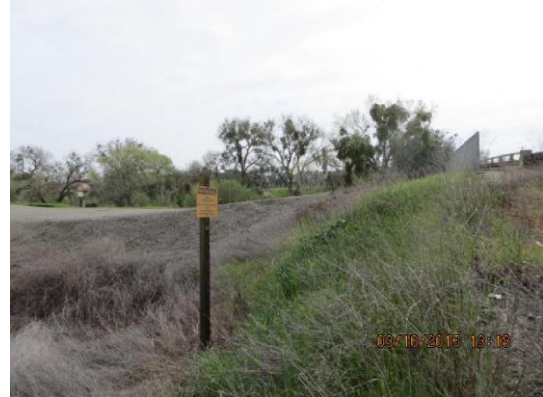
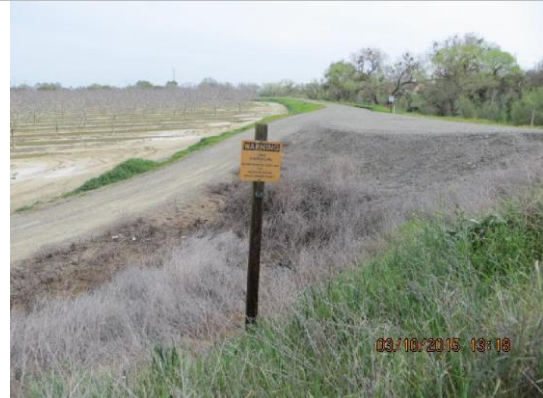
Sign on LS toe.

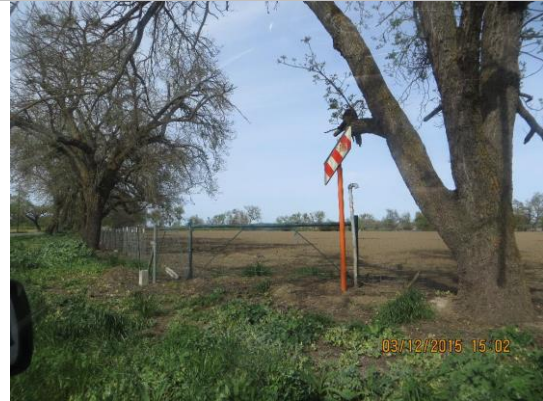
Photo 1 of 2 : UCIP_FA_2015_5788.jpg

Gasline marker at Best Ranch Road, 1500-feet south of levee crossing.

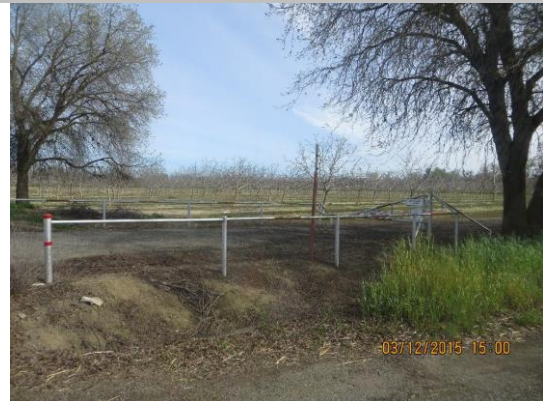
Photo 2 of 2 : UCIP_FA_2015_5789.jpg

Gasline marker next to levee access gate 500-feet north of levee crown.

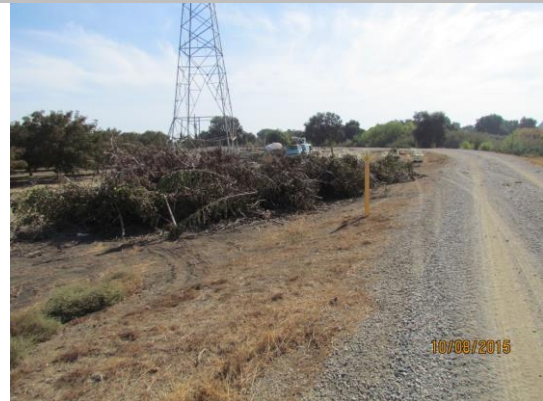
Photo 1 of 1 : FA_2015_ST0001_259_60_20151012_00056.jpg

View of the pruning pile on the landward side of the levee looking downstream. Fall 2015.

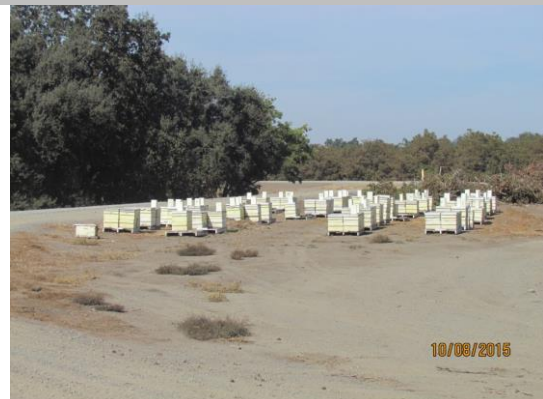
Photo 1 of 1 : FA_2015_ST0001_259_59_20151012_00055.jpg

View of the beehives on the landward side of the levee looking upstream. Fall 2015.

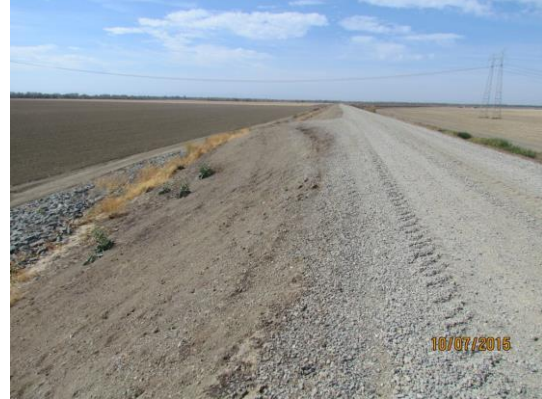
Photo 1 of 1 : FA_2015_ST0001_259_23_20151012_00037.jpg

View of the vegetation on the waterward side of the levee looking upstream taken at levee mile 11.69. Fall 2015.

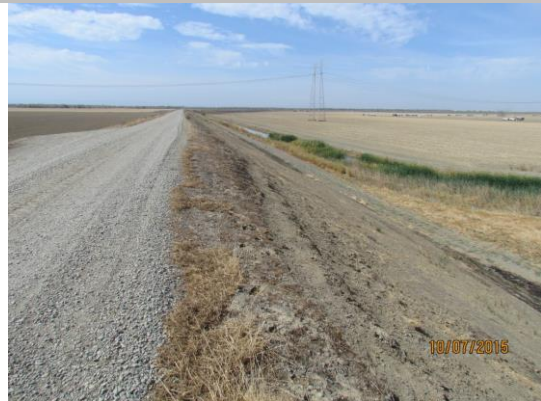
Photo 1 of 1 : FA_2015_ST0001_259_22_20151012_00038.jpg

LM Start	6.56	Rating **	A	Issue No.	22
LM End	11.69	Issue Type +	Ma	Location *	LS
Category	Earthen Levee			GPS Latitude/Longitude	
				Start	End
Item	Vegetation			38.728859 °	38.698622 °
				-121.741821 °	-121.674202 °
DWR ID	DWR_ST0001_01_f_2015_22				
Action/Comments					
Control annual grass and weeds on the levee slopes and easements. Inspector Comments: The LMA has burned and dragged the levee.

View of the vegetation on the landward side of the levee looking upstream taken at levee mile 11.69. Fall 2015.

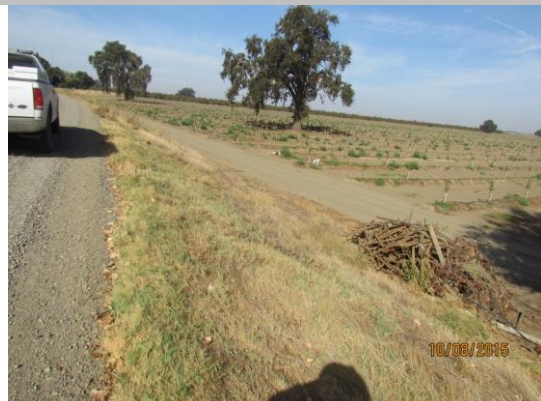
Photo 1 of 1 : FA_2015_ST0001_259_33_20151012_00052.jpg

View of the prunings and stakes on the landward side of the levee looking upstream. Fall 2015.

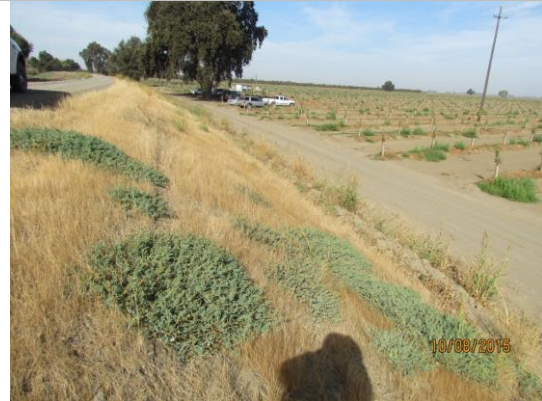
Photo 1 of 1 : FA_2015_ST0001_259_31_20151012_00053.jpg

View of the ditch at the levee toe on the landward side looking upstream. Fall 2015.

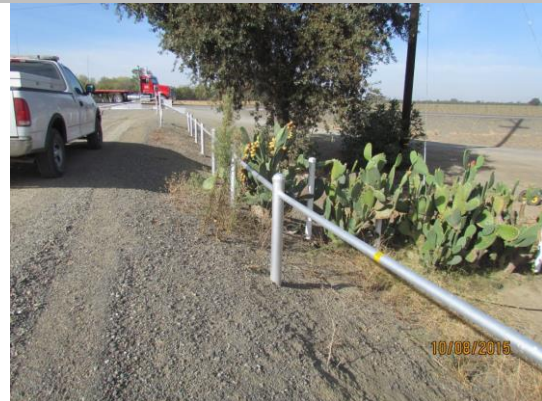
Photo 1 of 1 : FA_2015_ST0001_259_57_20151012_00050.jpg

View of the cactus on the landward side of the levee looking upstream. Fall 2015.

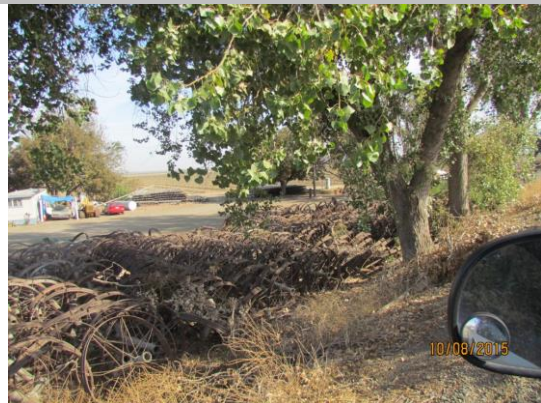
Photo 2 of 2 : FA_2015_ST0001_259_40_20151012_00051.jpg

View of the equipment at the levee toe on the landward side looking downstream. Fall 2015.

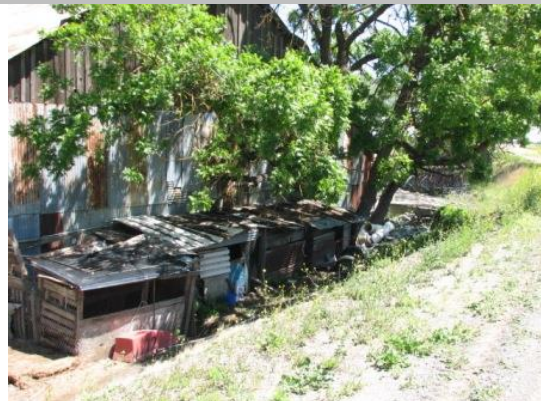
Photo 1 of 1 : FA_2015_ST0001_259_39_20150914_00027.jpg

The barn and livestock pens are within the easement of the levee.

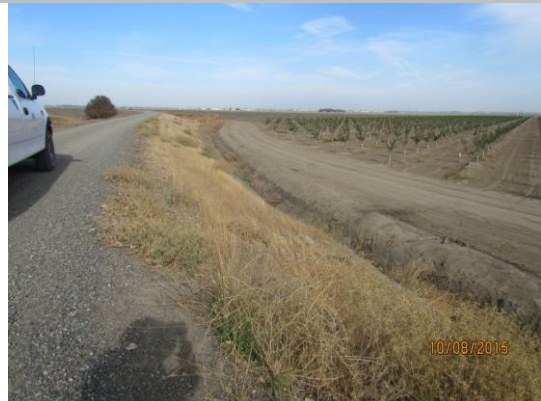
Photo 2 of 2 : FA_2015_ST0001_259_26_20151012_00047.jpg

View of the ditch on the landward side of the levee looking upstream. Fall 2015.

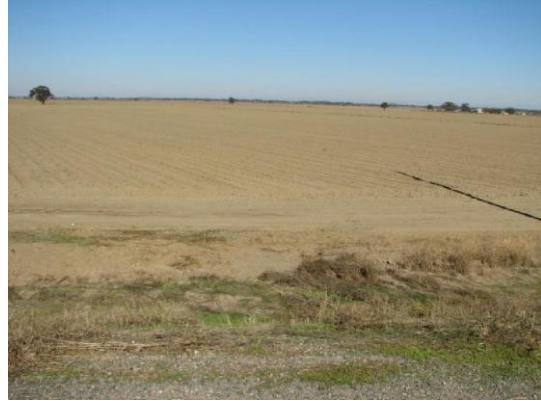
Photo 1 of 2 : UCIP_FA_2015_3936.jpg

Landside view: no indicator found.

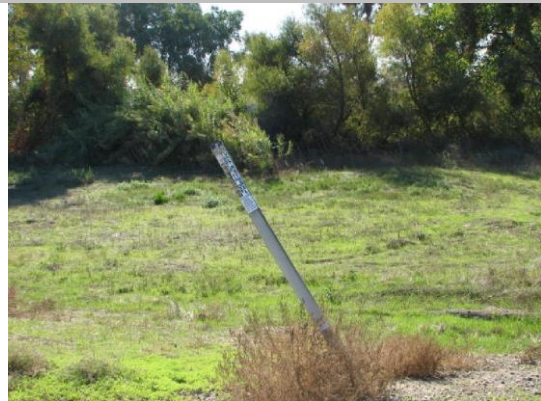
Photo 2 of 2 : UCIP_FA_2015_3937.jpg

Waterside view: gasline indicator

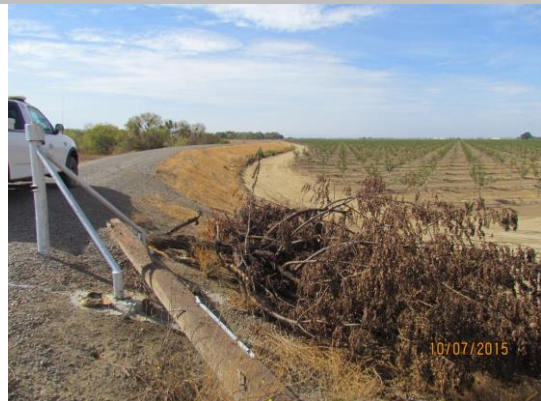
Photo 1 of 1 : FA_2015_ST0001_259_46_20151012_00044.jpg

View of the pile of prunings on the landward side of the levee looking upstream. Fall 2015.

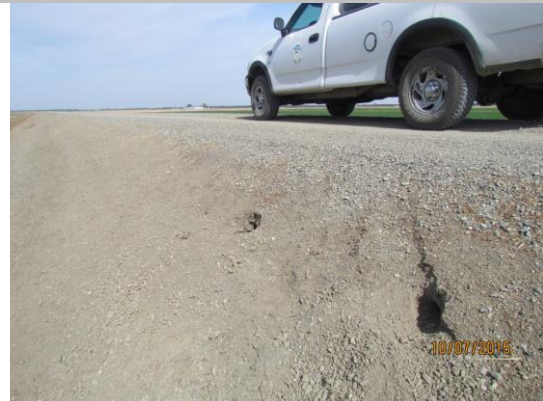
Photo 1 of 1 : FA_2015_ST0001_259_35_20151012_00039.jpg

View of the rodent hole on the waterward side of the levee looking upstream. Fall 2015.

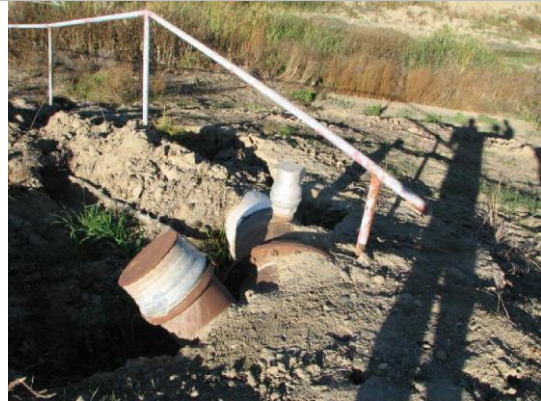
Photo 1 of 2 : UCIP_FA_2015_3631.jpg

Landside view: pipe daylight on LS levee slope

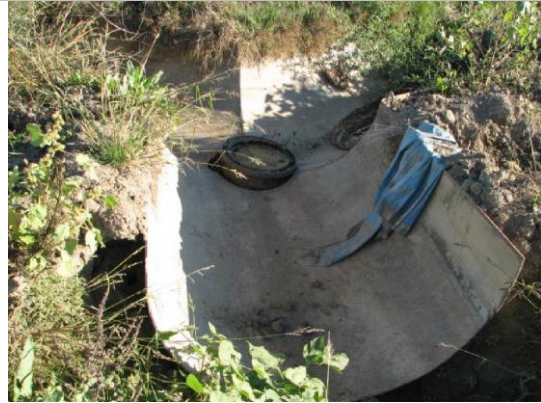
Photo 2 of 2 : UCIP_FA_2015_3632.jpg

Waterside view: pipe in the ditch

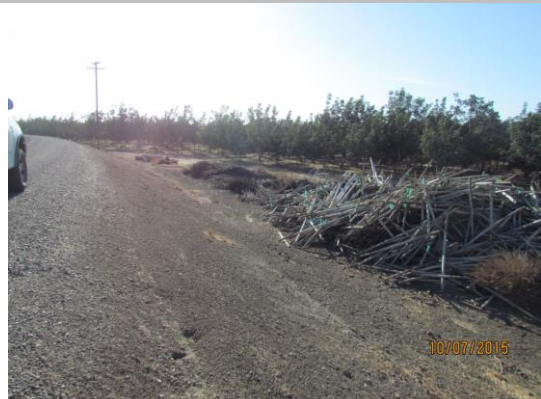
Photo 1 of 1 : FA_2015_ST0001_260_1_20151012_00022.jpg

View of the prunings and stakes at the toe of the landward side of the levee looking downstream. Fall 2015.

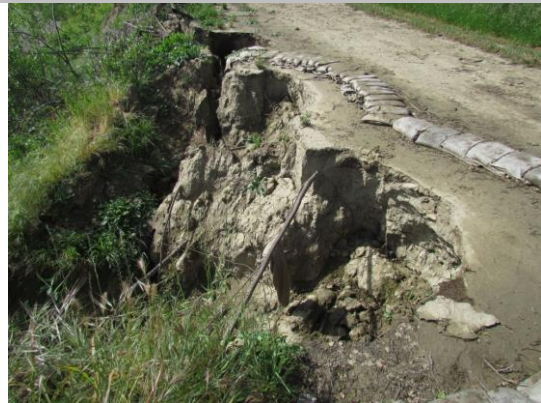
Photo 2 of 2 : FA_2015_ST0001_260_11_20150914_00009.jpg

View of the erosion on the channel looking downstream. Spring 2015.

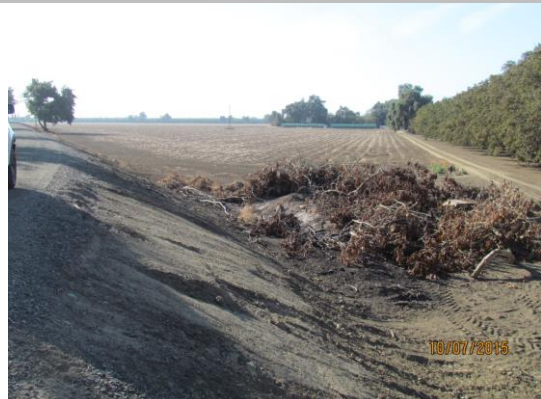
Photo 1 of 1 : FA_2015_ST0001_260_12_20151012_00023.jpg

View of the prunings pile on the landward side of the levee looking downstream. Fall 2015.

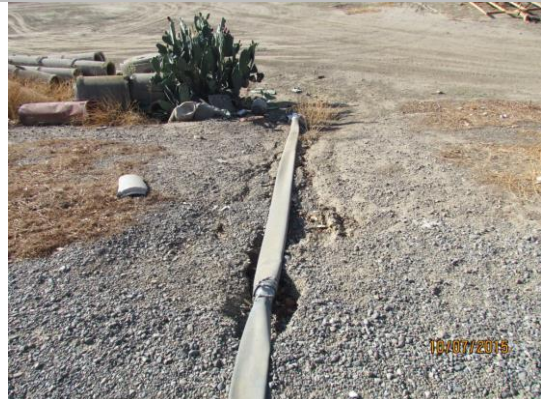
Photo 2 of 2 : FA_2015_ST0001_260_19_20151012_00026.jpg

The erosion is under the hose on the landward side of the levee. Fall 2015.

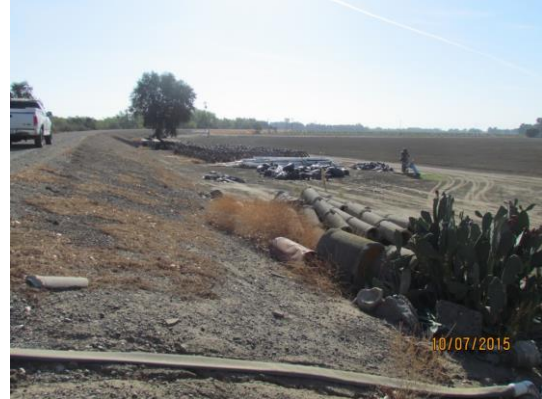
Photo 1 of 1 : FA_2015_ST0001_260_3_20151012_00024.jpg

View of the concrete pile at the toe of the landward side of the levee looking downstream. Fall 2015.

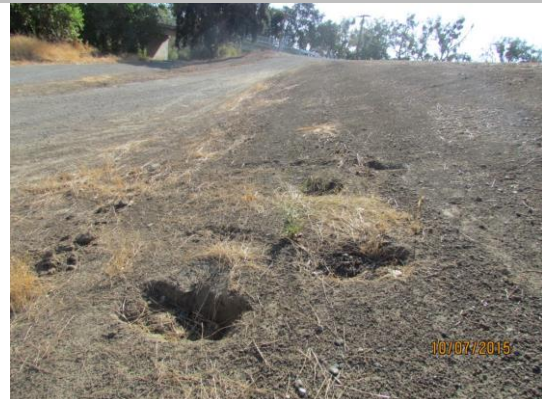
Photo 1 of 1 : FA_2015_ST0001_260_21_20151012_00028.jpg

View of the potholes created from vehicles on the waterward side of the levee looking downstream. Fall 2015.

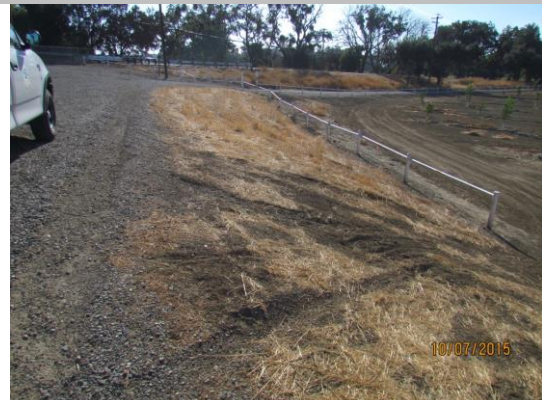
Photo 1 of 1 : FA_2015_ST0001_260_20_20151012_00027.jpg

View of the slope stability caused by vehicles on the landward side of the levee looking downstream. Fall 2015.

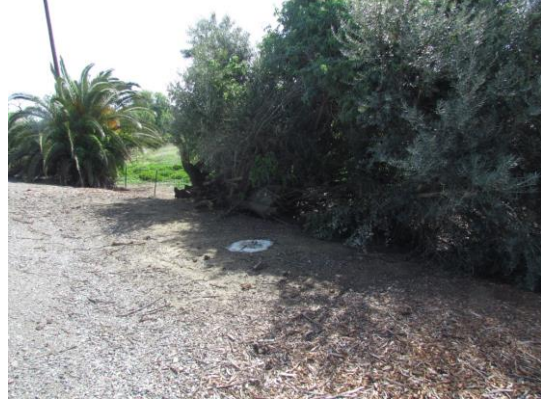
Photo 1 of 1 : FA_2015_ST0001_260_435_20150914_00018.jpg

View of the landscaping vegetation on the landward side of the levee looking downstream. The pile of pruning has been removed. Spring 2015.

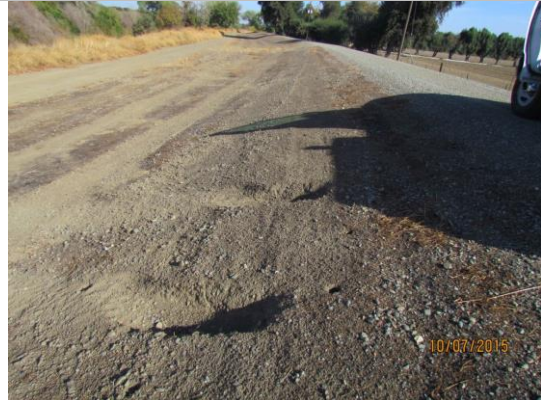
Photo 1 of 1 : FA_2015_ST0001_260_22_20151012_00029.jpg

View of the potholes created by vehicle access on the waterward side of the levee looking downstream. Fall 2015.

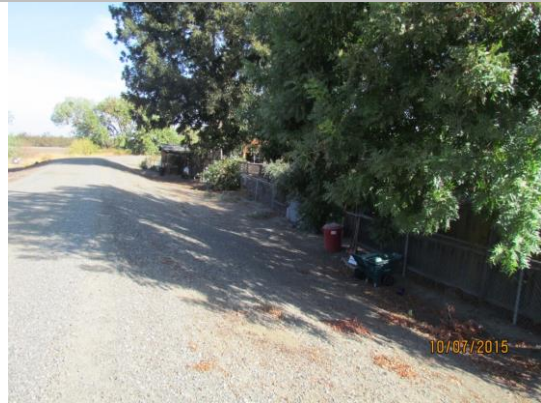
Photo 1 of 1 : FA_2015_ST0001_260_7_20151012_00030.jpg

View of the landscaping and fence on the landward side of the levee looking downstream. Fall 2015.

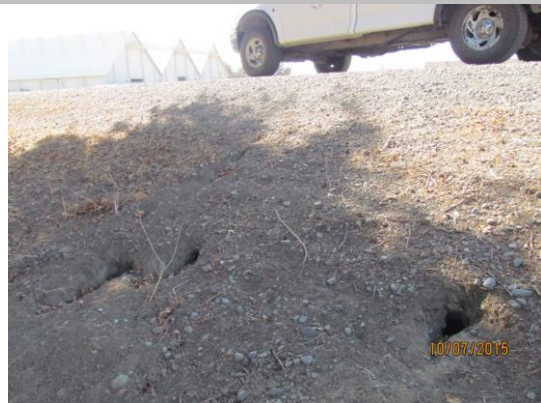
Photo 1 of 1 : FA_2015_ST0001_260_23_20151012_00033.jpg

View of the animal holes on the waterward side of the levee. Fall 2015.

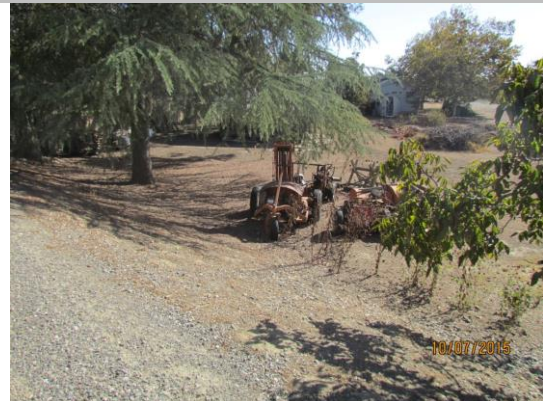
Photo 1 of 1 : FA_2015_ST0001_260_26_20151012_00034.jpg

View of the equipment at the toe of the landward side of the levee. Fall 2015.

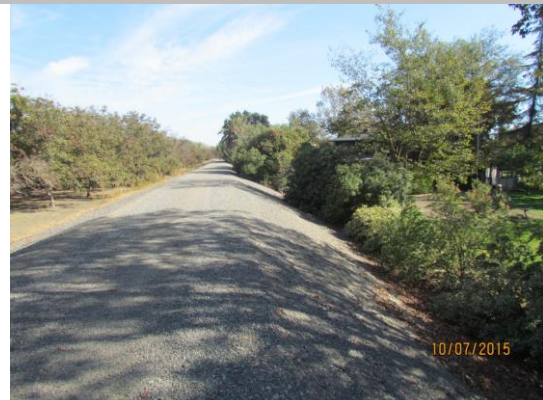
Photo 1 of 1 : FA_2015_ST0001_260_9_20151012_00036.jpg

View of the landscaping vegetation on the landward side of the levee looking downstream. Fall 2015.

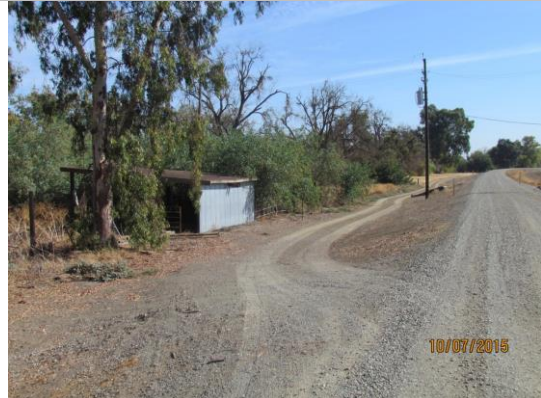
Photo 1 of 1 : FA_2015_ST0001_260_27_20151012_00037.jpg

View of the horse corral and building on the waterward side of the levee looking downstream. Fall 2015.

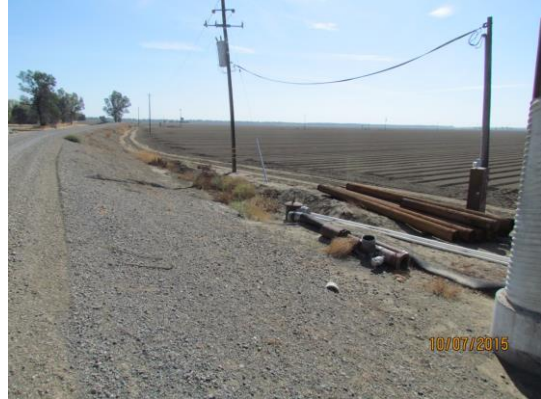
Photo 1 of 1 : FA_2015_ST0001_260_24_20151012_00038.jpg

View of the pipes on the landward side of the levee looking downstream.
Fall 2015.

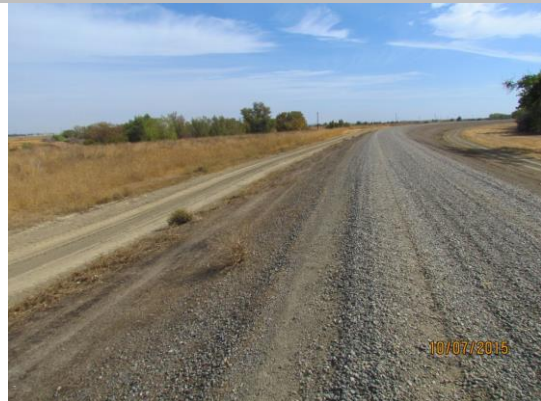
Photo 1 of 1 : FA_2015_ST0001_261_1_20151012_00001.jpg

View of the vegetation on the landward side of the levee looking downstream. Fall 2015.
