**Flood Control Project Maintenance
Levee Inspections**

Fall 2016 Levee Maintenance Deficiency Summary Report

Sacramento River Basin

Sacramento Maintenance Yard Cache Creek

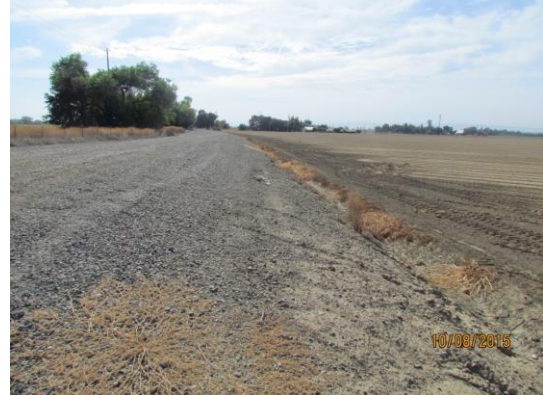
Photo 1 of 1 : FA_2016_ST0001_259_48_20160913_00038.jpg

View of the ditch on the landward side of the levee looking upstream.
Fall 2015.

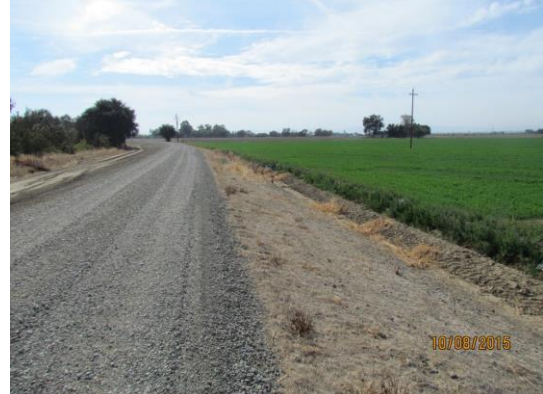
Photo 1 of 1 : FA_2016_ST0001_259_47_20160913_00037.jpg

LM Start	0.93	Rating **	M	Issue No.	47
LM End	1.02	Issue Type +	En	Location *	LS
Category	Earthen Levee			GPS Latitude/Longitude	
				Start	End
Item	Encroachments			38.719222 °	38.720183 °
				-121.815130 °	-121.813995 °
DWR ID	DWR_ST0001_01_s_2015_47				
Comment Code					
DT : Ditch					
Inspector Comment					
Ditch is located at the toe levee.

View of the ditch on the landward side of the levee looking upstream.
Fall 2015.

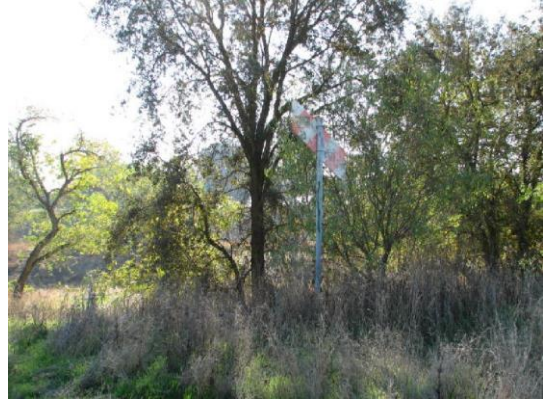
Photo 1 of 2 : UCIP_FA_2016_50432_60162.jpg

LM Start	1.37	Rating **	M	Issue No.	75
LM End	1.37	Issue Type +	En	Location *	LS
Category	Supplemental			GPS Latitude/Longitude	
				Start	End
Item	DWR UCIP Field Study			38.722669 °	38.722669 °
				-121.808792 °	-121.808792 °
DWR ID					
Comment Code					
Inspector Comment					
FS_ID:50432 DS_ID:16270 EP_NO: 6790 Repair Type: Non-Urgent Crossing Status: Indicator Found UCIP Comments: May need additional signs on LS of levee. FIELD_STRUCT_DESC: 6-inch gas line through the levee at an unknown elevation and under channel. Gasline marker on WS slope (Permit No. 6790 - PG&E) FS Date: 6/16/2016 6:58:00 AM

Waterside view: gasline marker

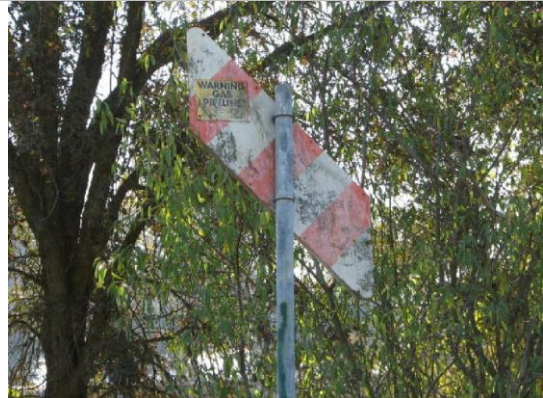
Photo 2 of 2 : UCIP_FA_2016_50432_60161.jpg

Waterside view: closer look at gasline marker

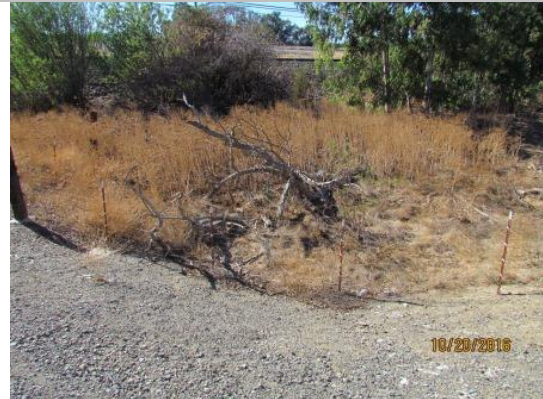
Photo 1 of 1 : FA_2016_ST0001_259_64_20161025_00080.jpg

Prunings on LS slope. Fall 2016.

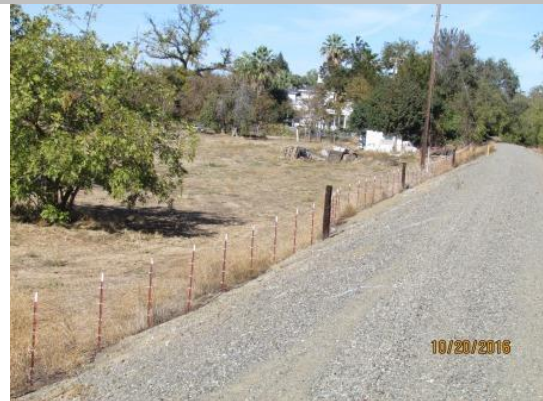
Photo 1 of 1 : FA_2016_ST0001_259_63_20161025_00079.jpg

LM Start	1.77	Rating **	M	Issue No.	63
LM End	1.90	Issue Type +	En	Location *	LS
Category	Earthen Levee			GPS Latitude/Longitude	
				Start	End
Item	Encroachments			38.728217 °	38.729944 °
				-121.806903 °	-121.806506 °
DWR ID	DWR_ST0001_01_f_2016_63				
Comment Code					
FE : Fence					
Inspector Comment

View of fence on LS slope. Fall 2016.

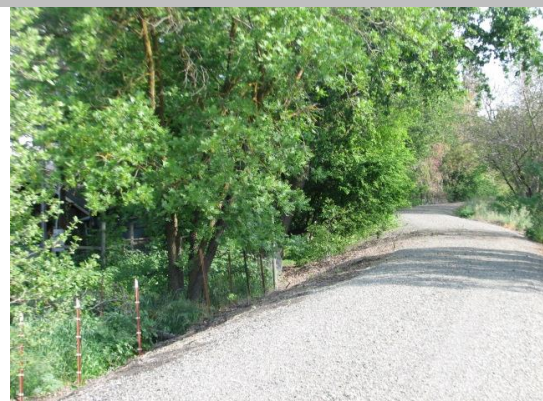
Photo 1 of 2 : FA_2016_ST0001_259_3_20160913_00002.jpg

LM Start	1.89	Rating **	M	Issue No.	3
LM End	1.98	Issue Type +	En	Location *	LS
Category	Earthen Levee			GPS Latitude/Longitude	
				Start	End
Item	Vegetation			38.729828 °	38.731143 °
				-121.806532 °	-121.806255 °
DWR ID	DWR_ST0001_01_s_2012_3				
Comment Code					
V6 : Landscaping					
Inspector Comment

The landscape needs to be trimmed up. Spring 2014

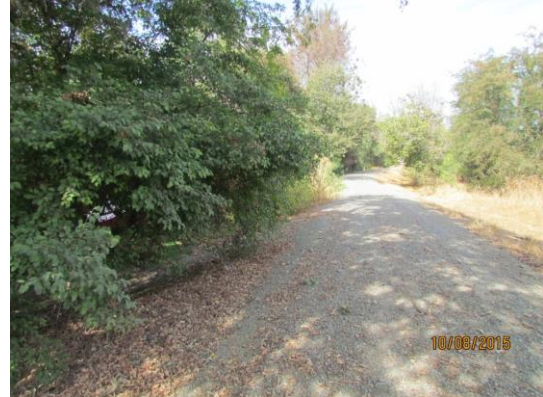
Photo 2 of 2 : FA_2016_ST0001_259_3_20160913_00003.jpg

View of the landscaping that needs to be trimmed on the landward side of the levee looking downstream. Fall 2015.

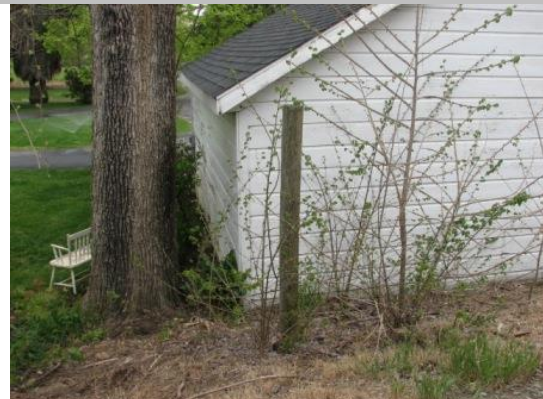
Photo 1 of 1 : FA_2016_ST0001_259_4_20160913_00004.jpg

LM Start	1.94	Rating **	M	Issue No.	4
LM End	1.94	Issue Type +	En	Location *	LS
Category	Earthen Levee			GPS Latitude/Longitude	
				Start	End
Item	Encroachments			38.730528 °	38.730528 °
				-121.806485 °	-121.806485 °
DWR ID	DWR_ST0001_01_s_2012_4				
Comment Code					
BU : Building					
Inspector Comment

The building backs up to the landside levee toe of the levee.

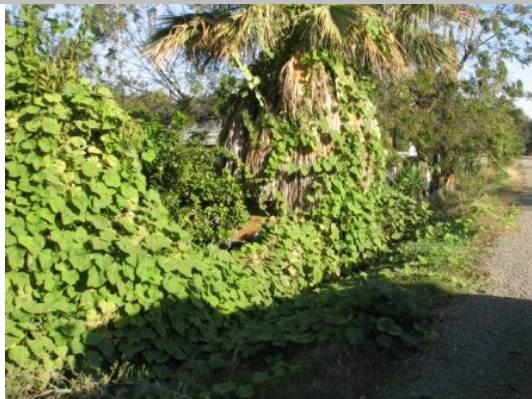
Photo 1 of 2 : FA_2016_ST0001_259_7_20160913_00006.jpg

Wild grape and other plants are obstructing the view for inspection. Fall 2011

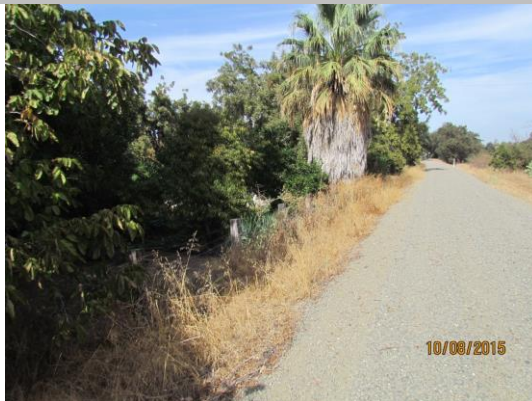
Photo 2 of 2 : FA_2016_ST0001_259_7_20160913_00007.jpg

View of the landscaping on the landward side of the levee looking downstream. Fall 2015.

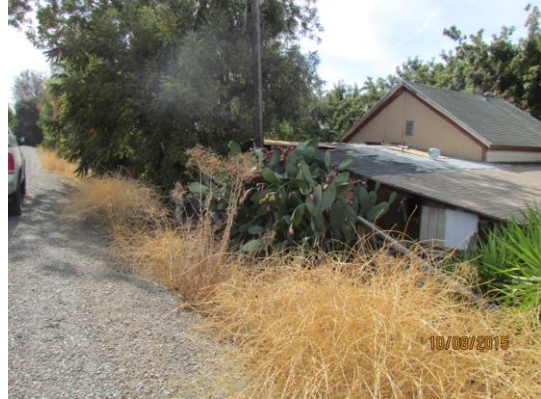
Photo 1 of 1 : FA_2016_ST0001_259_8_20160913_00008.jpg

View of the building on the landward side of the levee looking upstream.
Cactus planted at the toe obstructs visibility. Fall 2015.

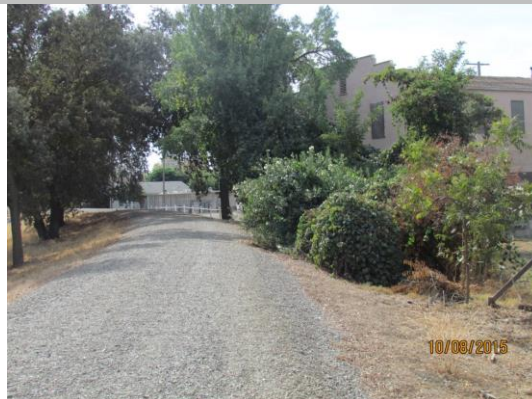
Photo 1 of 2 : FA_2016_ST0001_259_14_20160913_00014.jpg

View of the shrubs on the landward side of the levee looking upstream. Fall 2015.

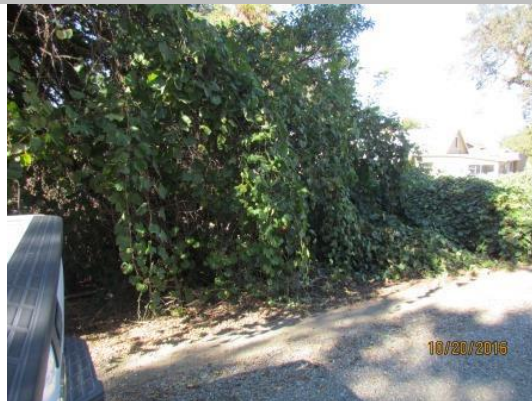
Photo 2 of 2 : FA_2016_ST0001_259_14_20161025_00078.jpg

Another view of the shrubs. Fall 2016.

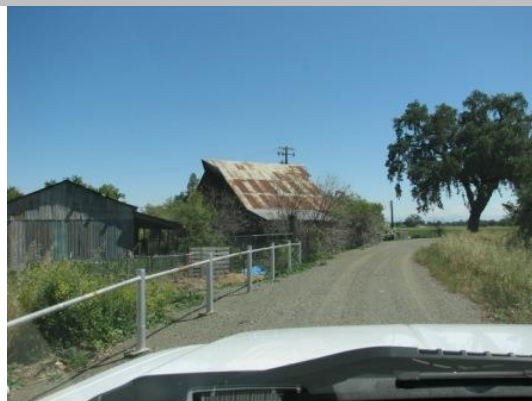
Photo 1 of 2 : FA_2016_ST0001_259_16_20160913_00016.jpg

Horse barn and corral are within the easement of the levee.

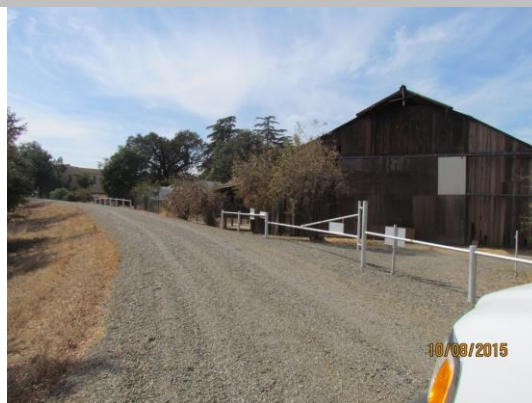
Photo 2 of 2 : FA_2016_ST0001_259_16_20160913_00017.jpg

View of the horse barn on the landward side of the levee looking upstream. Fall 2015.

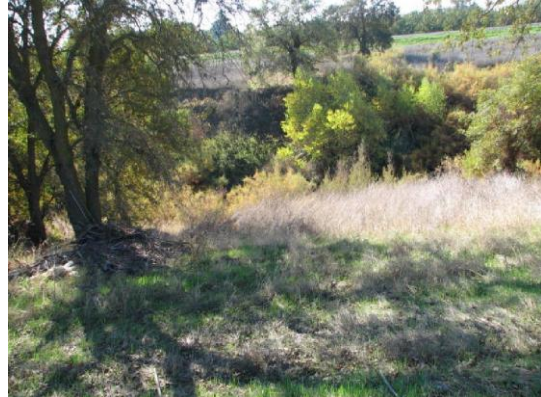
Photo 1 of 2 : UCIP_FA_2016_49099_60164.jpg

LM Start	2.26	Rating **	M	Issue No.	72
LM End	2.26	Issue Type +	En	Location *	LS
Category	Supplemental			GPS Latitude/Longitude	
				Start	End
Item	DWR UCIP Field Study			38.733675 °	38.733675 °
				-121.803009 °	-121.803009 °
DWR ID					
Comment Code					
Inspector Comment					
FS_ID:49099					
DS_ID:16268					
EP_NO: 2415					
Repair Type: Non-Urgent					
Crossing Status: Indicator Found					
UCIP Comments: May need to install gasoline marker on WS slope.					
FIELD_STRUCT_DESC: 20-inch gas line through the levee 4.0 feet below the crown. Two cutoff walls. Gasline indicator found on landside of the levee (Permit No. 2415 - PG&E)					
FS Date: 6/16/2016 7:00:04 AM

Waterside view: no indicators found

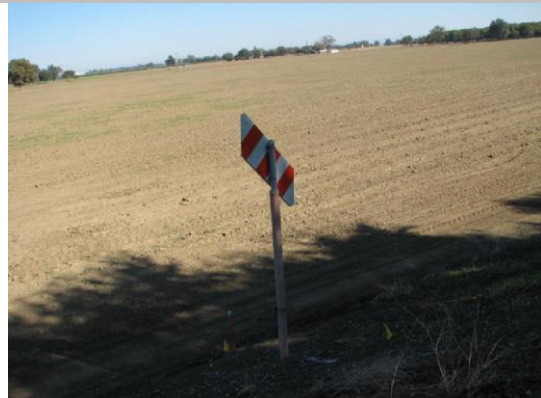
Photo 2 of 2 : UCIP_FA_2016_49099_60163.jpg

Landside view: gasoline indicator

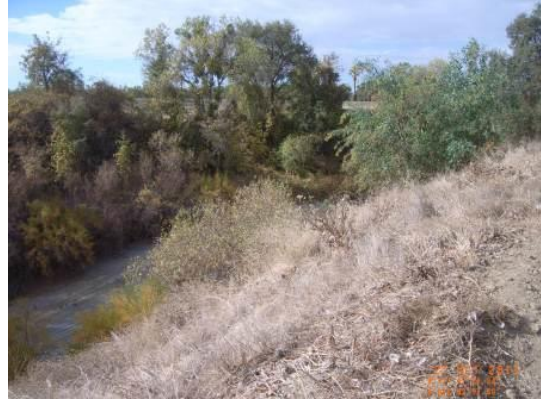
Photo 1 of 1 : FA_2016_ST0001_259_17_20160913_00018.jpg

LM Start	2.57	Rating **	A/W	Issue No.	17
LM End	2.61	Issue Type +	Ma	Location *	WS
Category	Supplemental			GPS Latitude/Longitude	
				Start	End
Item	2015 USACE Erosion Survey, DRAFT			38.732836 °	38.732685 °
				-121.797893 °	-121.797154 °
DWR ID	DWR_ST0001_01_s_2016_17				
Comment Code					
Inspector Comment					
Site identified as CRITICAL in 2002. 2006 - Currently constructing a setback levee. New failures present and extensive. Downstream end of the setback levee did not extend far enough. Upstream end was repaired. 2007 - DWR repaired with a setback levee, but the levee did not go far enough downstream. 2012 - New cracks observed. 2013 - Fresh erosion on upper bank. 2015: No observed changes. [2015 Site ID: CHC 2-4 L]

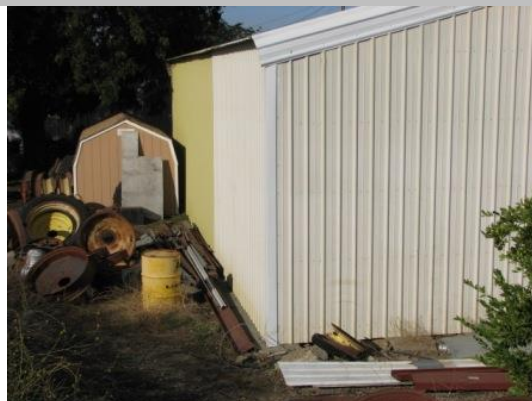
Photo 1 of 2 : FA_2016_ST0001_259_20_20160913_00022.jpg

The corner of the shop is within the easement of the levee. Fall 2011

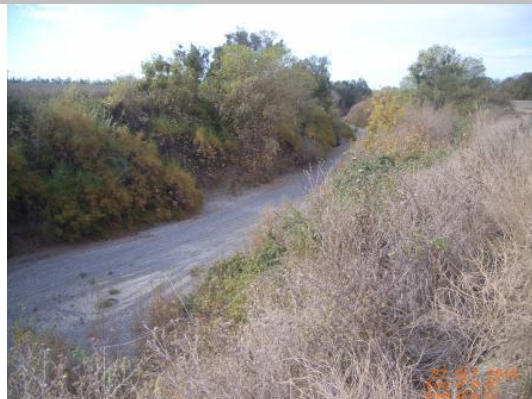
Photo 1 of 1 : FA_2016_ST0001_259_38_20160913_00032.jpg

LM Start	2.82	Rating **	A/W	Issue No.	38
LM End	2.86	Issue Type +	Ma	Location *	WS
Category	Supplemental			GPS Latitude/Longitude	
				Start	End
Item	2015 USACE Erosion Survey, DRAFT			38.734067 °	38.734171 °
				-121.793713 °	-121.792992 °
DWR ID	DWR_ST0001_01_s_2016_38				
Comment Code					
Inspector Comment					
2006 - Large new failure. 2008 - Plans for repair currently in the design phase. 2010 - Planned setback levee by CA DWR, 60% design complete, construction planned for 2012. 2011 - Construction delayed to 2013 - 2014. 2015: No observed changes. [2015 Site ID: CHC_2-8_L]

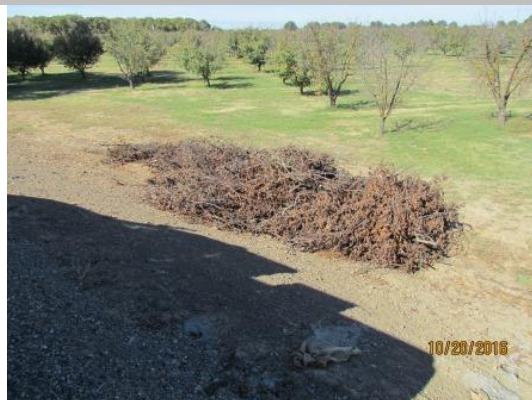
Photo 1 of 1 : FA_2016_ST0001_259_56_20161025_00076.jpg

Prunings on LS slope. Fall 2016.

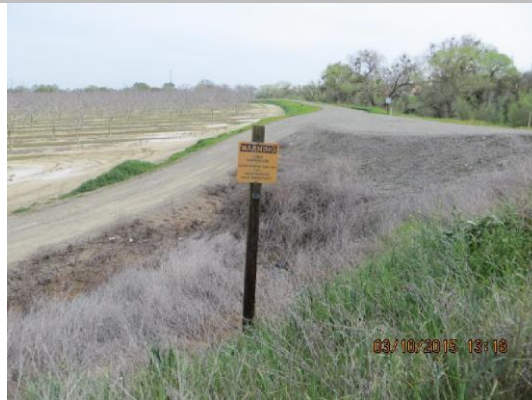
Photo 1 of 2 : UCIP_FA_2016_49111_73501.jpg

LM Start	4.98	Rating **	M	Issue No.	73
LM End	4.98	Issue Type +	En	Location *	LS
Category	Supplemental			GPS Latitude/Longitude	
				Start	End
Item	DWR UCIP Field Study			38.721038 °	38.721038 °
				-121.764180 °	-121.764180 °
DWR ID					
Comment Code					
Inspector Comment					
FS_ID:49111 DS_ID:16265 EP_NO: 7232 Repair Type: Non-Urgent Crossing Status: Indicator Found UCIP Comments: May need marker on WS. FIELD_STRUCT_DESC: Submarine Communication cable through the levee 2.5-feet below the crown. Communication marker located on eastside of highway 113 on LS toe. (Permit No. 7232 - PT&T). FS Date: 6/16/2016 7:08:33 AM

Sign on LS toe.

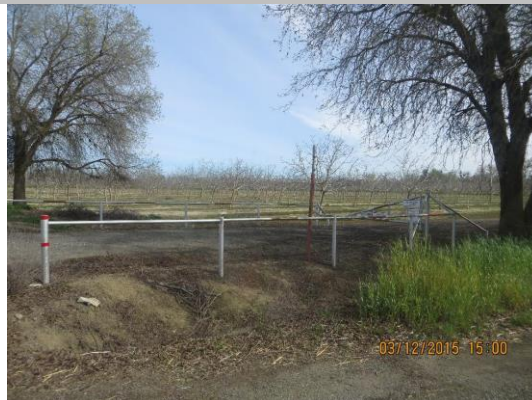
Photo 1 of 2 : UCIP_FA_2016_49112_73504.jpg

LM Start	4.99	Rating **	M	Issue No.	74
LM End	4.99	Issue Type +	En	Location *	LS
Category	Supplemental			GPS Latitude/Longitude	
				Start	End
Item	DWR UCIP Field Study			38.721025 °	38.721025 °
				-121.764147 °	-121.764147 °
DWR ID					
Comment Code					
Inspector Comment					
FS_ID:49112					
DS_ID:16756					
EP_NO: 3089					
Repair Type: Non-Urgent					
Crossing Status: Indicator Found					
UCIP Comments: Signage in disrepair and need signs at Levee. Need to contact owner to determine status of crossing and install new signs if appropriate to do so.					
FIELD_STRUCT_DESC: 4-inch steel gas line through the levee 4-feet below the crown.Gasline marker located 500-feet north of levee crossing at levee access road/gate. Pipe alignment to east of bridge (Permit No. 3089, 1959).					
FS Date: 6/16/2016 7:09:02 AM

Gasline marker next to levee access gate 500-feet north of levee crown.

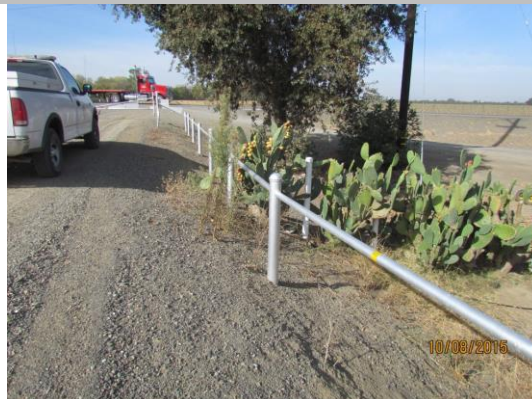
Photo 1 of 1 : FA_2016_ST0001_259_57_20160913_00043.jpg

View of the cactus on the landward side of the levee looking upstream. Fall 2015.

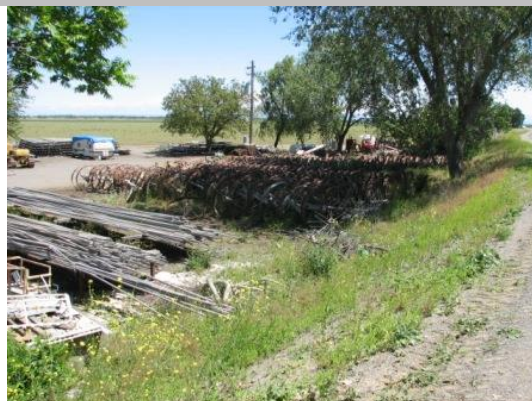
Photo 1 of 2 : FA_2016_ST0001_259_40_20160913_00034.jpg

Irrigation pipe and equipment are within the easement of the levee.

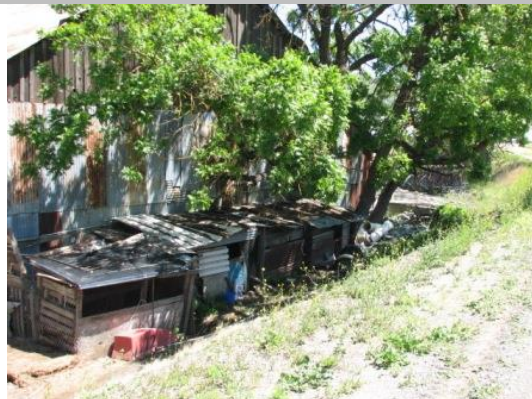
Photo 1 of 1 : FA_2016_ST0001_259_39_20160913_00033.jpg

The barn and livestock pens are within the easement of the levee.

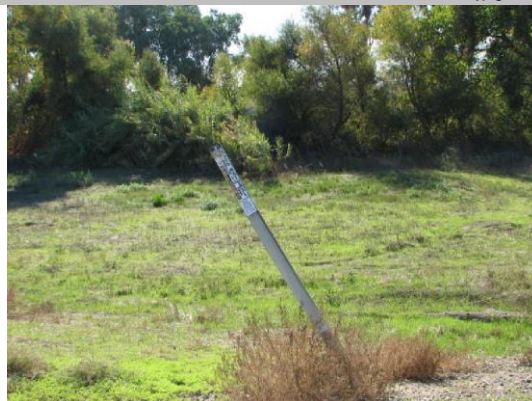
Photo 1 of 2 : UCIP_FA_2016_50811_60197.jpg

LM Start	7.89	Rating **	M	Issue No.	76
LM End	7.89	Issue Type +	En	Location *	LS
Category	Supplemental			GPS Latitude/Longitude	
				Start	End
Item	DWR UCIP Field Study			38.727333 °	38.727333 °
				-121.718558 °	-121.718558 °
DWR ID					
Comment Code					
Inspector Comment					
FS_ID:50811					
DS_ID:16264					
EP_NO: 12983					
Repair Type: Non-Urgent					
Crossing Status: Indicator Found					
UCIP Comments: Gasline markers in disrepair and should be replaced.					
Gasline indicator found on waterside of the levee.					
FIELD_STRUCT_DESC: 6-inch diameter gas pipeline through the levee					
(App. No. 12983 - Shell Oil Co.). To install a 4-inch and 6-inch gas					
pipeline crossing Cache Creek, Cache Creek levees, and the Cache					
Creek Settling Basin.					
FS Date: 11/21/2016 7:56:33 AM

Waterside view: gasline indicator

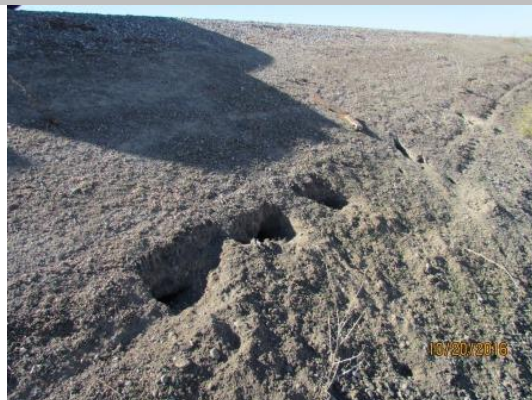
Photo 1 of 1 : FA_2016_ST0001_259_34_20161025_00067.jpg

Rodent holes on landside slope of the levee. Fall 2016.

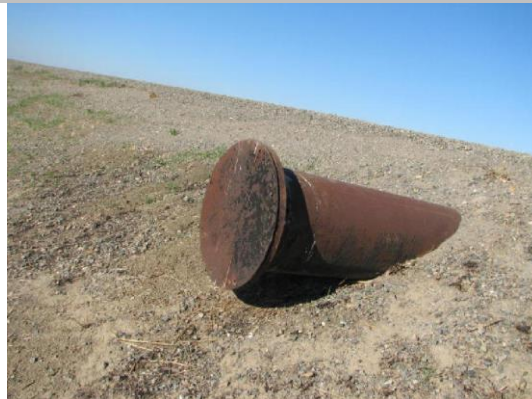
Photo 2 of 2 : UCIP_FA_2016_50812_60223.jpg

Waterside view: closer look at capped pipe.

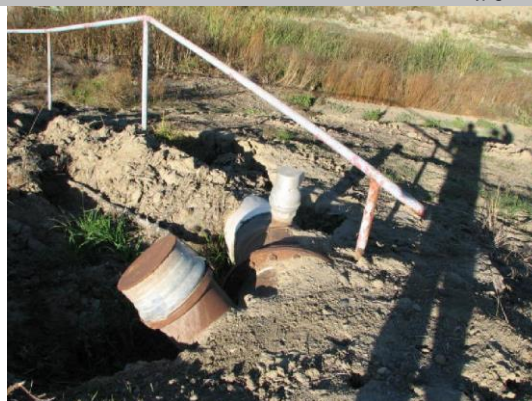
Photo 2 of 2 : UCIP_FA_2016_50813_60147.jpg

Landside view: pipe daylight on LS levee slope

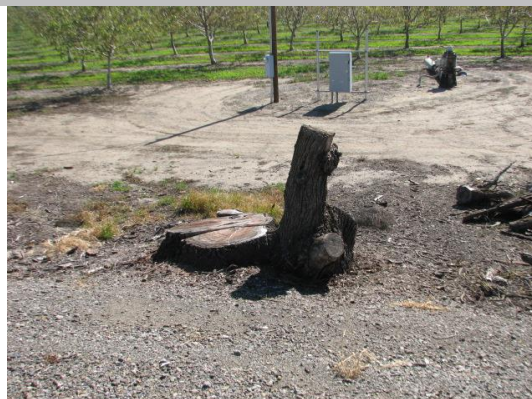
Photo 1 of 1 : FA_2016_ST0001_260_6_20160913_00004.jpg

A large black walnut tree stump is at the toe of the levee. Spring 2014

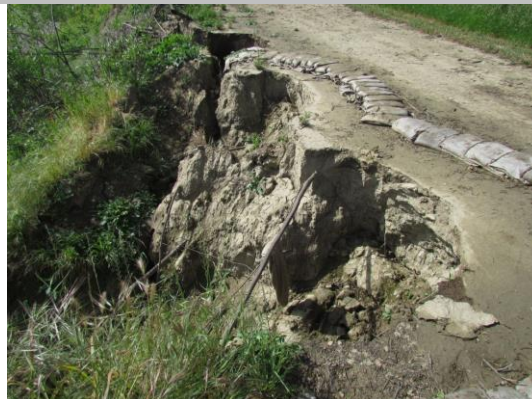
Photo 2 of 2 : FA_2016_ST0001_260_11_20160913_00010.jpg

View of the erosion on the channel looking downstream. Spring 2015.

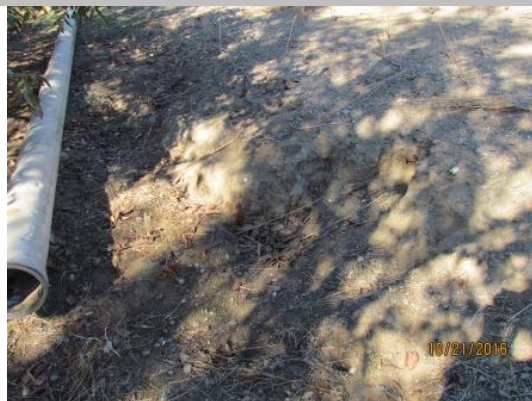
Photo 1 of 1 : FA_2016_ST0001_260_4_20161025_00020.jpg

Erosion on LS levee slope toward the toe. Fall 2016.

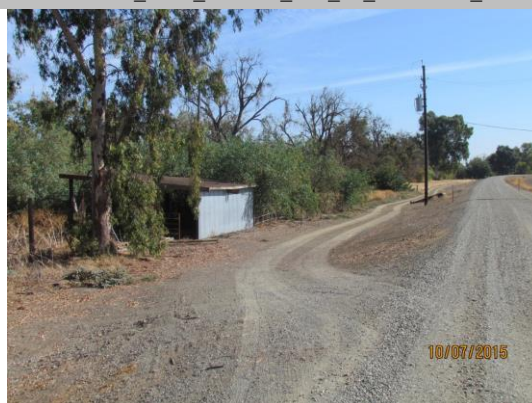
Photo 1 of 1 : FA_2016_ST0001_260_27_20160913_00016.jpg

View of the horse corral and building on the waterward side of the levee looking downstream. Fall 2015.
