**Flood Control Project Maintenance
Levee Inspections**

Fall 2017 Levee Maintenance Deficiency Summary Report

Overall LMA & Unit Ratings, including USACE Erosion Survey

Sacramento River Basin

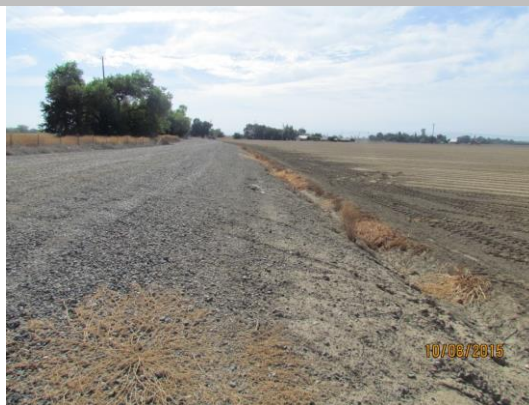
Photo 2 of 2 : FA_2017_ST0001_259_48_20170911_00038.jpg

View of the ditch on the landward side of the levee looking upstream.
Fall 2015.

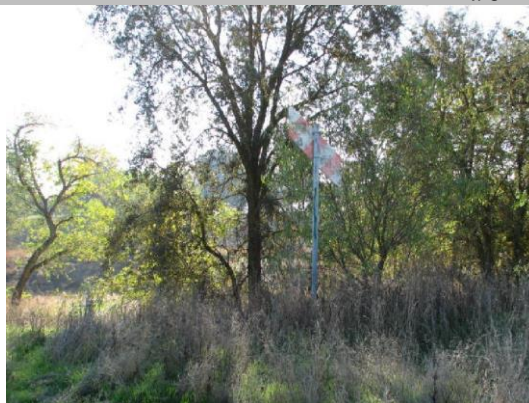
Photo 1 of 3 : UCIP_FA_2017_50432_60162.jpg

| FS_ID:50432 DS_ID:16270 EP_NO: 6790 Repair Type: Non-Urgent Crossing Status: Indicator Found UCIP Comments: May need additional signs on LS of levee. FIELD_STRUCT_DESC: 6-inch high-pressure natural gas main of an unknown material through the levee and under the channel, at an unknown depth. Gas line marker on the waterside (WS) slope. (6-inch high-pressure natural gas main authorized under Permit No. 6790, 1969 - Pacific Gas and Electric Company [PG&E]). [Additional Reference(s): DWR Levee Log, 1993]. FS Date: 6/16/2016 6:58:00 AM | | | | | |

Waterside view: gasline marker

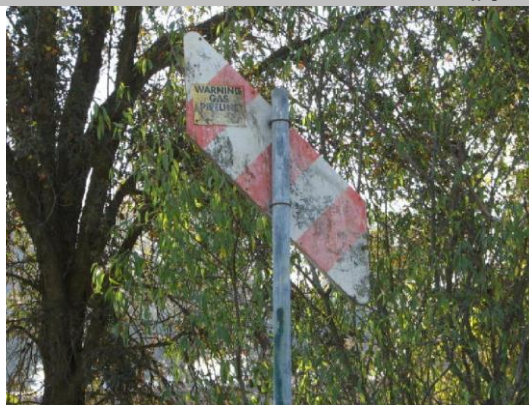
Photo 2 of 3 : UCIP_FA_2017_50432_60161.jpg

Waterside view: closer look at gasline marker

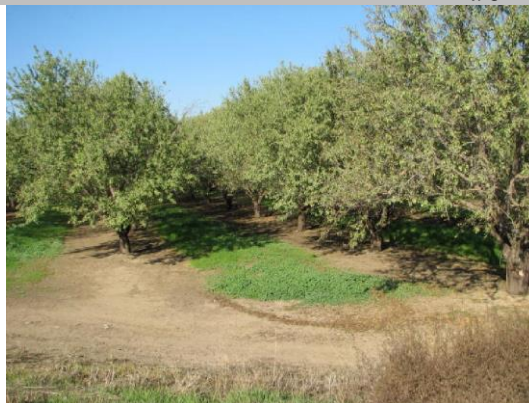
Photo 3 of 3 : UCIP_FA_2017_50432_60160.jpg

| FS_ID:50432 DS_ID:16270 EP_NO: 6790 Repair Type: Non-Urgent Crossing Status: Indicator Found UCIP Comments: May need additional signs on LS of levee. FIELD_STRUCT_DESC: 6-inch high-pressure natural gas main of an unknown material through the levee and under the channel, at an unknown depth. Gas line marker on the waterside (WS) slope. (6-inch high-pressure natural gas main authorized under Permit No. 6790, 1969 - Pacific Gas and Electric Company [PG&E]). [Additional Reference(s): DWR Levee Log, 1993]. FS Date: 6/16/2016 6:58:00 AM | | | | | | |

Landside view: no gasoline marker

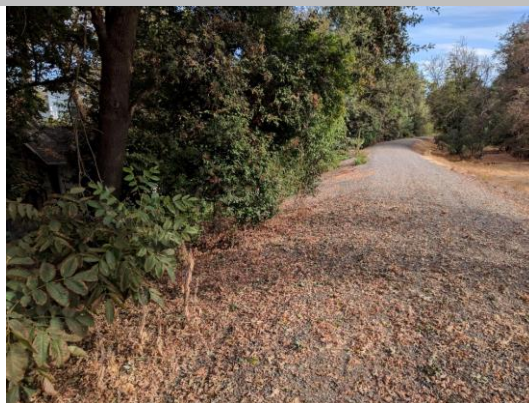
Photo 1 of 3 : FA_2017_ST0001_259_3_20170914_00078.jpg

View of thick vegetation on landside slope. Fall 2017.

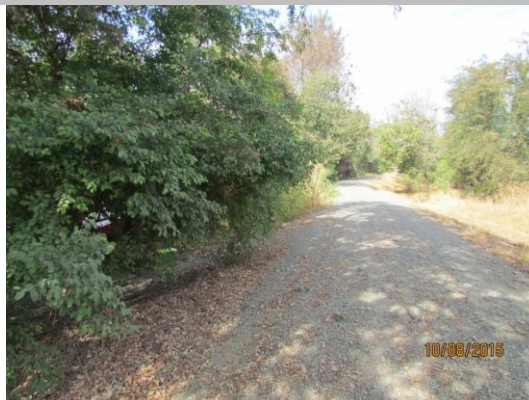
Photo 2 of 3 : FA_2017_ST0001_259_3_20170911_00003.jpg

View of the landscaping that needs to be trimmed on the landward side of the levee looking downstream. Fall 2015.

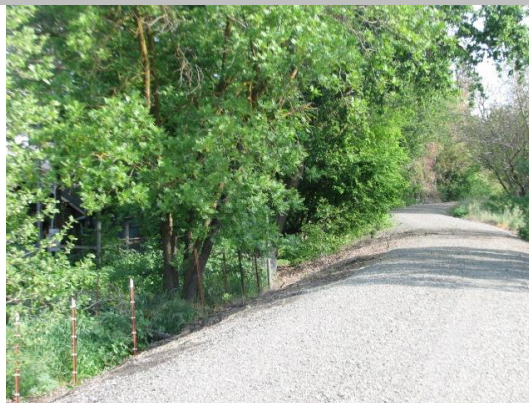
Photo 3 of 3 : FA_2017_ST0001_259_3_20170911_00002.jpg

The landscape needs to be trimmed up. Spring 2014

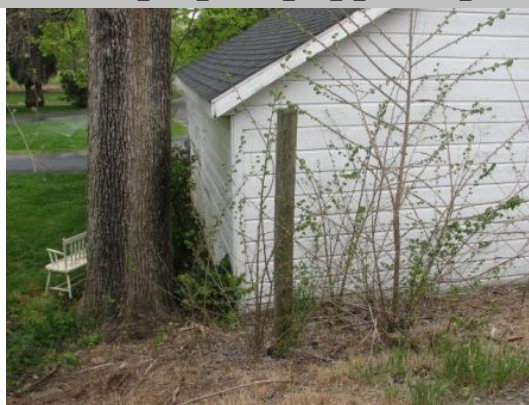
Photo 1 of 1 : FA_2017_ST0001_259_4_20170911_00004.jpg

The building backs up to the landside levee toe of the levee.

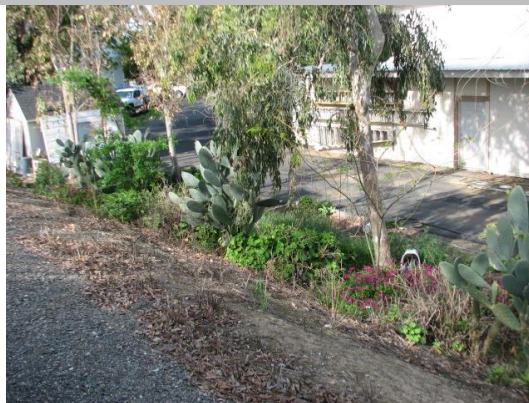
Photo 1 of 1 : FA_2017_ST0001_259_28_20170911_00026.jpg

The property owner has planted cactus along the toe of the levee. Spring 2014

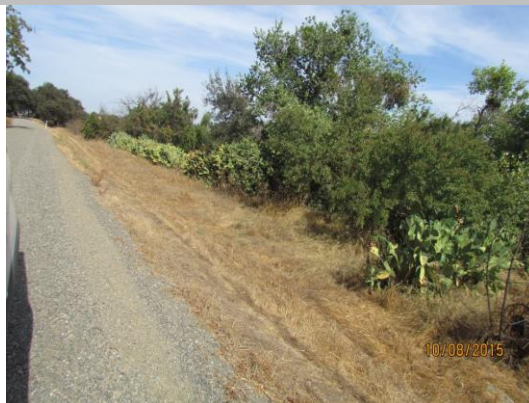
Photo 1 of 1 : FA_2017_ST0001_259_6_20170911_00005.jpg

View of the cactus landscaping on the waterward side of the levee looking downstream. Fall 2015.

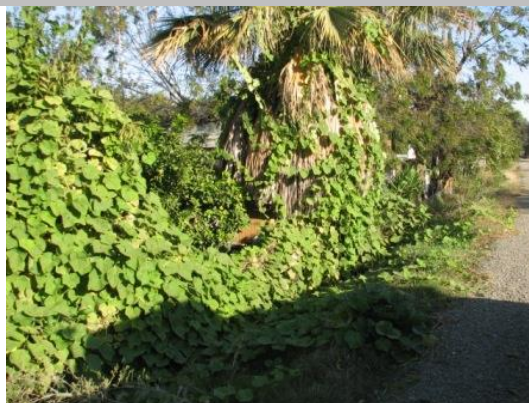
Photo 1 of 2 : FA_2017_ST0001_259_7_20170911_00006.jpg

Wild grape and other plants are obstructing the view for inspection. Fall 2011

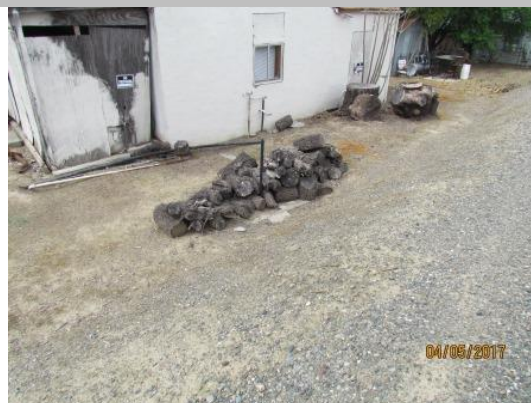
Photo 1 of 1 : FA_2017_ST0001_259_82_20170911_00058.jpg

Firewood pile at landside levee toe. Spring 2017.

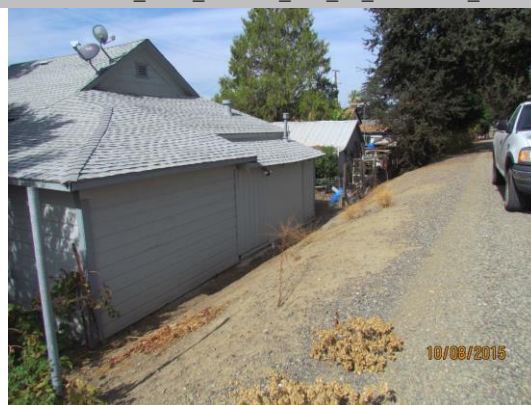
Photo 1 of 1 : FA_2017_ST0001_259_10_20170911_00010.jpg

View of the house on the landward side of the levee looking downstream. Fall 2015.

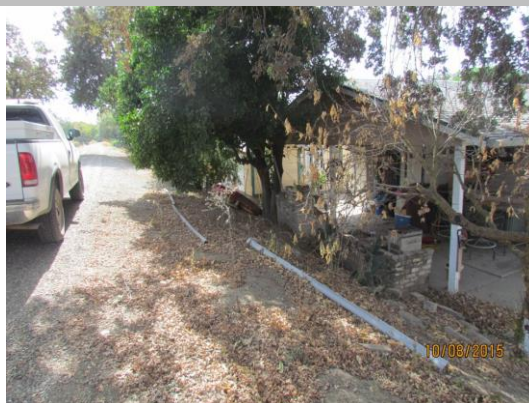
Photo 1 of 1 : FA_2017_ST0001_259_13_20170911_00013.jpg

View of the building on the landward side of the levee looking upstream. Fall 2015.

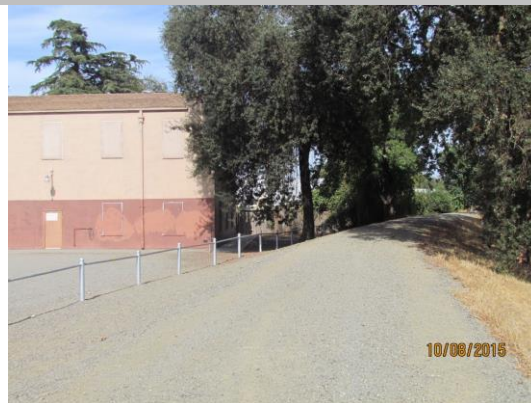
Photo 1 of 1 : FA_2017_ST0001_259_12_20170911_00012.jpg

View of the building on the landward side of the levee looking downstream. Fall 2015.

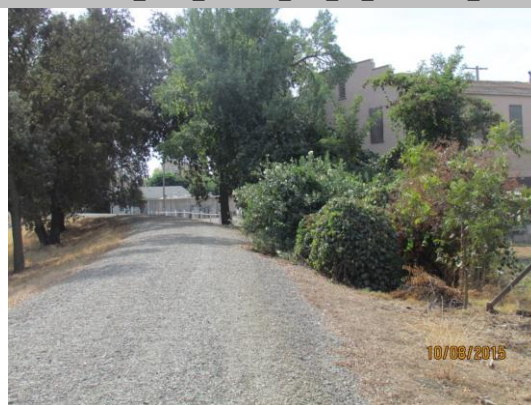
Photo 1 of 2 : FA_2017_ST0001_259_14_20170911_00014.jpg

View of the shrubs on the landward side of the levee looking upstream. Fall 2015.

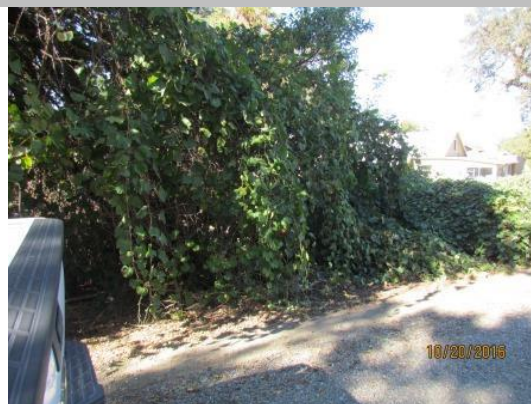
Photo 2 of 2 : FA_2017_ST0001_259_14_20170911_00015.jpg

Another view of the shrubs. Fall 2016.

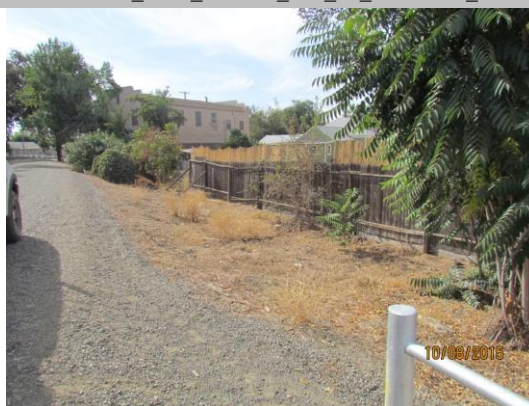
Photo 1 of 1 : FA_2017_ST0001_259_15_20170911_00016.jpg

View of the fence on the landward side of the levee looking upstream.
Fall 2015.

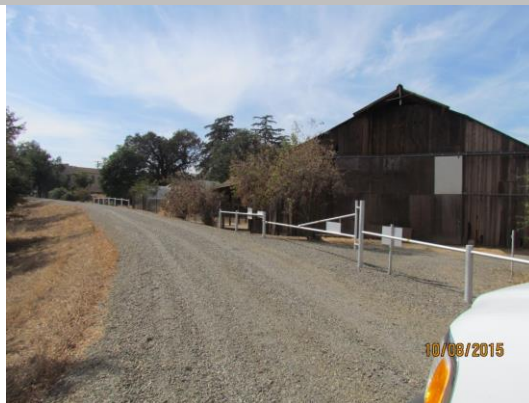
Photo 2 of 2 : FA_2017_ST0001_259_16_20170911_00018.jpg

View of the horse barn on the landward side of the levee looking upstream. Fall 2015.

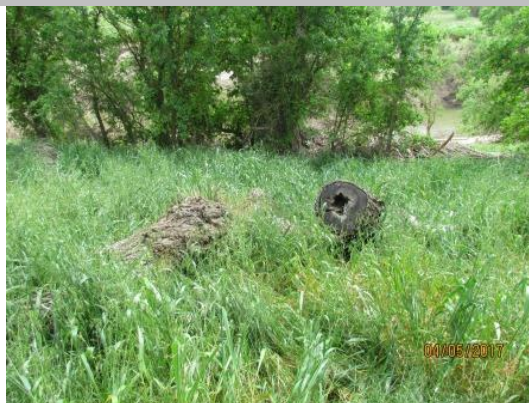
Photo 1 of 1 : FA_2017_ST0001_259_81_20170911_00057.jpg

Dead tree stumps on waterside levee slope. Spring 2017.

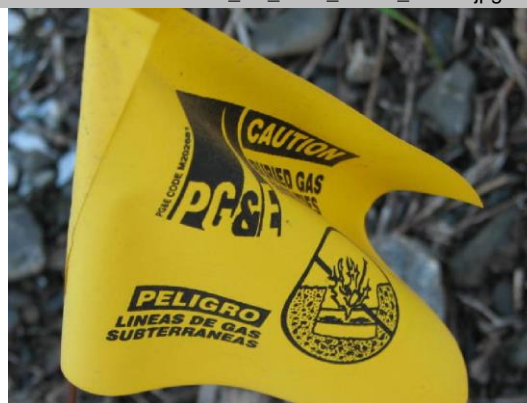
Photo 3 of 3 : UCIP_FA_2017_49099_60165.jpg

| FS_ID:49099 DS_ID:16268 EP_NO: 2415 Repair Type: Non-Urgent Crossing Status: Indicator Found UCIP Comments: May need to install gasoline marker on WS slope. FIELD_STRUCT_DESC: 20-inch wrapped steel natural gas pipeline through the levee, 4 feet below the crown. Two cutoff walls. Gas line indicator found on the landside (LS) of the levee. (20-inch wrapped steel natural gas pipeline authorized under Permit No. 2415, 1956 - Pacific Gas and Electric Company [PG&E]). [Additional Reference(s): DWR Levee Log, 1993. USACE Sacramento O&M Manual 126, November 1961, (HLM 2.24)]. FS Date: 6/16/2016 7:00:04 AM | | | | | |

Landside view: gasoline indicator/flag

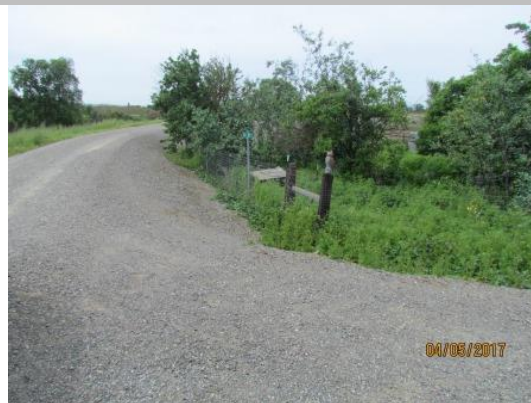
Photo 1 of 1 : FA_2017_ST0001_259_78_20170911_00056.jpg

Chain fence at landside levee toe. Spring 2017.

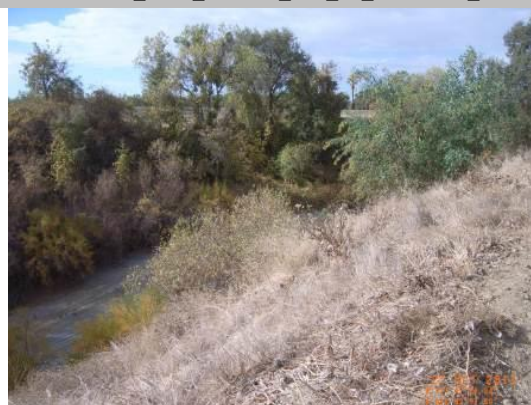
Photo 1 of 1 : FA_2017_ST0001_259_17_20170911_00019.jpg

| Site identified as CRITICAL in 2002. 2006 - Currently constructing a setback levee. New failures present and extensive. Downstream end of the setback levee did not extend far enough. Upstream end was repaired. 2007 - DWR repaired with a setback levee, but the levee did not go far enough downstream. 2012 - New cracks observed. 2013 - Fresh erosion on upper bank. 2015: No observed changes. [2015 Site ID: CHC_2-4_L] | | | | | |

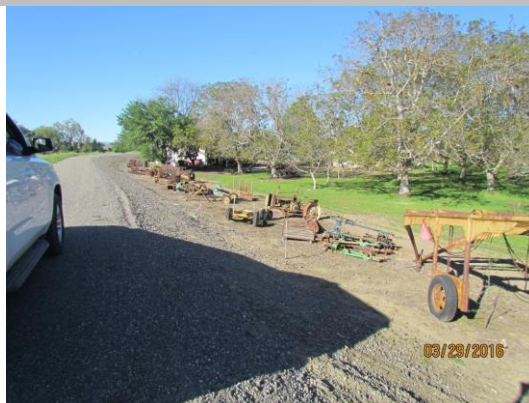
Photo 1 of 1 : FA_2017_ST0001_259_71_20170911_00053.jpg

View of the equipment on the landward side of the levee looking upstream. Spring 2016.

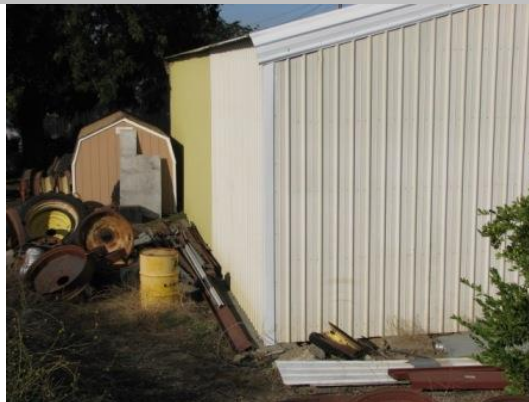
Photo 1 of 2 : FA_2017_ST0001_259_20_20170911_00020.jpg

The corner of the shop is within the easement of the levee. Fall 2011

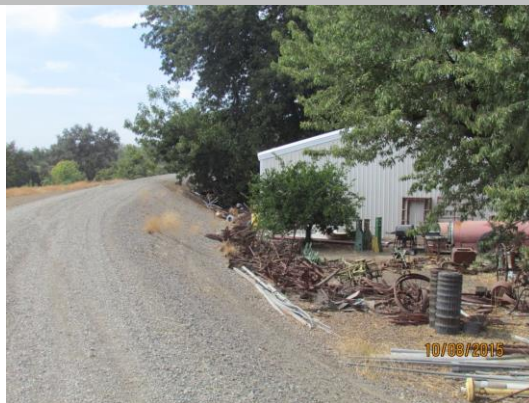
Photo 2 of 2 : FA_2017_ST0001_259_20_20170911_00021.jpg

View of the building on the landward side of the levee looking upstream.
Fall 2015.

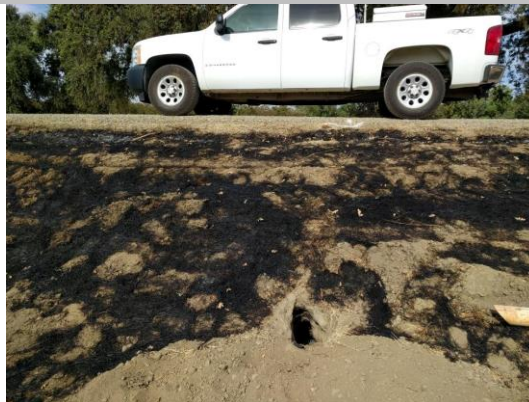
Photo 1 of 1 : FA_2017_ST0001_259_38_20170914_00079.jpg

View of rodent hole on landside slope. Fall 2017.

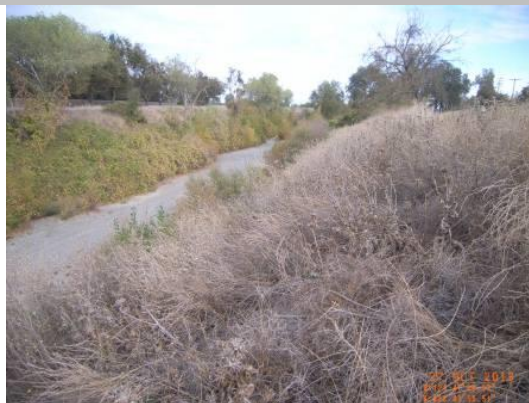
Photo 1 of 1 : FA_2017_ST0001_259_1_20170911_00001.jpg

| 2006 - Some significant new erosion, especially fresh upper bank slumping. Still substantial berm. 2010 - Site extended downstream, some new erosion, heavily vegetated and hard to see. Planned setback levee by CA DWR, 60% design complete, construction planned for 2012. 2011 - Construction delayed to 2013 - 2014. 2015: No observed changes. [2015 Site ID: CHC 3-4 L] | | | | | |

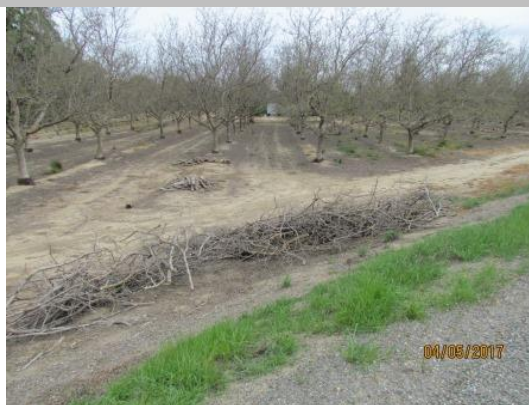
Photo 1 of 1 : FA_2017_ST0001_259_75_20170911_00054.jpg

Prunings at landside levee toe. Spring 2017.

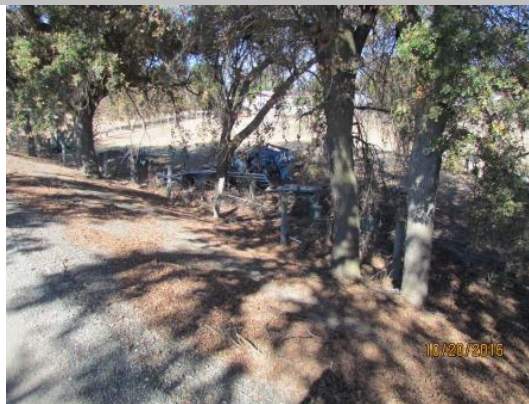
Photo 1 of 1 : FA_2017_ST0001_259_52_20170911_00041.jpg

Fence on landside slope. Fall 2016.

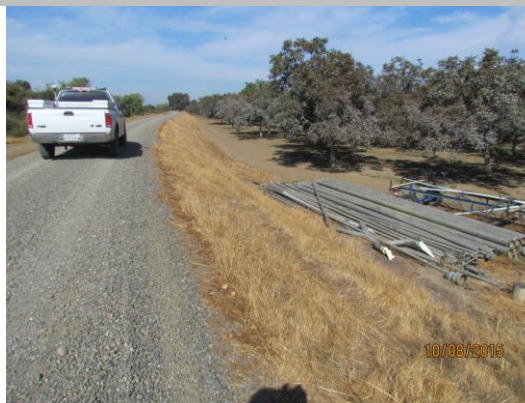
Photo 1 of 1 : FA_2017_ST0001_259_24_20170911_00022.jpg

View of the aluminum irrigation pipe along the levee toe of the landward side looking upstream. Fall 2015.

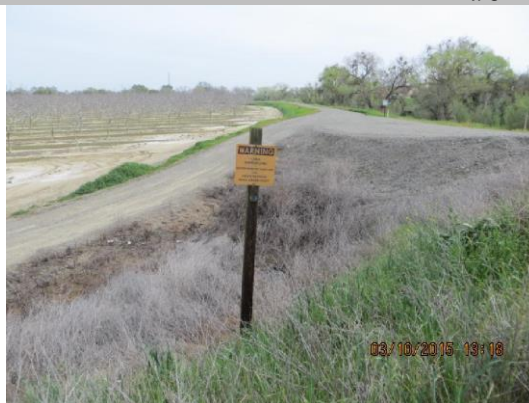
Photo 1 of 2 : UCIP_FA_2017_49111_73501.jpg

| FS_ID:49111 DS_ID:16265 EP_NO: 7232 Repair Type: Non-Urgent Crossing Status: Indicator Found UCIP Comments: May need marker on WS. FIELD_STRUCT_DESC: Telephone conduit of an unknown size or material through the levee, 2.5 feet below the crown. Communications marker located on the east side of Highway 113 on the landside (LS) toe. (Telephone conduit authorized under Permit No. 7232, 1970 - Pacific Telephone and Telegraph Company [PT&T]). [Additional Reference(s): DWR Levee Log, 1993]. FS Date: 6/16/2016 7:08:33 AM | | | | | |

Sign on LS toe.

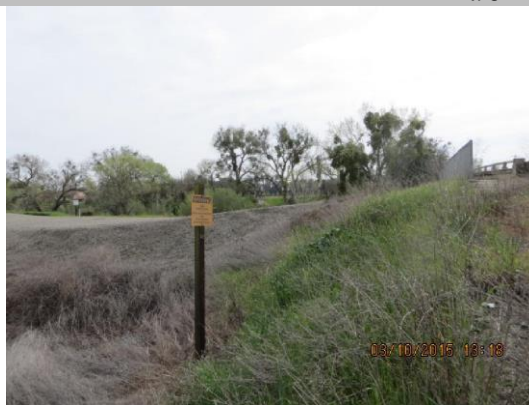
Photo 2 of 2 : UCIP_FA_2017_49111_73500.jpg

Sign on LS toe.

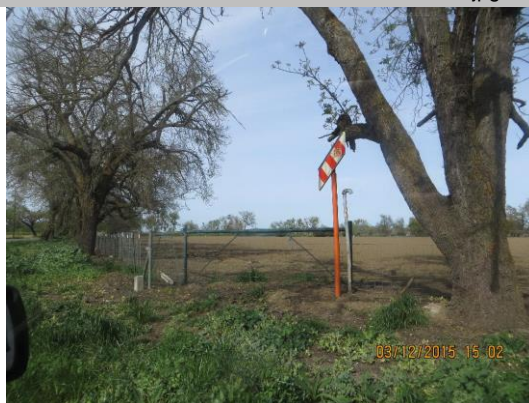
Photo 2 of 2 : UCIP_FA_2017_49112_73503.jpg

| FIELD_STRUCT_DESC: 4-inch steel natural gas pipeline through the levee, 4 feet below the crownGas line marker located 500 feet north of the levee crossing at the levee access road/gate. Pipe alignment to east of bridge. (4-inch natural gas pipeline grouted in place and replaced with a 4-inch steel natural gas pipeline to east side of bridge under Permit No. 3089, 1959 - Yolo County Sales Company). | | | | | | |

Gasline marker at Best Ranch Road, 1500-feet south of levee crossing.

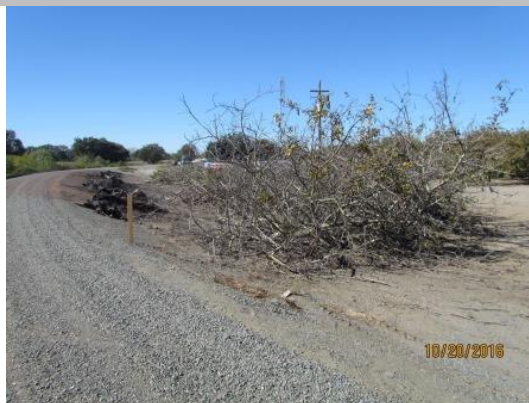
Photo 2 of 2 : FA_2017_ST0001_259_45_20170911_00035.jpg

View of prunings on landside slope. Fall 2016.

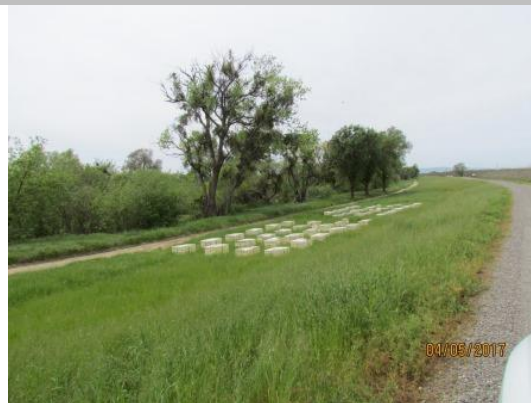
Photo 1 of 1 : FA_2017_ST0001_259_68_20170911_00050.jpg

Beehives at waterside levee toe. Spring 2017.

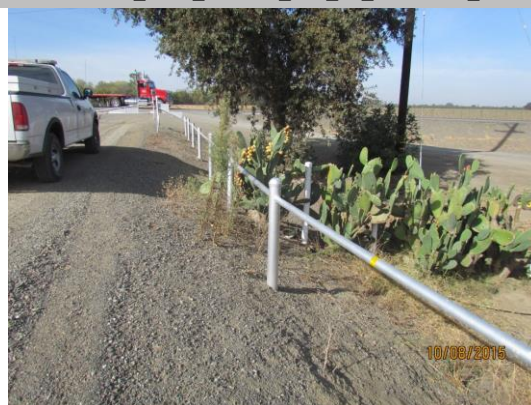
Photo 1 of 1 : FA_2017_ST0001_259_57_20170911_00045.jpg

View of the cactus on the landward side of the levee looking upstream. Fall 2015.

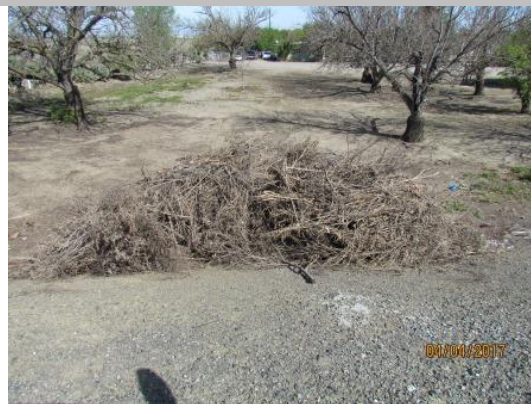
Photo 1 of 1 : FA_2017_ST0001_259_35_20170911_00029.jpg

Prunings at landside levee toe. Spring 2017.

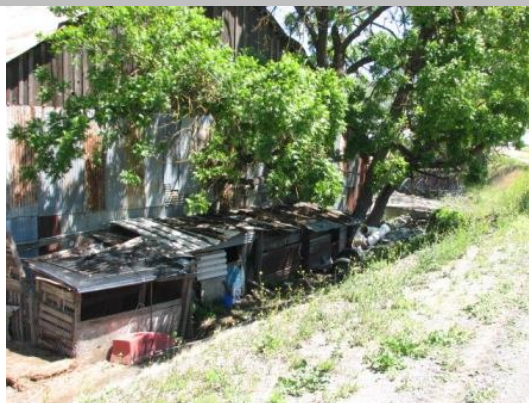
Photo 1 of 1 : FA_2017_ST0001_259_39_20170911_00030.jpg

The barn and livestock pens are within the easement of the levee.

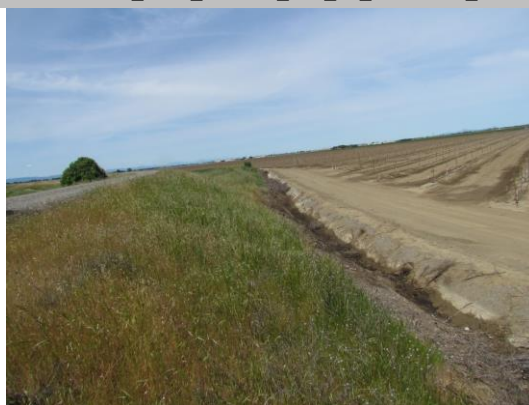
Photo 1 of 2 : FA_2017_ST0001_259_26_20170911_00024.jpg

View of ditch on the landward side of the levee looking upstream. Spring 2015.

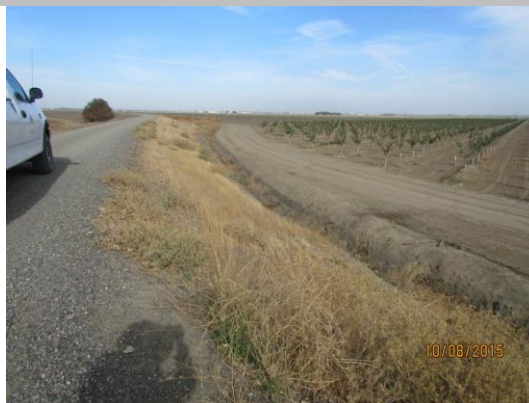
Photo 2 of 2 : FA_2017_ST0001_259_26_20170911_00025.jpg

View of the ditch on the landward side of the levee looking upstream. Fall 2015.

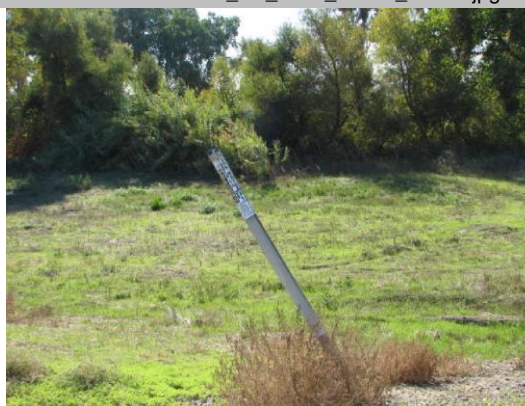
Photo 1 of 2 : UCIP_FA_2017_50811_60197.jpg

Waterside view: gasline indicator

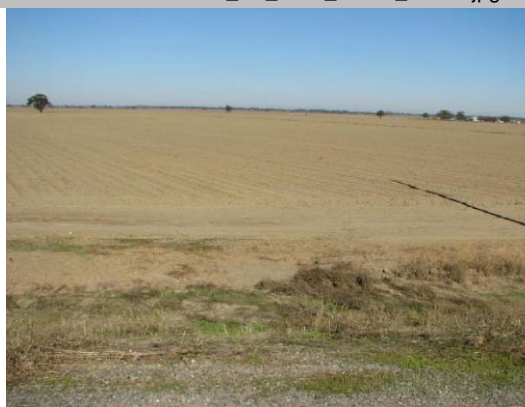
Photo 2 of 2 : UCIP_FA_2017_50811_60196.jpg

Landside view: no indicator found.

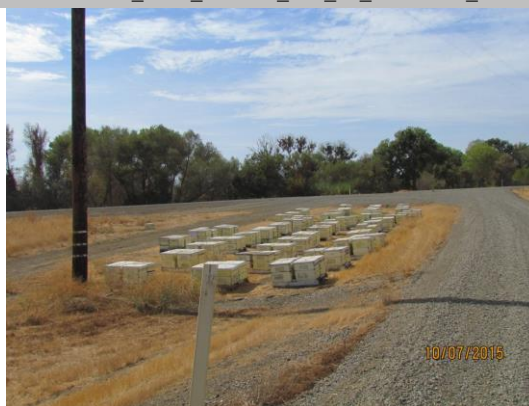
Photo 1 of 1 : FA_2017_ST0001_259_50_20170911_00039.jpg

View of the beehives on the waterward side of the levee looking upstream. Fall 2015.

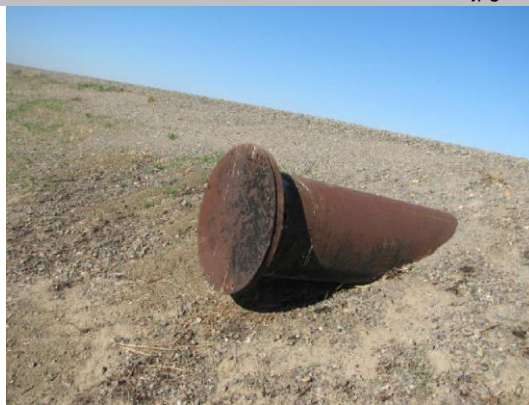
Photo 2 of 3 : UCIP_FA_2017_52531_60223.jpg

Waterside view: closer look at capped pipe.

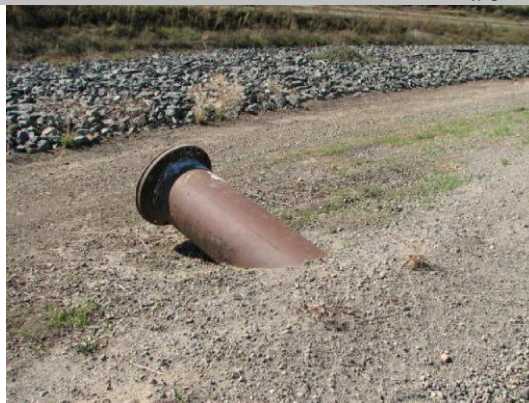
Photo 3 of 3 : UCIP_FA_2017_52531_60222.jpg

Waterside view: steel pipe on the slope of the levee

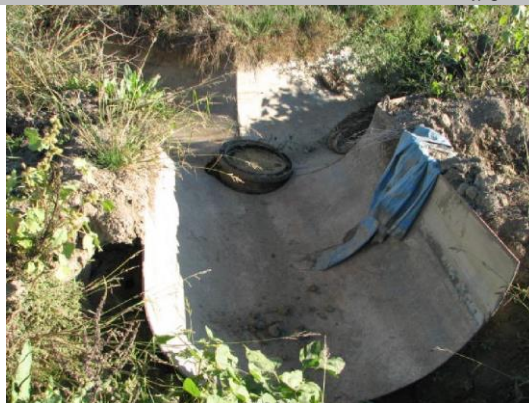
Photo 1 of 3 : UCIP_FA_2017_52532_60148.jpg

Waterside view: pipe in the ditch

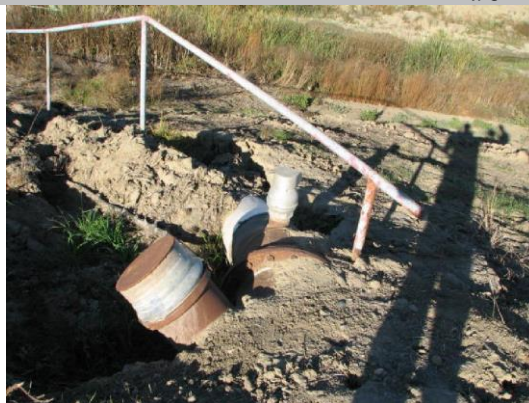
Photo 2 of 3 : UCIP_FA_2017_52532_60147.jpg

Landside view: pipe daylight on LS levee slope

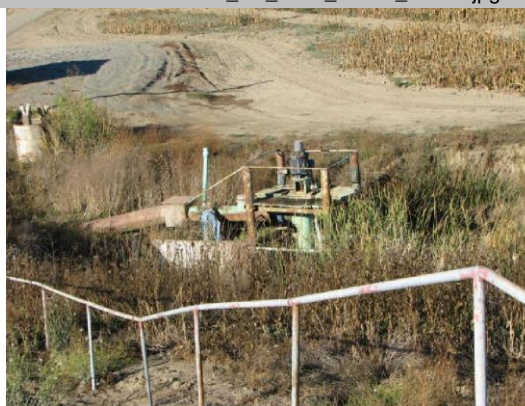
Photo 3 of 3 : UCIP_FA_2017_52532_60149.jpg

Landside view: pumping plant

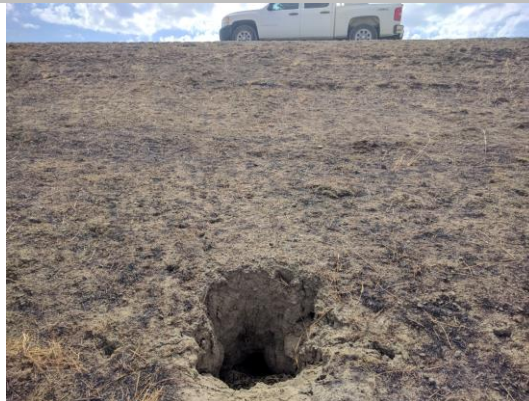
Photo 1 of 1 : FA_2017_ST0001_259_58_20170914_00080.jpg

View of large rodent hole on landside slope. Fall 2017.

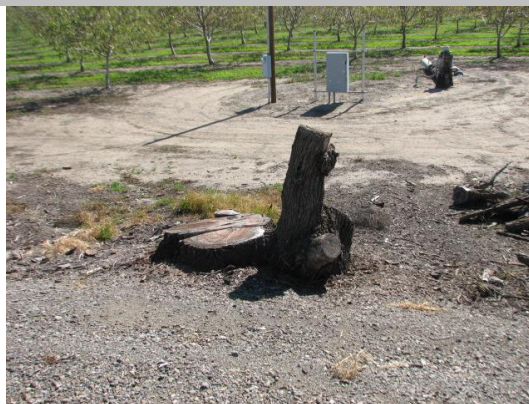
Photo 1 of 1 : FA_2017_ST0001_260_6_20170911_00007.jpg

A large black walnut tree stump is at the toe of the levee. Spring 2014

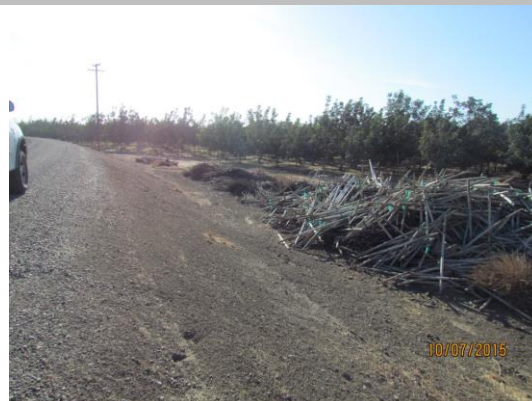
Photo 1 of 1 : FA_2017_ST0001_260_1_20170911_00001.jpg

View of the prunings and stakes at the toe of the landward side of the levee looking downstream. Fall 2015.

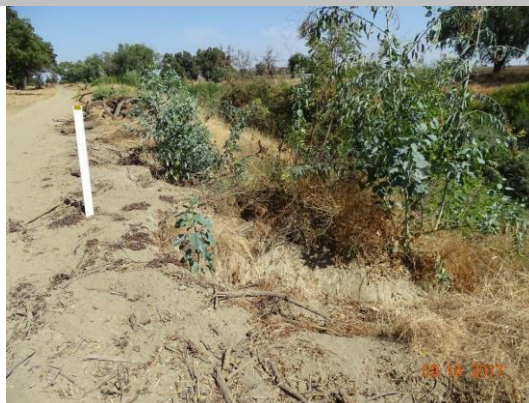
Photo 1 of 1 : FA_2017_ST0001_260_16_20170914_00035.jpg

View of storm damage site on waterside berm. Does not appear to be within the levee prism at this time. Fall 2017.

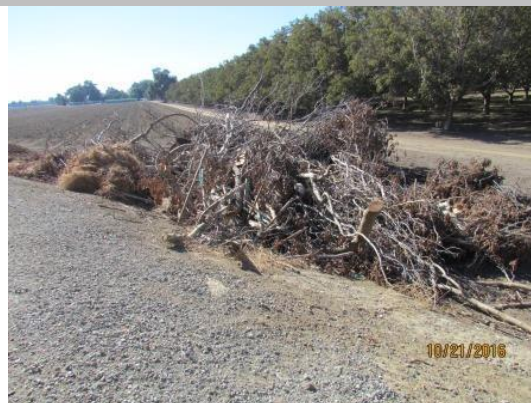
Photo 1 of 1 : FA_2017_ST0001_260_20_20170911_00021.jpg

View of prunings on LS slope of the levee. Fall 2016.

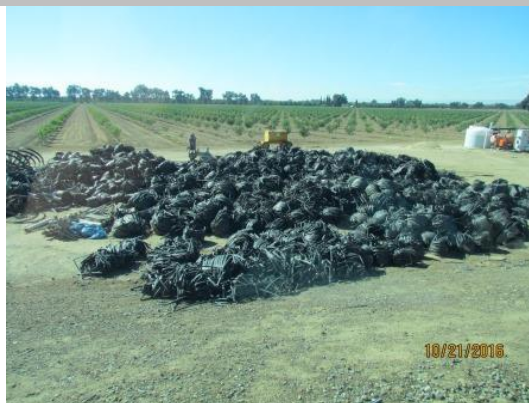
Photo 1 of 2 : FA_2017_ST0001_260_3_20170911_00003.jpg

Additional view of debris at the same site on landward side of the levee.
Fall 2016.

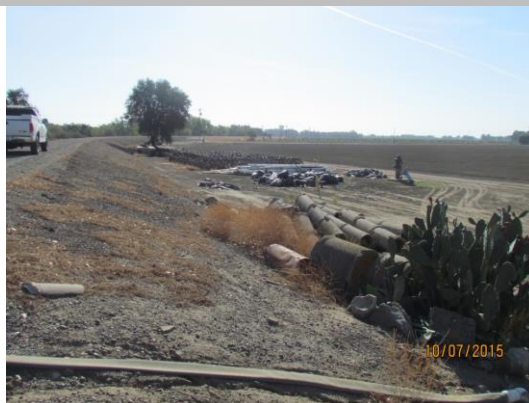
Photo 2 of 2 : FA_2017_ST0001_260_3_20170911_00004.jpg

View of the concrete pile at the toe of the landward side of the levee
looking downstream. Fall 2015.

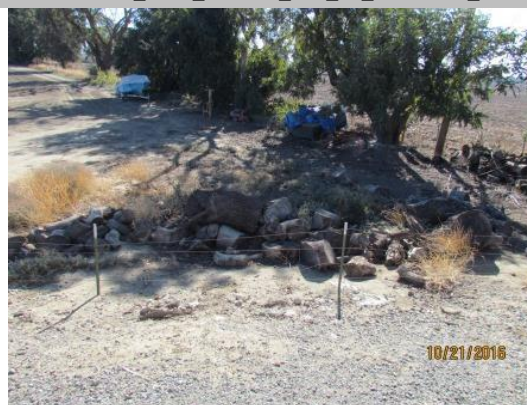
Photo 1 of 1 : FA_2017_ST0001_260_17_20170911_00019.jpg

View of firewood at LS levee toe. Fall 2016.

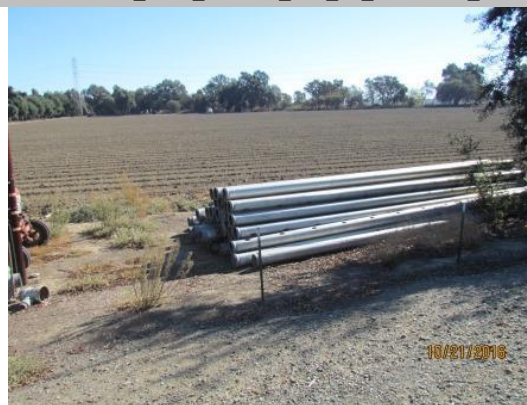
Photo 1 of 1 : FA_2017_ST0001_260_12_20170911_00014.jpg

Pipes are stored at levee toe on landside. Fall 2016.

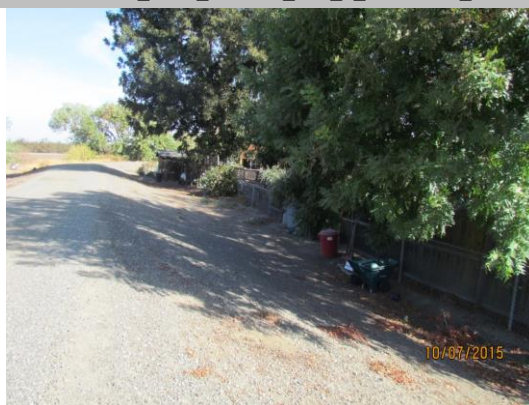
Photo 1 of 1 : FA_2017_ST0001_260_7_20170911_00008.jpg

View of the landscaping and fence on the landward side of the levee looking downstream. Fall 2015.

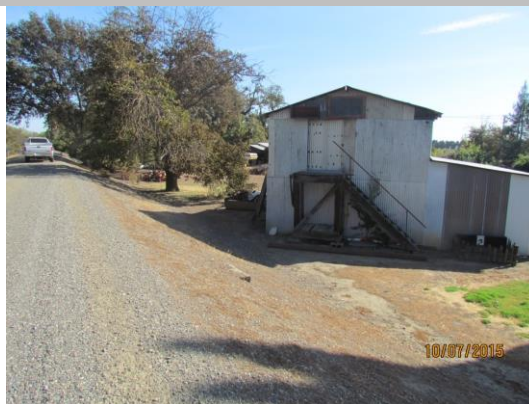
Photo 1 of 1 : FA_2017_ST0001_260_8_20170911_00009.jpg

View of the building on the landward side of the levee looking downstream. Fall 2015.

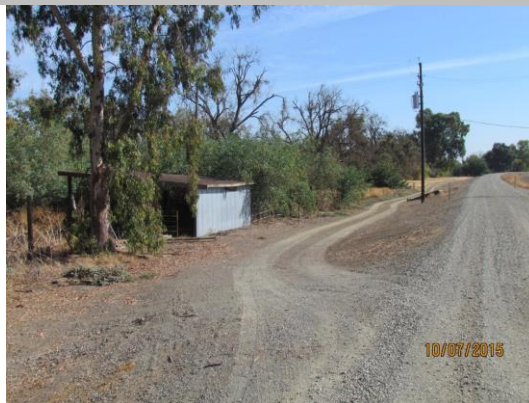
Photo 1 of 1 : FA_2017_ST0001_260_27_20170911_00027.jpg

View of the horse corral and building on the waterward side of the levee looking downstream. Fall 2015.

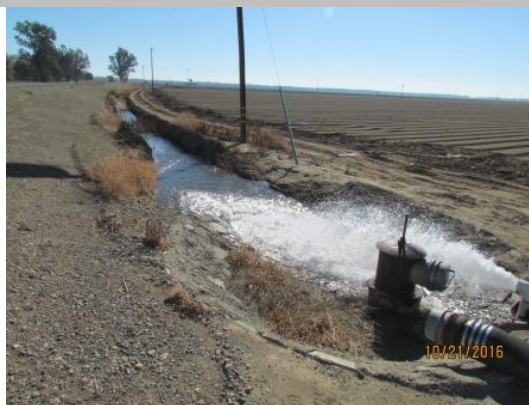
Photo 2 of 2 : FA_2017_ST0001_260_14_20170911_00017.jpg

View of ditch on landside near the levee toe looking downstream of Cache Creek. Fall 2016.

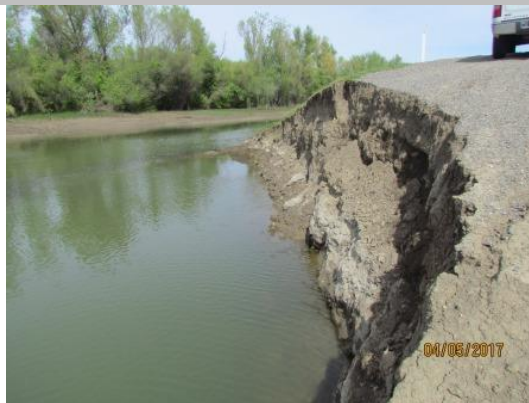
Photo 2 of 2 : FA_2017_ST0001_261_3_20170911_00001.jpg

Scour on waterside levee slope at end of Unit 04 levee. Spring 2017.
