**Flood Control Project Maintenance
Levee Inspections**

Fall 2018 Levee Maintenance Deficiency Summary Report

Sacramento River Basin

Sacramento Maintenance Yard Cache Creek

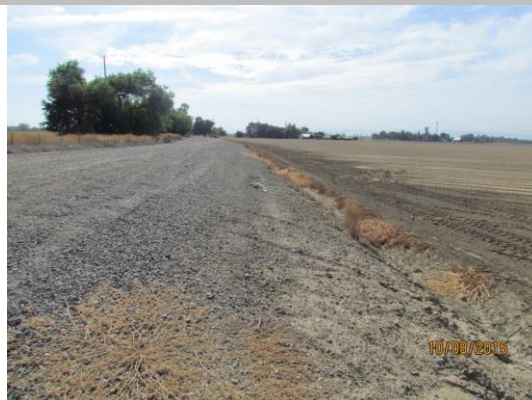
Photo 2 of 2 : FA_2018_ST0001_259_48_20180904_00035.jpg

View of the ditch on the landward side of the levee looking upstream. Fall 2015.

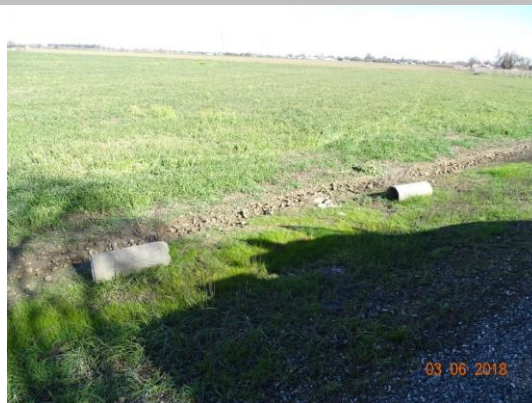
Photo 1 of 1 : FA_2018_ST0001_259_41_20180904_00031.jpg

LM Start	1.04	Rating **	M	Issue No.	41
LM End	1.04	Issue Type +	En	Location *	LS
Category	Earthen Levee			GPS Latitude/Longitude	
				Start	End
Item	Encroachments			38.720327°	38.720327°
				-121.813742°	-121.813742°
DWR ID	DWR_ST0001_01_s_2018_41				
Comment Code					
DE : Debris					
Inspector Comment					
Broken concrete standpipes on landside slope.

View of standpipes on landside slope. Spring 2018.

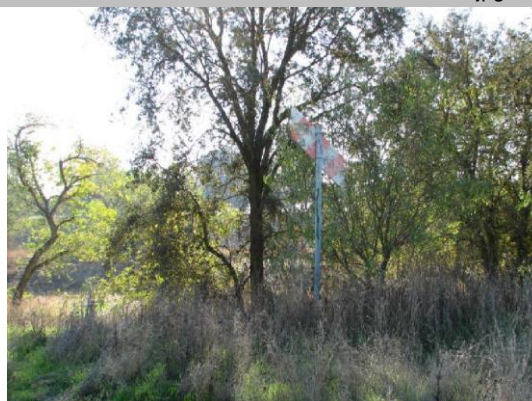
Photo 1 of 3 : UCIP_FA_2018_50432_60162.jpg

Waterside view: gasline marker

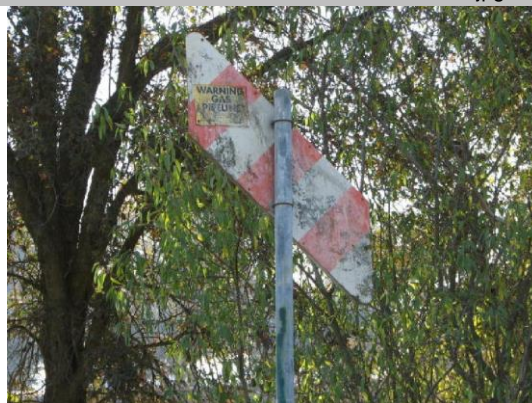
Photo 2 of 3 : UCIP_FA_2018_50432_60161.jpg

Waterside view: closer look at gasline marker

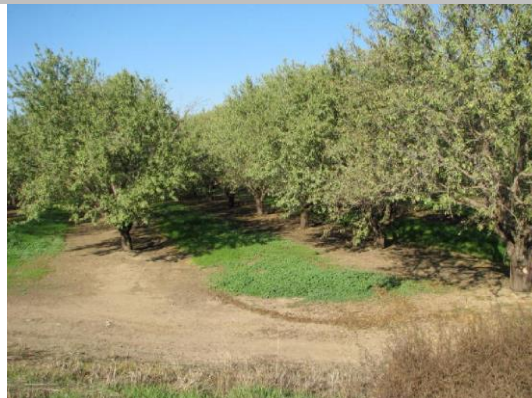
Photo 3 of 3 : UCIP_FA_2018_50432_60160.jpg

Landside view: no gasoline marker

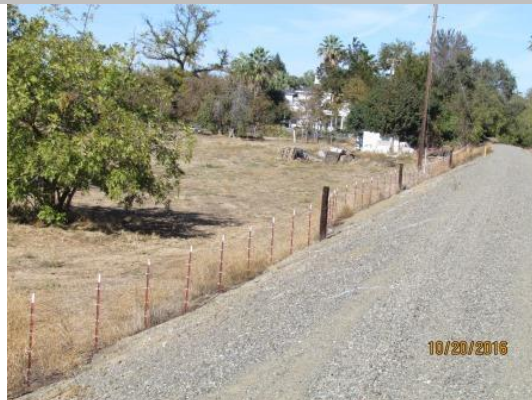
Photo 1 of 1 : FA_2018_ST0001_259_63_20180904_00044.jpg

LM Start	1.77	Rating **	M	Issue No.	63
LM End	1.90	Issue Type +	En	Location *	LS
Category	Earthen Levee			GPS Latitude/Longitude	
				Start	End
Item	Encroachments			38.728217 °	38.729944 °
				-121.806903 °	-121.806506 °
DWR ID	DWR_ST0001_01_s_2017_63				
Comment Code					
FE : Fence					
Inspector Comment

View of fence on LS slope. Fall 2016.

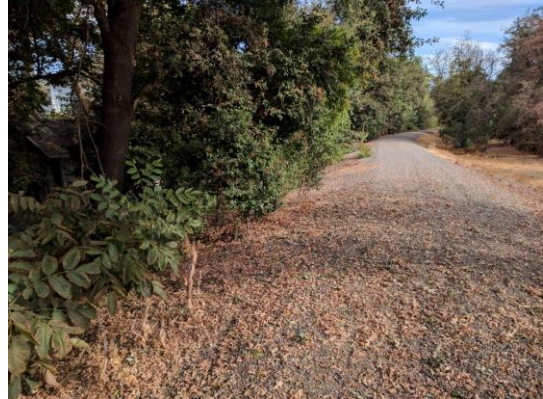
Photo 1 of 3 : FA_2018_ST0001_259_3_20180904_00001.jpg

View of thick vegetation on landside slope. Fall 2017.

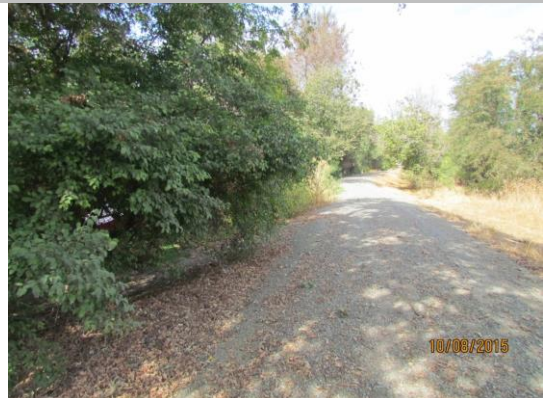
Photo 2 of 3 : FA_2018_ST0001_259_3_20180904_00002.jpg

View of the landscaping that needs to be trimmed on the landward side of the levee looking downstream. Fall 2015.

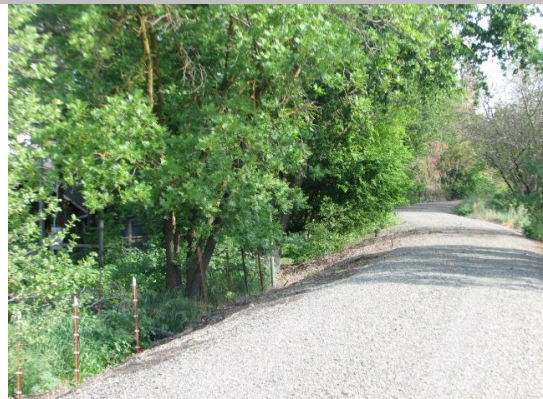
Photo 3 of 3 : FA_2018_ST0001_259_3_20180904_00003.jpg

The landscape needs to be trimmed up. Spring 2014

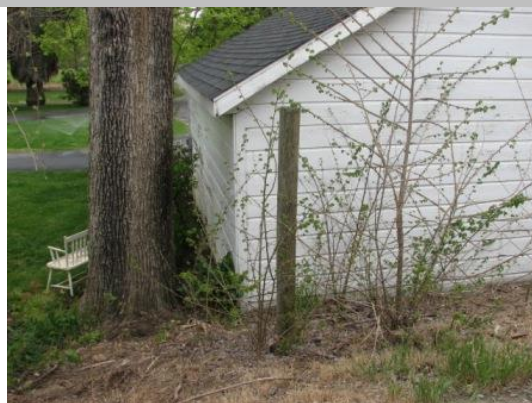
Photo 1 of 1 : FA_2018_ST0001_259_4_20180904_00004.jpg

The building backs up to the landside levee toe of the levee.

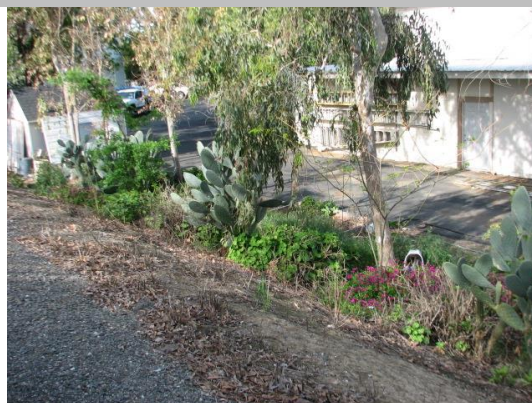
Photo 1 of 1 : FA_2018_ST0001_259_28_20180904_00023.jpg

LM Start	1.96	Rating **	M	Issue No.	28
LM End	1.96	Issue Type +	En	Location *	LS
Category	Earthen Levee			GPS Latitude/Longitude	
				Start	End
Item	Vegetation			38.730860 °	38.730860 °
				-121.806332 °	-121.806332 °
DWR ID	DWR_ST0001_01_s_2014_28				
Comment Code					
V6 : Landscaping					
Inspector Comment					
Cactus at the toe of the levee.

The property owner has planted cactus along the toe of the levee. Spring 2014

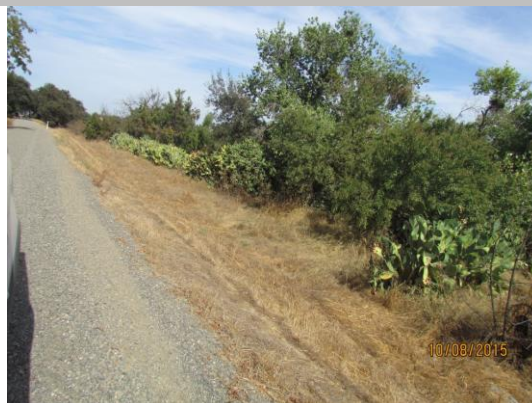
Photo 1 of 1 : FA_2018_ST0001_259_6_20180904_00005.jpg

LM Start	1.98	Rating **	M	Issue No.	6
LM End	2.01	Issue Type +	En	Location *	WS
Category	Earthen Levee			GPS Latitude/Longitude	
				Start	End
Item	Vegetation			38.731166 °	38.731620 °
				-121.806215 °	-121.806032 °
DWR ID	DWR_ST0001_01_s_2012_6				
Comment Code					
V6 : Landscaping					
Inspector Comment					
Catus on the waterside berm.

View of the cactus landscaping on the waterward side of the levee looking downstream. Fall 2015.

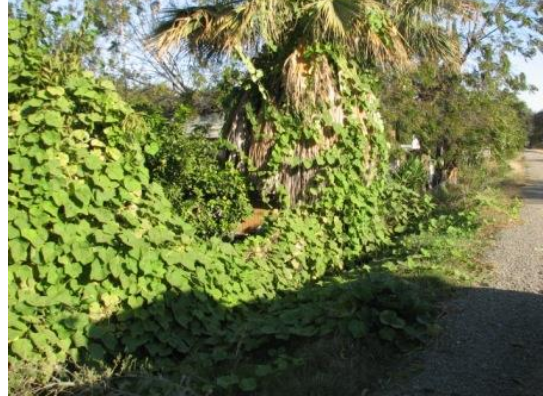
Photo 1 of 2 : FA_2018_ST0001_259_7_20180904_00006.jpg

Wild grape and other plants are obstructing the view for inspection. Fall 2011

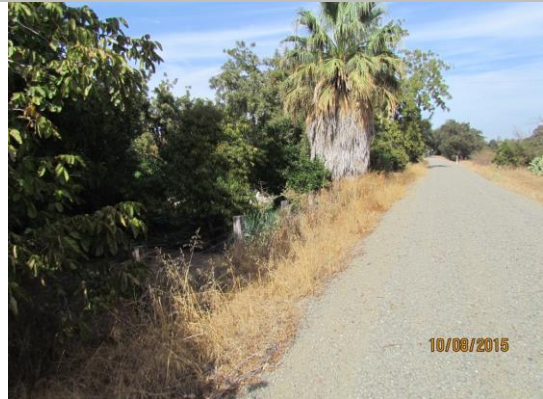
Photo 2 of 2 : FA_2018_ST0001_259_7_20180904_00007.jpg

View of the landscaping on the landward side of the levee looking downstream. Fall 2015.

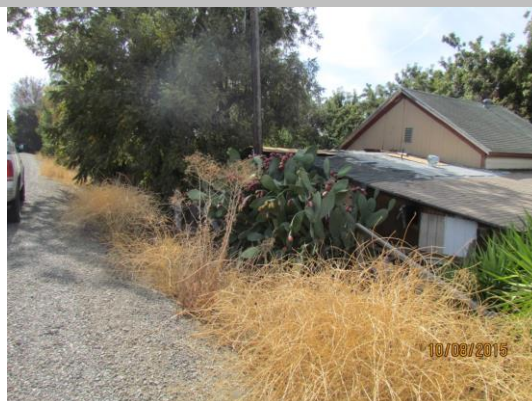
Photo 1 of 1 : FA_2018_ST0001_259_8_20180904_00008.jpg

View of the building on the landward side of the levee looking upstream.
Cactus planted at the toe obstructs visibility. Fall 2015.

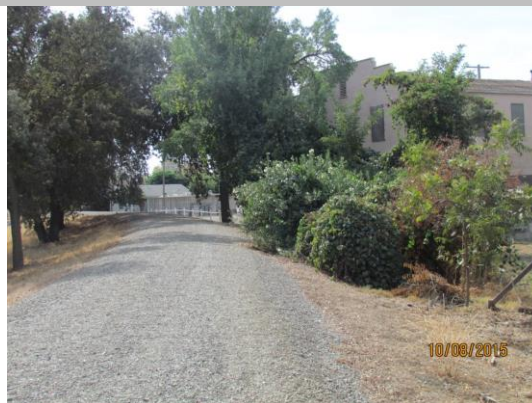
Photo 1 of 2 : FA_2018_ST0001_259_14_20180904_00013.jpg

View of the shrubs on the landward side of the levee looking upstream. Fall 2015.

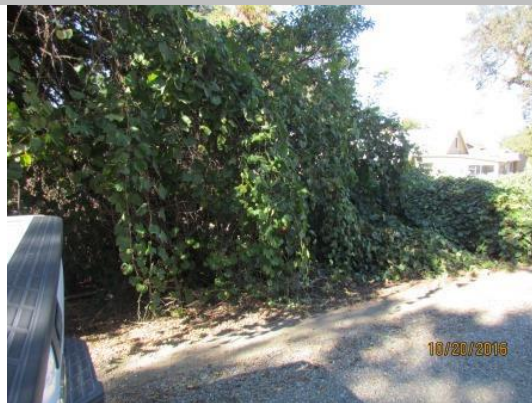
Photo 2 of 2 : FA_2018_ST0001_259_14_20180904_00014.jpg

Another view of the shrubs. Fall 2016.

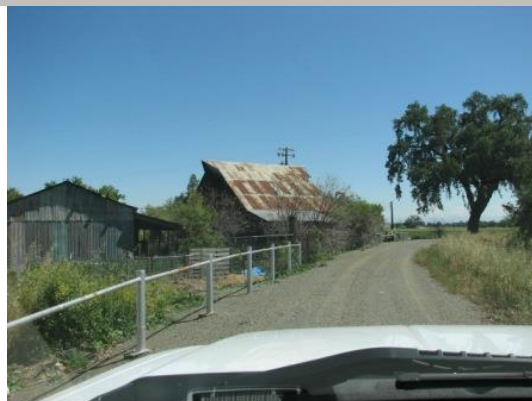
Photo 1 of 2 : FA_2018_ST0001_259_16_20180904_00016.jpg

Horse barn and corral are within the easement of the levee.

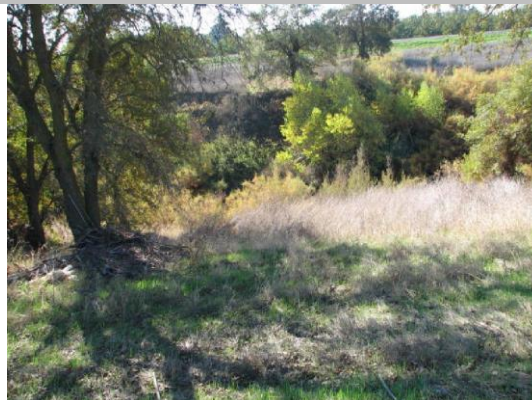
Photo 1 of 3 : UCIP_FA_2018_49099_60164.jpg

Comment Code					
Inspector Comment					
FS_ID:49099					
DS_ID:16268					
EP_NO: 2415					
Repair Type: Non-Urgent					
Crossing Status: Indicator Found					
UCIP Comments: May need to install gasoline marker on WS slope.					
FIELD_STRUCT_DESC: 20-inch wrapped steel natural gas pipeline					
through the levee, 4 feet below the crown. Two cutoff walls. Gas line					
indicator found on the landside (LS) of the levee. (20-inch wrapped steel					
natural gas pipeline authorized under Permit No. 2415, 1956 - Pacific					
Gas and Electric Company [PG&E]). [Additional Reference(s): DWR					
Levee Log, 1993. USACE Sacramento O&M Manual 126, November					
1961, (HLM 2.24)].					
FS Date: 6/16/2016 7:00:04 AM

Waterside view: no indicators found

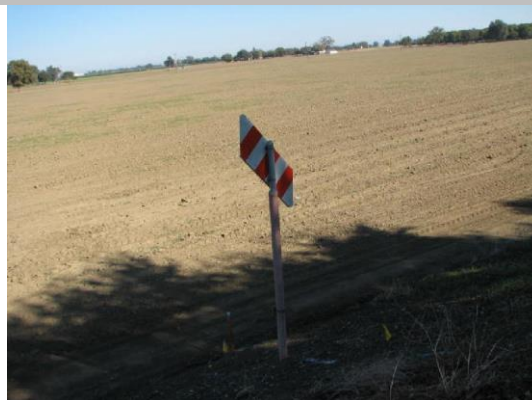
Photo 2 of 3 : UCIP_FA_2018_49099_60163.jpg

Landside view: gasoline indicator

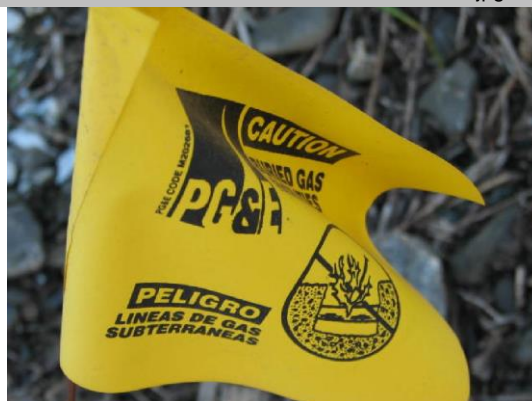
Photo 3 of 3 : UCIP_FA_2018_49099_60165.jpg

Comment Code						
Inspector Comment						
FS_ID:49099						
DS_ID:16268						
EP_NO: 2415						
Repair Type: Non-Urgent						
Crossing Status: Indicator Found						
UCIP Comments: May need to install gasoline marker on WS slope.						
FIELD_STRUCT_DESC: 20-inch wrapped steel natural gas pipeline						
through the levee, 4 feet below the crown. Two cutoff walls. Gas line						
indicator found on the landside (LS) of the levee. (20-inch wrapped steel						
natural gas pipeline authorized under Permit No. 2415, 1956 - Pacific						
Gas and Electric Company [PG&E]). [Additional Reference(s): DWR						
Levee Log, 1993. USACE Sacramento O&M Manual 126, November						
1961, (HLM 2.24)].						
FS Date: 6/16/2016 7:00:04 AM

Landside view: gasoline indicator/flag

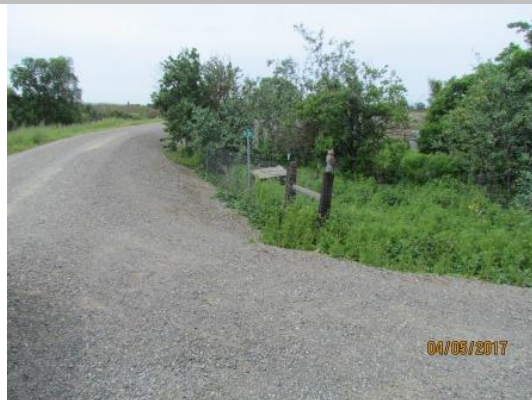
Photo 1 of 1 : FA_2018_ST0001_259_78_20180904_00048.jpg

Chain fence at landside levee toe. Spring 2017.

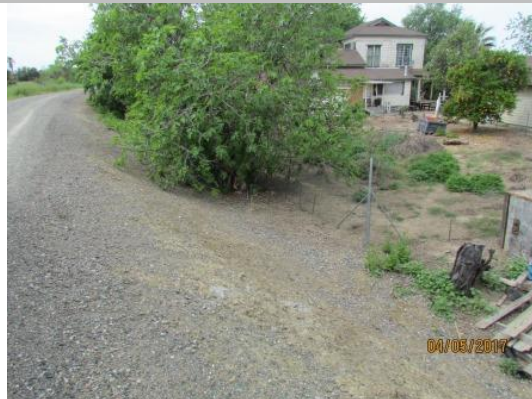
Photo 1 of 1 : FA_2018_ST0001_259_77_20180904_00047.jpg

Chain fence at landside levee toe. Spring 2017.

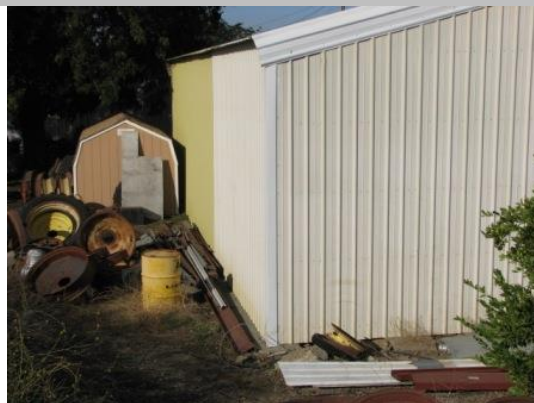
Photo 1 of 2 : FA_2018_ST0001_259_20_20180904_00018.jpg

The corner of the shop is within the easement of the levee. Fall 2011

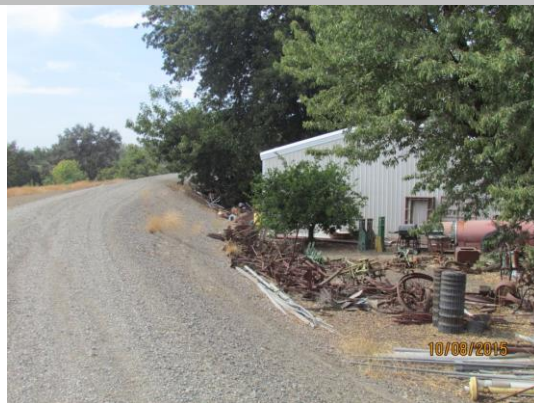
Photo 2 of 2 : FA_2018_ST0001_259_20_20180904_00019.jpg

View of the building on the landward side of the levee looking upstream. Fall 2015.

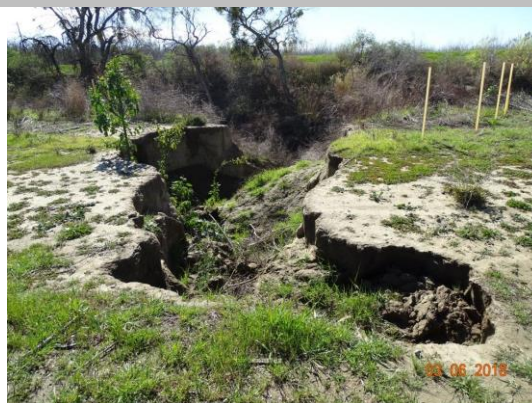
Photo 1 of 5 : FA_2018_ST0001_259_62_20180904_00039.jpg

View of erosion on toe road, looking towards Cache Creek. Spring 2018.

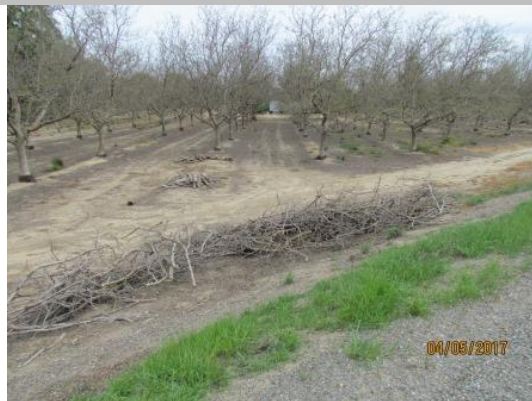
Photo 1 of 1 : FA_2018_ST0001_259_75_20180904_00046.jpg

Prunings at landside levee toe. Spring 2017.

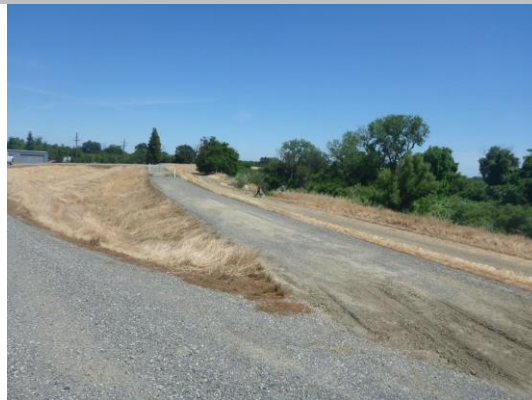
Photo 1 of 3 : LEVAL_FA_2018_249_954.jpg

LM Start	4.22	Rating **	A/W	Issue No.	34
LM End	4.23	Issue Type +	Ma	Location *	WS
Category	Supplemental			GPS Latitude/Longitude	
				Start	End
Item	2017 Storm Damage			38.727207°	38.727187°
				-121.775521°	-121.775450°
DWR ID	DWR_ST0001_01_f_2017_34				
Comment Code					
Inspector Comment					
Levee Evaluation Comments					
Description:					
Site ID No:249					
Site Designation:LMA-57					
Repair Type: Erosion					
Rating:Area of Concern					
Field Date:6/2/2017					
Notes: setback levee site; remaining berm greater than 86 feet, no section taken, photo only.

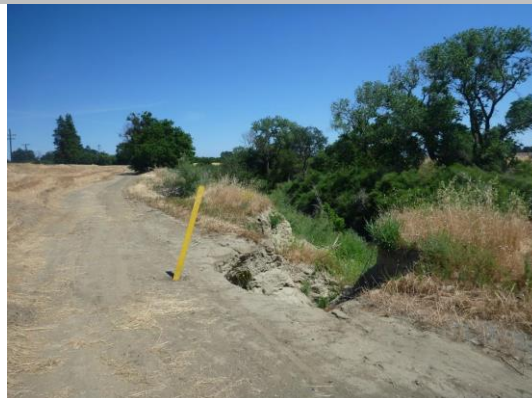
Photo 3 of 3 : LEVAL_FA_2018_249_960.jpg

LM Start	4.22	Rating **	A/W	Issue No.	34 (cont)	
LM End	4.23	Issue Type +	Ma	Location *	WS	
Category	Supplemental			GPS Latitude/Longitude		
				Start		End
Item	2017 Storm Damage			38.727207 °		38.727187 °
				-121.775521 °		-121.775450 °
DWR ID	DWR_ST0001_01_f_2017_34					
Comment Code						
Inspector Comment						
Levee Evaluation Comments						
Description:						
Site ID No:249						
Site Designation:LMA-57						
Repair Type: Erosion						
Rating:Area of Concern						
Field Date:6/2/2017						
Notes: setback levee site; remaining berm greater than 86 feet, no section taken, photo only.

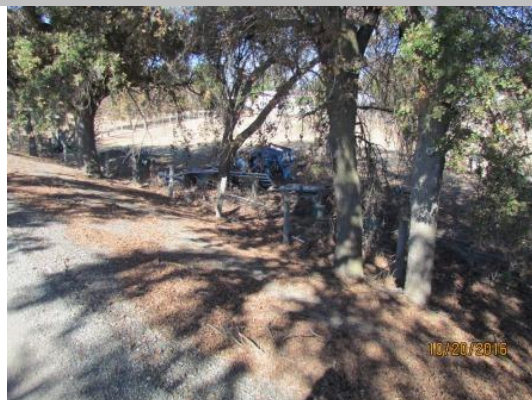
Photo 1 of 1 : FA_2018_ST0001_259_52_20180904_00037.jpg

LM Start	4.34	Rating **	M	Issue No.	52
LM End	4.42	Issue Type +	En	Location *	LS
Category	Earthen Levee			GPS Latitude/Longitude	
				Start	End
Item	Encroachments			38.726754 °	38.726242 °
				-121.773424 °	-121.772221 °
DWR ID	DWR_ST0001_01_f_2016_52				
Comment Code					
FE : Fence					
Inspector Comment					
Fence on LS slope.

Fence on landside slope. Fall 2016.

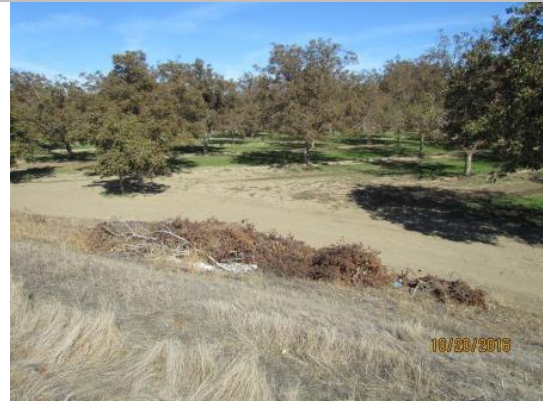
Photo 1 of 1 : FA_2018_ST0001_259_51_20180904_00036.jpg

View of prunings on LS slope. Fall 2016.

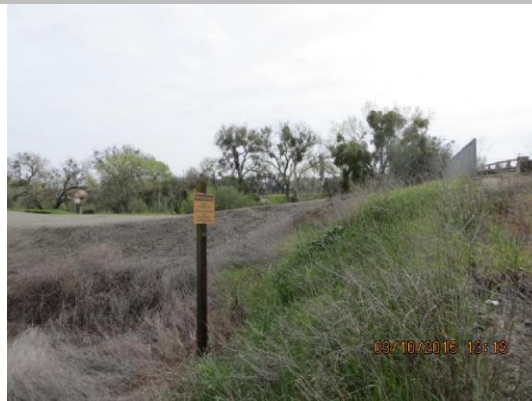
Photo 2 of 2 : UCIP_FA_2018_49111_73500.jpg

Sign on LS toe.

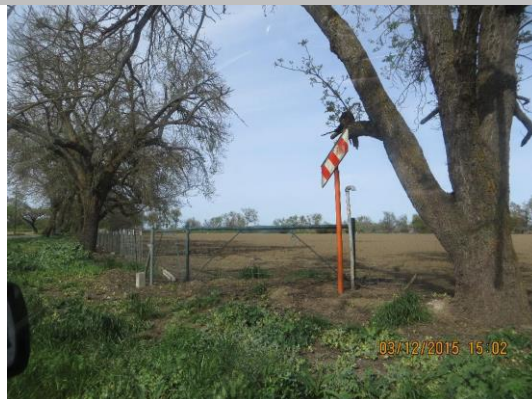
Photo 2 of 2 : UCIP_FA_2018_49112_73503.jpg

Comment Code						
Inspector Comment						
FS_ID:49112 DS_ID:16756 EP_NO: 3089 Repair Type: Non-Urgent Crossing Status: Indicator Found UCIP Comments: Signage in disrepair and need signs at Levee. Need to contact owner to determine status of crossing and install new signs if appropriate to do so. FIELD_STRUCT_DESC: 4-inch steel natural gas pipeline through the levee, 4 feet below the crownGas line marker located 500 feet north of the levee crossing at the levee access road/gate. Pipe alignment to east of bridge. (4-inch natural gas pipeline grouted in place and replaced with a 4-inch steel natural gas pipeline to east side of bridge under Permit No. 3089, 1959 - Yolo County Sales Company). [Additional Reference(s): USACE Sacramento O&M Manual 126, November 1961, (HLM 4.98)]. FS Date: 6/16/2016 7:09:02 AM

Gasline marker at Best Ranch Road, 1500-feet south of levee crossing.

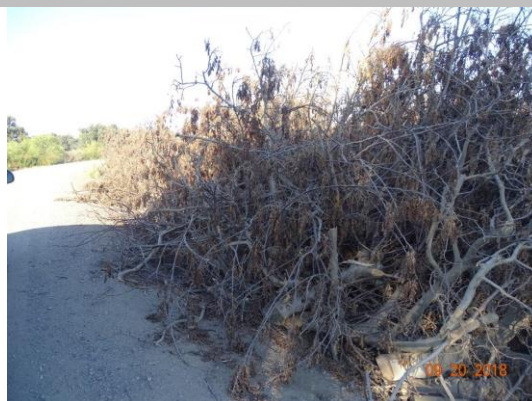
Photo 1 of 2 : FA_2018_ST0001_259_45_20180924_00070.jpg

View of the pruning pile on the landside slope. Fall 2018.

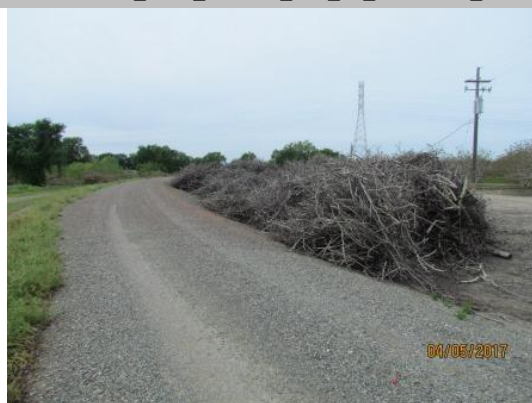
Photo 2 of 2 : FA_2018_ST0001_259_45_20180904_00032.jpg

View of prunings on landside slope. Spring 2017.

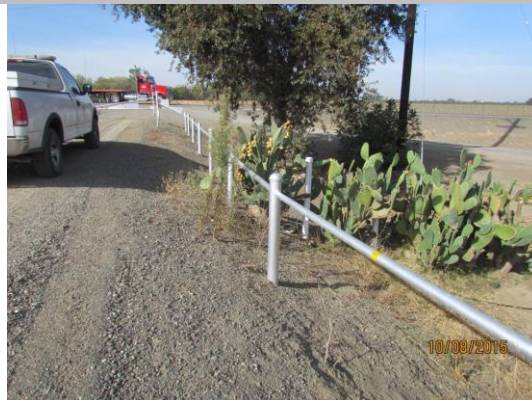
Photo 1 of 1 : FA_2018_ST0001_259_57_20180904_00038.jpg

View of the cactus on the landward side of the levee looking upstream.
Fall 2015.

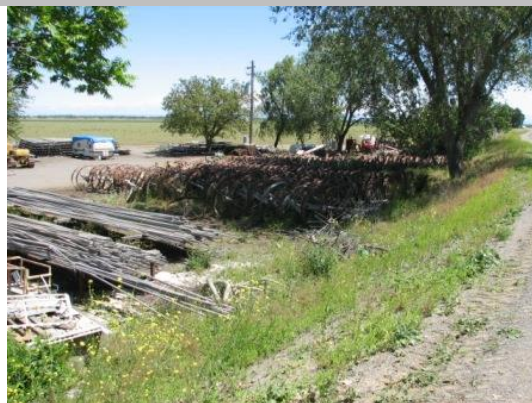
Photo 1 of 2 : FA_2018_ST0001_259_40_20180904_00029.jpg

Irrigation pipe and equipment are within the easement of the levee.

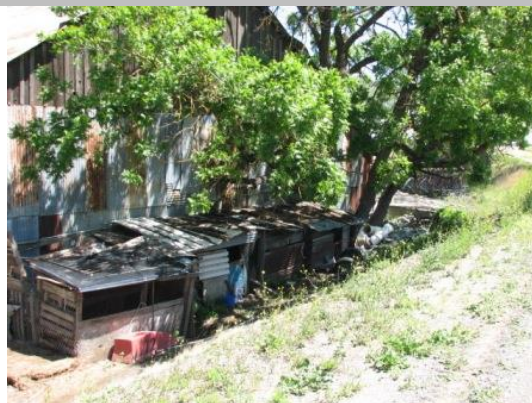
Photo 1 of 1 : FA_2018_ST0001_259_39_20180904_00028.jpg

The barn and livestock pens are within the easement of the levee.

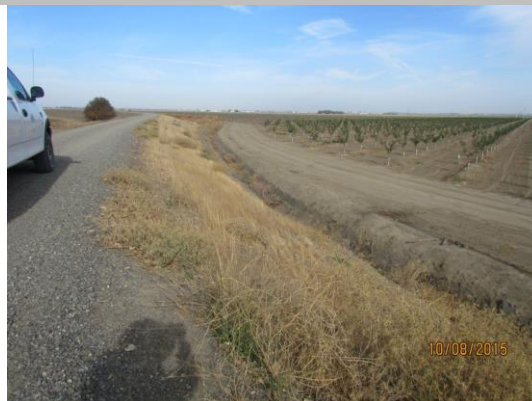
Photo 2 of 2 : FA_2018_ST0001_259_26_20180904_00022.jpg

View of the ditch on the landward side of the levee looking upstream. Fall 2015.

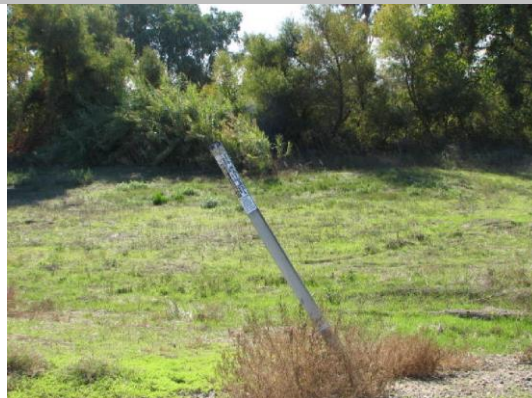
Photo 1 of 2 : UCIP_FA_2018_50811_60197.jpg

Waterside view: gasline indicator

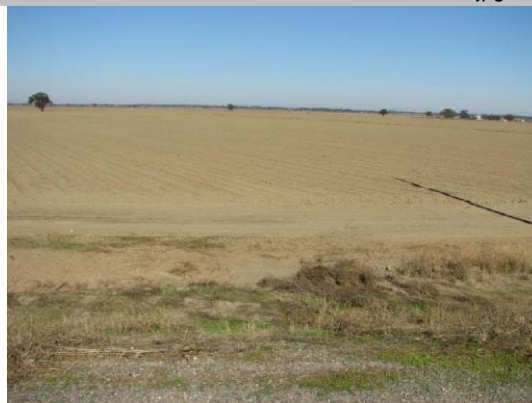
Photo 2 of 2 : UCIP_FA_2018_50811_60196.jpg

Landside view: no indicator found.

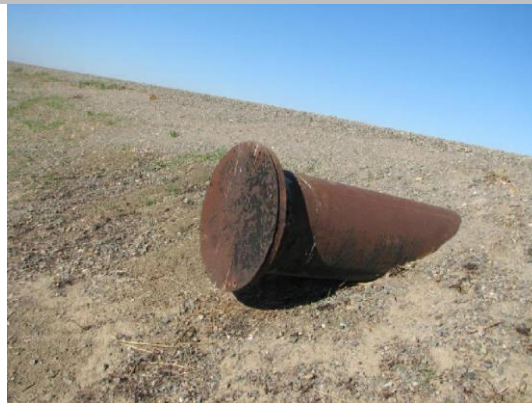
Photo 2 of 3 : UCIP_FA_2018_53214_60223.jpg

Waterside view: closer look at capped pipe.

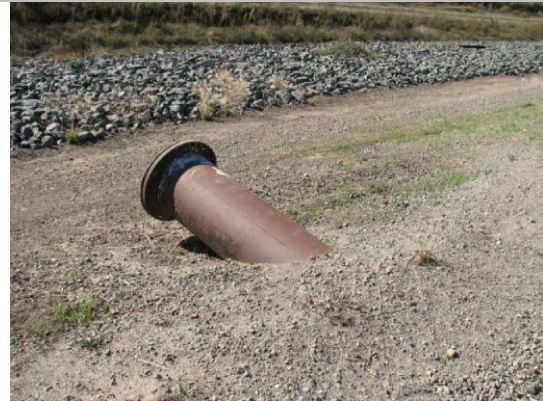
Photo 3 of 3 : UCIP_FA_2018_53214_60222.jpg

Waterside view: steel pipe on the slope of the levee

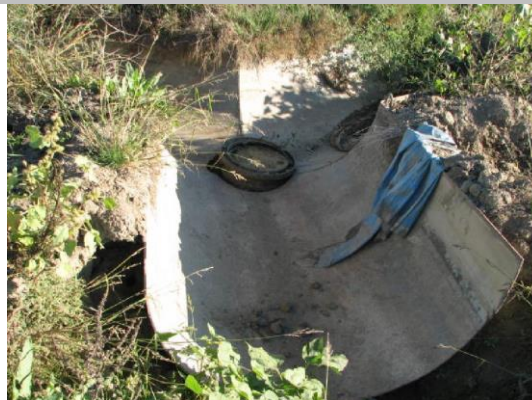
Photo 1 of 3 : UCIP_FA_2018_53215_60148.jpg

Waterside view: pipe in the ditch

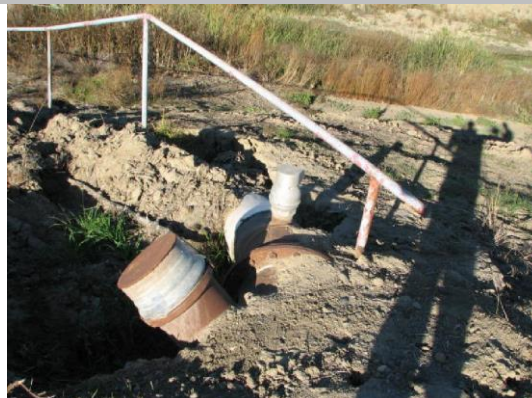
Photo 2 of 3 : UCIP_FA_2018_53215_60147.jpg

Landside view: pipe daylight on LS levee slope

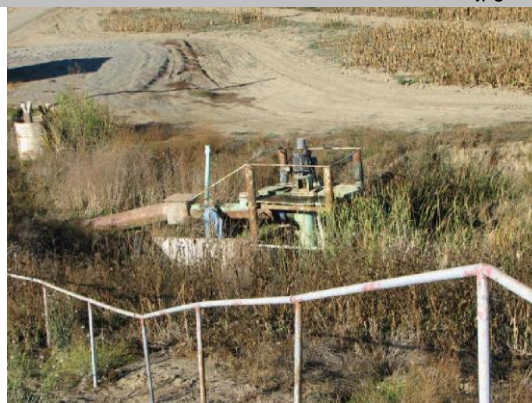
Photo 3 of 3 : UCIP_FA_2018_53215_60149.jpg

Landside view: pumping plant

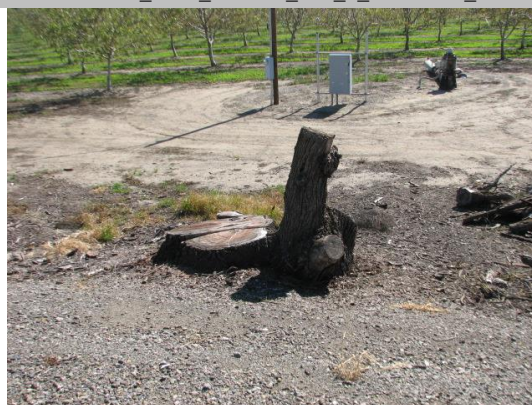
Photo 1 of 1 : FA_2018_ST0001_260_6_20180904_00006.jpg

A large black walnut tree stump is at the toe of the levee. Spring 2014

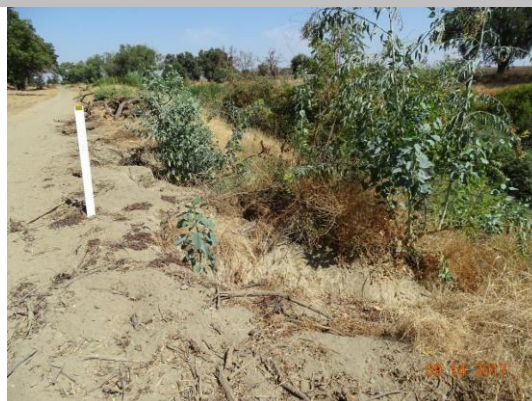
Photo 1 of 1 : FA_2018_ST0001_260_16_20180904_00015.jpg

View of storm damage site on waterside berm. Does not appear to be within the levee prism at this time. Fall 2017.

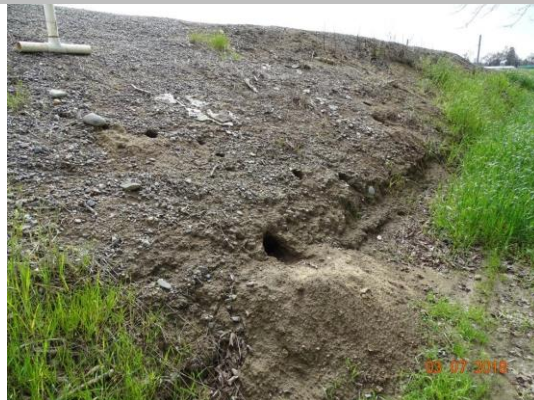
Photo 1 of 1 : FA_2018_ST0001_260_38_20180904_00022.jpg

View of rodent holes on the landside slope. Spring 2018.

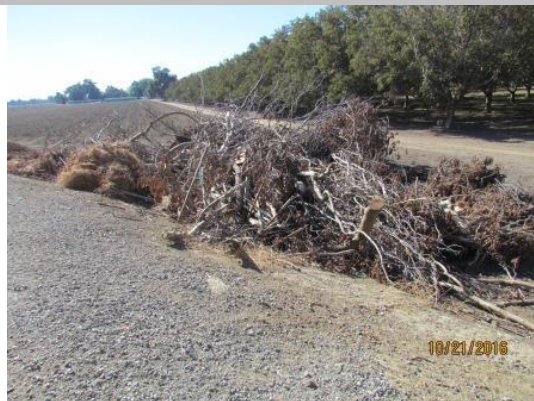
Photo 1 of 1 : FA_2018_ST0001_260_20_20180904_00017.jpg

View of prunings on LS slope of the levee. Fall 2016.

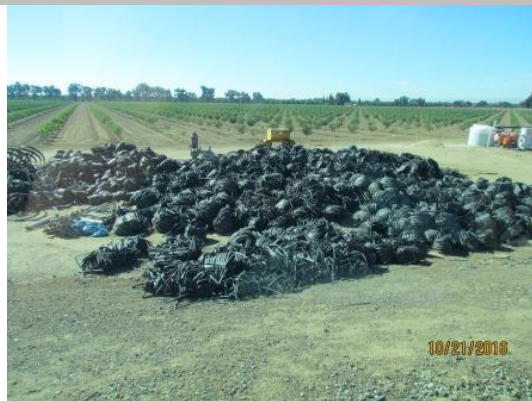
Photo 1 of 2 : FA_2018_ST0001_260_3_20180904_00002.jpg

Additional view of debris at the same site on landward side of the levee. Fall 2016.

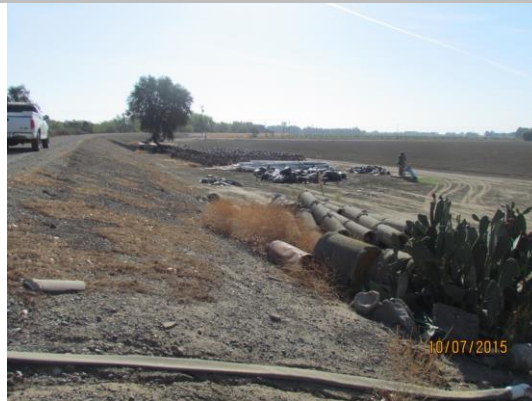
Photo 2 of 2 : FA_2018_ST0001_260_3_20180904_00003.jpg

View of the concrete pile at the toe of the landward side of the levee looking downstream. Fall 2015.

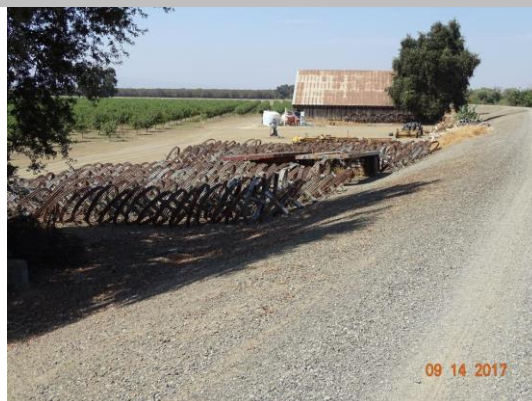
Photo 1 of 1 : FA_2018_ST0001_260_29_20180904_00020.jpg

View of farm equipment at landside toe. Fall 2017.

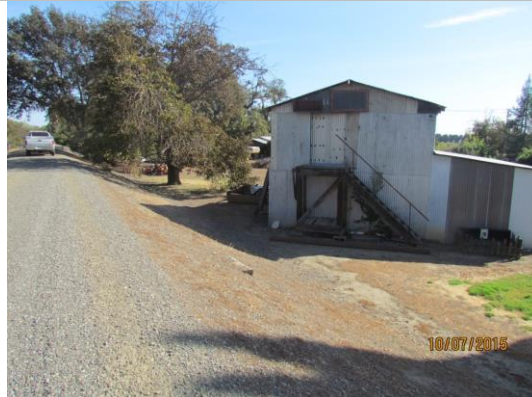
Photo 1 of 1 : FA_2018_ST0001_260_8_20180904_00008.jpg

View of the building on the landward side of the levee looking downstream. Fall 2015.

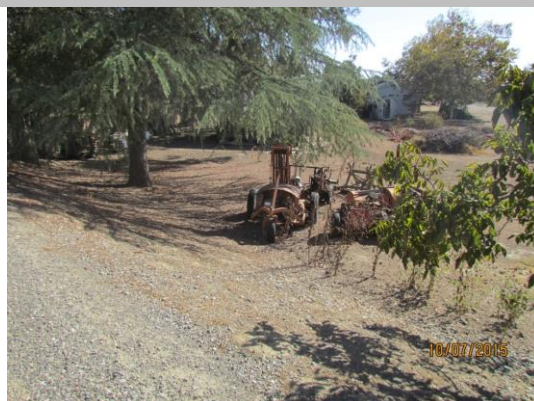
Photo 1 of 1 : FA_2018_ST0001_260_26_20180904_00018.jpg

View of the equipment at the toe of the landward side of the levee. Fall 2015.

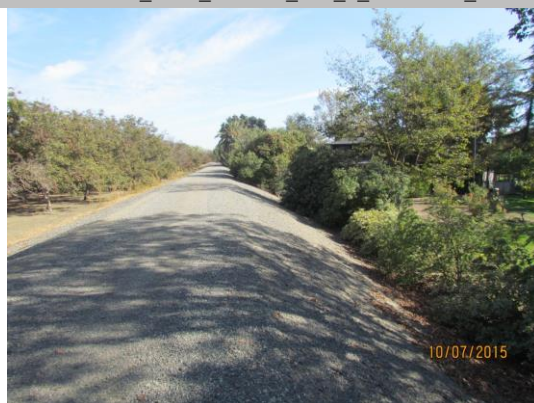
Photo 1 of 1 : FA_2018_ST0001_260_9_20180904_00009.jpg

View of the landscaping vegetation on the landward side of the levee looking downstream. Fall 2015.

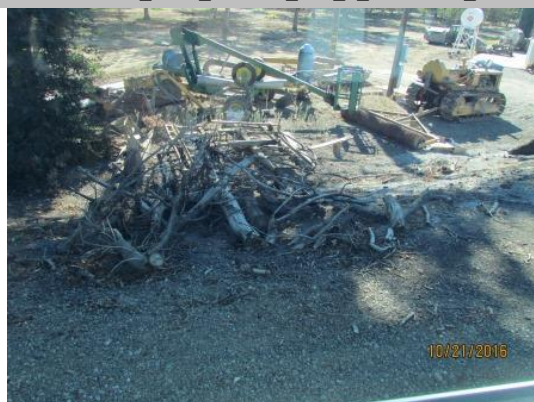
Photo 1 of 1 : FA_2018_ST0001_260_5_20180904_00005.jpg

Prunings on LS levee slope. Fall 2016.

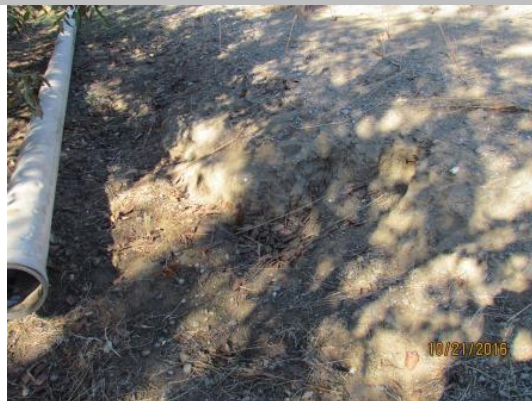
Photo 1 of 1 : FA_2018_ST0001_260_4_20180904_00004.jpg

Erosion on LS levee slope toward the toe. Fall 2016.

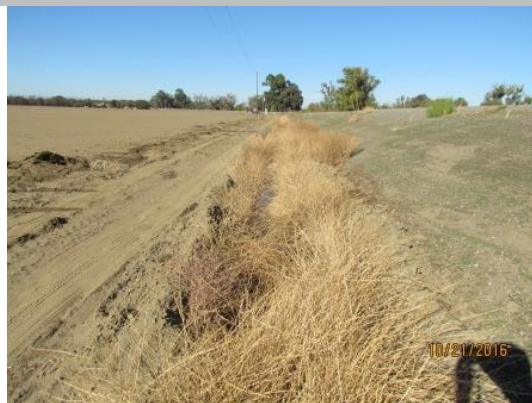
Photo 1 of 2 : FA_2018_ST0001_260_14_20180904_00012.jpg

View of ditch on landside near the levee toe looking upstream of Cache Creek. Fall 2016.

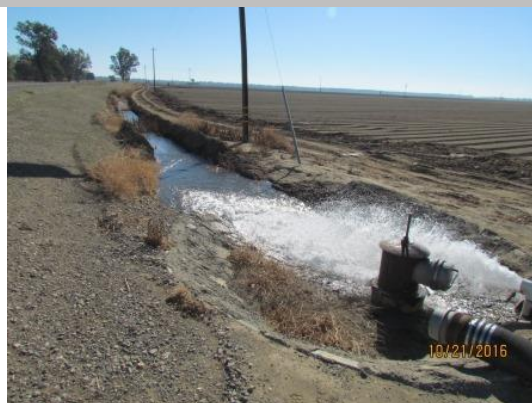
Photo 2 of 2 : FA_2018_ST0001_260_14_20180904_00013.jpg

View of ditch on landside near the levee toe looking downstream of Cache Creek. Fall 2016.

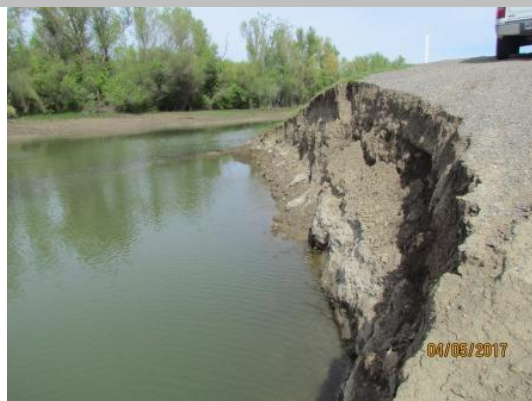
Photo 4 of 4 : FA_2018_ST0001_261_3_20180904_00007.jpg

Scour on waterside levee slope at end of Unit 04 levee. Spring 2017.
