**Flood Control Project Maintenance
Levee Inspections**

Fall 2019 Levee Maintenance Deficiency Summary Report

Sacramento River Basin

Sacramento Maintenance Yard Cache Creek

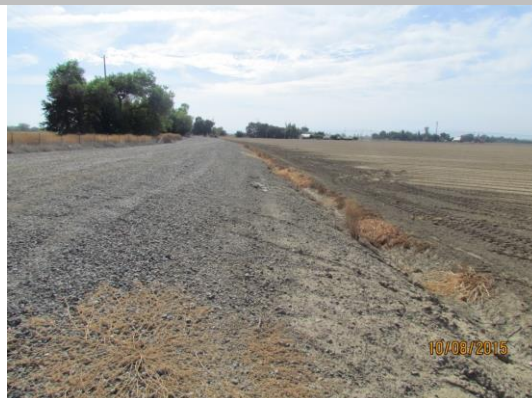
Photo 2 of 2 : FA_2019_ST0001_259_48_20190829_00035.jpg

View of the ditch on the landward side of the levee looking upstream.
Fall 2015.

LM Start	1.04	Rating **	C	Issue No.	41
LM End	1.04	Issue Type +	En	Location *	LS
Category	Earthen Levee			GPS Latitude/Longitude	
				Start	End
Item	Encroachments			38.720327°	38.720327°
				-121.813742°	-121.813742°
DWR ID	DWR_ST0001_01_s_2018_41				
Comment Code					
DE : Debris					
Inspector Comment					
There are broken concrete standpipes on the landside slope.

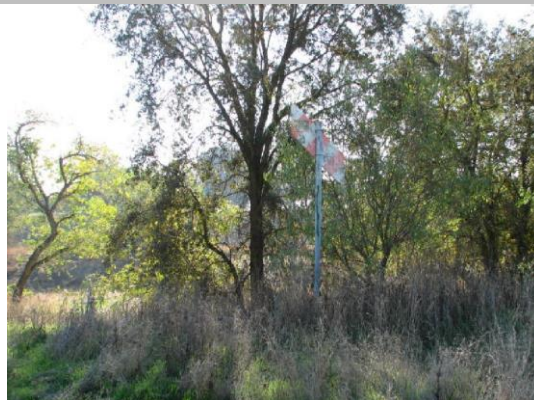
Photo 1 of 3 : UCIP_FA_2019_50432_60162.jpg

LM Start	1.37	Rating **	M	Issue No.	79
LM End	1.37	Issue Type +	En	Location *	
Category	Supplemental			GPS Latitude/Longitude	
				Start	End
Item	DRAFT DWR UCIP Field Study			38.722669 °	38.722669 °
				-121.808792 °	-121.808792 °
DWR ID	16270				
Comment Code					
Inspector Comment					
DS_ID:16270 FS_ID:50432 EP_NO: 6790 Repair Type: Non-Urgent Crossing Status: Indicator Found UCIP Comments: May need additional signs on LS of levee. FIELD_STRUCT_DESC: 6-inch high-pressure natural gas main of an unknown material through the levee and under the channel, at an unknown depth. Gas line marker on the waterside (WS) slope. (6-inch high-pressure natural gas main authorized under Permit No. 6790, 1969 - Pacific Gas and Electric Company [PG&E]). [Additional Reference(s): DWR Levee Log, 1993]. FS Date: 6/16/2016 6:58:00 AM

Waterside view: gasline marker

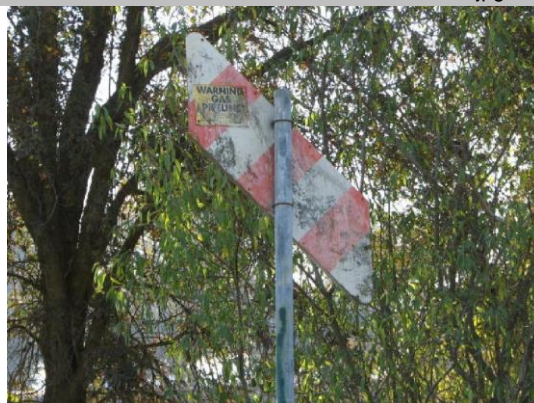
Photo 2 of 3 : UCIP_FA_2019_50432_60161.jpg

Waterside view: closer look at gasline marker

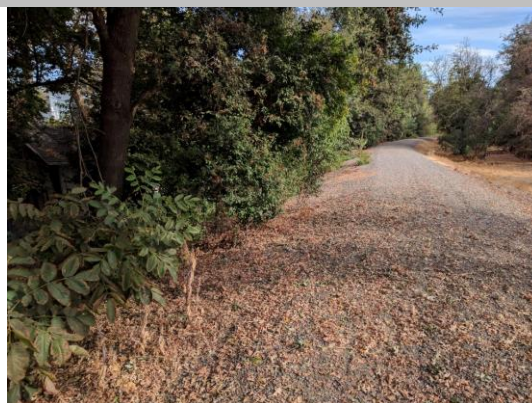
Photo 1 of 3 : FA_2019_ST0001_259_3_20190829_00001.jpg

View of thick vegetation on landside slope. Fall 2017.

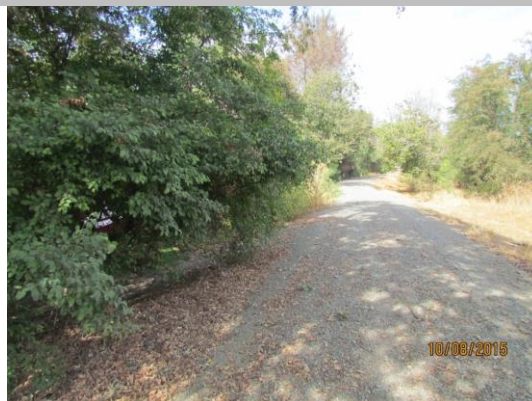
Photo 2 of 3 : FA_2019_ST0001_259_3_20190829_00002.jpg

View of the landscaping that needs to be trimmed on the landward side of the levee looking downstream. Fall 2015.

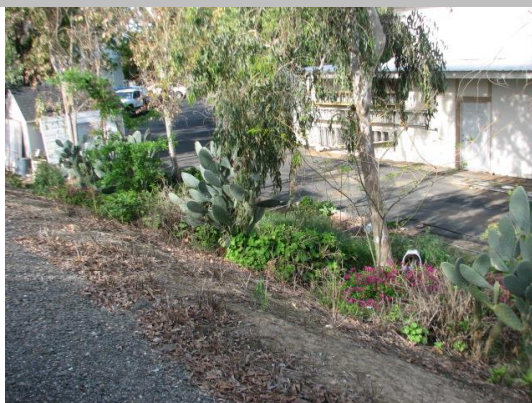
Photo 1 of 1 : FA_2019_ST0001_259_28_20190829_00021.jpg

The property owner has planted cactus along the toe of the levee. Spring 2014

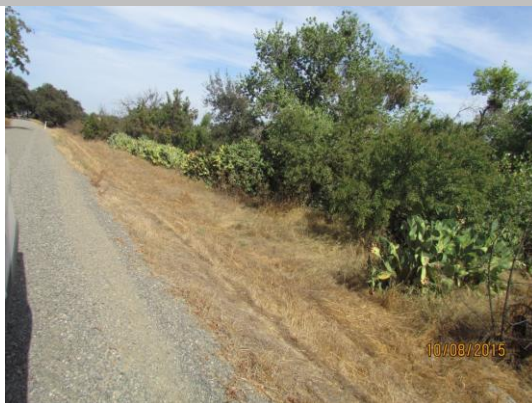
Photo 1 of 1 : FA_2019_ST0001_259_6_20190829_00004.jpg

LM Start	1.98	Rating **	M	Issue No.	6
LM End	2.01	Issue Type +	En	Location *	WS
Category	Earthen Levee			GPS Latitude/Longitude	
				Start	End
Item	Vegetation			38.731166°	38.731620°
				-121.806215°	-121.806032°
DWR ID	DWR_ST0001_01_s_2012_6				
Comment Code					
V6 : Landscaping					
Inspector Comment					
Catus is located on the waterside berm.

View of the cactus landscaping on the waterward side of the levee looking downstream. Fall 2015.

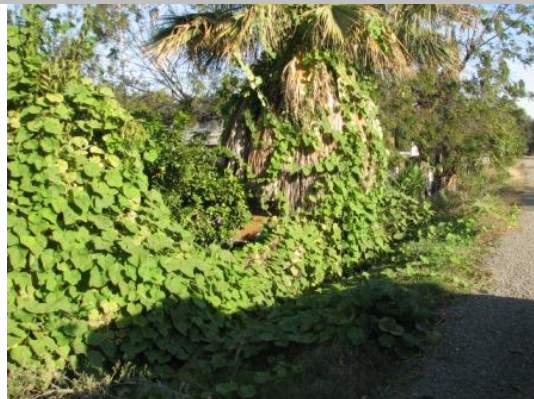
Photo 1 of 2 : FA_2019_ST0001_259_7_20190829_00005.jpg

Wild grape and other plants are obstructing the view for inspection. Fall 2011

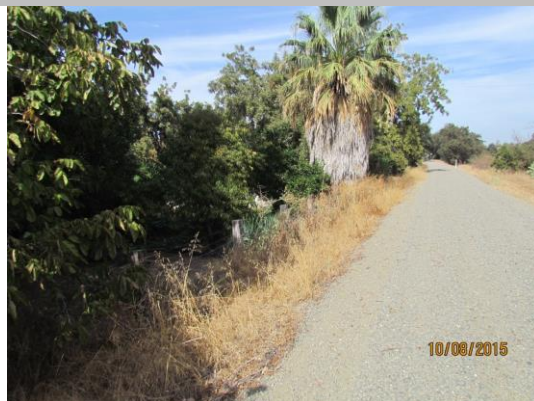
Photo 2 of 2 : FA_2019_ST0001_259_7_20190829_00006.jpg

View of the landscaping on the landward side of the levee looking downstream. Fall 2015.

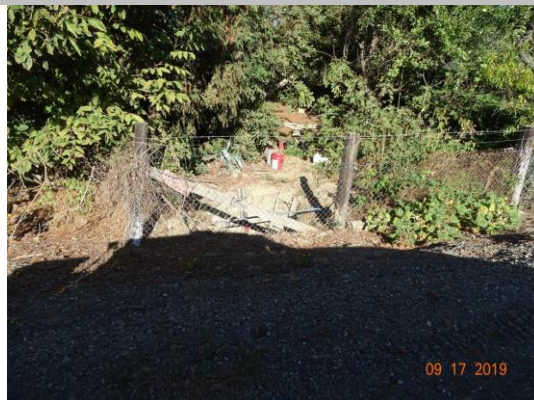
Photo 1 of 2 : FA_2019_ST0001_259_35_20190919_00065.jpg

LM Start	1.98	Rating **	U	Issue No.	35
LM End	1.98	Issue Type +	En	Location *	LS
Category	Earthen Levee			GPS Latitude/Longitude	
				Start	End
Item	Encroachments			38.731208 °	38.731208 °
				-121.806220 °	-121.806220 °
DWR ID	DWR_ST0001_01_s_2019_35				
Comment Code					
DT : Ditch					
Inspector Comment					
The landowner has dug a 5' diameter hole within 10' of the landside toe and it appears to cut into the levee prism.

View of the hole within the landside easement. Fall 2019.

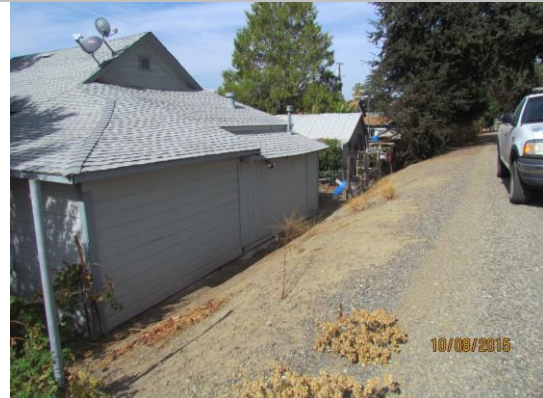
Photo 1 of 1 : FA_2019_ST0001_259_10_20190829_00008.jpg

View of the house on the landward side of the levee looking downstream. Fall 2015.

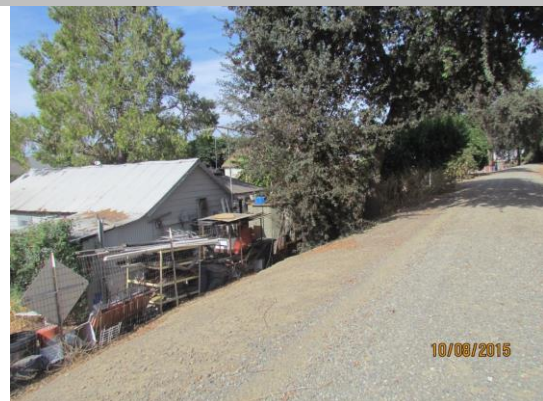
Photo 1 of 1 : FA_2019_ST0001_259_11_20190829_00009.jpg

View of the building on the landward side of the levee looking downstream. Fall 2015.

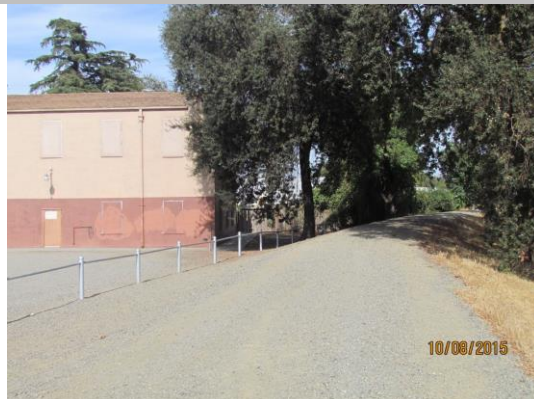
Photo 1 of 1 : FA_2019_ST0001_259_12_20190829_00010.jpg

View of the building on the landward side of the levee looking downstream. Fall 2015.

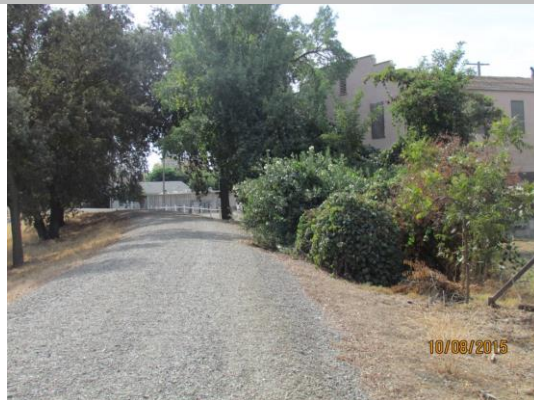
Photo 1 of 2 : FA_2019_ST0001_259_14_20190829_00012.jpg

View of the shrubs on the landward side of the levee looking upstream.
Fall 2015.

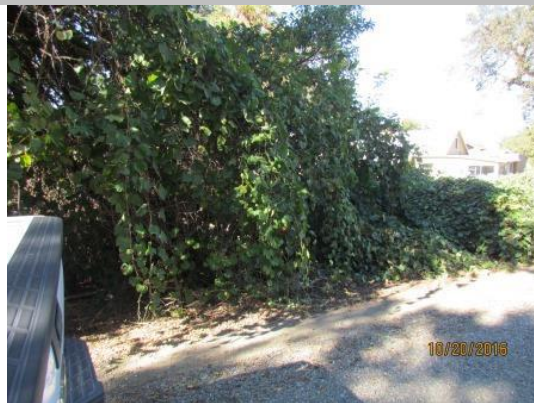
Photo 2 of 2 : FA_2019_ST0001_259_14_20190829_00013.jpg

Another view of the shrubs. Fall 2016.

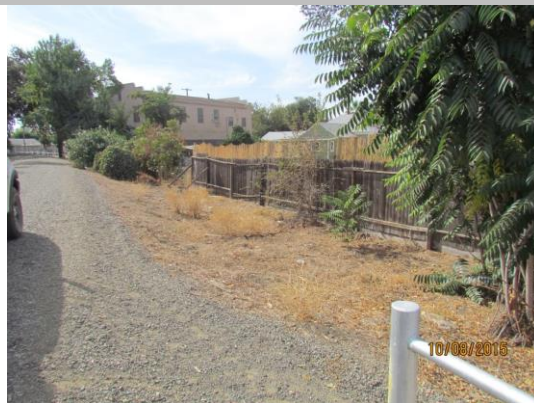
Photo 1 of 1 : FA_2019_ST0001_259_15_20190829_00014.jpg

View of the fence on the landward side of the levee looking upstream.
Fall 2015.

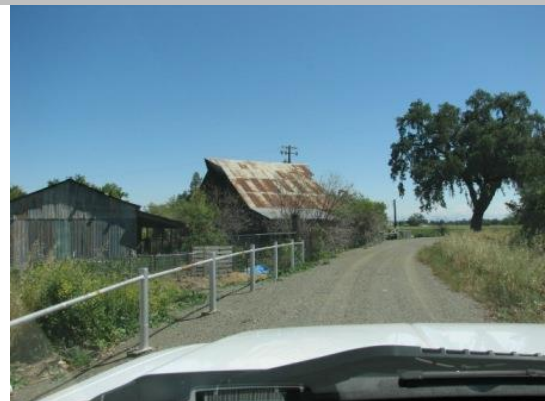
Photo 1 of 2 : FA_2019_ST0001_259_16_20190829_00015.jpg

Horse barn and corral are within the easement of the levee.

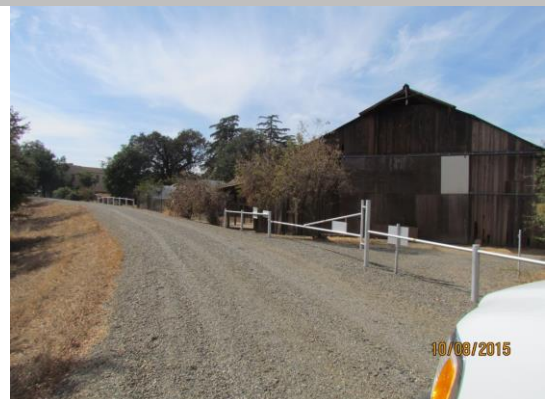
Photo 2 of 2 : FA_2019_ST0001_259_16_20190829_00016.jpg

View of the horse barn on the landward side of the levee looking upstream. Fall 2015.

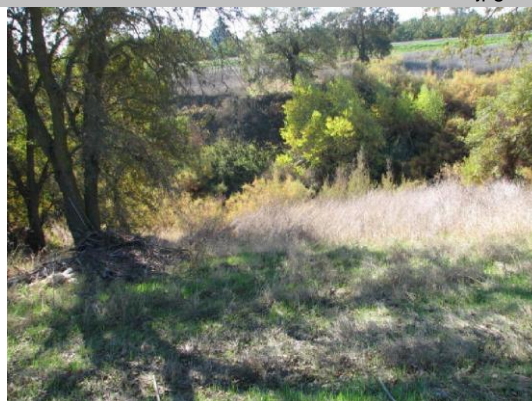
Photo 1 of 3 : UCIP_FA_2019_49099_60164.jpg

Waterside view: no indicators found

Comment Code						
Inspector Comment						
DS_ID:16268 FS_ID:49099 EP_NO: 2415 Repair Type: Non-Urgent Crossing Status: Indicator Found UCIP Comments: May need to install gasoline marker on WS slope. FIELD_STRUCT_DESC: 20-inch wrapped steel natural gas pipeline through the levee, 4 feet below the crown. Two cutoff walls. Gas line indicator found on the landside (LS) of the levee. (20-inch wrapped steel natural gas pipeline authorized under Permit No. 2415, 1956 - Pacific Gas and Electric Company [PG&E]). [Additional Reference(s): DWR Levee Log, 1993. USACE Sacramento O&M Manual 126, November 1961, (HLM 2.24)]. FS Date: 6/16/2016 7:00:04 AM

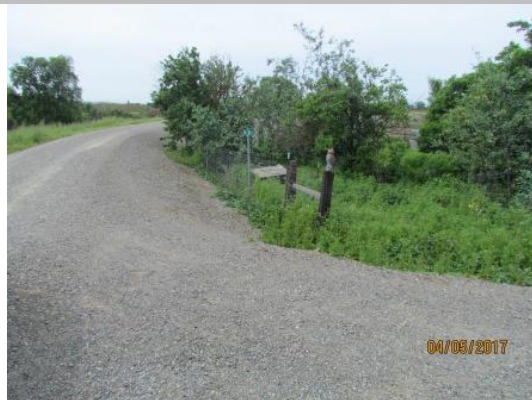
Photo 1 of 1 : FA_2019_ST0001_259_78_20190829_00046.jpg

Chain fence at landside levee toe. Spring 2017.

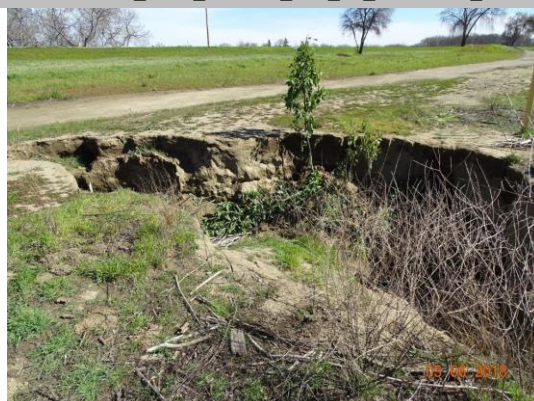
Photo 2 of 5 : FA_2019_ST0001_259_62_20190829_00039.jpg

View of erosion looking towards the landside levee slope, facing northeast. Spring 2018.

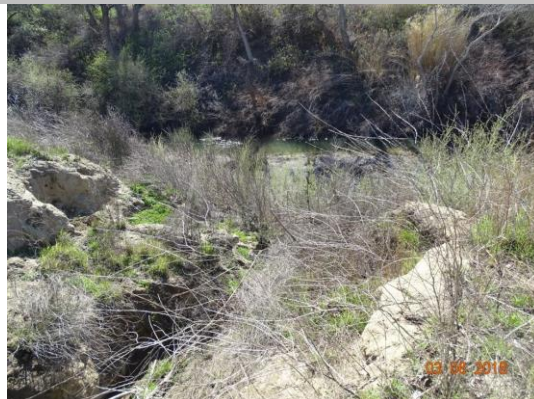
Photo 3 of 5 : FA_2019_ST0001_259_62_20190829_00040.jpg

Downslope view of erosion, facing Cache Creek. Spring 2018.

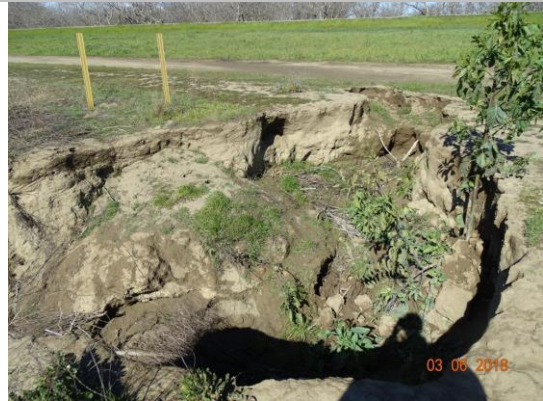
Photo 4 of 5 : FA_2019_ST0001_259_62_20190829_00041.jpg

Additional view of erosion, looking northwest. Spring 2018.

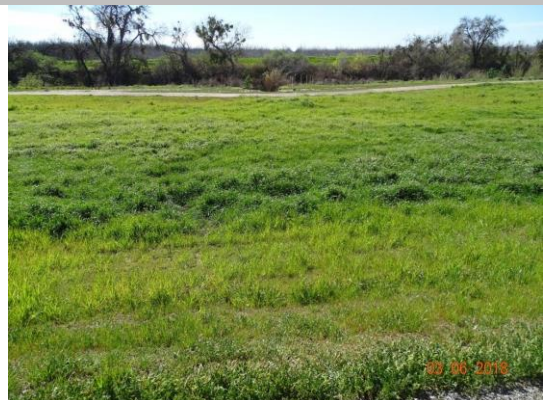
Photo 5 of 5 : FA_2019_ST0001_259_62_20190829_00042.jpg

View of erosion from levee crown, facing Cache Creek. Fall 2018.

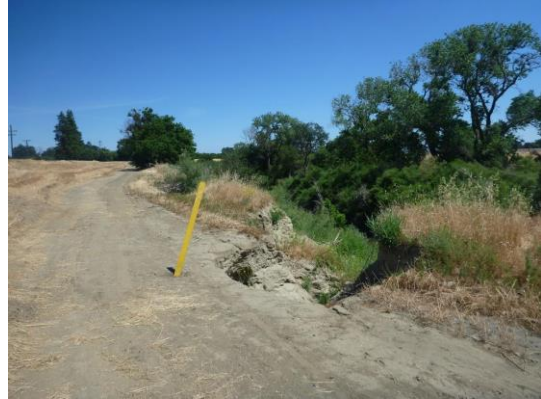
Photo 3 of 3 : LEVAL_FA_2019_249_960.jpg

LM Start	4.22	Rating **	A/W	Issue No.	34 (cont)
LM End	4.23	Issue Type +	Ma	Location *	WS
Category	Supplemental			GPS Latitude/Longitude	
				Start	End
Item	2017 Storm Damage			38.727207 °	38.727187 °
				-121.775521 °	-121.775450 °
DWR ID	LMA-57				
Comment Code					
Inspector Comment					
Levee Evaluation Comments					
Description:					
Site ID No:249					
Site Designation:LMA-57					
Repair Type: Erosion					
Rating:Area of Concern					
Field Date:6/2/2017					
Notes: setback levee site; remaining berm greater than 86 feet, no section taken, photo only.

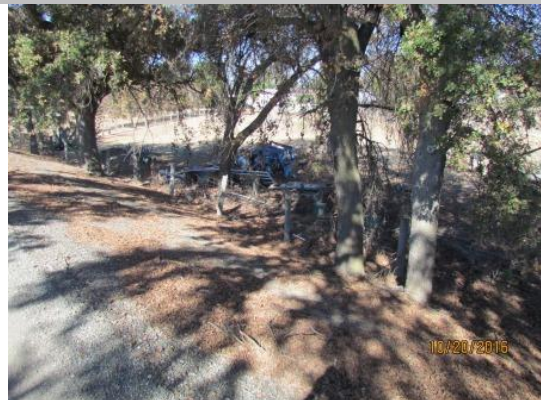
Photo 1 of 1 : FA_2019_ST0001_259_52_20190829_00036.jpg

LM Start	4.34	Rating **	M	Issue No.	52
LM End	4.42	Issue Type +	En	Location *	LS
Category	Earthen Levee			GPS Latitude/Longitude	
				Start	End
Item	Encroachments			38.726754 °	38.726242 °
				-121.773424 °	-121.772221 °
DWR ID	DWR_ST0001_01_f_2016_52				
Comment Code					
FE : Fence					
Inspector Comment					
A fence is located on the landside slope.

Fence on landside slope. Fall 2016.

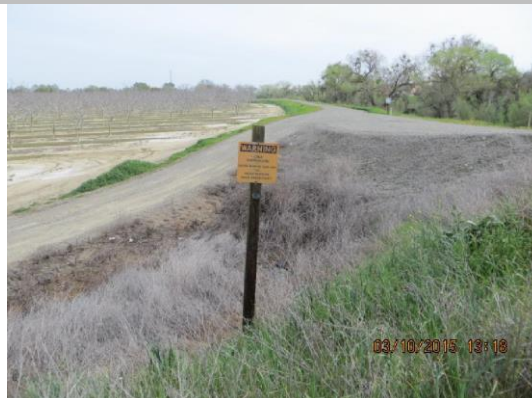
Photo 1 of 2 : UCIP_FA_2019_49111_73501.jpg

Sign on LS toe.

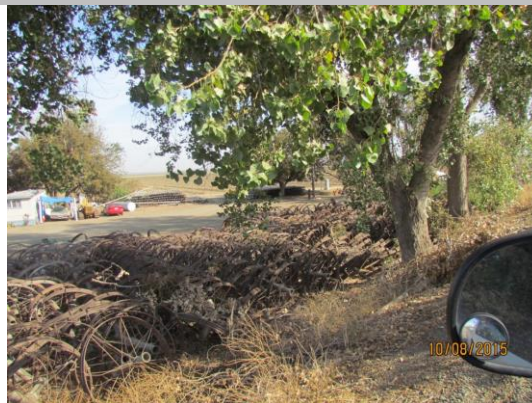
Photo 2 of 2 : FA_2019_ST0001_259_40_20190829_00032.jpg

View of the equipment at the levee toe on the landward side looking downstream. Fall 2015.

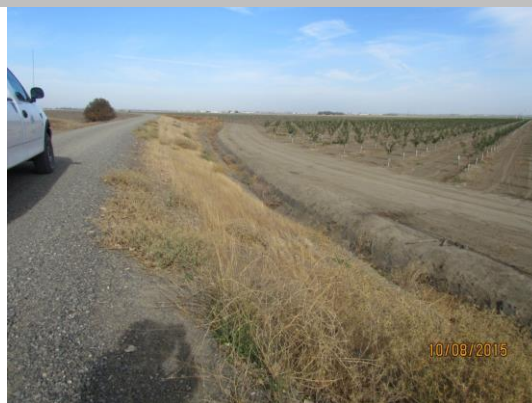
Photo 2 of 2 : FA_2019_ST0001_259_26_20190829_00020.jpg

View of the ditch on the landward side of the levee looking upstream.
Fall 2015.

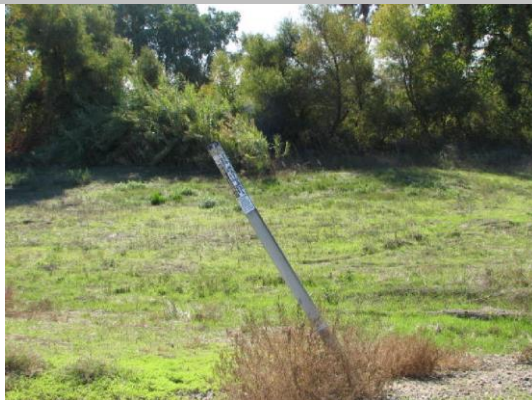
Photo 1 of 2 : UCIP_FA_2019_50811_60197.jpg

Waterside view: gasline indicator

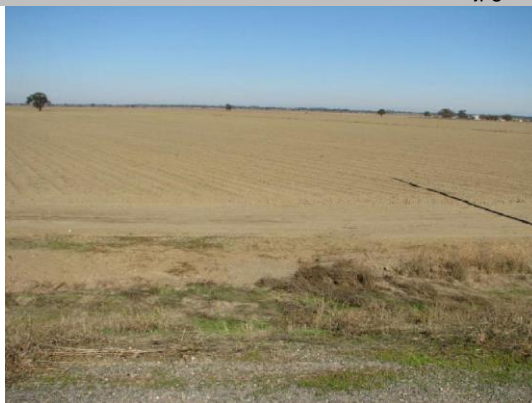
Photo 2 of 2 : UCIP_FA_2019_50811_60196.jpg

Landside view: no indicator found.

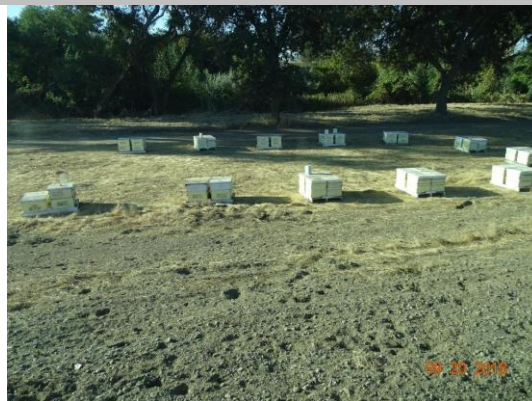
Photo 1 of 1 : FA_2019_ST0001_259_38_20190829_00029.jpg

View of beehives at the landside toe. Fall 2018.

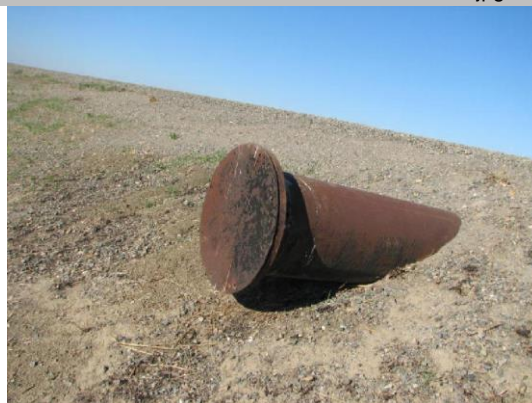
Photo 2 of 3 : UCIP_FA_2019_53214_60223.jpg

Waterside view: closer look at capped pipe.

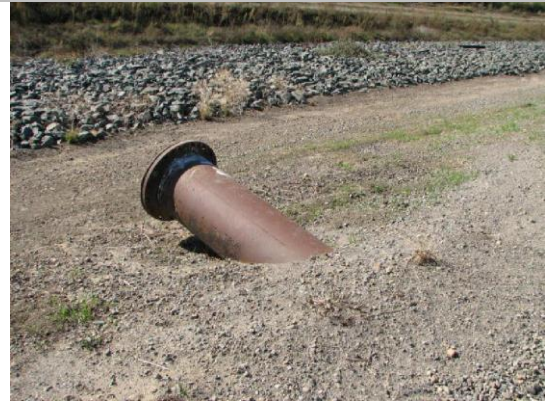
Photo 3 of 3 : UCIP_FA_2019_53214_60222.jpg

Waterside view: steel pipe on the slope of the levee

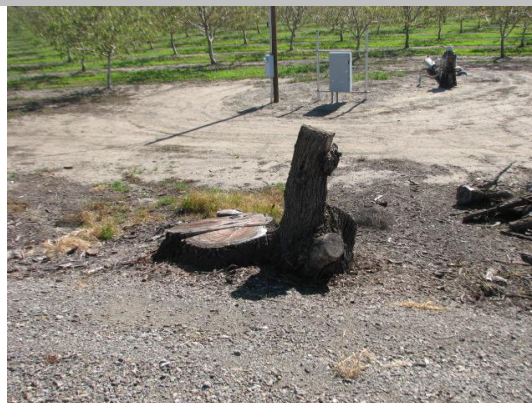
Photo 1 of 1 : FA_2019_ST0001_260_6_20190829_00005.jpg

View of large black walnut tree stump is at the landside toe. Spring 2014

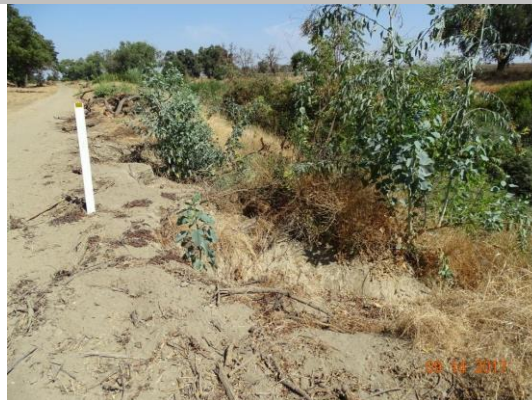
Photo 1 of 1 : FA_2019_ST0001_260_16_20190829_00014.jpg

View of storm damage site on waterside berm. Does not appear to be within the levee prism at this time. Fall 2017.

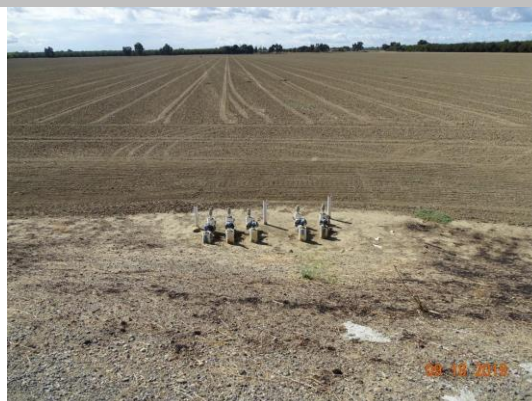
Photo 1 of 1 : FA_2019_ST0001_260_24_20190919_00023.jpg

View of the pumps, air valves, and bollards at the landside toe. Fall 2019.

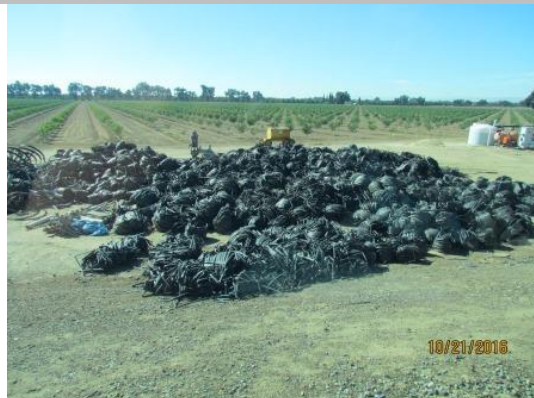
Photo 1 of 2 : FA_2019_ST0001_260_3_20190829_00002.jpg

Additional view of debris on landward side of the levee. Fall 2016.

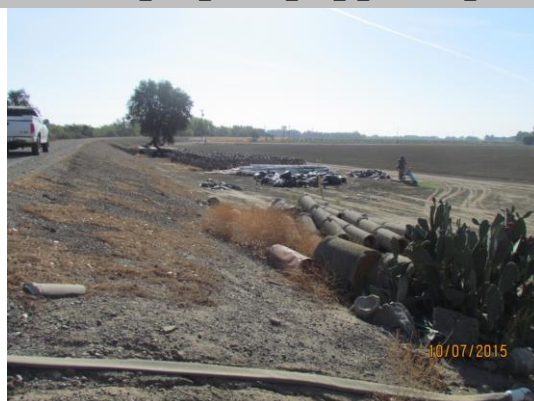
Photo 2 of 2 : FA_2019_ST0001_260_3_20190829_00003.jpg

View of the concrete pile at the toe of the landward side of the levee looking downstream. Fall 2015.

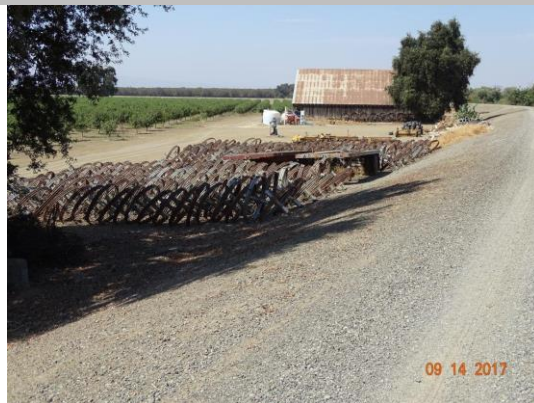
Photo 1 of 1 : FA_2019_ST0001_260_29_20190829_00019.jpg

View of farm equipment at landside toe. Fall 2017.

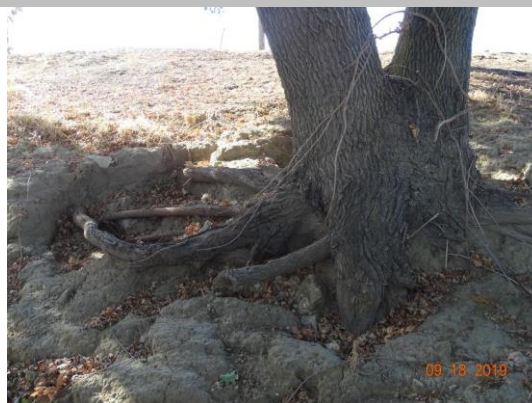
Photo 1 of 1 : FA_2019_ST0001_260_18_20190919_00022.jpg

View of the erosion around the tree. Fall 2019.

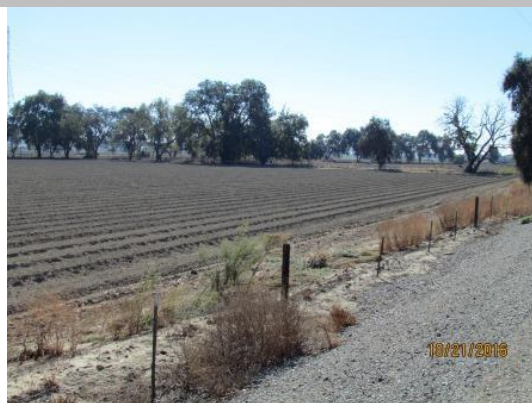
Photo 1 of 1 : FA_2019_ST0001_260_15_20190829_00013.jpg

View of fence on LS slope. Fall 2016.

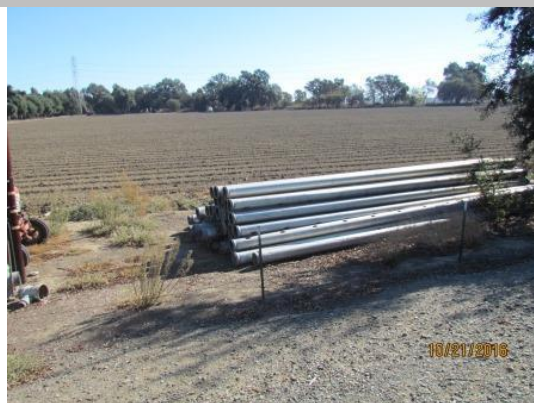
Photo 1 of 1 : FA_2019_ST0001_260_12_20190829_00010.jpg

Pipes are stored at levee toe on landside. Fall 2016.

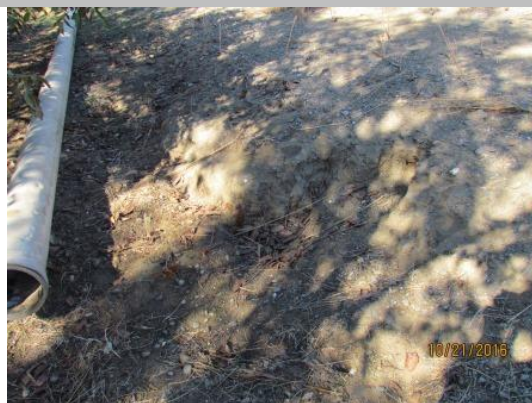
Photo 1 of 1 : FA_2019_ST0001_260_4_20190829_00004.jpg

Erosion on LS levee slope toward the toe. Fall 2016.

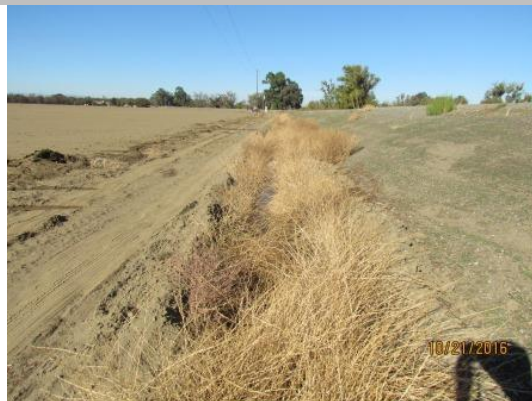
Photo 1 of 2 : FA_2019_ST0001_260_14_20190829_00011.jpg

View of ditch on landside near the levee toe looking upstream of Cache Creek. Fall 2016.

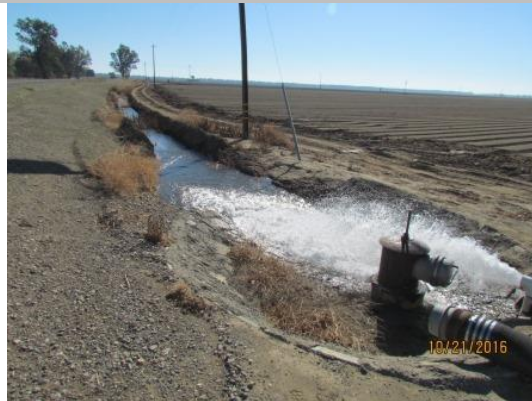
Photo 2 of 2 : FA_2019_ST0001_260_14_20190829_00012.jpg

View of ditch on landside near the levee toe looking downstream of Cache Creek. Fall 2016.

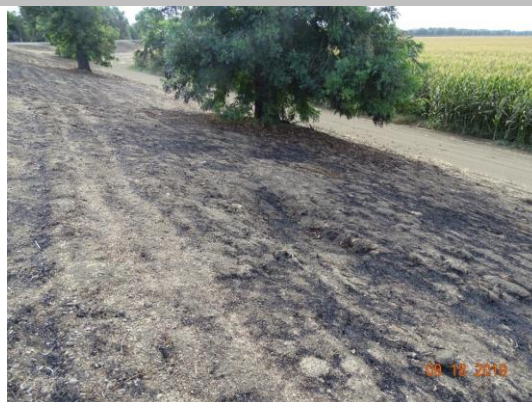
Photo 1 of 1 : FA_2019_ST0001_260_5_20190919_00021.jpg

View of sinkhole on the landside slope. Fall 2019.

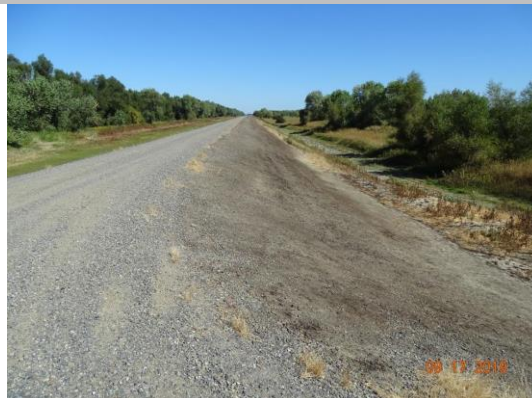
Photo 1 of 1 : FA_2019_ST0001_261_2_20190919_00008.jpg

View of the maintained landside slope. Fall 2019.
