Flood Control Project Maintenance Levee Inspections

Fall 2020 Levee Maintenance Deficiency Summary Report

Sacramento River Basin

Sacramento Maintenance Yard Cache Creek

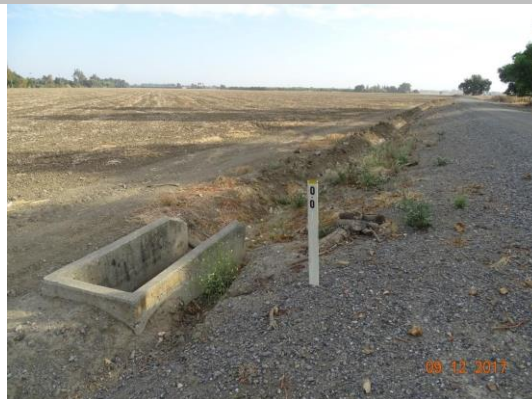
Photo 1 of 2 : FA_2020_ST0001_259_48_20200813_00032.jpg

LM Start	0.03	Rating **	M	Issue No.	48
LM End	0.16	Issue Type +	En	Location *	LS
Category	Earthen Levee			GPS Latitude/Longitude	
				Start	End
Item	Encroachments			38.715268 °	38.716647 °
				-121.825345 °	-121.823667 °
DWR ID	DWR_ST0001_01_s _ 2015_48				
Comment Code					
DT : Ditch					
Inspector Comment					
A ditch is located at the levee toe.

View of the ditch at the landside levee toe. Fall 2017.

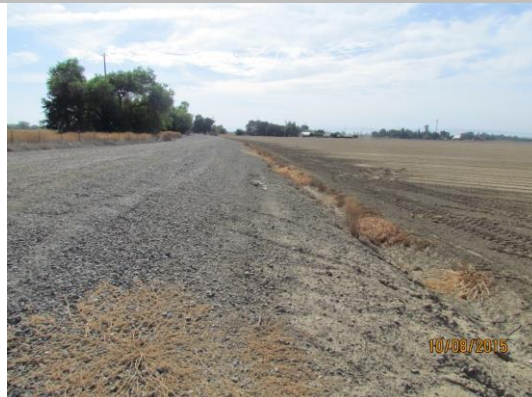
Photo 2 of 2 : FA_2020_ST0001_259_48_20200813_00033.jpg

View of the ditch on the landward side of the levee looking upstream.
Fall 2015.

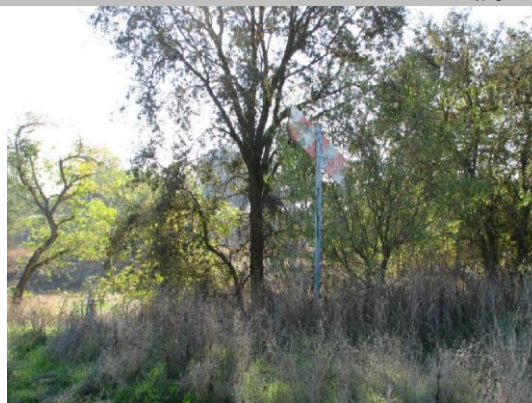
Photo 1 of 3 : UCIP_FA_2020_50432_60162.jpg

LM Start	1.37	Rating **	M	Issue No.	79
LM End	1.37	Issue Type +	En	Location *	
Category	Supplemental			GPS Latitude/Longitude	
				Start	End
Item	DWR UCIP Field Study			38.722669 °	38.722669 °
				-121.808792 °	-121.808792 °
DWR ID	16270				
Comment Code					
Inspector Comment					
DS_ID:16270					
FS_ID:50432					
EP_NO: 6790					
Repair Type: Non-Urgent					
EVAL Issue:					
Crossing Status: Indicator Found					
UCIP Comments: May need additional signs on LS of levee.					
FIELD_STRUCT_DESC: 6-inch high-pressure natural gas main of an unknown material through the levee and under the channel, at an unknown depth. Gas line marker on the waterside (WS) slope. (6-inch high-pressure natural gas main authorized under Permit No. 6790, 1969 - Pacific Gas and Electric Company [PG&E]). [Additional Reference(s): DWR Levee Log, 1993].					
FS Date: 6/16/2016 6:58:00 AM

Waterside view: gasline marker

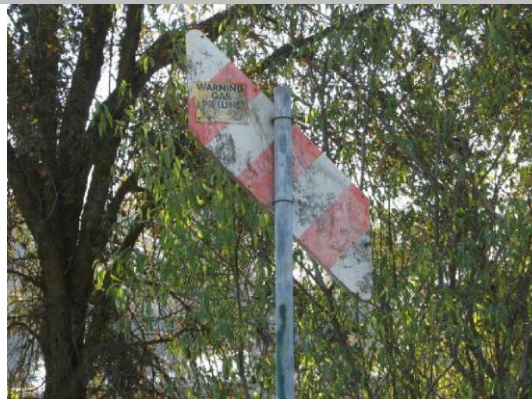
Photo 2 of 3 : UCIP_FA_2020_50432_60161.jpg

Waterside view: closer look at gasoline marker

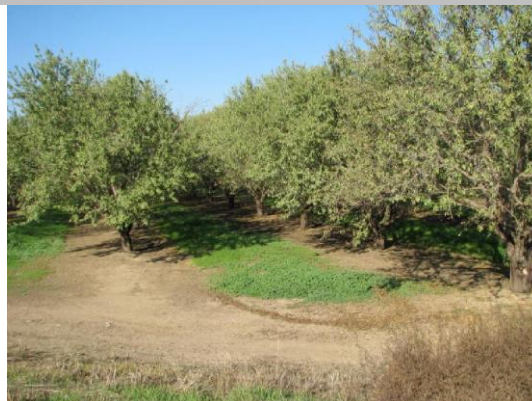
Photo 3 of 3 : UCIP_FA_2020_50432_60160.jpg

Landside view: no gasoline marker

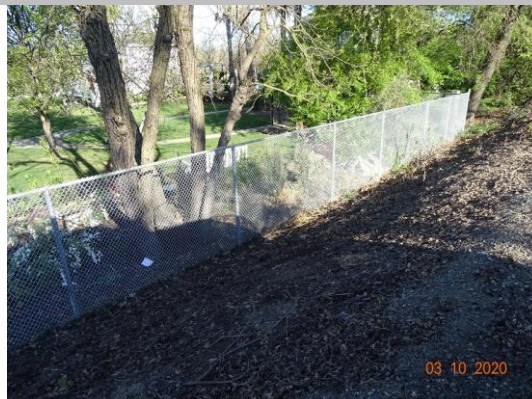
Photo 1 of 1 : FA_2020_ST0001_259_63_20200813_00042.jpg

LM Start	1.77	Rating **	M	Issue No.	63
LM End	1.90	Issue Type +	En	Location *	LS
Category	Earthen Levee			GPS Latitude/Longitude	
				Start	End
Item	Encroachments			38.728217 °	38.729944 °
				-121.806903 °	-121.806506 °
DWR ID	DWR_ST0001_01_s_2017_63				
Comment Code					
FE : Fence					
Inspector Comment

View of fence at the landside toe. Spring 2020.

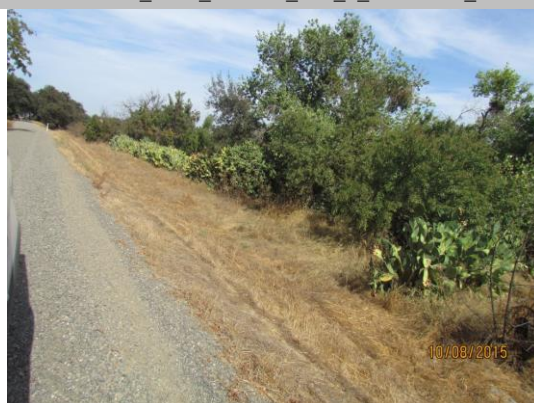
Photo 1 of 1 : FA_2020_ST0001_259_6_20200813_00004.jpg

LM Start	1.98	Rating **	M	Issue No.	6
LM End	2.01	Issue Type +	En	Location *	WS
Category	Earthen Levee			GPS Latitude/Longitude	
				Start	End
Item	Vegetation			38.731166 °	38.731620 °
				-121.806215 °	-121.806032 °
DWR ID	DWR_ST0001_01_s_2012_6				
Comment Code					
V6 : Landscaping					
Inspector Comment					
Catus is located on the waterside berm.

View of the cactus landscaping on the waterward side of the levee looking downstream. Fall 2015.

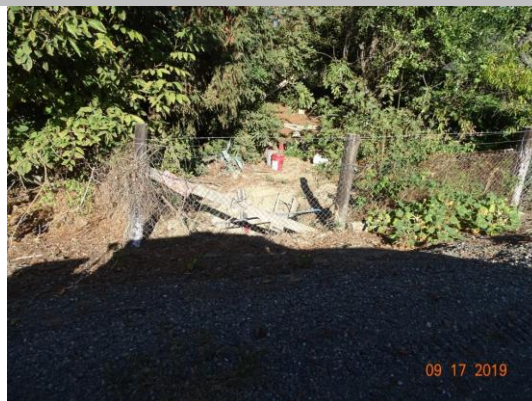
Photo 1 of 2 : FA_2020_ST0001_259_35_20200813_00027.jpg

LM Start	1.98	Rating **	U	Issue No.	35
LM End	1.98	Issue Type +	En	Location *	LS
Category	Earthen Levee			GPS Latitude/Longitude	
				Start	End
Item	Encroachments			38.731208 °	38.731208 °
				-121.806220 °	-121.806220 °
DWR ID	DWR_ST0001_01_s_2020_35				
Comment Code					
DT : Ditch					
Inspector Comment					
The landowner has dug a 5' diameter hole within 10' of the landside toe and it appears to cut into the levee prism.

View of the hole within the landside easement. Fall 2019.

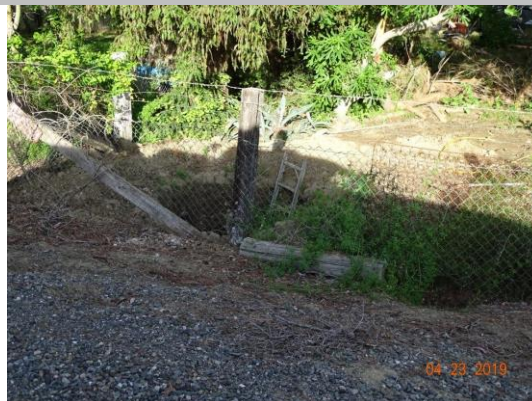
Photo 2 of 2 : FA_2020_ST0001_259_35_20200813_00028.jpg

View of the hole within the landside easement. Spring 2019.

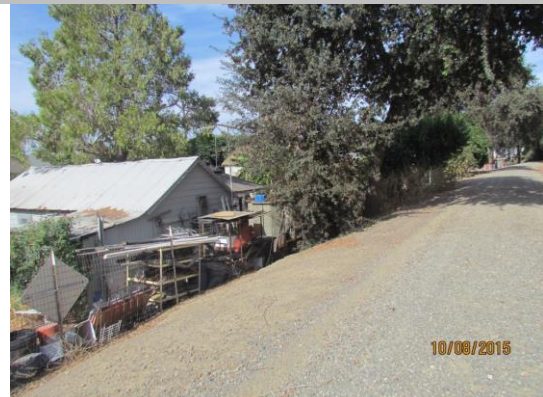
Photo 1 of 1 : FA_2020_ST0001_259_11_20200813_00008.jpg

LM Start	2.06	Rating **	M	Issue No.	11
LM End	2.06	Issue Type +	En	Location *	LS
Category	Earthen Levee			GPS Latitude/Longitude	
				Start	End
Item	Encroachments			38.732268 °	38.732268 °
				-121.805832 °	-121.805832 °
DWR ID	DWR_ST0001_01_s_ 2012_11				
Comment Code					
BU : Building					
Inspector Comment

View of the building on the landward side of the levee looking downstream. Fall 2015.

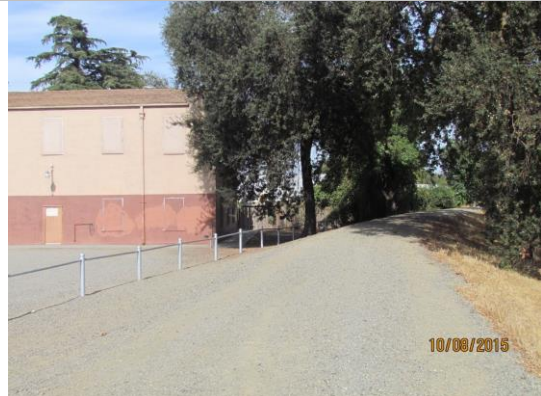
Photo 1 of 1 : FA_2020_ST0001_259_12_20200813_00009.jpg

LM Start	2.12	Rating **	M	Issue No.	12
LM End	2.12	Issue Type +	En	Location *	LS
Category	Earthen Levee			GPS Latitude/Longitude	
				Start	End
Item	Encroachments			38.733000 °	38.733000 °
				-121.805409 °	-121.805409 °
DWR ID	DWR_ST0001_01_f _ 2019_12				
Comment Code					
BU : Building					
Inspector Comment

View of the building on the landward side of the levee looking downstream. Fall 2015.

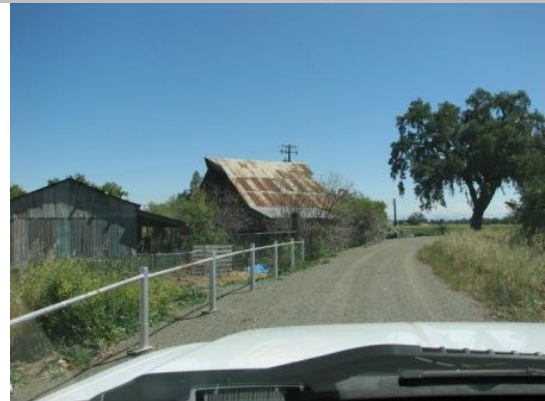
Photo 1 of 2 : FA_2020_ST0001_259_16_20200813_00014.jpg

Horse barn and corral are within the easement of the levee.

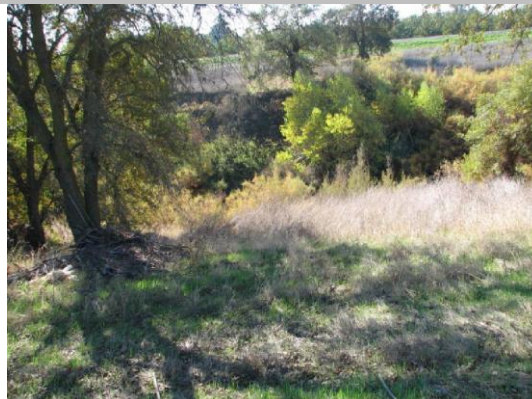
Photo 1 of 3 : UCIP_FA_2020_49099_60164.jpg

Comment Code						
Inspector Comment						
DS_ID:16268 FS_ID:49099 EP_NO: 2415 Repair Type: Non-Urgent EVAL Issue: Crossing Status: Indicator Found UCIP Comments: May need to install gasoline marker on WS slope. FIELD_STRUCT_DESC: 20-inch wrapped steel natural gas pipeline through the levee, 4 feet below the crown. Two cutoff walls. Gas line indicator found on the landside (LS) of the levee. (20-inch wrapped steel natural gas pipeline authorized under Permit No. 2415, 1956 - Pacific Gas and Electric Company [PG&E]). [Additional Reference(s): DWR Levee Log, 1993. USACE Sacramento O&M Manual 126, November 1961, (HLM 2.24)]. FS Date: 6/16/2016 7:00:04 AM

Waterside view: no indicators found

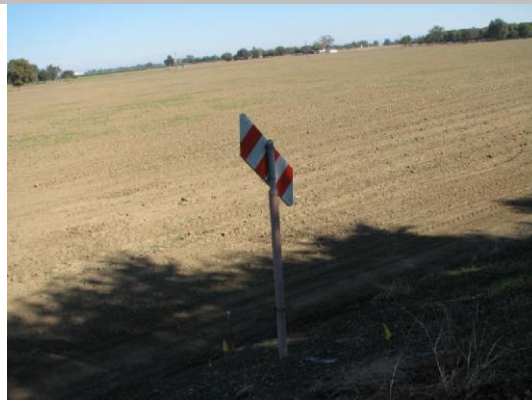
Photo 2 of 3 : UCIP_FA_2020_49099_60163.jpg

Landside view: gasoline indicator

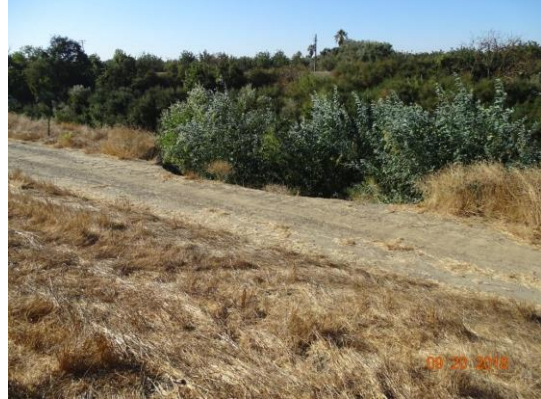
Photo 1 of 3 : FA_2020_ST0001_259_30_20200813_00021.jpg

2017 Site ID: CHC 2.4 L
Status: Critical
2017 Field Notes: No observed change.
Site History: Site identified as CRITICAL in 2002. 2006 - Currently constructing a setback levee. New failures present and extensive. Downstream end of the setback levee did not extend far enough. Upstream end was repaired. 2007 - DWR repaired with a setback levee, but the levee did not go far enough downstream. 2012 - New cracks observed. 2013 - Fresh erosion on upper bank.

View of erosion on the waterside toe road. Fall 2018.

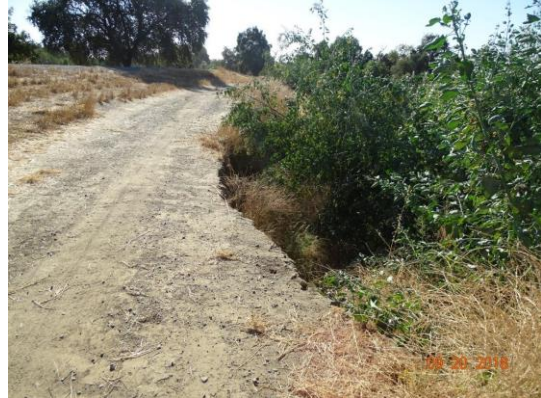
Photo 2 of 3 : FA_2020_ST0001_259_30_20200813_00022.jpg

Additional view of the erosion, facing downstream. Fall 2018.

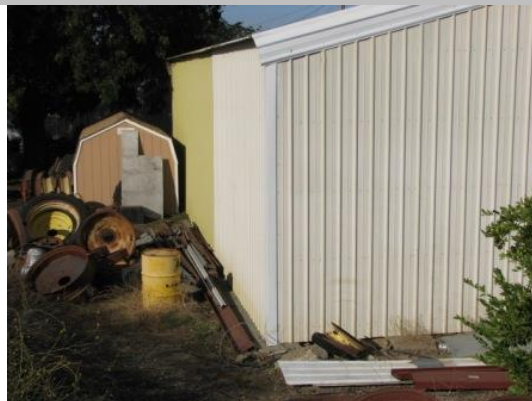
Photo 2 of 2 : FA_2020_ST0001_259_20_20200813_00016.jpg

The corner of the shop is within the easement of the levee. Fall 2011

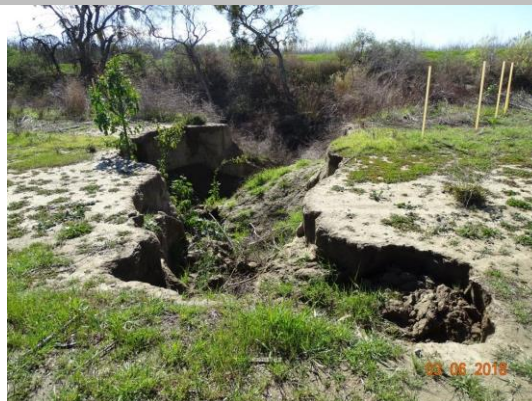
Photo 1 of 4 : FA_2020_ST0001_259_62_20200813_00037.jpg

View of erosion on toe road, looking towards Cache Creek. Spring 2018.

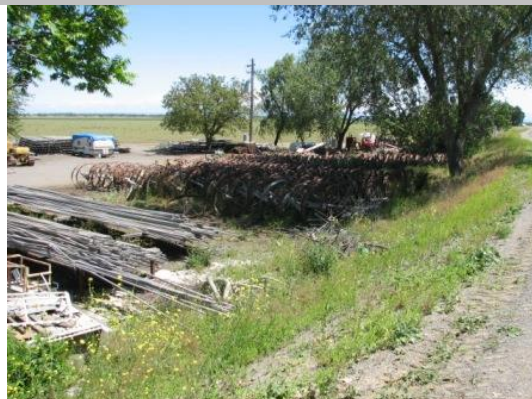
Photo 1 of 2 : FA_2020_ST0001_259_40_20200813_00030.jpg

Irrigation pipe and equipment are within the easement of the levee.

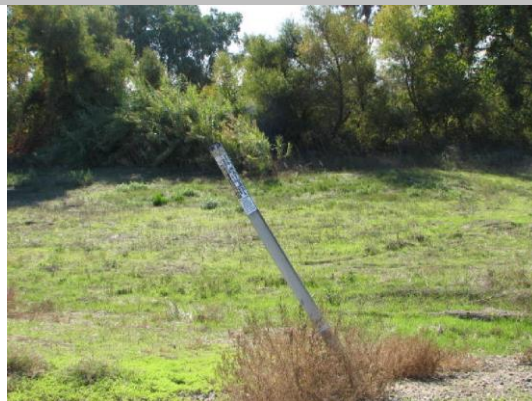
Photo 1 of 2 : UCIP_FA_2020_50811_60197.jpg

LM Start	7.89	Rating **	M	Issue No.	83	
LM End	7.89	Issue Type +	En	Location *		
Category	Supplemental			GPS Latitude/Longitude		
				Start		End
Item	DWR UCIP Field Study			38.727333 °		38.727333 °
				-121.718558 °		-121.718558 °
DWR ID	16264					
Comment Code						
Inspector Comment						
DS_ID:16264 FS_ID:50811 EP_NO: 12983 Repair Type: Non-Urgent EVAL Issue: Crossing Status: Indicator Found UCIP Comments: Gasline markers in disrepair and should be replaced. Gasline indicator found on waterside of the levee. FIELD_STRUCT_DESC: 4-inch and 6-inch coated steel natural gas pipelines through the levee and under the Cache Creek Settling Basin, at an unknown depth. (4-inch and 6-inch pipelines authorized under Permit No. 12983, 1980 - Shell Oil Company). [Additional Reference(s): DWR Levee Log, 1993]. FS Date: 11/21/2016 7:56:33 AM

Waterside view: gasline indicator

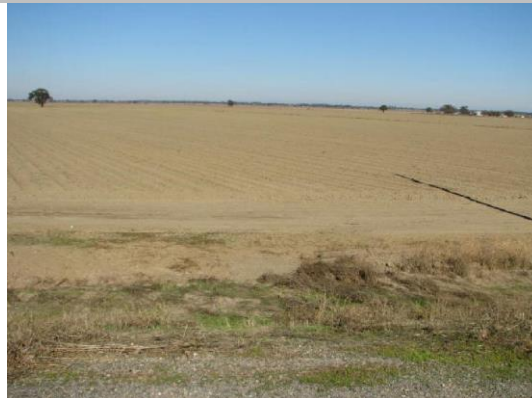
Photo 2 of 2 : UCIP_FA_2020_50811_60196.jpg

Landside view: no indicator found.

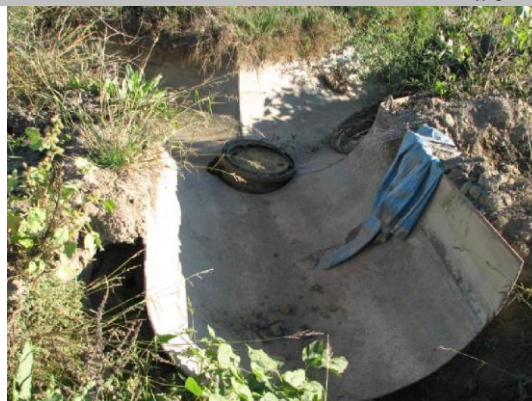
Photo 1 of 3 : UCIP_FA_2020_53215_60148.jpg

Comment Code						
Inspector Comment						
DS_ID:17119 FS_ID:53215 EP_NO: N/A Repair Type: Non-Urgent EVAL Issue: Crossing Status: Found UCIP Comments: 11/3/2016: Per Ted Skidgel, new cap and gasket installed by farmer on LS vent, and siphon breaker/vent installed on WS. No permit was found for this work. Siphon breaker on WS needs cover. Repair Priority changed from No Action Needed to Non-Urgent. (K. Fazel - UCIP)08/16/2016: Repaired erosion L/S 8/16 pipe repaired by farmer prior to erosion. (T. Skidgel - ST0001). (Note: crossing was downgraded from Urgent to No Action Needed)06/28/2016: Erosion still present off LS shoulder, caused by leaking vent. Erosion to be repaired and backfilled this summer by Sac Yard. Pipe leaking at LS toe into ditch (not affecting levee prism) (K. Fazel - UCIP).2013-2016: Pipe leaks, severe erosion from levee shoulder to pipe daylight on landside levee slope, summer of 2013 repaired erosion,pipe needs repaired. (P. Amatya - DWR) FIELD_STRUCT_DESC: 18-inch, 0.25-inch-thick soil-proofed steel irrigation pipe, 2 feet below the crown. Capped vent on the apex of the pipe off the landside (LS) shoulder. Booster pump located off the LS toe at the LS toe ditch. Another groundwater pump is located a further distance off the LS toe. Pumped groundwater is conveyed to the toe ditch and a booster pump pumps water through the levee and into a waterside (WS) ditch in the Cache Creek Settling Basin. Distribution box off the WS toe at the WS toe ditch. Could not locate a positive closure device. [Additional Reference(s): USACE As-Constructed Drawing North Station 49+50]. FS Date: 11/16/2018 8:35:41 AM

Waterside view: pipe in the ditch

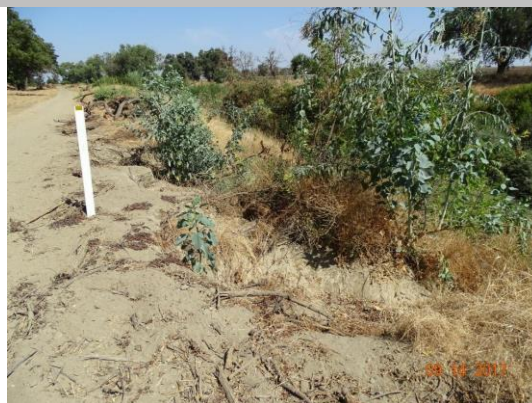
Photo 1 of 1 : FA_2020_ST0001_260_16_20200813_00011.jpg

View of storm damage site on waterside berm. Does not appear to be within the levee prism at this time. Fall 2017.

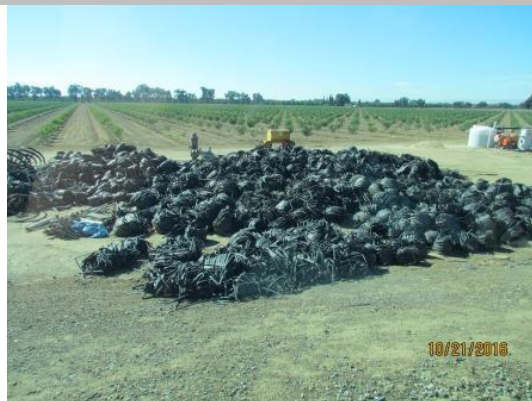
Photo 1 of 2 : FA_2020_ST0001_260_3_20200813_00002.jpg

Additional view of debris on landward side of the levee. Fall 2016.

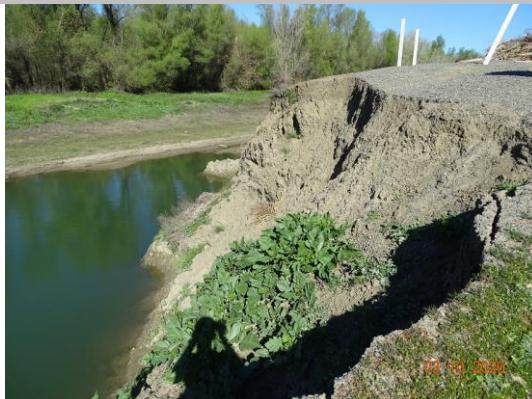
Photo 1 of 2 : FA_2020_ST0001_261_3_20200813_00001.jpg

View of scour at the end of the levee unit. Spring 2020.

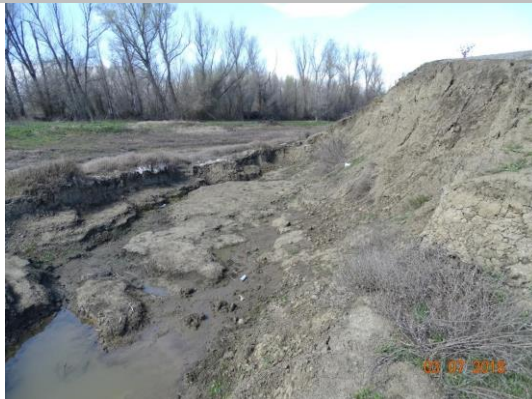
Photo 2 of 2 : FA_2020_ST0001_261_3_20200813_00002.jpg

View of scour on waterside levee slope at the end of Unit 4. Spring 2018.
