Flood Control Project Maintenance Levee Inspections

Fall 2021 Levee Maintenance Deficiency Summary Report

Sacramento River Basin

Sacramento Maintenance Yard Cache Creek

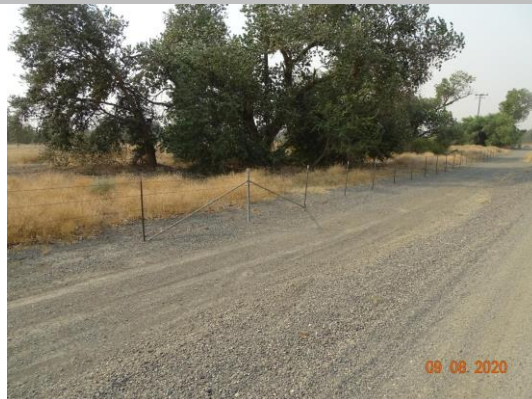
Photo 1 of 1 : FA_2021_ST0001_259_24_20210907_00013.jpg

View of the fence near the toe road. Fall 2020.

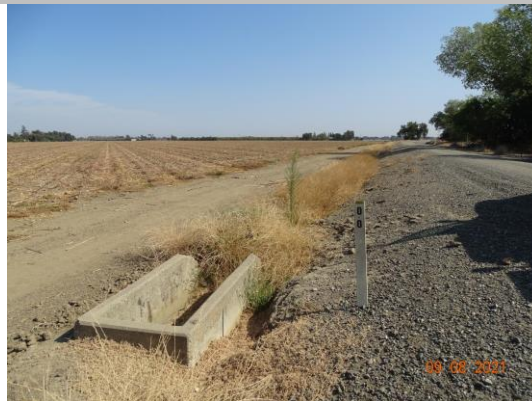
Photo 1 of 1 : FA_2021_ST0001_259_48_20210908_00053.jpg

LM Start	0.03	Rating **	M	Issue No.	48
LM End	0.16	Issue Type +	En	Location *	LS
Category	Earthen Levee			GPS Latitude/Longitude	
				Start	End
Item	Encroachments			38.715268 °	38.716647 °
				-121.825345 °	-121.823667 °
DWR ID	DWR_ST0001_01_s _ 2015_48				
Comment Code					
DT : Ditch					
Inspector Comment					
A ditch is located at the levee toe.

View of ditch at landside toe. Fall 2021.

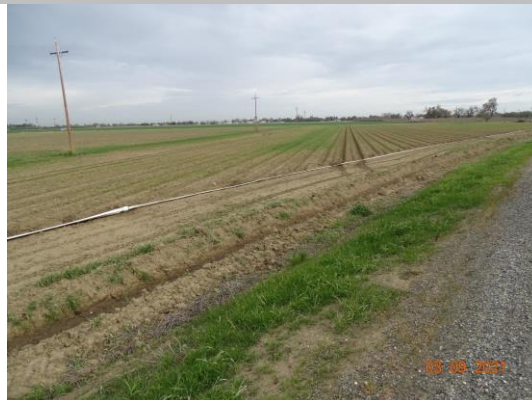
Photo 1 of 1 : FA_2021_ST0001_259_27_20210907_00015.jpg

LM Start	0.92	Rating **	M	Issue No.	27
LM End	1.09	Issue Type +	En	Location *	LS
Category	Earthen Levee			GPS Latitude/Longitude	
				Start	End
Item	Encroachments			38.719051 °	38.720864 °
				-121.815287 °	-121.812980 °
DWR ID	DWR_ST0001_01_f_2021_27				
Comment Code					
DT : Ditch					
Inspector Comment					
There is an irrigation ditch at the landside toe.

View of irrigation ditch near the landside toe. Spring 2021.

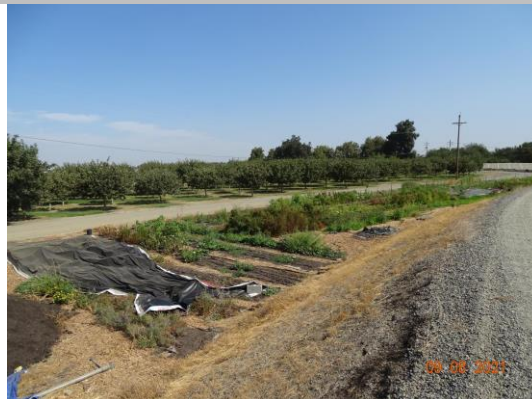
Photo 1 of 1 : FA_2021_ST0001_259_25_20210908_00054.jpg

View of garden at landside toe. Fall 2021.

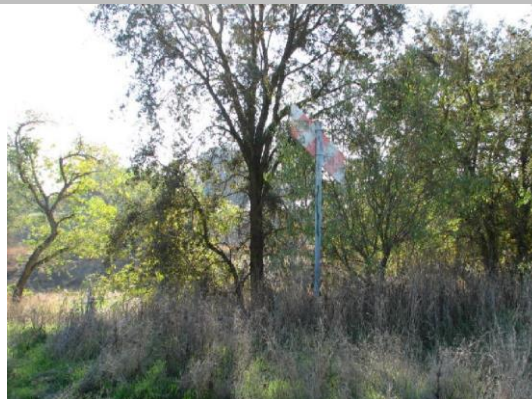
Photo 1 of 3 : UCIP_FA_2021_50432_60162.jpg

LM Start	1.37	Rating **	M	Issue No.	79	
LM End	1.37	Issue Type +	En	Location *		
Category	Supplemental			GPS Latitude/Longitude		
				Start		End
Item	DWR UCIP Field Study			38.722669 °		38.722669 °
				-121.808792 °		-121.808792 °
DWR ID	16270					
Comment Code						
Inspector Comment						
DS_ID:16270 FS_ID:50432 EP_NO: 6790 Repair Type: Non-Urgent EVAL Issue: Crossing Status: Indicator Found UCIP Comments: May need additional signs on LS of levee. FIELD_STRUCT_DESC: 6-inch high-pressure natural gas main of an unknown material through the levee and under the channel, at an unknown depth. Gas line marker on the waterside (WS) slope. (6-inch high-pressure natural gas main authorized under Permit No. 6790, 1969 - Pacific Gas and Electric Company [PG&E]). [Additional Reference(s): DWR Levee Log, 1993]. FS Date: 6/16/2016 6:58:00 AM

Waterside view: gasline marker

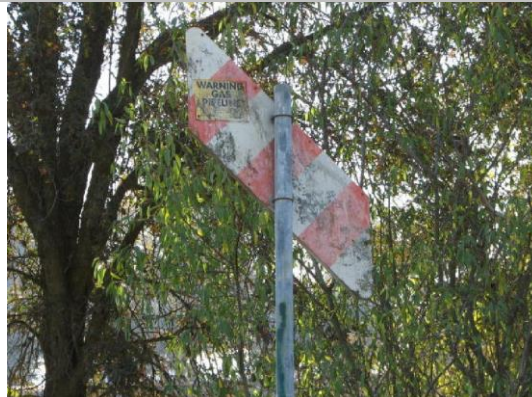
Photo 2 of 3 : UCIP_FA_2021_50432_60161.jpg

Waterside view: closer look at gasline marker

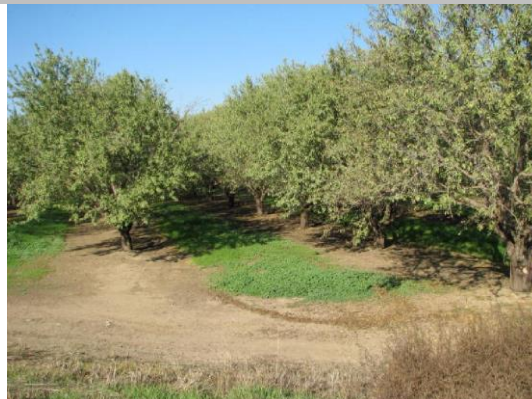
Photo 3 of 3 : UCIP_FA_2021_50432_60160.jpg

Landside view: no gasoline marker

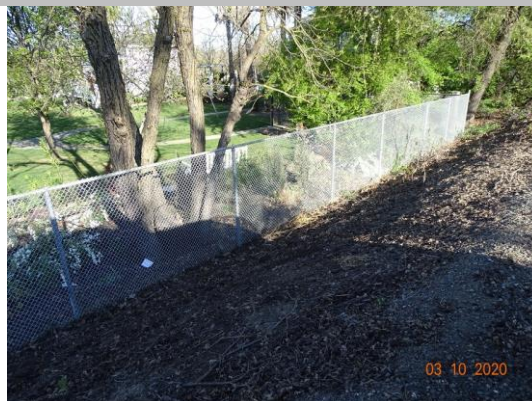
Photo 1 of 1 : FA_2021_ST0001_259_63_20210907_00030.jpg

LM Start	1.77	Rating **	M	Issue No.	63
LM End	1.90	Issue Type +	En	Location *	LS
Category	Earthen Levee			GPS Latitude/Longitude	
				Start	End
Item	Encroachments			38.728217 °	38.729944 °
				-121.806903 °	-121.806506 °
DWR ID	DWR_ST0001_01_s_2017_63				
Comment Code					
FE : Fence					
Inspector Comment

View of fence at the landside toe. Spring 2020.

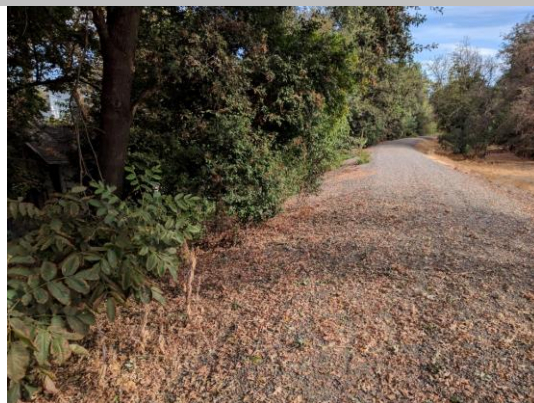
Photo 1 of 1 : FA_2021_ST0001_259_3_20210907_00001.jpg

View of thick vegetation on landside slope. Fall 2017.

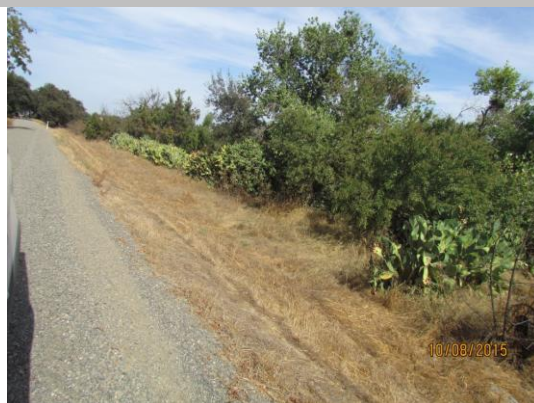
Photo 1 of 1 : FA_2021_ST0001_259_6_20210907_00002.jpg

LM Start	1.98	Rating **	M	Issue No.	6
LM End	2.01	Issue Type +	En	Location *	WS
Category	Earthen Levee			GPS Latitude/Longitude	
				Start	End
Item	Vegetation			38.731166 °	38.731620 °
				-121.806215 °	-121.806032 °
DWR ID	DWR_ST0001_01_s_2012_6				
Comment Code					
V6 : Landscaping					
Inspector Comment					
Catus is located on the waterside berm.

View of the cactus landscaping on the waterward side of the levee looking downstream. Fall 2015.

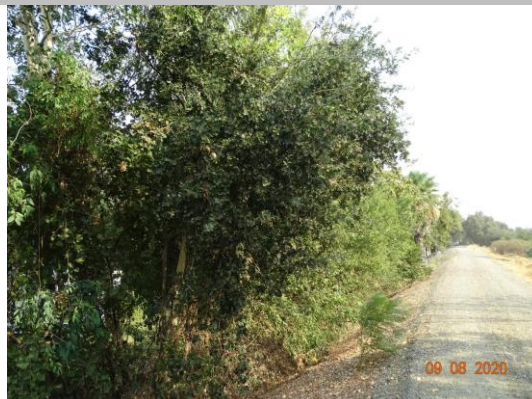
Photo 1 of 1 : FA_2021_ST0001_259_7_20210907_00003.jpg

View of the landscaping on the landward side of the levee looking downstream. Fall 2020.

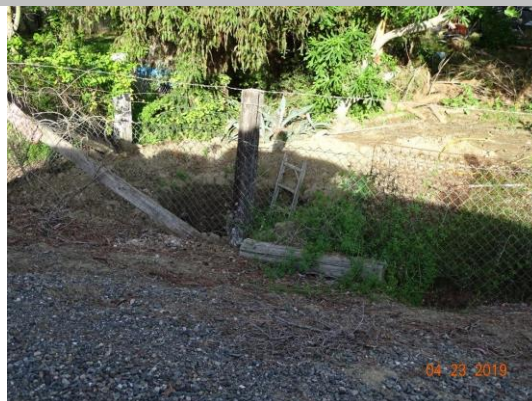
Photo 1 of 1 : FA_2021_ST0001_259_35_20210907_00021.jpg

LM Start	1.98	Rating **	U	Issue No.	35
LM End	1.98	Issue Type +	En	Location *	LS
Category	Earthen Levee			GPS Latitude/Longitude	
				Start	End
Item	Encroachments			38.731208 °	38.731208 °
				-121.806220 °	-121.806220 °
DWR ID	DWR_ST0001_01_s_2020_35				
Comment Code					
DT : Ditch					
Inspector Comment					
The landowner has dug a 5' diameter hole within 10' of the landside toe and it appears to cut into the levee prism.

View of the hole within the landside easement. Spring 2019.

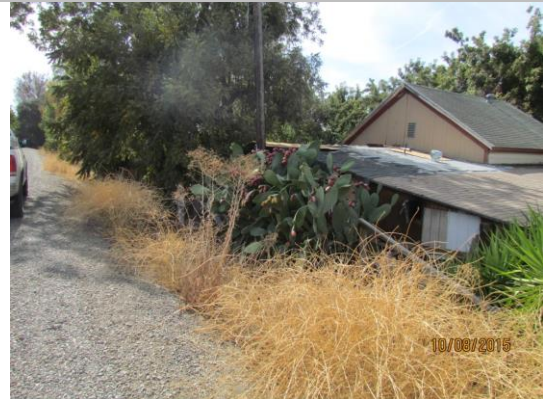
Photo 1 of 1 : FA_2021_ST0001_259_8_20210907_00004.jpg

View of the building on the landward side of the levee looking upstream.
Fall 2015.

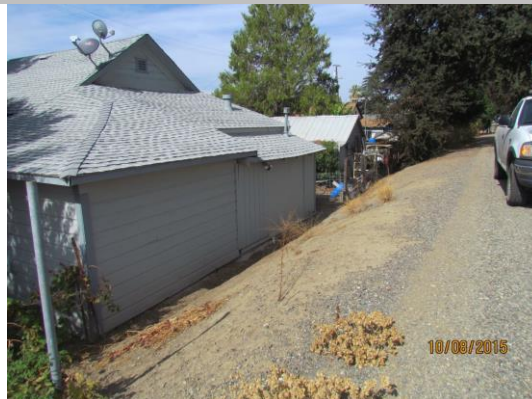
Photo 1 of 1 : FA_2021_ST0001_259_10_20210907_00005.jpg

View of the house on the landward side of the levee looking downstream. Fall 2015.

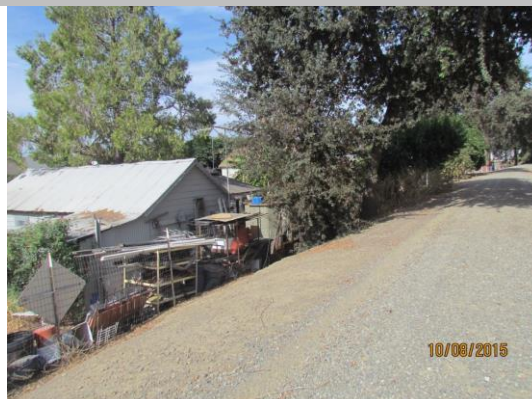
Photo 1 of 1 : FA_2021_ST0001_259_11_20210907_00006.jpg

LM Start	2.06	Rating **	M	Issue No.	11
LM End	2.06	Issue Type +	En	Location *	LS
Category	Earthen Levee			GPS Latitude/Longitude	
				Start	End
Item	Encroachments			38.732268 °	38.732268 °
				-121.805832 °	-121.805832 °
DWR ID	DWR_ST0001_01_s_ 2012_11				
Comment Code					
BU : Building					
Inspector Comment

View of the building on the landward side of the levee looking downstream. Fall 2015.

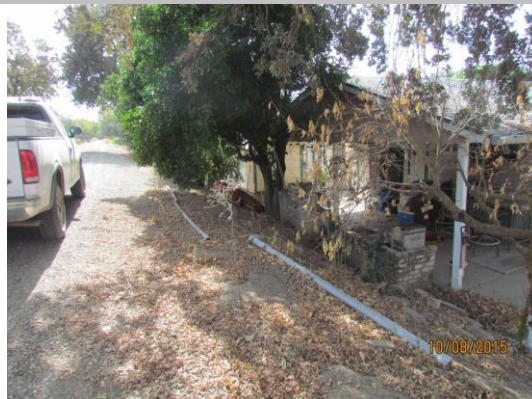
Photo 1 of 1 : FA_2021_ST0001_259_13_20210907_00008.jpg

View of the building on the landward side of the levee looking upstream. Fall 2015.

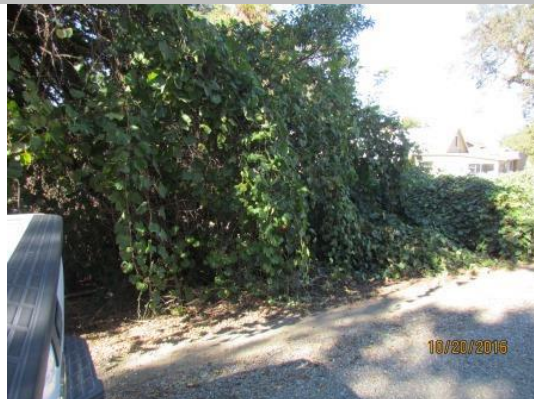
Photo 1 of 1 : FA_2021_ST0001_259_14_20210907_00009.jpg

View of the shrubs. Fall 2016.

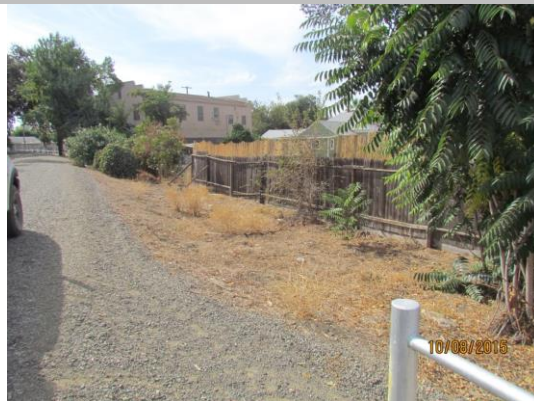
Photo 1 of 1 : FA_2021_ST0001_259_15_20210907_00010.jpg

LM Start	2.13	Rating **	U	Issue No.	15
LM End	2.15	Issue Type +	En	Location *	LS
Category	Earthen Levee			GPS Latitude/Longitude	
				Start	End
Item	Encroachments			38.733215 °	38.733350 °
				-121.805262 °	-121.805082 °
DWR ID	DWR_ST0001_01_s_2012_15				
Comment Code					
FE : Fence					
Inspector Comment

View of the fence on the landward side of the levee looking upstream.
Fall 2015.

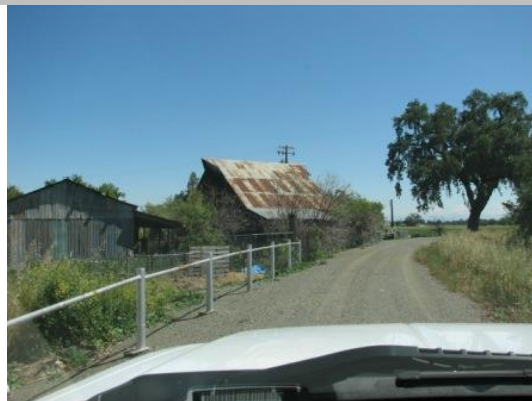
Photo 1 of 1 : FA_2021_ST0001_259_16_20210907_00011.jpg

Horse barn and corral are within the easement of the levee.

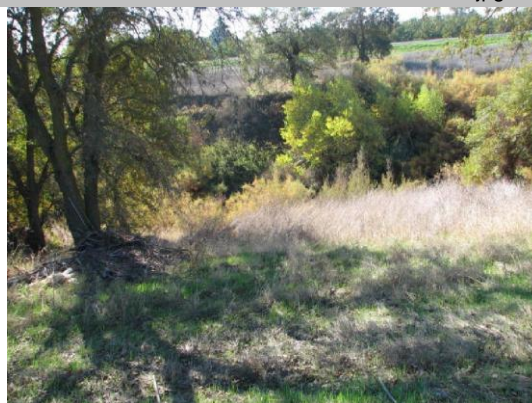
Photo 1 of 3 : UCIP_FA_2021_49099_60164.jpg

Comment Code					
Inspector Comment					
DS_ID:16268					
FS_ID:49099					
EP_NO: 2415					
Repair Type: Non-Urgent					
EVAL Issue:					
Crossing Status: Indicator Found					
UCIP Comments: May need to install gasoline marker on WS slope.					
FIELD_STRUCT_DESC: 20-inch wrapped steel natural gas pipeline through the levee, 4 feet below the crown. Two cutoff walls. Gas line indicator found on the landside (LS) of the levee. (20-inch wrapped steel natural gas pipeline authorized under Permit No. 2415, 1956 - Pacific Gas and Electric Company [PG&E]). [Additional Reference(s): DWR Levee Log, 1993. USACE Sacramento O&M Manual 126, November 1961, (HLM 2.24)].					
FS Date: 6/16/2016 7:00:04 AM

Waterside view: no indicators found

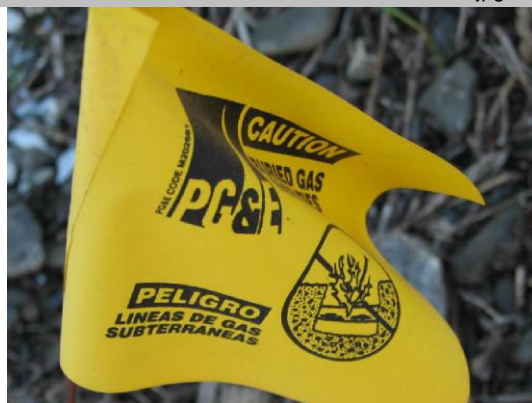
Photo 3 of 3 : UCIP_FA_2021_49099_60165.jpg

Landside view: gasline indicator/flag

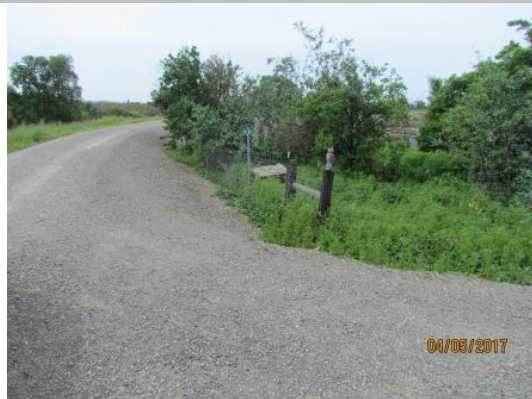
Photo 1 of 1 : FA_2021_ST0001_259_78_20210907_00034.jpg

Chain fence at landside levee toe. Spring 2017.

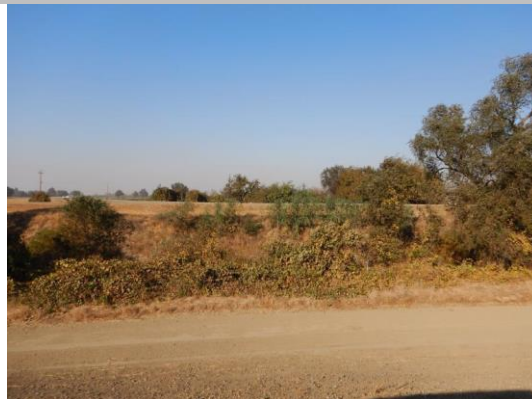
Photo 1 of 1 : FA_2021_ST0001_259_30_20211218_14.jpg

LM Start	2.57	Rating **	A/W	Issue No.	30
LM End	2.61	Issue Type +	Ma	Location *	WS
Category	Supplemental			GPS Latitude/Longitude	
				Start	End
Item	2018 USACE Erosion Survey			38.732836 °	38.732685 °
				-121.797893 °	-121.797154 °
DWR ID					
Comment Code					
Inspector Comment					
2018 Site ID: CHC 2.4 L					
Status: Critical					
2018 Field Notes: No observed change.					
Site History: Site identified as CRITICAL in 2002. 2006 - Currently constructing a setback levee. New failures present and extensive. Downstream end of the setback levee did not extend far enough. Upstream end was repaired. 2007 - DWR repaired with a setback levee, but the levee did not go far enough downstream. 2012 - New cracks observed. 2013 - Fresh erosion on upper bank.

USACE 2018 Erosion Photo #1

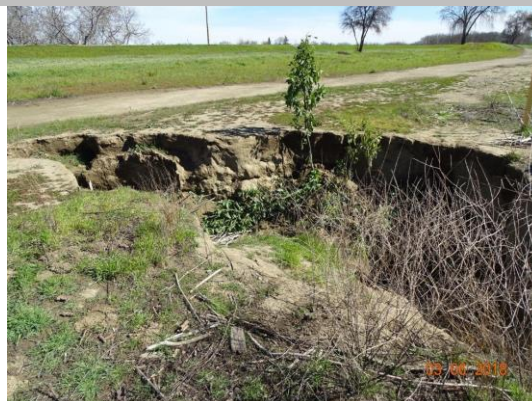
Photo 1 of 2 : FA_2021_ST0001_259_62_20210907_00028.jpg

View of erosion looking towards the landside levee slope, facing northeast. Spring 2018.

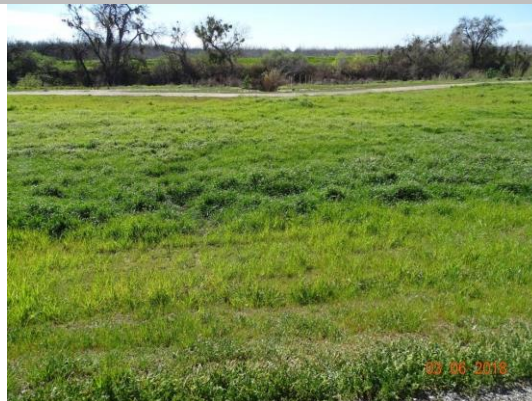
Photo 2 of 2 : FA_2021_ST0001_259_62_20210907_00029.jpg

View of erosion from levee crown, facing Cache Creek. Fall 2018.

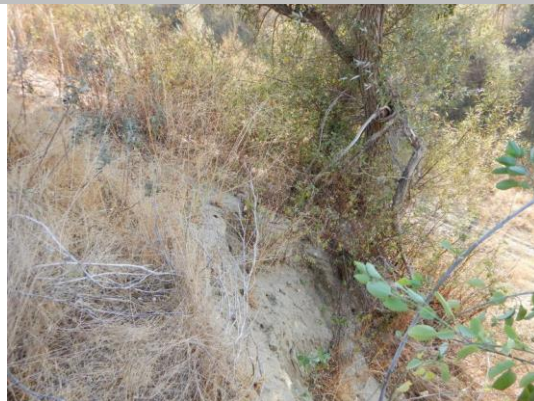
Photo 2 of 2 : FA_2021_ST0001_259_41_20211218_17.jpg

USACE 2018 Erosion Photo #2

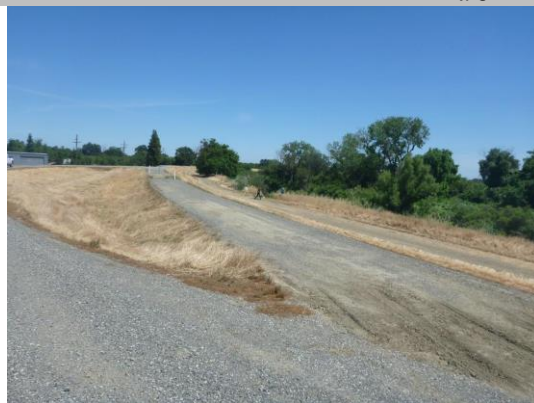
Photo 1 of 2 : LEVAL_FA_2021_249_954.jpg

View of toe road where erosion is located.

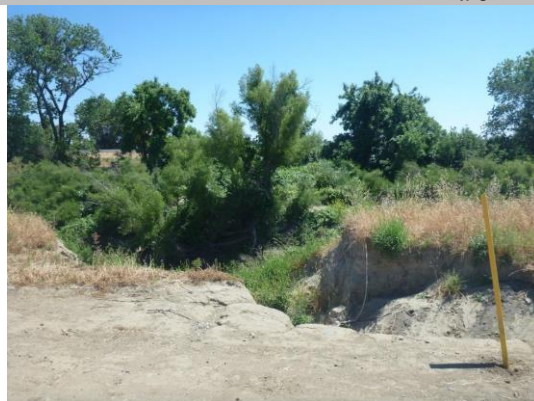
Photo 2 of 2 : LEVAL_FA_2021_249_959.jpg

View of erosion near waterside toe road.

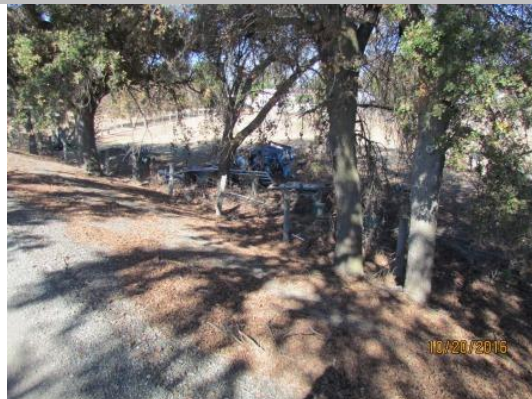
Photo 1 of 1 : FA_2021_ST0001_259_52_20210907_00025.jpg

Fence on landside slope. Fall 2016.

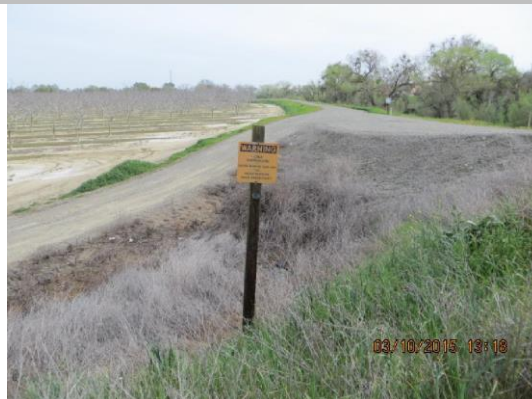
Photo 1 of 2 : UCIP_FA_2021_49111_73501.jpg

LM Start	4.98	Rating **	M	Issue No.	81
LM End	4.98	Issue Type +	En	Location *	
Category	Supplemental			GPS Latitude/Longitude	
				Start	End
Item	DWR UCIP Field Study			38.721038 °	38.721038 °
				-121.764180 °	-121.764180 °
DWR ID	16265				
Comment Code					
Inspector Comment					
DS_ID:16265 FS_ID:49111 EP_NO: 7232 Repair Type: Non-Urgent EVAL Issue: Crossing Status: Indicator Found UCIP Comments: May need marker on WS. FIELD_STRUCT_DESC: Telephone conduit of an unknown size or material through the levee, 2.5 feet below the crown. Communications marker located on the east side of Highway 113 on the landside (LS) toe. (Telephone conduit authorized under Permit No. 7232, 1970 - Pacific Telephone and Telegraph Company [PT&T]). [Additional Reference(s): DWR Levee Log, 1993]. FS Date: 6/16/2016 7:08:33 AM

Sign on LS toe.

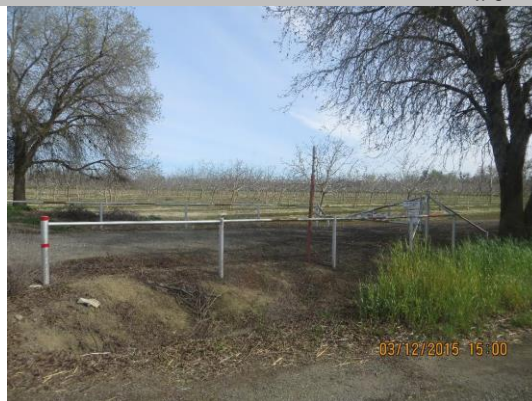
Photo 1 of 2 : UCIP_FA_2021_49112_73504.jpg

DS_ID:16756
 FS_ID:49112
 EP_NO: 3089
 Repair Type: Non-Urgent
 EVAL Issue:
 Crossing Status: Indicator Found
 UCIP Comments: Signage in disrepair and need signs at Levee. Need to contact owner to determine status of crossing and install new signs if appropriate to do so.
 FIELD_STRUCT_DESC: 4-inch steel natural gas pipeline through the levee, 4 feet below the crown. Gas line marker located 500 feet north of the levee crossing at the levee access road/gate. Pipe alignment to east of bridge. (4-inch natural gas pipeline grouted in place and replaced with a 4-inch steel natural gas pipeline to east side of bridge under Permit No. 3089, 1959 - Yolo County Sales Company).
 [Additional Reference(s): USACE Sacramento O&M Manual 126, November 1961, (HLM 4.98)].
 FS Date: 6/16/2016 7:09:02 AM

Gasline marker next to levee access gate 500-feet north of levee crown.

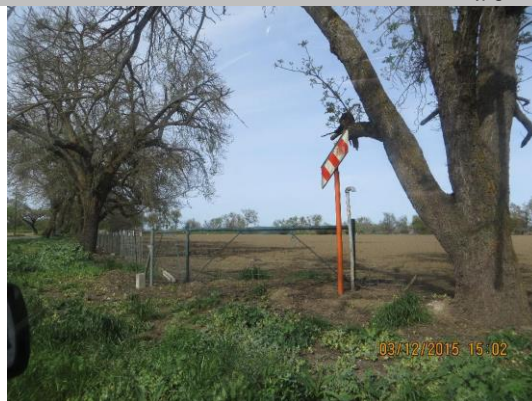
Photo 2 of 2 : UCIP_FA_2021_49112_73503.jpg

Gasline marker at Best Ranch Road, 1500-feet south of levee crossing.

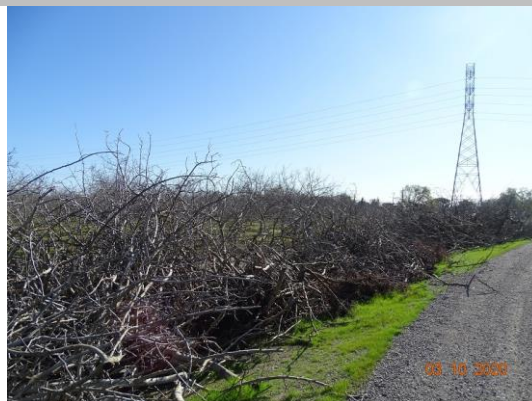
Photo 1 of 1 : FA_2021_ST0001_259_73_20210907_00032.jpg

View of downed trees on the landside slope. Spring 2020.

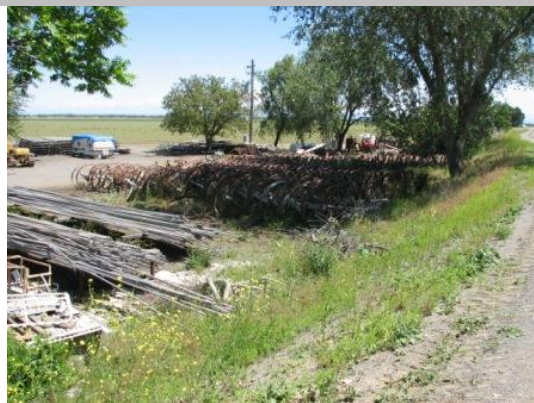
Photo 1 of 1 : FA_2021_ST0001_259_40_20210907_00023.jpg

Irrigation pipe and equipment are within the easement of the levee.

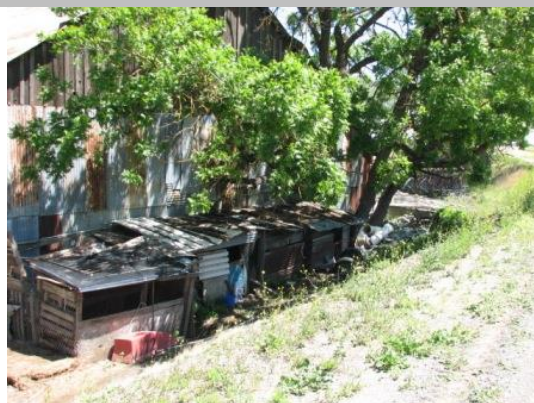
Photo 1 of 1 : FA_2021_ST0001_259_39_20210907_00022.jpg

View of barn and livestock pens.

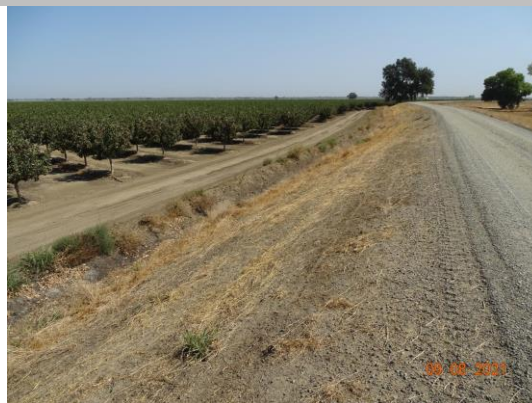
Photo 1 of 1 : FA_2021_ST0001_259_26_20210908_00055.jpg

View of ditch at landside toe. Fall 2021.

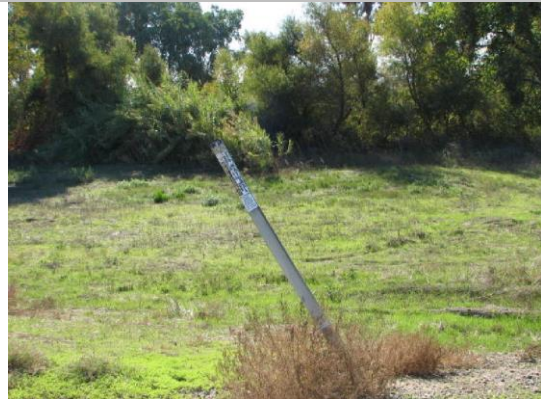
Photo 1 of 2 : UCIP_FA_2021_50811_60197.jpg

LM Start	7.89	Rating **	M	Issue No.	83
LM End	7.89	Issue Type +	En	Location *	
Category	Supplemental			GPS Latitude/Longitude	
				Start	End
Item	DWR UCIP Field Study			38.727333 °	38.727333 °
				-121.718558 °	-121.718558 °
DWR ID	16264				
Comment Code					
Inspector Comment					
DS_ID:16264 FS_ID:50811 EP_NO: 12983 Repair Type: Non-Urgent EVAL Issue: Crossing Status: Indicator Found UCIP Comments: Gasline markers in disrepair and should be replaced. Gasline indicator found on waterside of the levee. FIELD_STRUCT_DESC: 4-inch and 6-inch coated steel natural gas pipelines through the levee and under the Cache Creek Settling Basin, at an unknown depth. (4-inch and 6-inch pipelines authorized under Permit No. 12983, 1980 - Shell Oil Company). [Additional Reference(s): DWR Levee Log, 1993]. FS Date: 11/21/2016 7:56:33 AM

Waterside view: gasline indicator

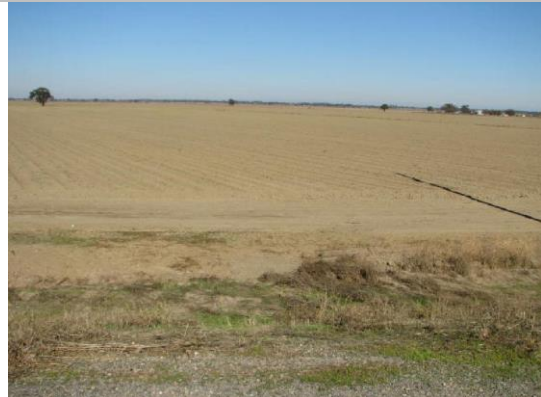
Photo 2 of 2 : UCIP_FA_2021_50811_60196.jpg

Landside view: no indicator found.

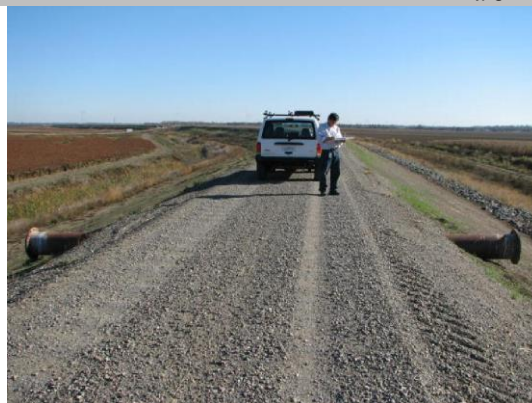
Photo 1 of 3 : UCIP_FA_2021_53214_60219.jpg

LM Start	10.40	Rating **	M	Issue No.	84
LM End	10.40	Issue Type +	En	Location *	
Category	Supplemental			GPS Latitude/Longitude	
				Start	End
Item	DWR UCIP Field Study			38.705051 °	38.705051 °
				-121.695577 °	-121.695577 °
DWR ID	17115				
Comment Code					
Inspector Comment					
DS_ID:17115 FS_ID:53214 EP_NO: N/A Repair Type: Non-Urgent EVAL Issue: Crossing Status: Found UCIP Comments: 10/19/16 w/s capped l/s capped FIELD_STRUCT_DESC: 18-inch, 0.25-inch-thick soil-proofed steel irrigation pipe through the levee, 4 feet below the crown. Pipe used for seasonal irrigation. Pipe opening capped on both ends. As-Built Drawing North Station 68+00. Pipe installed during Cache Creek Settling Basin Enlargement, 1991. FS Date: 11/16/2018 8:34:00 AM

Crown view: overview

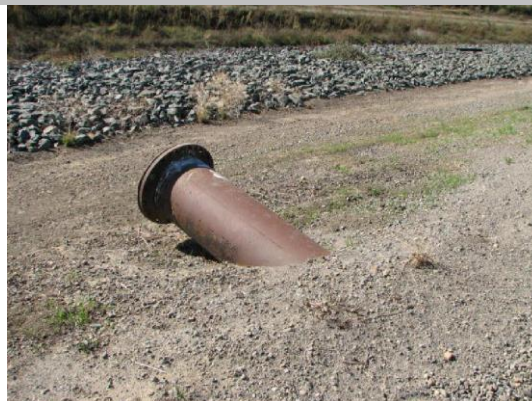
Photo 3 of 3 : UCIP_FA_2021_53214_60222.jpg

Waterside view: steel pipe on the slope of the levee

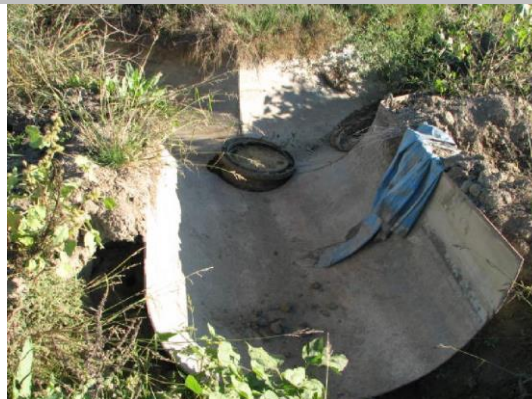
Photo 1 of 3 : UCIP_FA_2021_53215_60148.jpg

Comment Code						
Inspector Comment						
DS_ID:17119 FS_ID:53215 EP_NO: N/A Repair Type: Non-Urgent EVAL Issue: Crossing Status: Found UCIP Comments: 11/3/2016: Per Ted Skidgel, new cap and gasket installed by farmer on LS vent, and siphon breaker/vent installed on WS. No permit was found for this work. Siphon breaker on WS needs cover. Repair Priority changed from No Action Needed to Non-Urgent. (K. Fazel - UCIP)08/16/2016: Repaired erosion L/S 8/16 pipe repaired by farmer prior to erosion. (T. Skidgel - ST0001). (Note: crossing was downgraded from Urgent to No Action Needed)06/28/2016: Erosion still present off LS shoulder, caused by leaking vent. Erosion to be repaired and backfilled this summer by Sac Yard. Pipe leaking at LS toe into ditch (not affecting levee prism) (K. Fazel - UCIP).2013-2016: Pipe leaks, severe erosion from levee shoulder to pipe daylight on landside levee slope, summer of 2013 repaired erosion,pipe needs repaired. (P. Amatya - DWR) FIELD_STRUCT_DESC: 18-inch, 0.25-inch-thick soil-proofed steel irrigation pipe, 2 feet below the crown. Capped vent on the apex of the pipe off the landside (LS) shoulder. Booster pump located off the LS toe at the LS toe ditch. Another groundwater pump is located a further distance off the LS toe. Pumped groundwater is conveyed to the toe ditch and a booster pump pumps water through the levee and into a waterside (WS) ditch in the Cache Creek Settling Basin. Distribution box off the WS toe at the WS toe ditch. Could not locate a positive closure device. [Additional Reference(s): USACE As-Constructed Drawing North Station 49+50]. FS Date: 11/16/2018 8:35:41 AM

Waterside view: pipe in the ditch

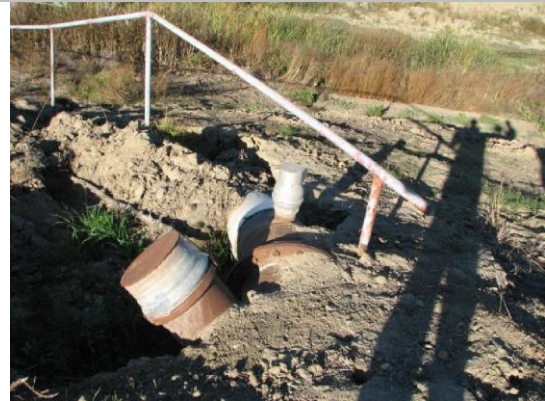
Photo 2 of 3 : UCIP_FA_2021_53215_60147.jpg

Landside view: pipe daylight on LS levee slope

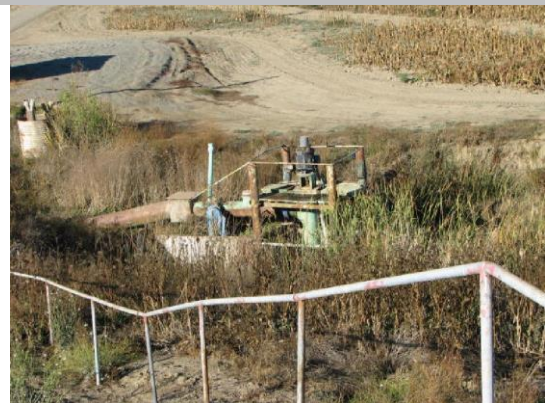
Photo 3 of 3 : UCIP_FA_2021_53215_60149.jpg

Landside view: pumping plant

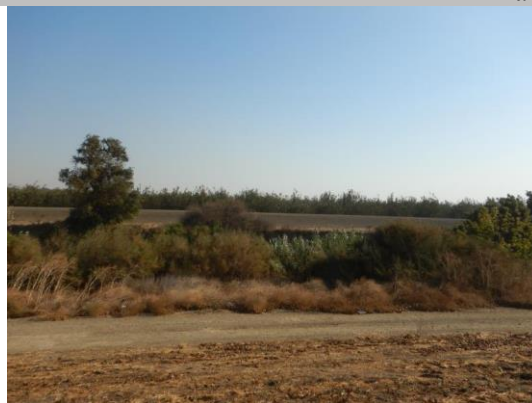
Photo 1 of 2 : FA_2021_ST0001_260_2_20211218_2.jpg

USACE 2018 Erosion Photo #1

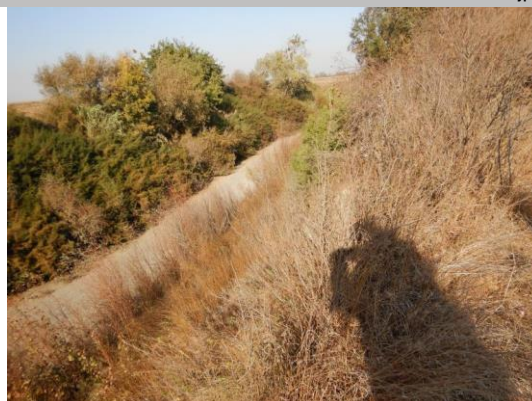
Photo 2 of 2 : FA_2021_ST0001_260_2_20211218_3.jpg

USACE 2018 Erosion Photo #2

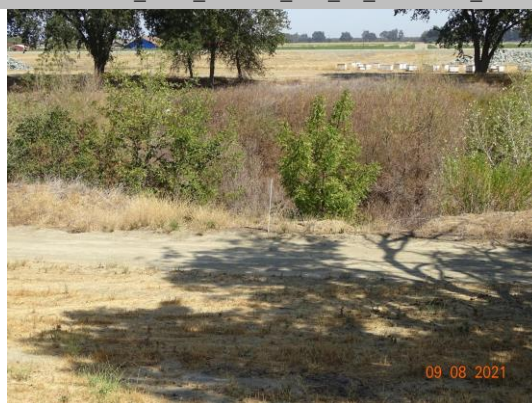
Photo 1 of 1 : FA_2021_ST0001_260_16_20210908_00035.jpg

View of erosion on waterside toe road. Fall 2021.

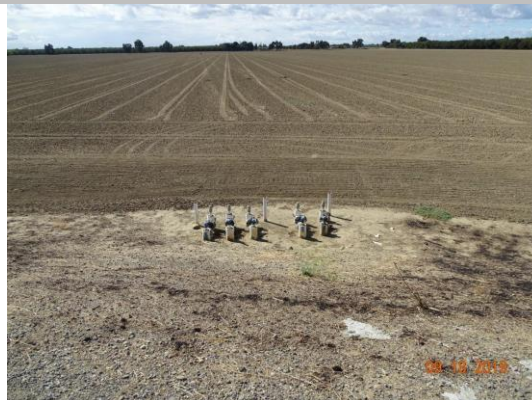
Photo 1 of 1 : FA_2021_ST0001_260_24_20210907_00013.jpg

View of the pumps, air valves, and bollards at the landside toe. Fall 2019.

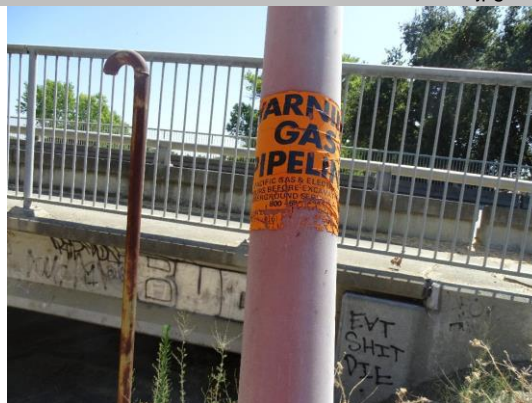
Photo 2 of 3 : UCIP_FA_2021_60019_87303.jpg

gasline marker near the bridge, waterside slope.

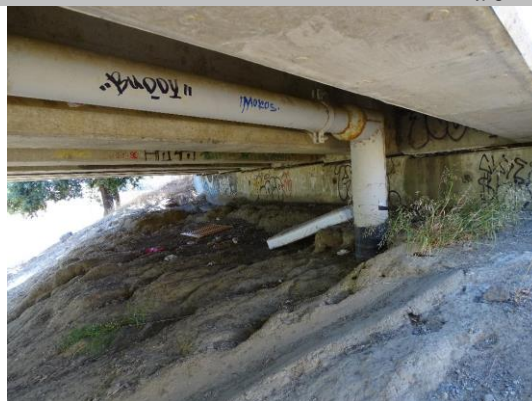
Photo 3 of 3 : UCIP_FA_2021_60019_87304.jpg

Pipeline seen under the bridge.

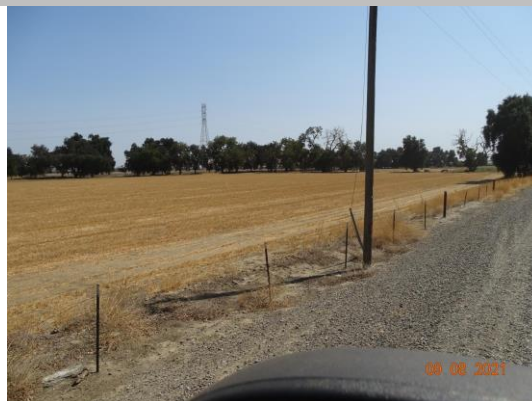
Photo 1 of 1 : FA_2021_ST0001_260_15_20210908_00034.jpg

View of fence at landside toe. Fall 2021.

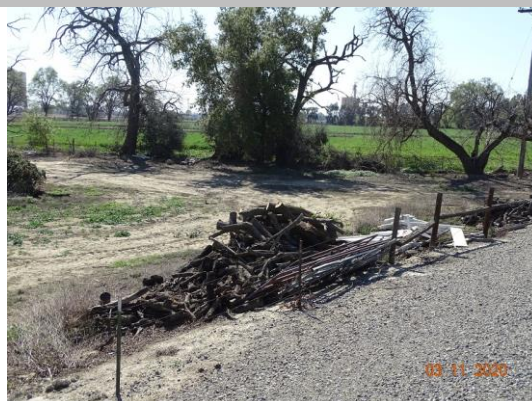
Photo 1 of 1 : FA_2021_ST0001_260_17_20210907_00012.jpg

View of firewood pile. Spring 2020.

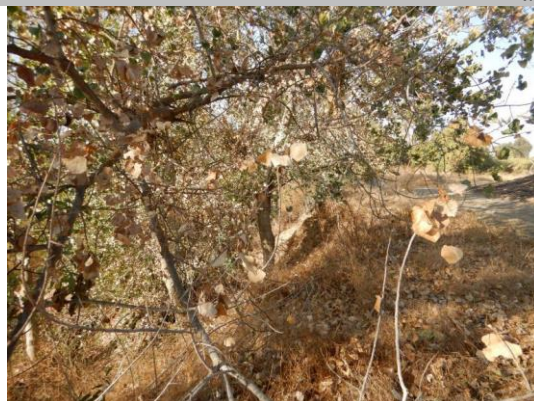
Photo 1 of 2 : FA_2021_ST0001_260_11_20211218_4.jpg

USACE 2018 Erosion Photo #1

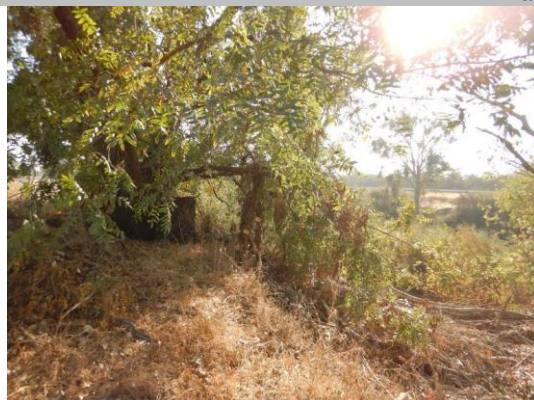
Photo 2 of 2 : FA_2021_ST0001_260_11_20211218_5.jpg

USACE 2018 Erosion Photo #2

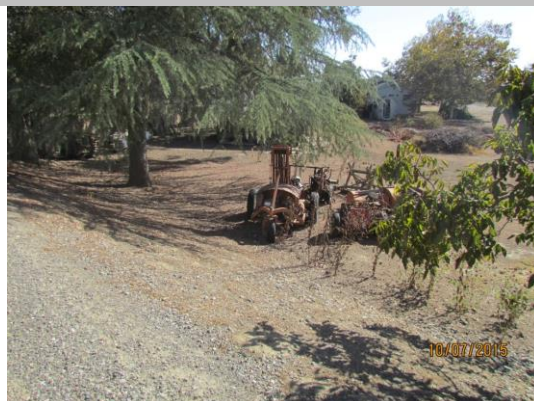
Photo 1 of 1 : FA_2021_ST0001_260_26_20210907_00014.jpg

View of the equipment at the toe of the landward side of the levee. Fall 2015.

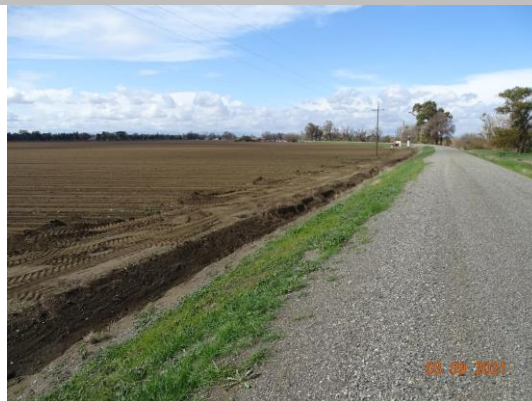
Photo 1 of 1 : FA_2021_ST0001_260_1_20210907_00001.jpg

View of irrigation ditch at the landside toe. Spring 2021.

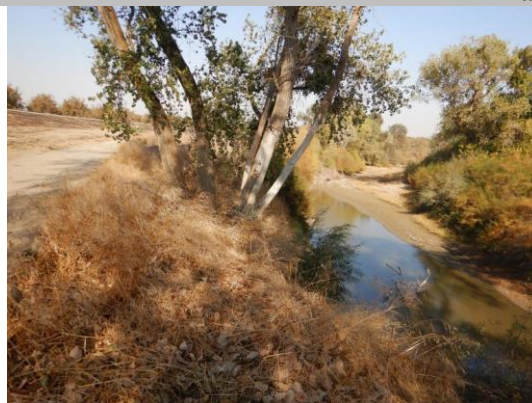
Photo 1 of 2 : FA_2021_ST0001_260_27_20211218_8.jpg

USACE 2018 Erosion Photo #1

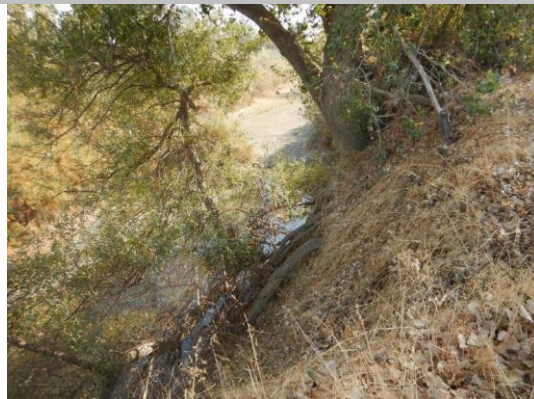
Photo 2 of 2 : FA_2021_ST0001_260_27_20211218_9.jpg

USACE 2018 Erosion Photo #2

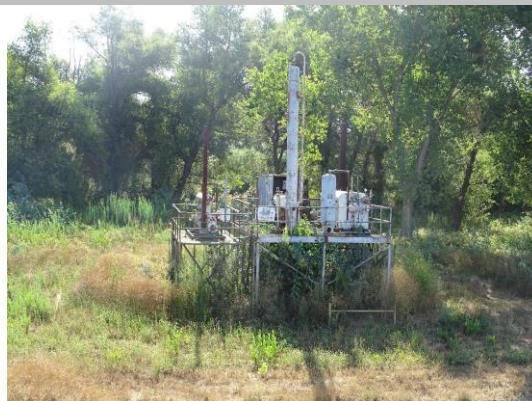
Photo 3 of 3 : UCIP_FA_2021_60171_87465.jpg

gas well at waterside

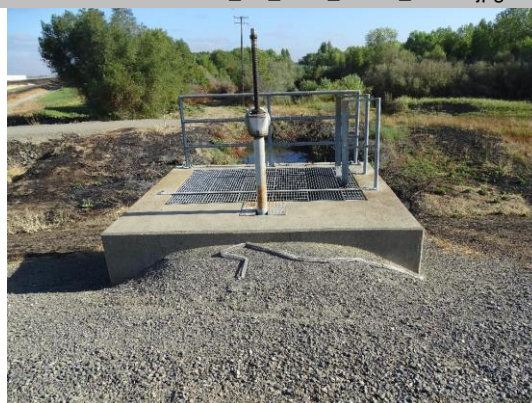
Photo 2 of 3 : UCIP_FA_2021_60172_87469.jpg

standpipe with pressure relief vent

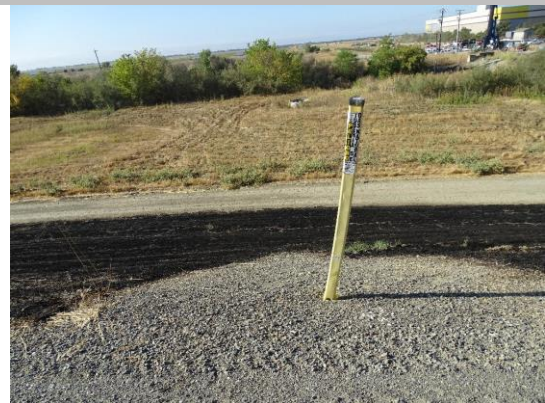
Photo 3 of 3 : UCIP_FA_2021_60175_87482.jpg

landside slope with gasline marker

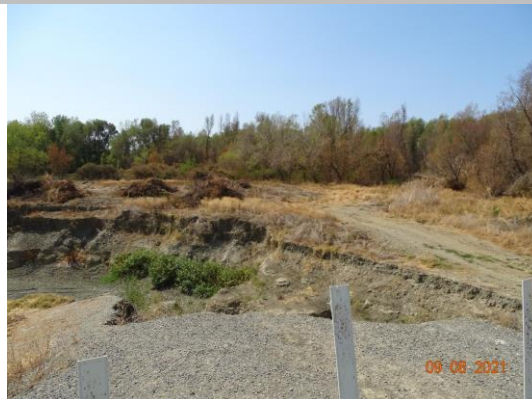
Photo 1 of 1 : FA_2021_ST0001_261_3_20210908_00001.jpg

View of erosion at end of levee unit. Fall 2021.
