**Flood Control Project Maintenance
Levee Inspections**

Fall 2022 Levee Maintenance Deficiency Summary Report

Sacramento River Basin

Sacramento Maintenance Yard Cache Creek

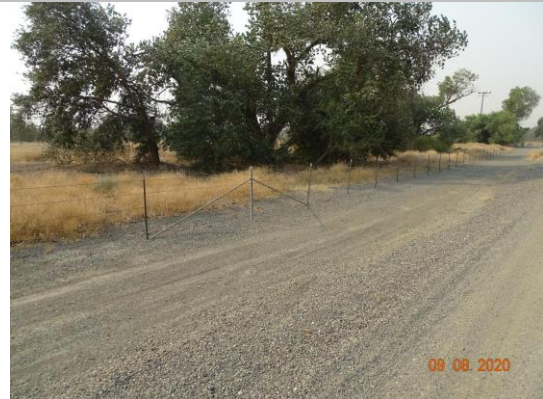
Photo 1 of 1 : FA_2022_ST0001_259_24_20220921_00013.jpg

View of the fence near the toe road. Fall 2020.

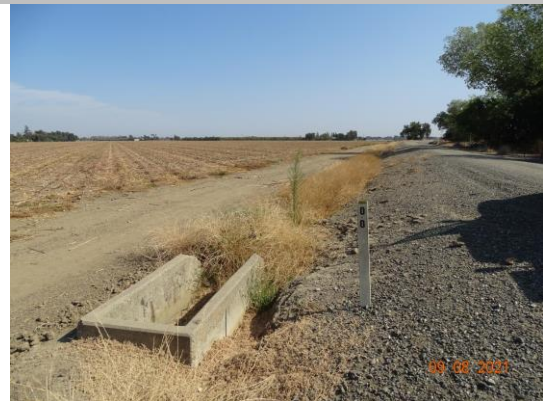
Photo 1 of 1 : FA_2022_ST0001_259_48_20220921_00025.jpg

LM Start	0.03	Rating **	M	Issue No.	48
LM End	0.16	Issue Type +	En	Location *	LS
Category	Earthen Levee			GPS Latitude/Longitude	
				Start	End
Item	Encroachments			38.715268 °	38.716647 °
				-121.825345 °	-121.823667 °
DWR ID	DWR_ST0001_01_s_2015_48				
Comment Code					
DT : Ditch					
Inspector Comment					
A ditch is located at the levee toe.

View of ditch at landside toe. Fall 2021.

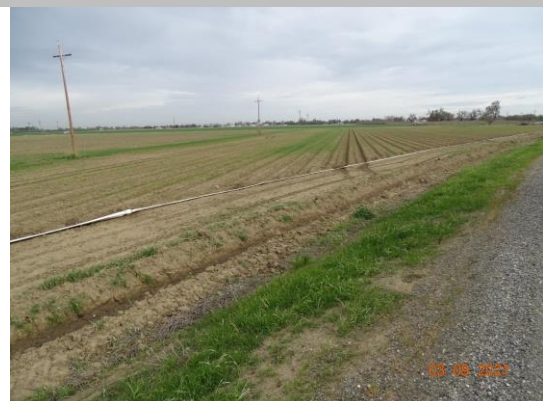
Photo 1 of 1 : FA_2022_ST0001_259_27_20220921_00016.jpg

LM Start	0.92	Rating **	M	Issue No.	27
LM End	1.09	Issue Type +	En	Location *	LS
Category	Earthen Levee			GPS Latitude/Longitude	
				Start	End
Item	Encroachments			38.719051 °	38.720864 °
				-121.815287 °	-121.812980 °
DWR ID	DWR_ST0001_01_f_2021_27				
Comment Code					
DT : Ditch					
Inspector Comment					
There is an irrigation ditch at the landside toe.

View of irrigation ditch near the landside toe. Spring 2021.

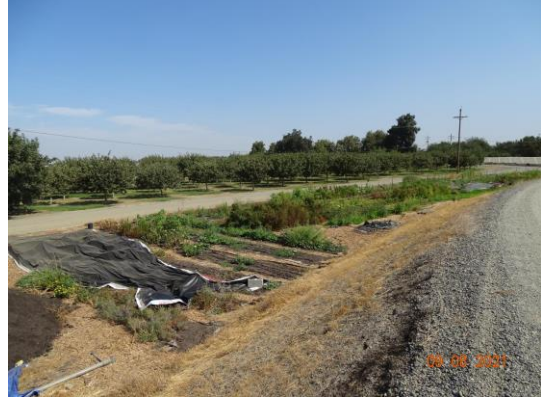
Photo 1 of 1 : FA_2022_ST0001_259_25_20220921_00014.jpg

View of garden at landside toe. Fall 2021.

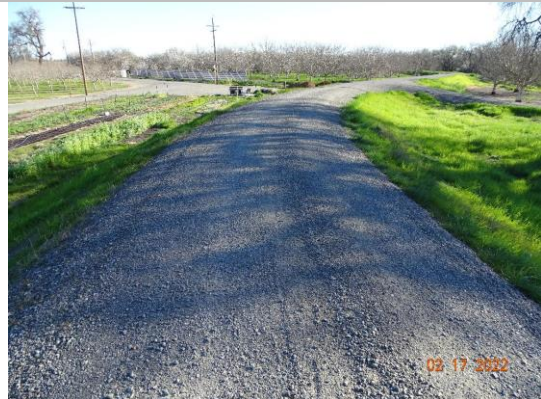
Photo 1 of 3 : UCIP_FA_2022_72495_108477.jpg

Comment Code						
Inspector Comment						
DS_ID:16271 FS_ID:72495 EP_NO: 10192 Repair Type: Non-Urgent EVAL Issue: Crossing Status: Indicator Found UCIP Comments: 02/17/2022 Record updated from No Action Needed to Non-Urgent. Concrete pipes are visible inside concrete riser on waterside. Unable to confirm that pipe is crossing new levee setback. Geophysical results did not confirm presence of pipe through levee. Record will remain in UCIP's inspection records until future Levee Improvement Project can confirm no crossing was found through the levee. No permit has been identified authorizing pipe. Crossing appears abandoned. Concrete debris, abandoned CMP riser at riverbank. Pipe was crossing old levee at angle. (O.Yakimov - DWR UCIP) 11/16/2018 There is a concrete standpipe and no other pipes connected to this standpipe. The standpipe is located between setback levee and the old levee. No other structure or pipe found. (Ted Skidgel - Sac Yard) FIELD_STRUCT_DESC: 24-inch corrugated metal drainage pipe through the levee, 6 feet below the crown. Slide gate in a concrete riser on the waterside (WS) shoulder. Plate welded on the waterside end. Well, pump, and discharge box on the landside (LS). (24-inch steel pipe [HLM 1.17] authorized under Automatic Board Order (ABO) issued as Permit No. 10192, 1974 - Harry H. and Jane Dewey). [Additional Reference(s): DWR Levee Log, 1993 (HLM 1.17), listed as abandoned 24-inch pipe. USACE Sacramento O&M Manual 126, November 1961, (HLM 1.17)]. USACE As-Built Drawing No. 50-04-3227, January 1960, Sheet 3, STA 215+50]. FS Date: 2/17/2022 9:28:04 AM

Top of Levee: View of levee crown looking downstream

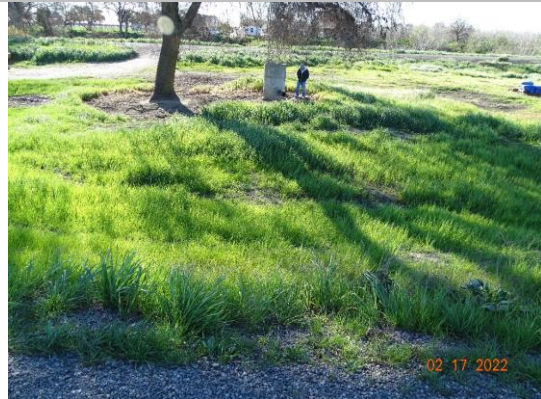
Photo 2 of 3 : UCIP_FA_2022_72495_108479.jpg

Water-Side: View of levee slope looking from crown

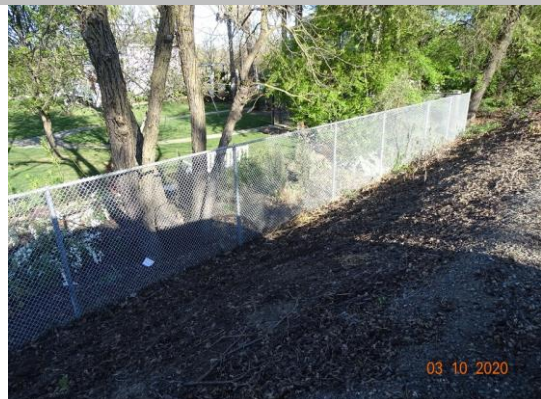
Photo 1 of 1 : FA_2022_ST0001_259_63_20220921_00029.jpg

View of fence at the landside toe. Spring 2020.

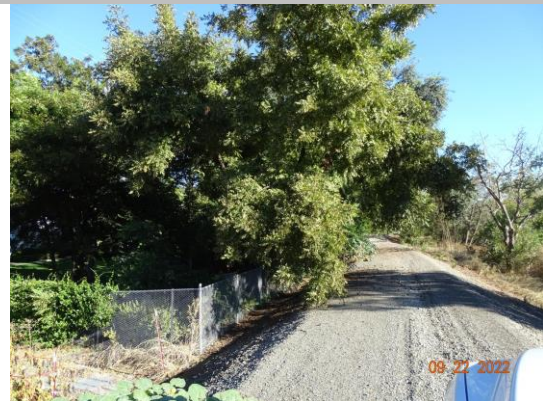
Photo 1 of 1 : FA_2022_ST0001_259_3_20220929_00037.jpg

View of vegetation on the landside slope. Fall 2022.

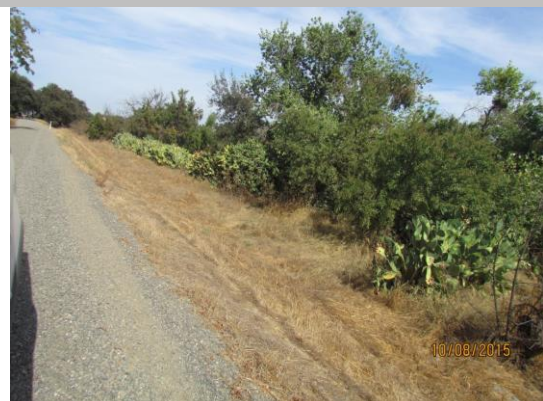
Photo 1 of 1 : FA_2022_ST0001_259_6_20220921_00002.jpg

LM Start	1.98	Rating **	M	Issue No.	6
LM End	2.01	Issue Type +	En	Location *	WS
Category	Earthen Levee			GPS Latitude/Longitude	
				Start	End
Item	Vegetation			38.731166 °	38.731620 °
				-121.806215 °	-121.806032 °
DWR ID	DWR_ST0001_01_s_2012_6				
Comment Code					
V6 : Landscaping					
Inspector Comment					
Catus is located on the waterside berm.

View of the cactus landscaping on the waterside side of the levee looking downstream. Fall 2015.

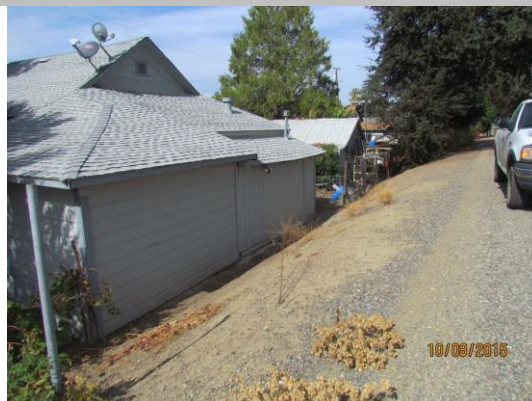
Photo 1 of 1 : FA_2022_ST0001_259_10_20220921_00005.jpg

View of the house on the landward side of the levee looking downstream. Fall 2015.

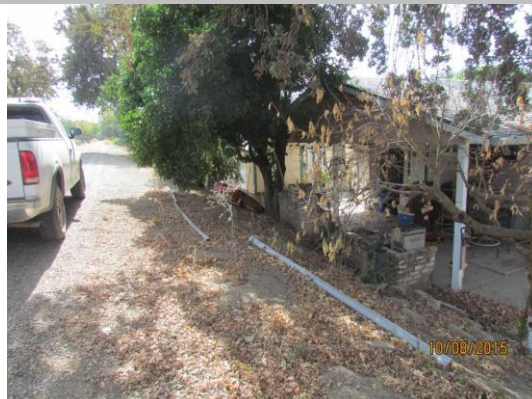
Photo 1 of 1 : FA_2022_ST0001_259_13_20220921_00008.jpg

View of the building on the landward side of the levee looking upstream. Fall 2015.

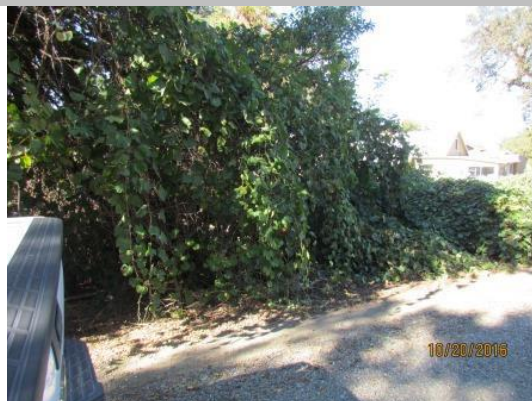
Photo 1 of 1 : FA_2022_ST0001_259_14_20220921_00009.jpg

View of the shrubs. Fall 2016.

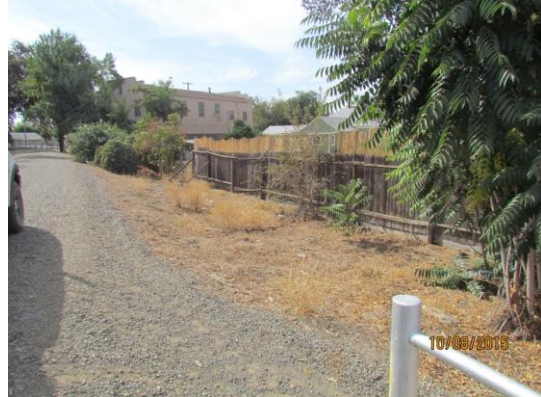
Photo 1 of 1 : FA_2022_ST0001_259_15_20220921_00010.jpg

View of the fence on the landward side of the levee looking upstream.
Fall 2015.

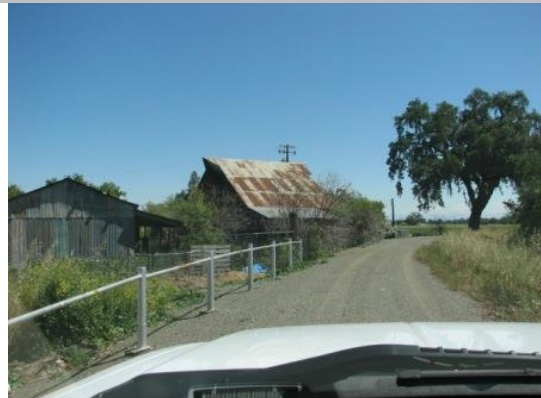
Photo 1 of 1 : FA_2022_ST0001_259_16_20220921_00011.jpg

Horse barn and corral are within the easement of the levee.

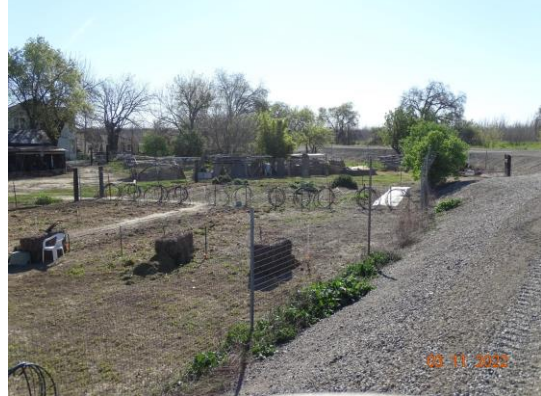
Photo 1 of 1 : FA_2022_ST0001_259_78_20220921_00032.jpg

Chain fence at the landside levee toe. Spring 2022.

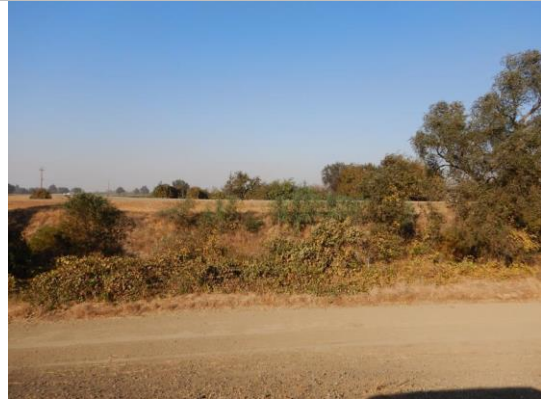
Photo 1 of 1 : FA_2022_ST0001_259_30_20220921_00017.jpg

LM Start	2.57	Rating **	A/W	Issue No.	30
LM End	2.61	Issue Type +	Ma	Location *	WS
Category	Supplemental			GPS Latitude/Longitude	
				Start	End
Item	2018 USACE Erosion Survey			38.732836 °	38.732685 °
				-121.797893 °	-121.797154 °
DWR ID	DWR_ST0001_01_s_2022_30				
Comment Code					
Inspector Comment					
2018 Site ID: CHC 2.4 L					
Status: Critical					
2018 Field Notes: No observed change.					
Site History: Site identified as CRITICAL in 2002. 2006 - Currently constructing a setback levee. New failures present and extensive. Downstream end of the setback levee did not extend far enough. Upstream end was repaired. 2007 - DWR repaired with a setback levee, but the levee did not go far enough downstream. 2012 - New cracks observed. 2013 - Fresh erosion on upper bank.

USACE 2018 Erosion Photo #1

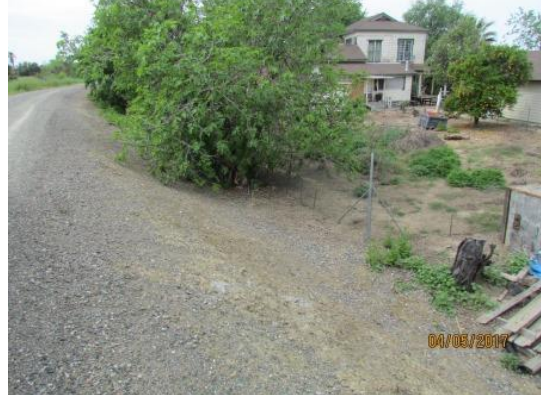
Photo 1 of 1 : FA_2022_ST0001_259_77_20220921_00031.jpg

Chain fence at landside levee toe. Spring 2017.

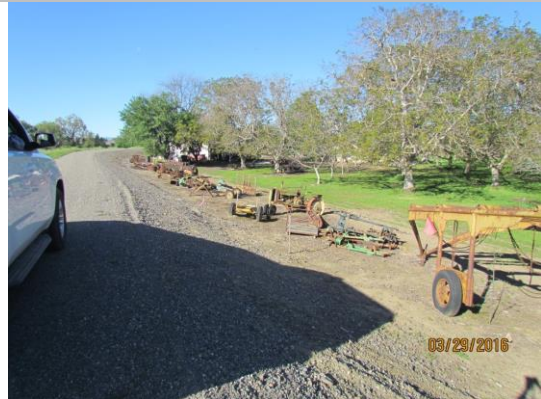
Photo 1 of 1 : FA_2022_ST0001_259_71_20220921_00030.jpg

View of the equipment on the landward side of the levee looking upstream. Spring 2016.

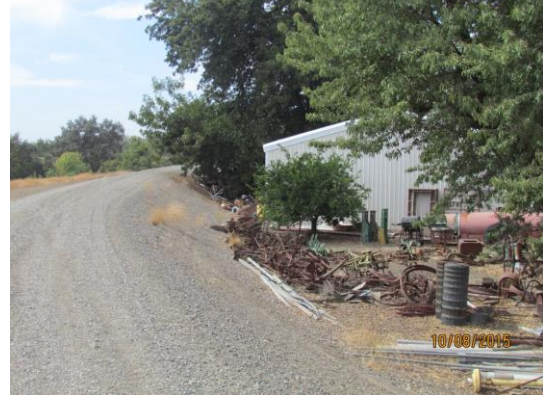
Photo 1 of 1 : FA_2022_ST0001_259_20_20220921_00012.jpg

View of the building on the landward side of the levee looking upstream.
Fall 2015.

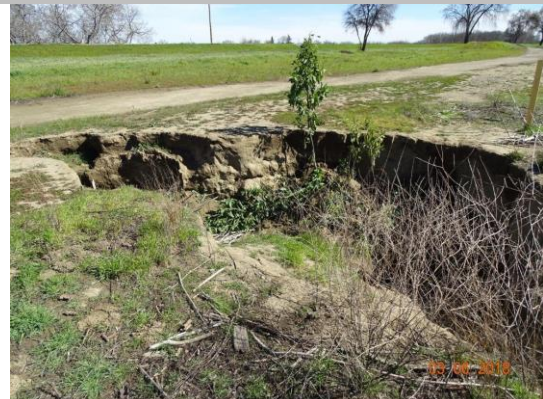
Photo 1 of 2 : FA_2022_ST0001_259_62_20220921_00027.jpg

View of erosion looking towards the landside levee slope, facing
northeast. Spring 2018.

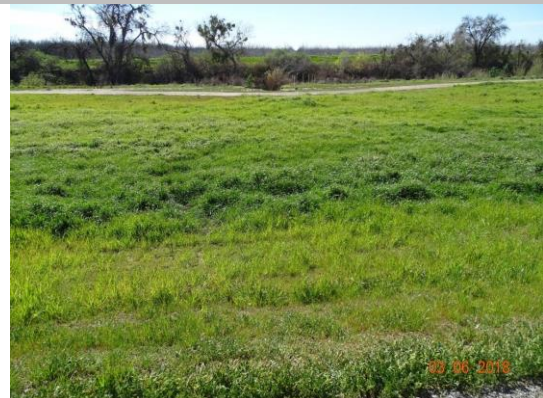
Photo 2 of 2 : FA_2022_ST0001_259_62_20220921_00028.jpg

View of erosion from levee crown, facing Cache Creek. Fall 2018.

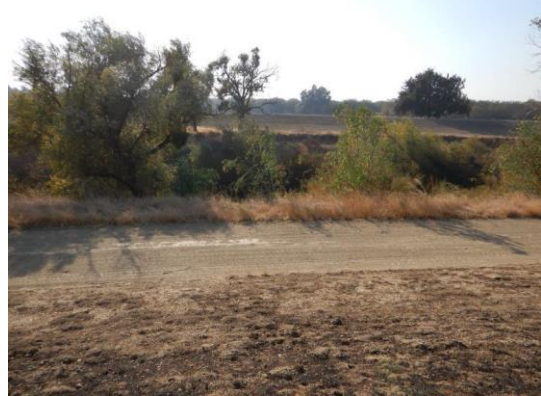
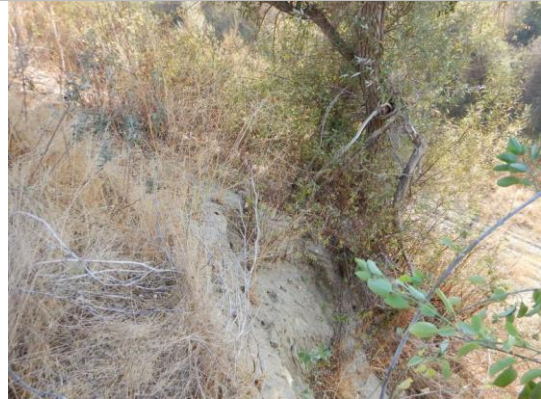
LM Start	3.71	Rating **	A/W	Issue No.	41
LM End	3.74	Issue Type +	Ma	Location *	WS
Category	Supplemental			GPS Latitude/Longitude	
				Start	End
Item	2018 USACE Erosion Survey			38.729664 °	38.729322 °
				-121.784222 °	-121.783842 °
DWR ID	DWR_ST0001_01_s_2022_41				
Comment Code					
Inspector Comment					
2018 Site ID: CHC 3.6 L					
Status: Eroding New					
2018 Field Notes: Erosion of entire bank slope. Possible tree popout.					
Slumping cracks along berm.					
Site History:

USACE 2018 Erosion Photo #1

USACE 2018 Erosion Photo #2

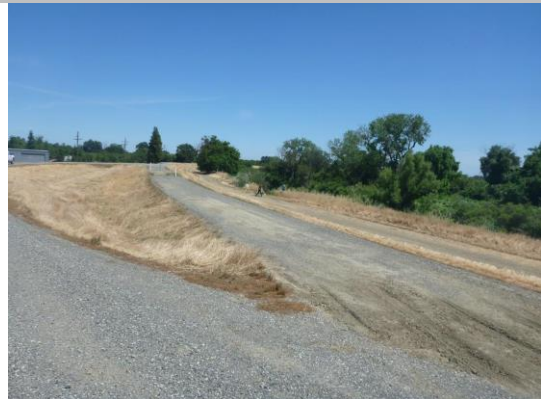
Photo 1 of 2 : LEVAL_FA_2022_249_954.jpg

View of toe road where erosion is located.

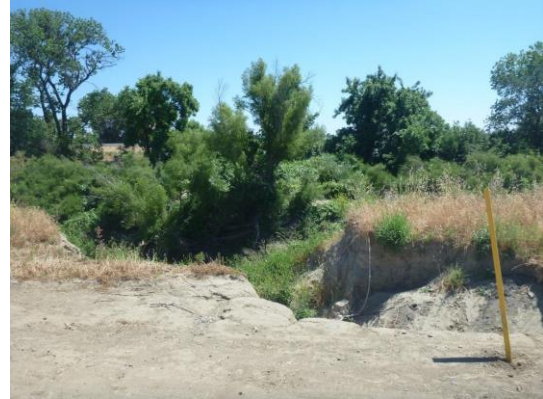
Photo 2 of 2 : LEVAL_FA_2022_249_959.jpg

View of erosion near waterside toe road.

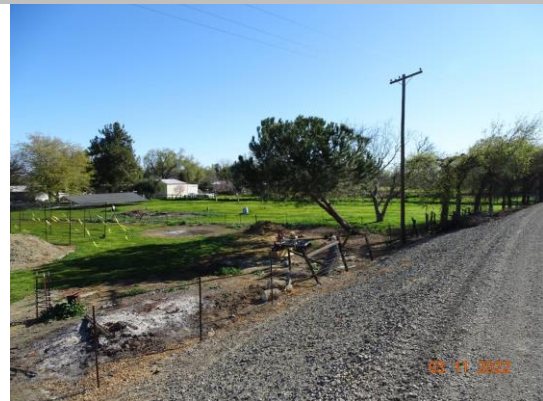
Photo 1 of 1 : FA_2022_ST0001_259_52_20220921_00026.jpg

Barbed wire fence at the landside levee toe. Spring 2022.

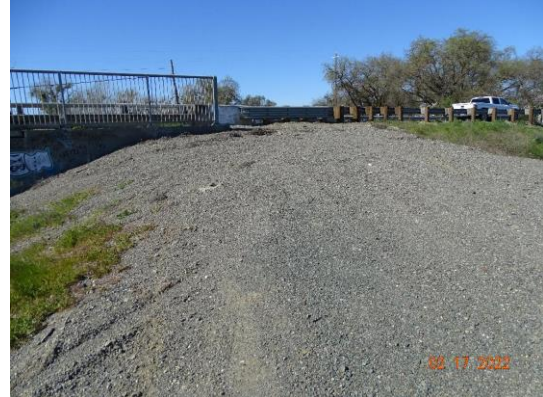
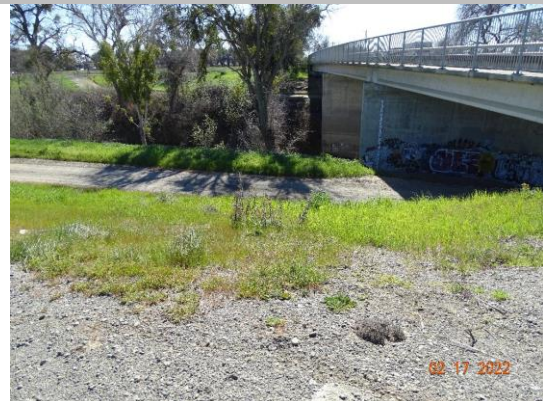
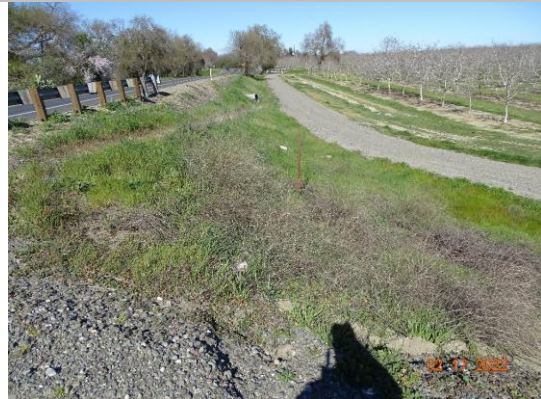
Comment Code					
Inspector Comment					
DS_ID:16265 FS_ID:72612 EP_NO: 7232 Repair Type: Non-Urgent EVAL Issue: 11, Maintenance Compliance Issue Crossing Status: Indicator Found UCIP Comments: 02/17/2022 Record remains Non-Urgent. Broken communication line sign found at landside toe needs repair. (O.Yakimov - DWR UCIP) 06/16/2016 May need marker on WS (Ted Skidgel - Sac Yard) FIELD_STRUCT_DESC: Telephone conduit of an unknown size or material through the levee, 2.5 feet below the crown. Communications marker located on the east side of Highway 113 on the landside (LS) toe. (Telephone conduit authorized under Permits No. 7232, 7232-A, issued in 1970 and 1971 correspondingly - Pacific Telephone and Telegraph Company [PT&T]). [Additional Reference(s): DWR Levee Log, 1993 (HLM 4.97)]. FS Date: 2/17/2022 9:12:09 AM

Top of Levee: View of levee crown looking upstream. State Hwy 113 on the background

Water-Side: View of levee slope looking from crown

Land-Side: View of levee slope looking from crown

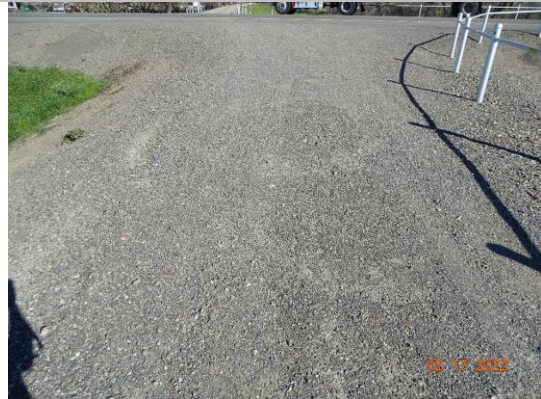
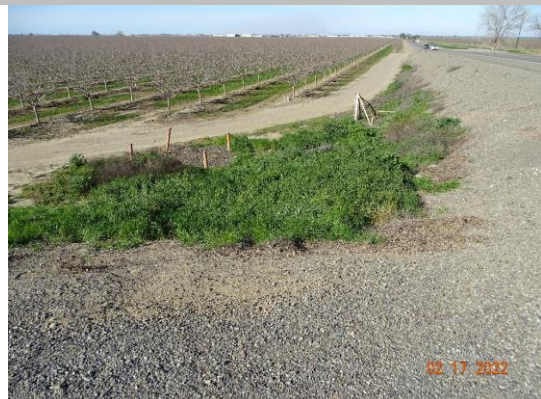
Top of Levee: View of levee crown looking downstream

Land-Side: View of levee slope looking from crown

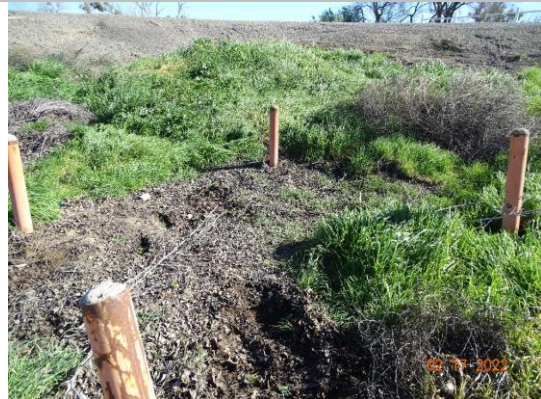
Photo 3 of 3 : UCIP_FA_2022_72622_108797.jpg

Comment Code						
Inspector Comment						
DS_ID:25072 FS_ID:72622 EP_NO: 7668 Repair Type: Non-Urgent EVAL Issue: 11, Maintenance Compliance Issue Crossing Status: Indicator Found UCIP Comments: 02/17/2022 Record is Non-Urgent. Manholes covered with debris. Markers are not installed on any side of levee. (O.Yakimov - DWR UCIP) FIELD_STRUCT_DESC: 4-inch telephone conduit of an unknown material through both levees and under Cache Creek, 6 feet below the crown. Conduit runs 10 feet west along County Road 102. Manhole just off the landside toe next to CO RD 102. (Telephone conduit authorized under Permit No. 7668, 1971 - Pacific Telephone and Telegraph Company [PT&T]). [Additional Reference(s): DWR Levee Log, 1993 (HLM 7.21)]. FS Date: 2/17/2022 11:22:31 AM

Land-Side: Manholes covered with vegetation and debris

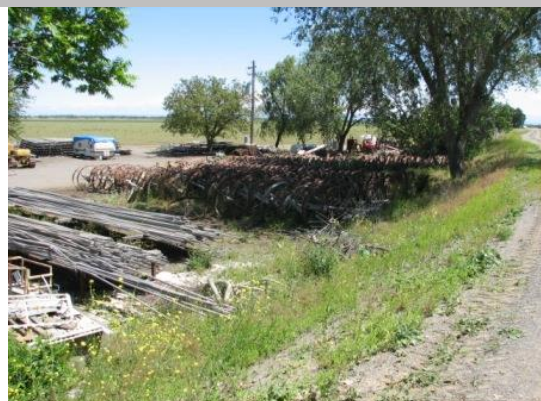
Photo 1 of 1 : FA_2022_ST0001_259_40_20220921_00022.jpg

Irrigation pipe and equipment are within the easement of the levee.

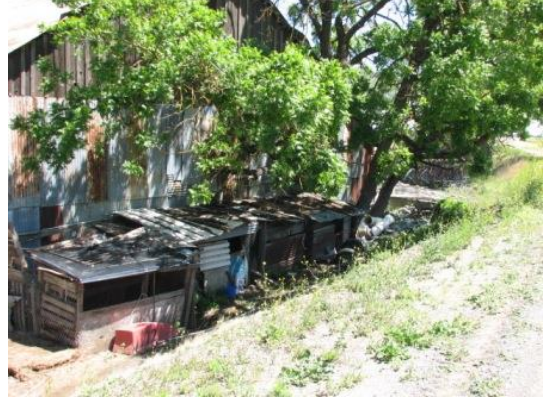
Photo 1 of 1 : FA_2022_ST0001_259_39_20220921_00021.jpg

View of barn and livestock pens.

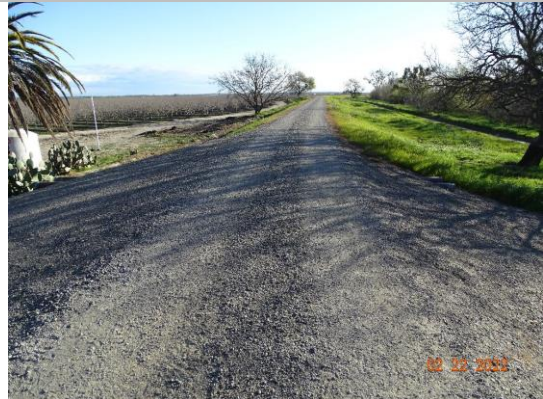
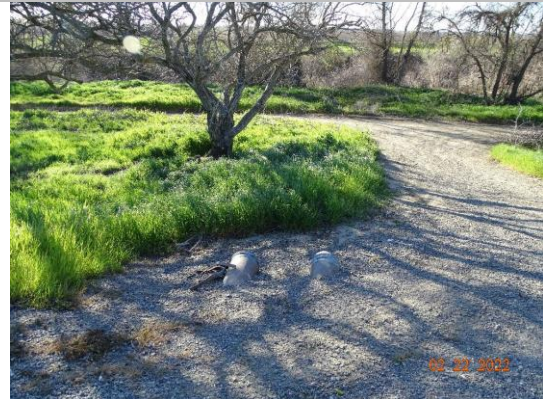
Top of Levee: View of levee crown looking downstream

Water-Side: View of levee slope looking from crown

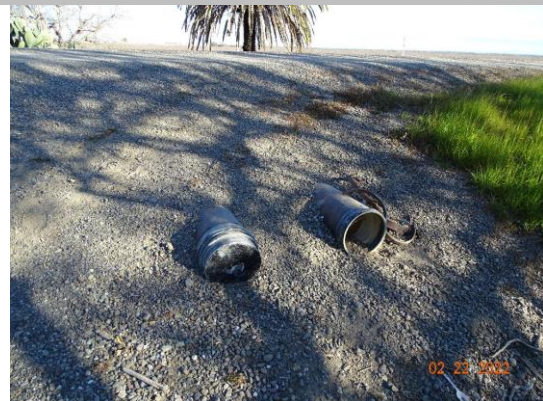
Photo 3 of 3 : UCIP_FA_2022_72738_109094.jpg

Comment Code						
Inspector Comment						
DS_ID:16765 FS_ID:72738 EP_NO: 16810 Repair Type: Non-Urgent EVAL Issue: 11, Maintenance Compliance Issue Crossing Status: Found UCIP Comments: 02/22/2022 Record updated from No Action Needed to Non-Urgent. Pipe is open on landside. Recommend owner to install a cap on landside pipe end. (O.Yakimov - DWR UCIP) 11/16/18 Two pipes W/S 1 capped, L/S both open. (Ted Skidgel - Sac Yard) FIELD_STRUCT_DESC: 1 of 2: 14-inch coated steel irrigation pipe through the levee approximately 2-3 feet below the crown. Pipe connects to a seasonal 14-inch polyvinyl chloride (PVC) pipe and a 100-horsepower mobile pumping plant on the waterside slope. (One 14-inch steel pipe authorized under Permit No. 16810, 1998 - W. Ashley Payne, permit inspection notes indicate that two 14-inch pipes were installed). (Retention of two 14-inch pipes authorized under Permit No. 16810-R, 2002 - Ashley Payne). FS Date: 2/22/2022 3:41:16 PM

Water-Side: pipes on levee slope. Cap is installed on pipe end

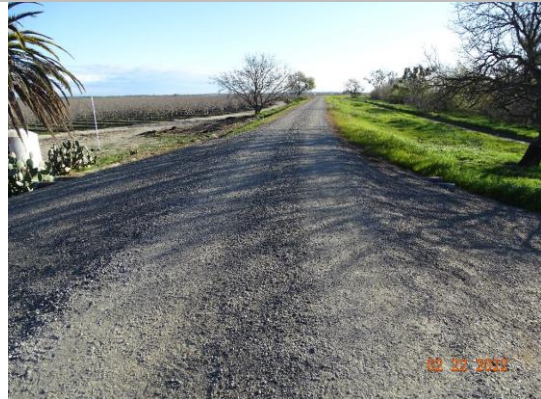
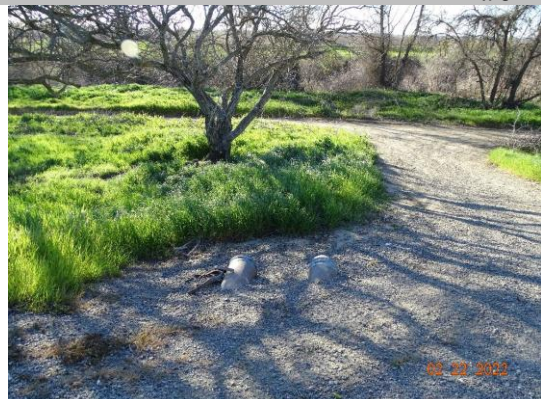
Top of Levee: View of levee crown looking downstream

Water-Side: View of levee slope looking from crown

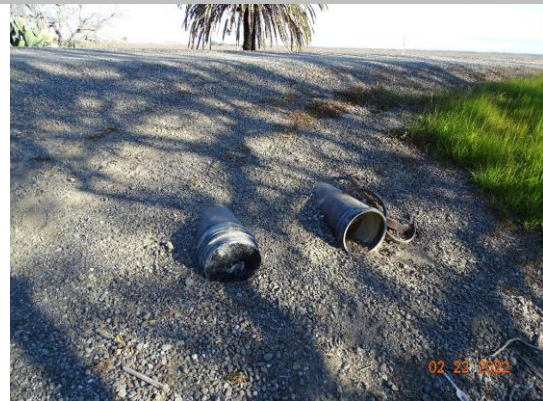
Photo 3 of 3 : UCIP_FA_2022_72745_109118.jpg

Comment Code						
Inspector Comment						
DS_ID:17032						
FS_ID:72745						
EP_NO: 16810						
Repair Type: Urgent						
EVAL Issue: 3a, Flood Risk						
Crossing Status: Found						
UCIP Comments: 02/22/2022 Record updated from No Action Needed to Urgent. Straight through pipe open on both ends provides flood threat to the landside during high water events. (O.Yakimov - DWR UCIP)						
11/16/18 Waterside: 1 open 1 closed, landside: both open. (Ted Skidgel - Sac Yard)						
FIELD_STRUCT_DESC: 2 of 2: 14-inch coated steel irrigation pipe through the levee approximately 2-3 feet below the crown. Pipe connects to a seasonal 14-inch polyvinyl chloride (PVC) pipe and a 100-horsepower mobile pumping plant on the waterside slope. (One 14-inch steel pipe authorized under Permit No. 16810, 1998 - W. Ashley Payne, permit inspection notes indicate that two 14-inch pipes were installed). (Retention of two 14-inch pipes authorized under Permit No. 16810-R, 2002 - Ashley Payne).

Water-Side: Open pipe on levee slope

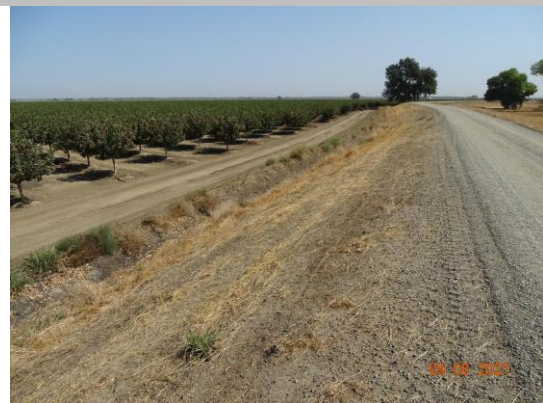
Photo 1 of 1 : FA_2022_ST0001_259_26_20220921_00015.jpg

View of ditch at landside toe. Fall 2021.

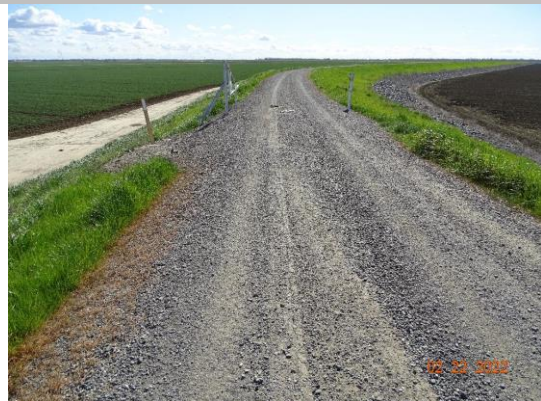
Photo 1 of 3 : UCIP_FA_2022_72789_109241.jpg

Top of Levee: View of levee crown looking downstream

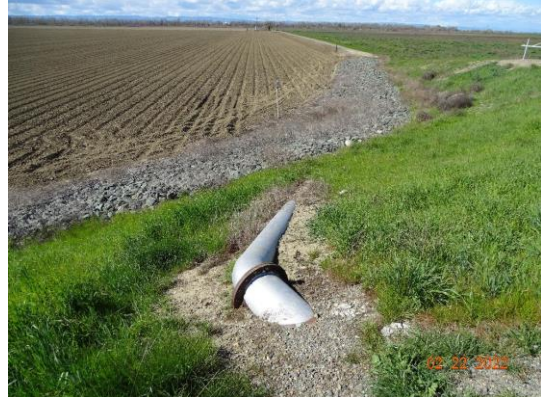
Photo 2 of 3 : UCIP_FA_2022_72789_109242.jpg

Comment Code						
Inspector Comment						
DS_ID:17113 FS_ID:72789 EP_NO: N/A Repair Type: Non-Urgent EVAL Issue: 11, Maintenance Compliance Issue Crossing Status: Found UCIP Comments: 02/22/2022 Record updated from No Action Needed to Non-Urgent. No permit has been found authorizing this pipe through the levee. Damaged siphon breaker on landside shoulder needs maintenance. (O.Yakimov - DWR UCIP) 11/16/2018 Waterside buried landside closed. (Ted Skidgel - Sac Yard) FIELD_STRUCT_DESC: 18-inch, 0.25-inch-thick soil-proofed steel irrigation pipe, 3 feet below the crown. Installed during Cache Creek Settling Basin enlargement in 1991. (24-inch steel irrigation pipes at 5 locations authorized under Permit No. 12705, 1979 - Layton Knaggs. Permit was administratively closed). [Additional Reference(s): DWR Levee Log, 1993 (HLM 9.37), listed as 24-inch pipe. FS Date: 2/22/2022 10:59:45 AM

Water-Side: View of levee slope looking from crown. Pipe daylights on levee slope

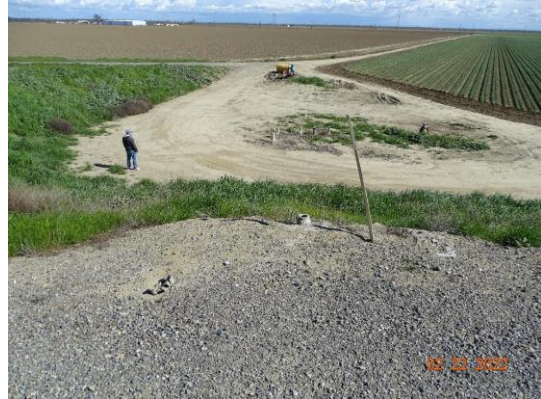
Photo 3 of 3 : UCIP_FA_2022_72789_109243.jpg

Land-Side: View of levee slope looking from crown. Water well in the

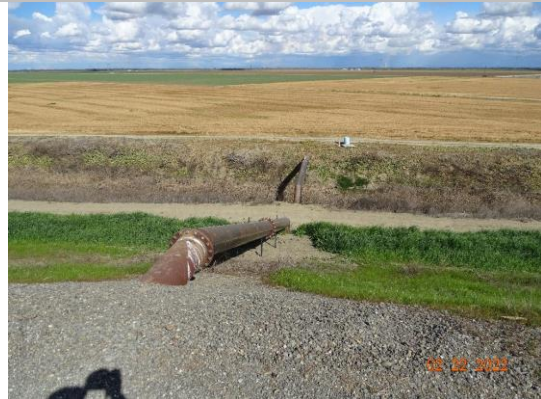
Photo 1 of 3 : UCIP_FA_2022_72795_109251.jpg

Comment Code						
Inspector Comment						
DS_ID:17115 FS_ID:72795 EP_NO: N/A Repair Type: Non-Urgent EVAL Issue: 10, Unauthorized Modification or Non-Compliant Permit Crossing Status: Found UCIP Comments: 02/22/2022 Record remains Non-Urgent. No permit has been found authorizing this pipe through the levee. On the landside pipe continues down levee sloe, under toe road, crossing irrigation ditch. Connection to groundwater system might be made in the field. On waterside pipe continues down the slope, under irrigation ditch. Siphon breaker and pipe discharge point in the field. Pipe has multiple flange joints on both slopes. Unable to find a permit for modification. (O.Yakimov - DWR UCIP) 10/19/16 Waterside capped, landside capped. (Ted Skidgel - Sac Yard) FIELD_STRUCT_DESC: 18-inch soil-proofed steel irrigation pipe through the levee, 4 feet below the crown. Pipe used for seasonal irrigation. Pipe opening capped on both ends. As-Built Drawing North Station 68+00. Pipe installed during Cache Creek Settling Basin Enlargement, 1991. (24-inch steel irrigation pipes at 5 locations authorized under Permit No. 12705, 1979 - Layton Knaggs. Permit was administratively closed). [Additional Reference(s): DWR Levee Log, 1993 (HLM 10.35), listed as 24-inch pipe. FS Date: 2/22/2022 12:48:39 PM

Land-Side: View of levee slope looking from crown. Pipe on the slope and over irrigation ditch

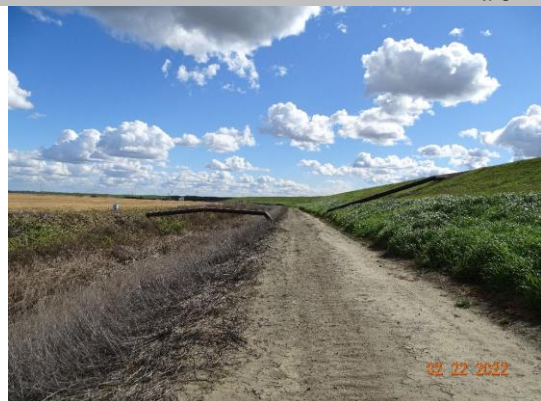
Photo 2 of 3 : UCIP_FA_2022_72795_109256.jpg

Land-Side: Pipe profile on landside

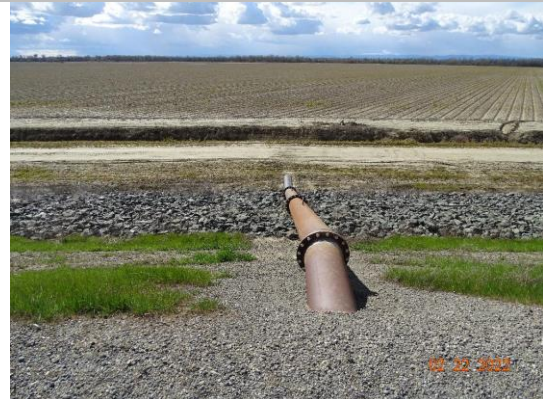
Photo 3 of 3 : UCIP_FA_2022_72795_109255.jpg

Water-Side: View of levee slope looking from crown. Pipe on levee slope

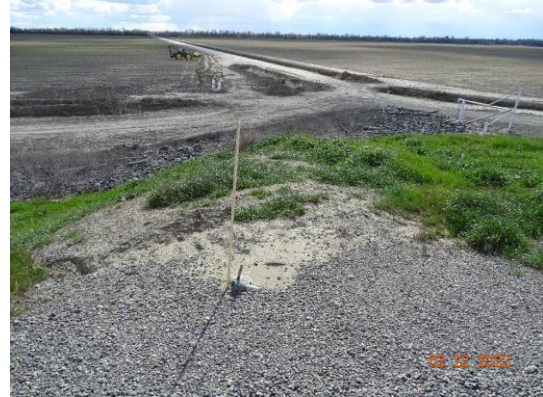
Photo 1 of 3 : UCIP_FA_2022_72797_109260.jpg

Water-Side: View of levee slope looking from crown

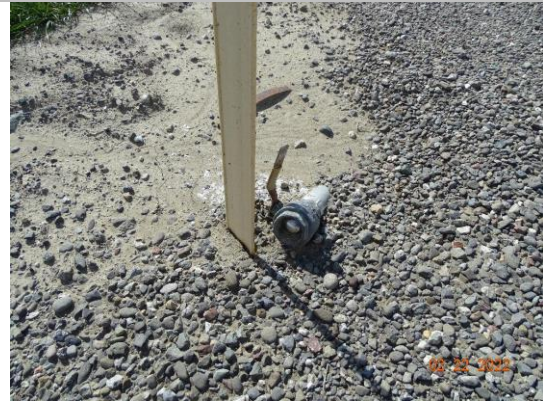
Photo 2 of 3 : UCIP_FA_2022_72797_109261.jpg

Water-Side: Air vent on levee shoulder

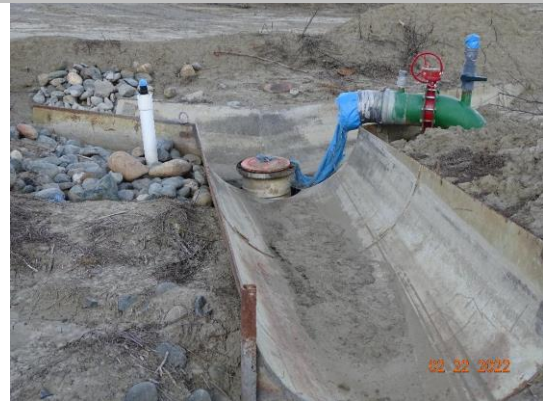
Photo 3 of 3 : UCIP_FA_2022_72797_109262.jpg

Water-Side: Capped pipe at irrigation ditch

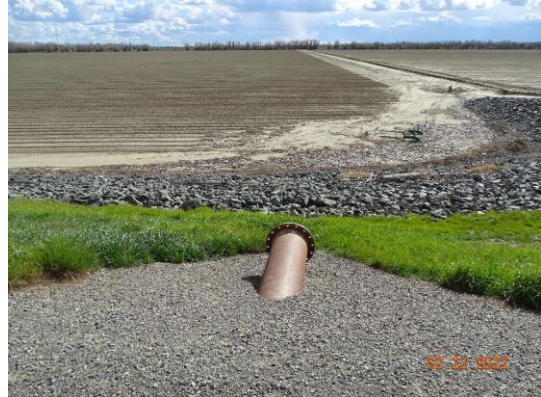
Photo 1 of 3 : UCIP_FA_2022_72802_109280.jpg

Water-Side: View of levee slope looking from crown. Pipe end is open

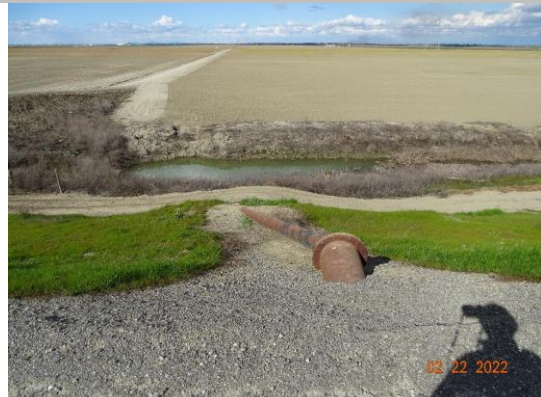
Photo 2 of 3 : UCIP_FA_2022_72802_109281.jpg

Land-Side: View of levee slope looking from crown

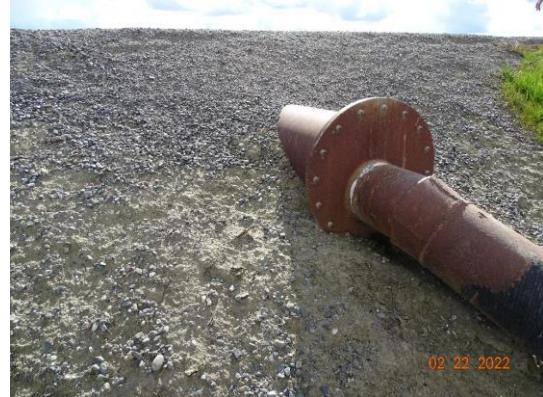
Photo 3 of 3 : UCIP_FA_2022_72802_109277.jpg

Land-Side: 11--inch pipe welder to flange joint on levee slope

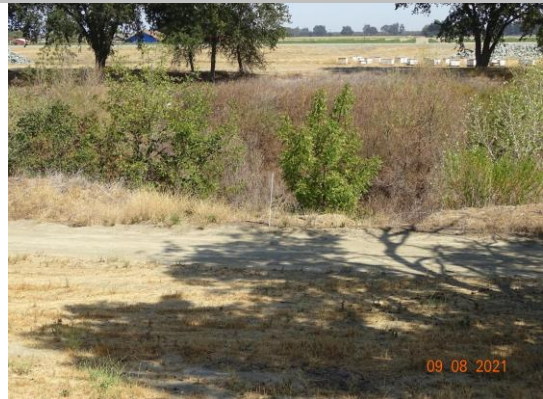
Photo 1 of 1 : FA_2022_ST0001_260_16_20220921_00010.jpg

View of erosion on waterside toe road. Fall 2021.

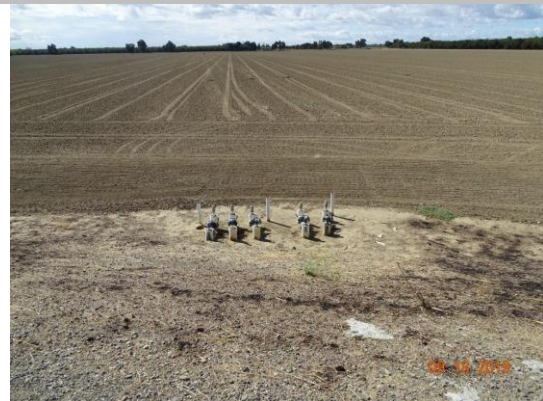
Photo 1 of 1 : FA_2022_ST0001_260_24_20220921_00013.jpg

View of the pumps, air valves, and bollards at the landside toe. Fall 2019.

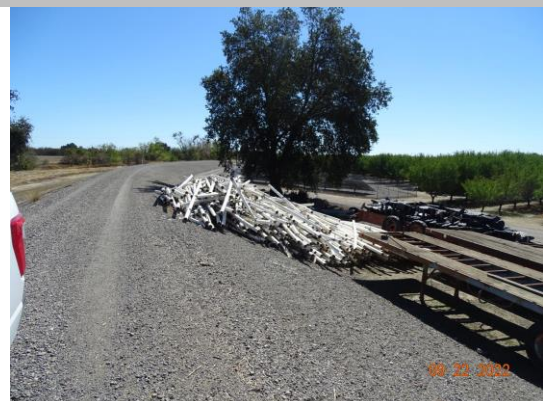
Photo 1 of 1 : FA_2022_ST0001_260_29_20220929_00025.jpg

View of equipment on the landside shoulder. Fall 2022.

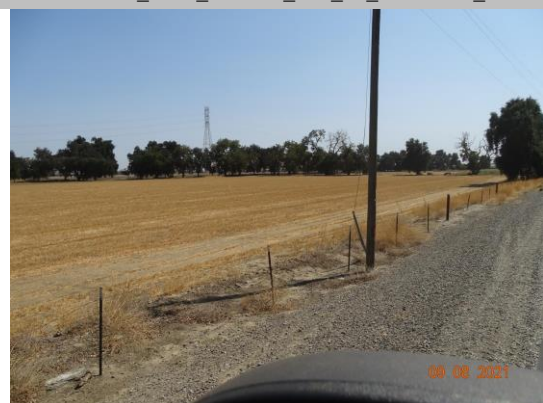
Photo 1 of 1 : FA_2022_ST0001_260_15_20220921_00009.jpg

View of fence at landside toe. Fall 2021.

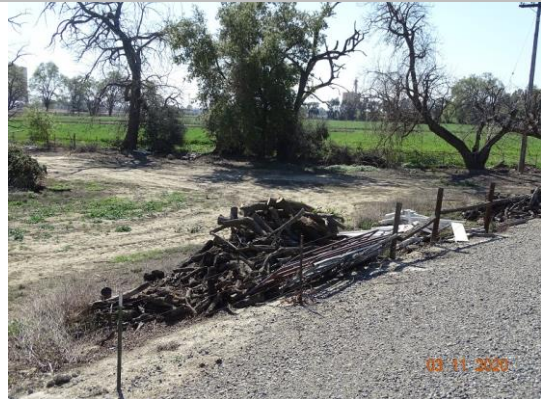
Photo 1 of 1 : FA_2022_ST0001_260_17_20220921_00011.jpg

View of firewood pile. Spring 2020.

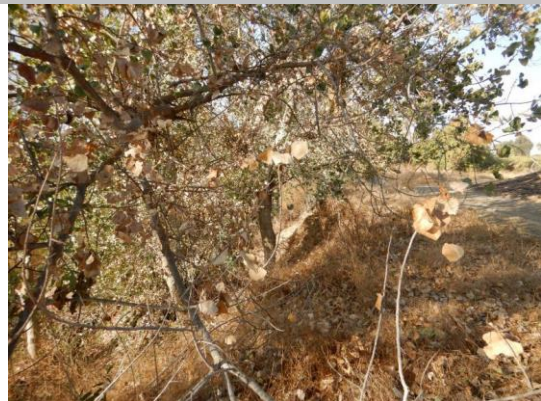
Photo 1 of 2 : FA_2022_ST0001_260_11_20220921_00006.jpg

USACE 2018 Erosion Photo #1

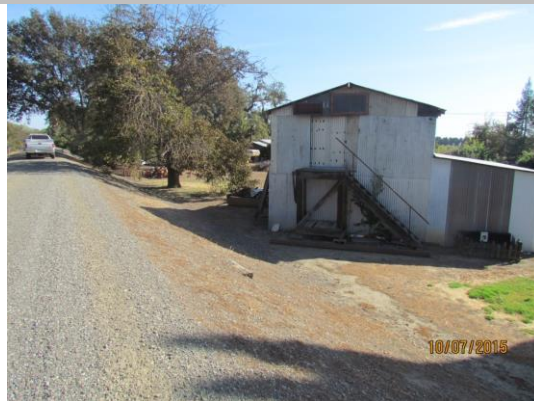
Photo 1 of 1 : FA_2022_ST0001_260_8_20220921_00004.jpg

View of the building on the landward side of the levee looking downstream. Fall 2015.

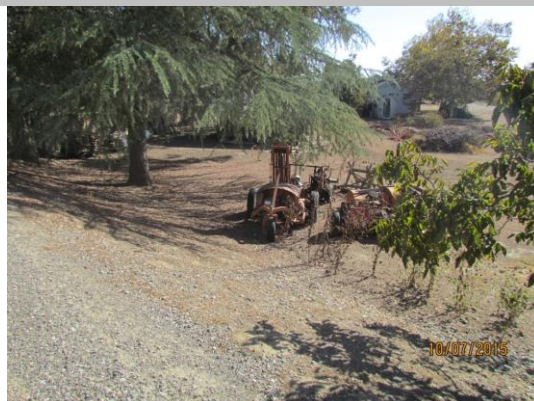
Photo 1 of 1 : FA_2022_ST0001_260_26_20220921_00014.jpg

View of the equipment at the toe of the landward side of the levee. Fall 2015.

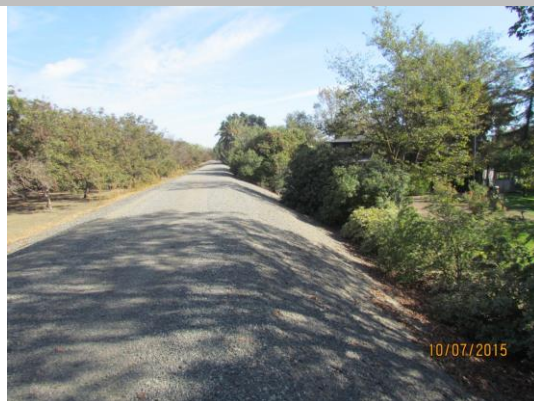
Photo 1 of 1 : FA_2022_ST0001_260_9_20220921_00005.jpg

View of the landscaping vegetation on the landward side of the levee looking downstream. Fall 2015.

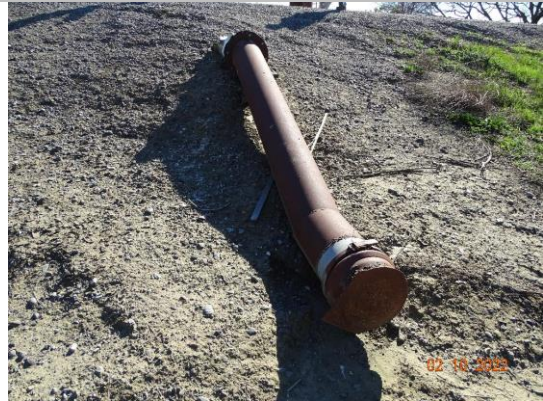
Photo 1 of 3 : UCIP_FA_2022_72295_107644.jpg

Water-Side: View of levee slope looking from toe. Capped pipe on the slope

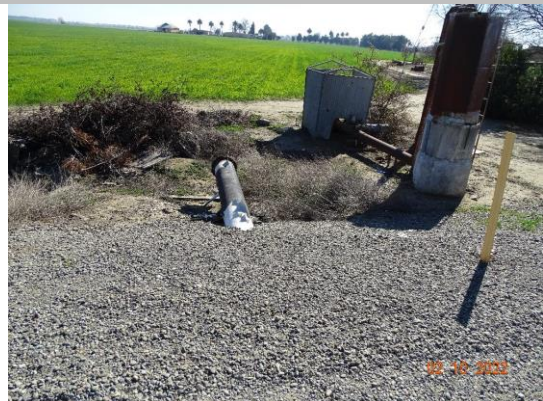
Photo 2 of 3 : UCIP_FA_2022_72295_107647.jpg

Land-Side: View of levee slope looking from crown

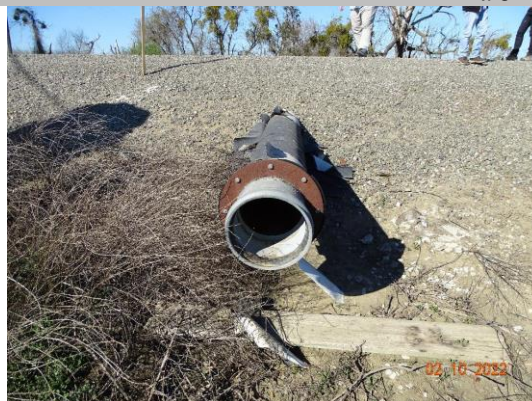
Photo 3 of 3 : UCIP_FA_2022_72295_107648.jpg

Land-Side: Pipe end open on landside

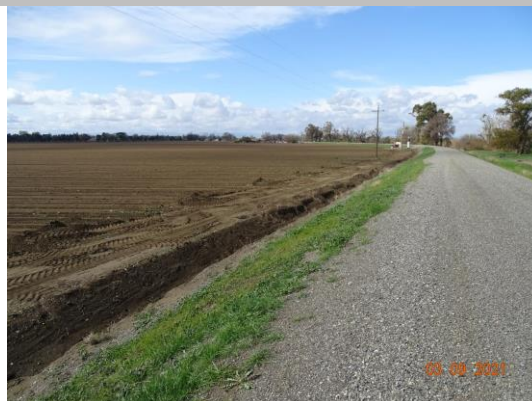
Photo 1 of 1 : FA_2022_ST0001_260_1_20220921_00001.jpg

View of irrigation ditch at the landside toe. Spring 2021.

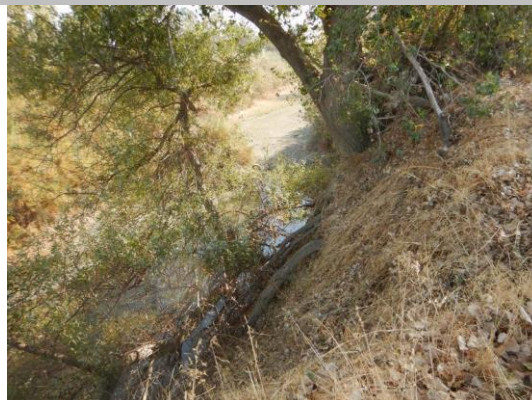
Photo 2 of 2 : FA_2022_ST0001_260_27_20220921_00016.jpg

USACE 2018 Erosion Photo #2

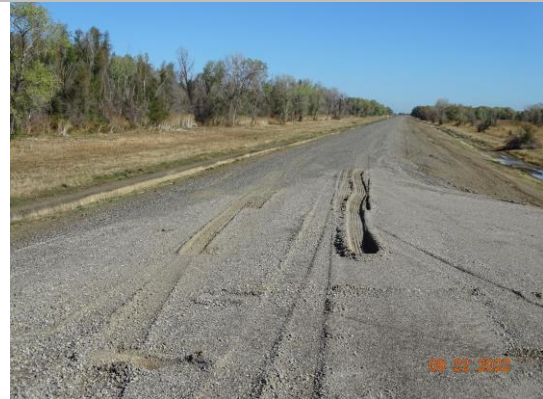
Photo 1 of 1 : FA_2022_ST0001_261_2_20220929_00002.jpg

View of tire ruts on the crown. Fall 2022.
