Flood Control Project Maintenance Levee Inspections

Fall 2023 Levee Maintenance Deficiency Summary Report

Sacramento River Basin

Sacramento Maintenance Yard Cache Creek

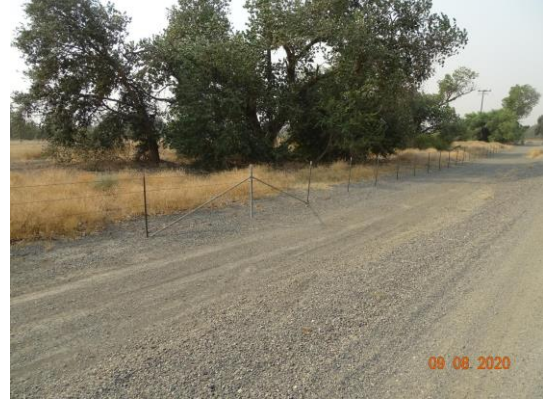
Photo 1 of 1 : FA_2023_ST0001_259_24_20230907_00012.jpg

View of the fence near the toe road. Fall 2020.

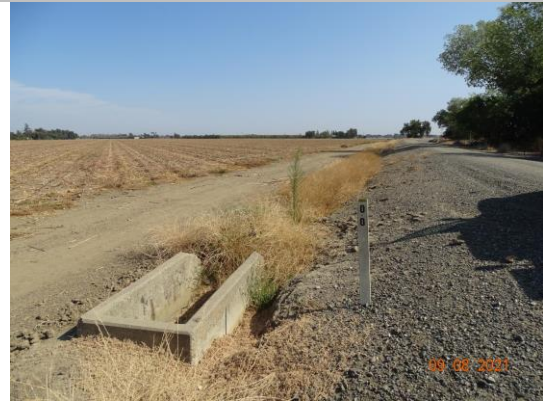
Photo 1 of 1 : FA_2023_ST0001_259_48_20230907_00025.jpg

LM Start	0.03	Rating **	M	Issue No.	48
LM End	0.16	Issue Type +	En	Location *	LS
Category	Earthen Levee			GPS Latitude/Longitude	
				Start	End
Item	Encroachments			38.715268°	38.716647°
				-121.825345°	-121.823667°
DWR ID	DWR_ST0001_01_s_2015_48				
Comment Code					
DT : Ditch					
Inspector Comment					
A ditch is located at the levee toe.

View of ditch at landside toe. Fall 2021.

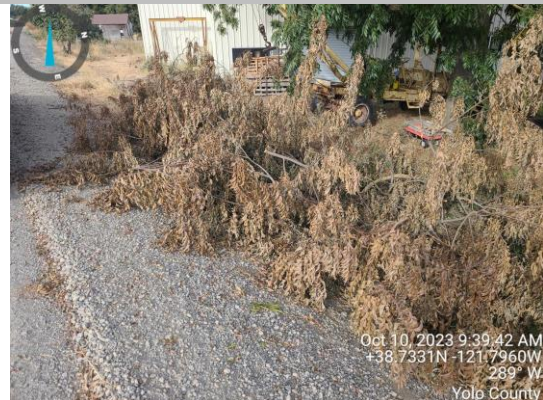
Photo 1 of 1 : FA_2023_ST0001_259_37_20231010_00061.jpg

LM Start	0.88	Rating **	M	Issue No.	37
LM End	0.88	Issue Type +	Ma	Location *	LS
Category	Earthen Levee			GPS Latitude/Longitude	
				Start	End
Item	Trim / Thin Trees			38.733100°	38.733100°
				-121.796000°	-121.796000°
DWR ID	DWR_ST0001_01_f_2023_37				
Comment Code					
T2 : Tree or limb.					
Inspector Comment					
Fallen tree limbs on the landside slope.

View of tree limbs on the landside slope. Fall 2023.

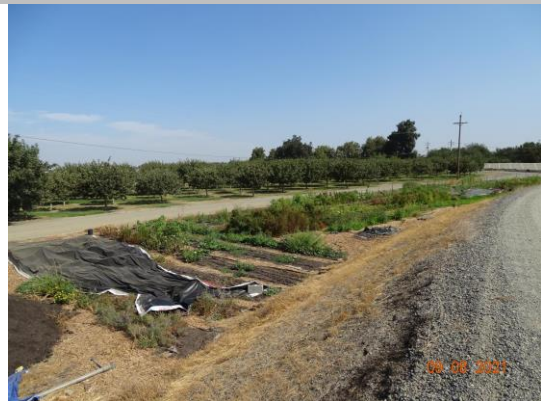
Photo 1 of 1 : FA_2023_ST0001_259_25_20230907_00013.jpg

View of garden at landside toe. Fall 2021.

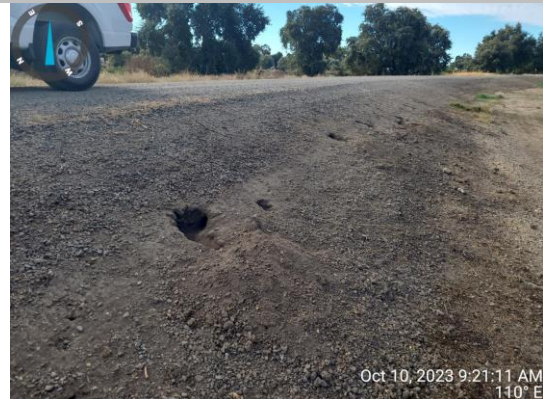
Photo 1 of 1 : FA_2023_ST0001_259_31_20231010_00060.jpg

View of rodent holes on the landside slope. Fall 2023.

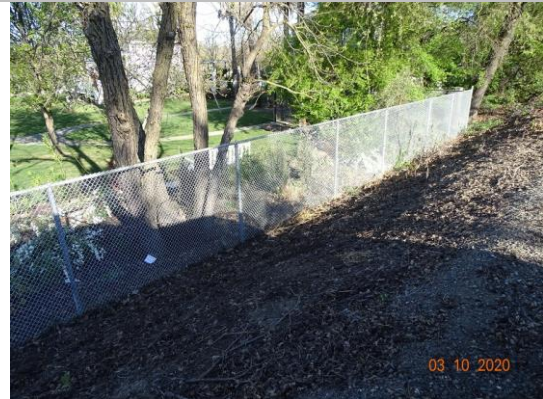
Photo 1 of 1 : FA_2023_ST0001_259_63_20230907_00029.jpg

View of fence at the landside toe. Spring 2020.

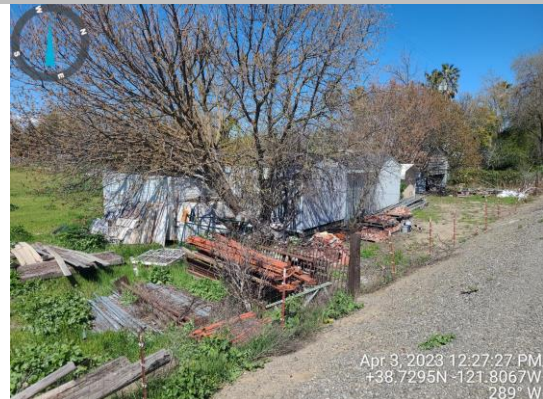
Photo 1 of 1 : FA_2023_ST0001_259_32_20230907_00017.jpg

LM Start	1.86	Rating **	M	Issue No.	32
LM End	1.86	Issue Type +	En	Location *	LS
Category	Earthen Levee			GPS Latitude/Longitude	
				Start	End
Item	Encroachments			38.729495°	38.729495°
				-121.806535°	-121.806535°
DWR ID	DWR_ST0001_01_s_2022_32				
Comment Code					
EQ : Equipment					
Inspector Comment					
Farm equipment and debris are located on the landside toe.

View of equipment on the landside easement. Spring 2023.

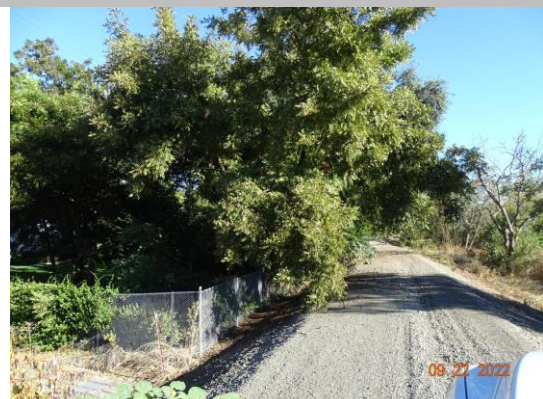
Photo 1 of 1 : FA_2023_ST0001_259_3_20230907_00001.jpg

LM Start	1.90	Rating **	U	Issue No.	3
LM End	1.98	Issue Type +	En	Location *	LS
Category	Earthen Levee			GPS Latitude/Longitude	
				Start	End
Item	Vegetation			38.730008°	38.731170°
				-121.806497°	-121.806220°
DWR ID	DWR_ST0001_01_s_2012_3				
Comment Code					
V6 : Landscaping					
Inspector Comment

View of vegetation on the landside slope. Fall 2022.

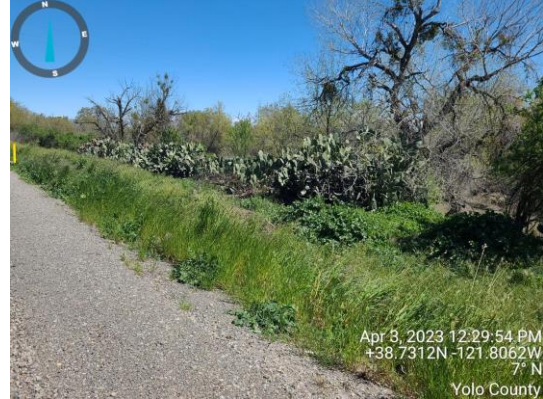
Photo 1 of 1 : FA_2023_ST0001_259_6_20230907_00002.jpg

View of cactus on the waterside slope. Spring 2023.

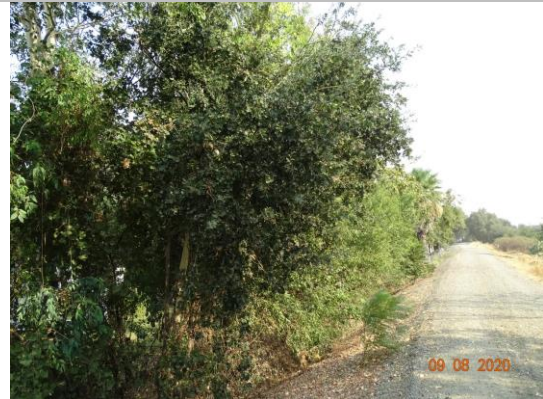
Photo 1 of 1 : FA_2023_ST0001_259_7_20230907_00003.jpg

LM Start	1.98	Rating **	U	Issue No.	7
LM End	2.01	Issue Type +	En	Location *	LS
Category	Earthen Levee			GPS Latitude/Longitude	
				Start	End
Item	Vegetation			38.731167°	38.731614°
				-121.806217°	-121.806032°
DWR ID	DWR_ST0001_01_s_2012_7				
Comment Code					
V6 : Landscaping					
Inspector Comment

View of the landscaping on the landward side of the levee looking downstream. Fall 2020.

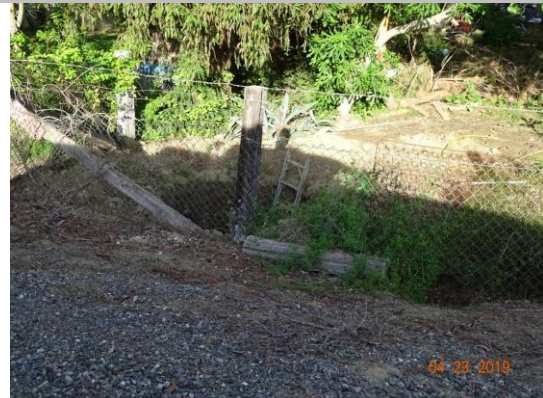
Photo 1 of 1 : FA_2023_ST0001_259_35_20230907_00020.jpg

LM Start	1.98	Rating **	U	Issue No.	35
LM End	1.98	Issue Type +	En	Location *	LS
Category	Earthen Levee			GPS Latitude/Longitude	
				Start	End
Item	Encroachments			38.731208°	38.731208°
				-121.806220°	-121.806220°
DWR ID	DWR_ST0001_01_s_2020_35				
Comment Code					
DT : Ditch					
Inspector Comment					
The landowner has dug a 5' diameter hole within 10' of the landside toe and it appears to cut into the levee prism.

View of the hole within the landside easement. Spring 2019.

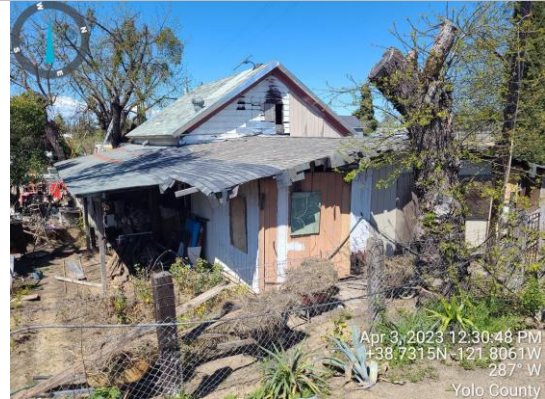
Photo 1 of 1 : FA_2023_ST0001_259_8_20230907_00004.jpg

View of building within landside easement. Spring 2023.

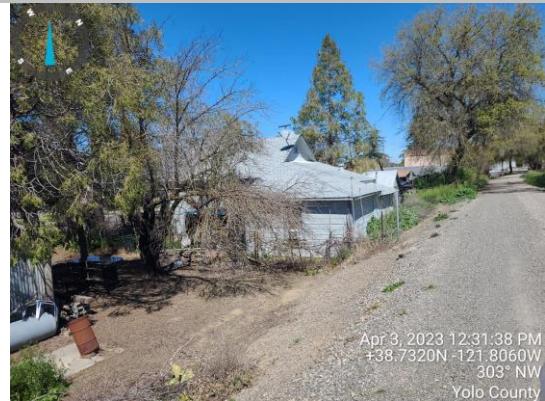
Photo 1 of 1 : FA_2023_ST0001_259_10_20230907_00005.jpg

LM Start	2.05	Rating **	M	Issue No.	10
LM End	2.05	Issue Type +	En	Location *	LS
Category	Earthen Levee			GPS Latitude/Longitude	
				Start	End
Item	Encroachments			38.732162°	38.732162°
				-121.805895°	-121.805895°
DWR ID	DWR_ST0001_01_s_2018_10				
Comment Code					
BU : Building					
Inspector Comment

View of house within landside easement. Spring 2023.

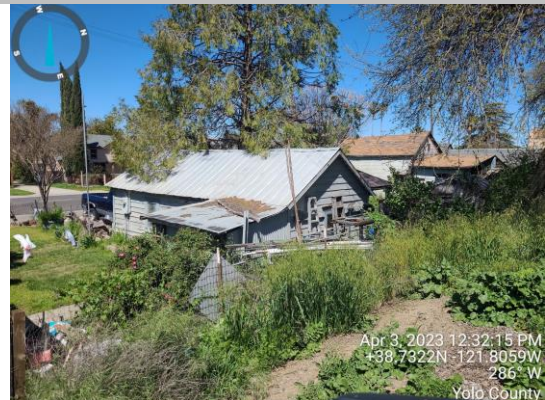
Photo 1 of 1 : FA_2023_ST0001_259_11_20230907_00006.jpg

View of building within landside easement. Spring 2023.

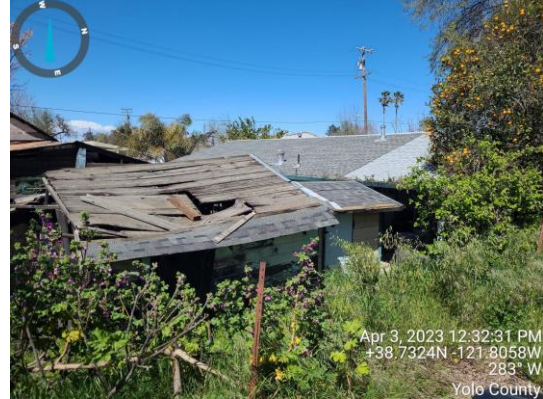
Photo 1 of 1 : FA_2023_ST0001_259_13_20230907_00008.jpg

View of building within landside easement. Spring 2023.

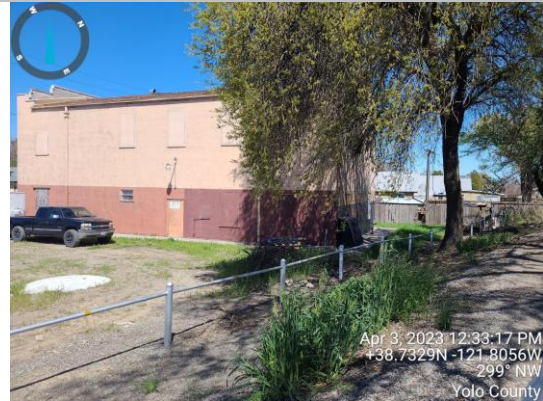
Photo 1 of 1 : FA_2023_ST0001_259_12_20230907_00007.jpg

View of building within landside easement. Spring 2023.

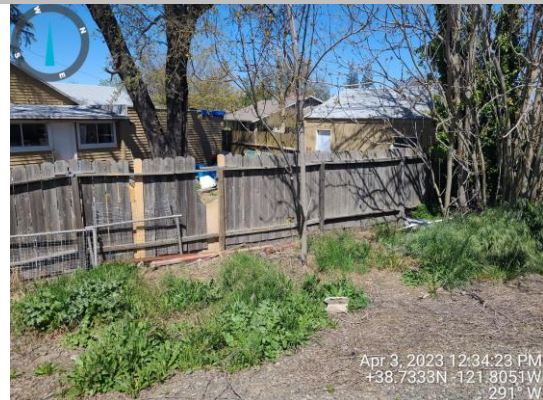
Photo 1 of 1 : FA_2023_ST0001_259_15_20230907_00009.jpg

View of the fence within landside easement. Spring 2023.

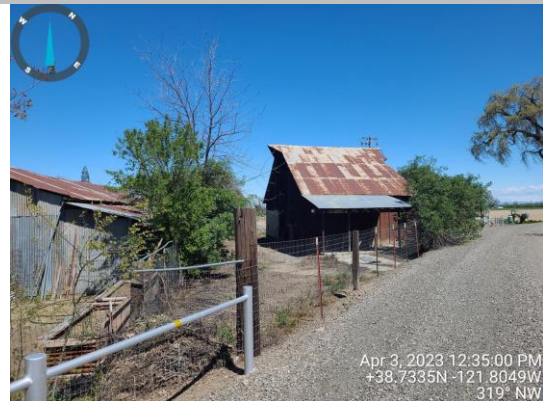
Photo 1 of 1 : FA_2023_ST0001_259_16_20230907_00010.jpg

View of horse barn and corral within landside easement. Spring 2023.

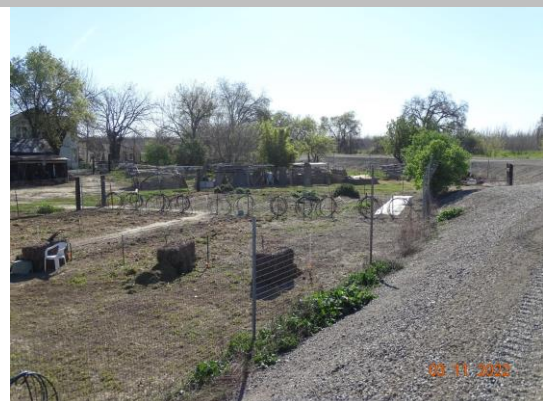
Photo 1 of 1 : FA_2023_ST0001_259_78_20230907_00032.jpg

Chain fence at the landside levee toe. Spring 2022.

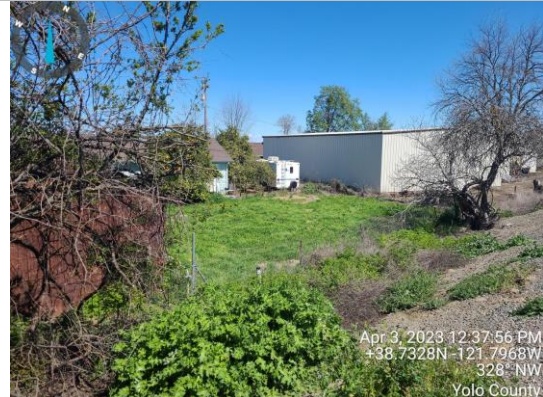
Photo 1 of 1 : FA_2023_ST0001_259_77_20230907_00031.jpg

View of wire fence on landside easement. Spring 2023.

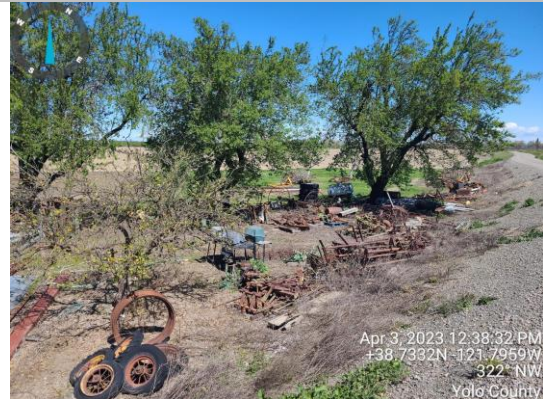
Photo 1 of 1 : FA_2023_ST0001_259_71_20230907_00030.jpg

View of equipment on landside toe. Spring 2023.

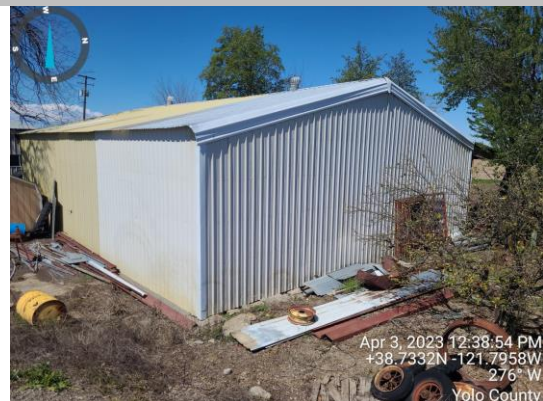
Photo 1 of 1 : FA_2023_ST0001_259_20_20230907_00011.jpg

View of building on landside easement. Spring 2023.

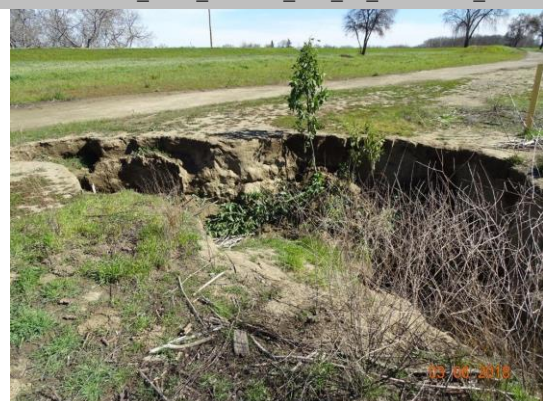
Photo 1 of 2 : FA_2023_ST0001_259_62_20230907_00027.jpg

View of erosion looking towards the landside levee slope, facing northeast. Spring 2018.

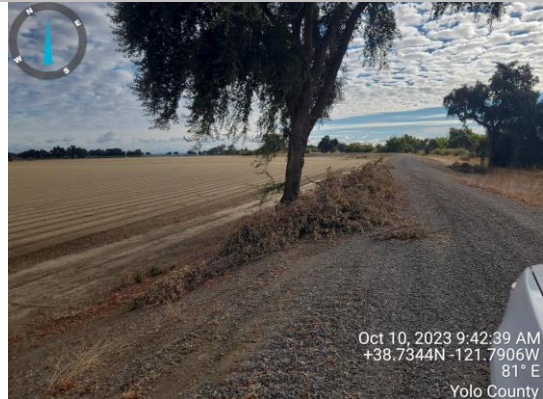
Photo 1 of 1 : FA_2023_ST0001_259_42_20231010_00062.jpg

View of tree limbs on the landside slope. Fall 2023.

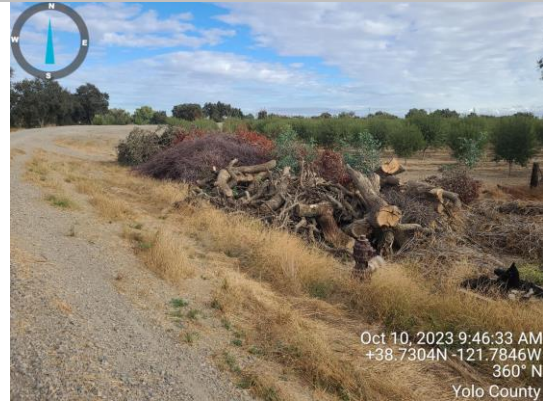
Photo 1 of 1 : FA_2023_ST0001_259_43_20231010_00063.jpg

View of tree at the landside toe. Fall 2023.

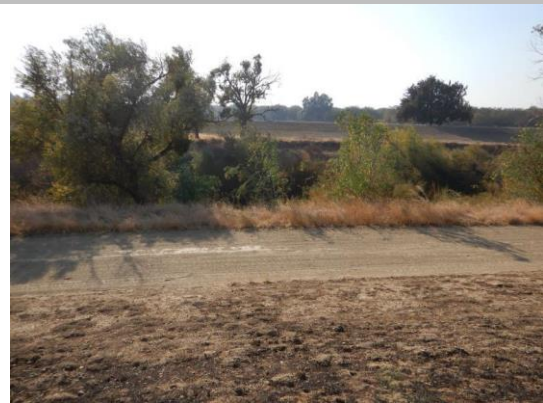
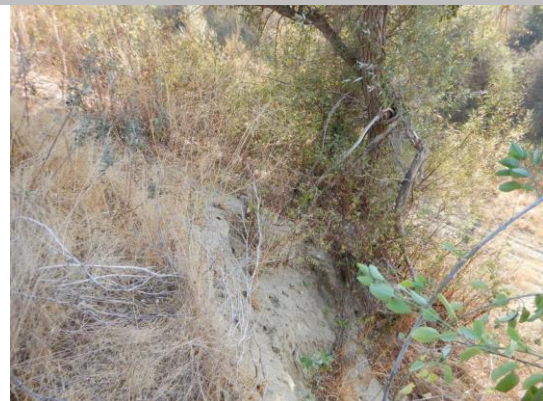
LM Start	3.71	Rating **	A/W	Issue No.	41
LM End	3.74	Issue Type +	Ma	Location *	WS
Category	Supplemental			GPS Latitude/Longitude	
				Start	End
Item	2018 USACE Erosion Survey			38.729664°	38.729322°
				-121.784222°	-121.783842°
DWR ID	DWR_ST0001_01_s_2022_41				
Comment Code					
Inspector Comment					
2018 Site ID: CHC 3.6 L					
Status: Eroding New					
2018 Field Notes: Erosion of entire bank slope. Possible tree popout.					
Slumping cracks along berm.					
Site History:

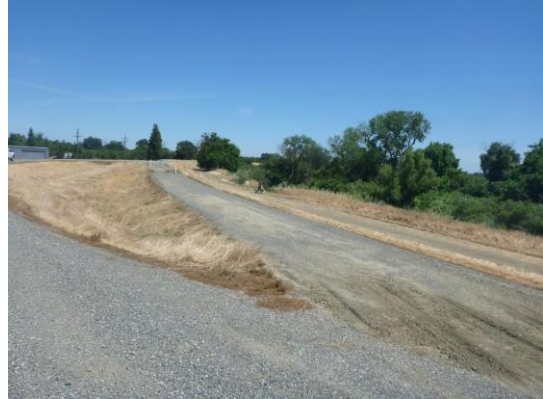
Photo 1 of 2 : LEVAL_FA_2023_249_954.jpg

View of toe road where erosion is located.

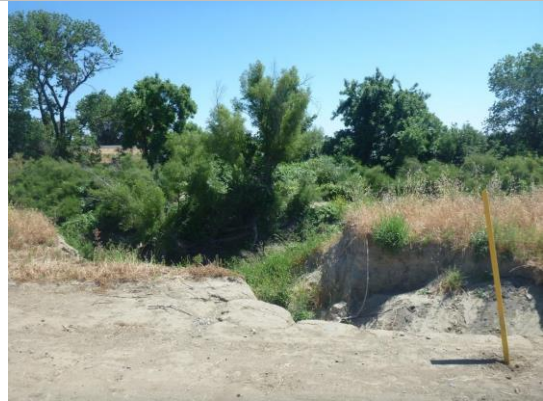
Photo 2 of 2 : LEVAL_FA_2023_249_959.jpg

View of erosion near waterside toe road.

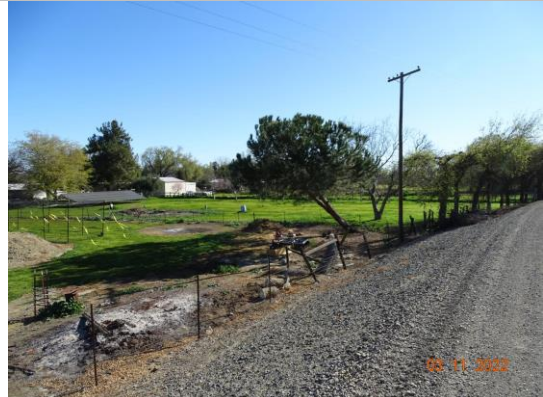
Photo 1 of 1 : FA_2023_ST0001_259_52_20230907_00026.jpg

Barbed wire fence at the landside levee toe. Spring 2022.

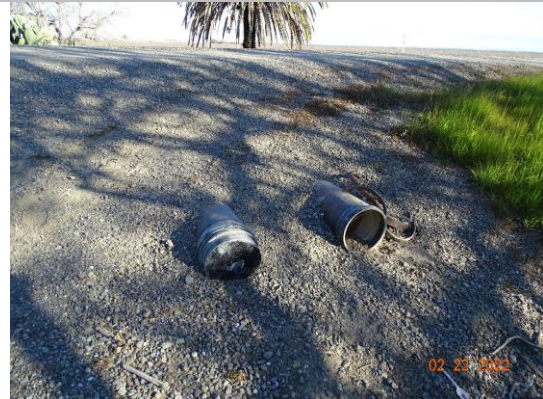
Photo 3 of 3 : UCIP_FA_2023_72745_109118.jpg

Comment Code					
Inspector Comment					
DS_ID:17032 FS_ID:72745 EP_NO: 16810 Repair Type: Urgent EVAL Issue: 3a, Flood Risk Crossing Status: Found UCIP Comments: 02/22/2022 Record updated from No Action Needed to Urgent. Straight through pipe open on both ends provides flood threat to the landside during high water events. (O.Yakimov - DWR UCIP) 11/16/18 Waterside: 1 open 1 closed, landside: both open. (Ted Skidgel - Sac Yard) FIELD_STRUCT_DESC: 2 of 2: 14-inch coated steel irrigation pipe through the levee approximately 2-3 feet below the crown. Pipe connects to a seasonal 14-inch polyvinyl chloride (PVC) pipe and a 100-horsepower mobile pumping plant on the waterside slope. (One 14-inch steel pipe authorized under Permit No. 16810, 1998 - W. Ashley Payne, permit inspection notes indicate that two 14-inch pipes were installed). (Retention of two 14-inch pipes authorized under Permit No. 16810-R, 2002 - Ashley Payne). FS Date: 2/22/2022 4:16:46 PM

Water-Side: Open pipe on levee slope

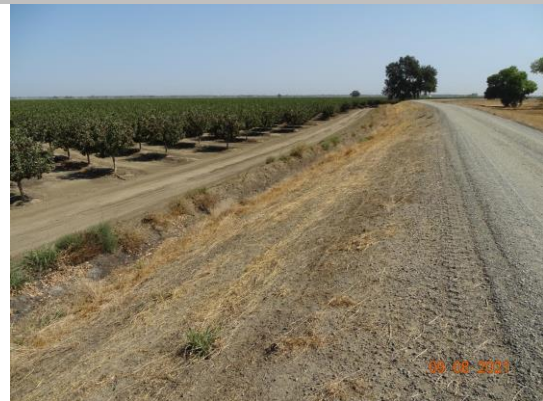
Photo 1 of 1 : FA_2023_ST0001_259_26_20230907_00014.jpg

View of ditch at landside toe. Fall 2021.

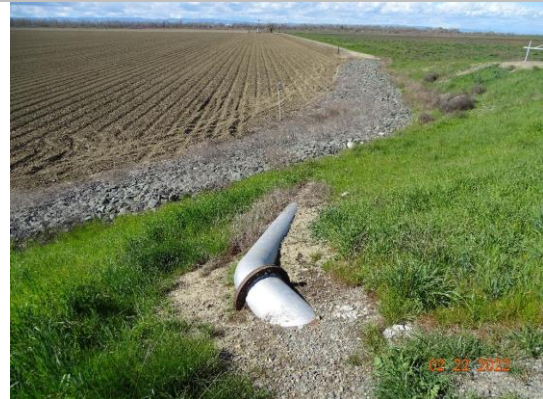
Photo 2 of 3 : UCIP_FA_2023_72789_109242.jpg

Comment Code					
Inspector Comment					
DS_ID:17113 FS_ID:72789 EP_NO: N/A Repair Type: Non-Urgent EVAL Issue: 11, Maintenance Compliance Issue Crossing Status: Found UCIP Comments: 02/22/2022 Record updated from No Action Needed to Non-Urgent. No permit has been found authorizing this pipe through the levee. Damaged siphon breaker on landside shoulder needs maintenance. (O.Yakimov - DWR UCIP) 11/16/2018 Waterside buried landside closed. (Ted Skidgel - Sac Yard) FIELD_STRUCT_DESC: 18-inch, 0.25-inch-thick soil-proofed steel irrigation pipe, 3 feet below the crown. Installed during Cache Creek Settling Basin enlargement in 1991. (24-inch steel irrigation pipes at 5 locations authorized under Permit No. 12705, 1979 - Layton Knaggs. Permit was administratively closed). [Additional Reference(s): DWR Levee Log, 1993 (HLM 9.37), listed as 24-inch pipe0. USACE As-Built Drawing No. CC5-04-0070, 6 May 1991, Sheet 15, STA UNK]. FS Date: 2/22/2022 10:59:45 AM

Water-Side: View of levee slope looking from crown. Pipe daylights on levee slope

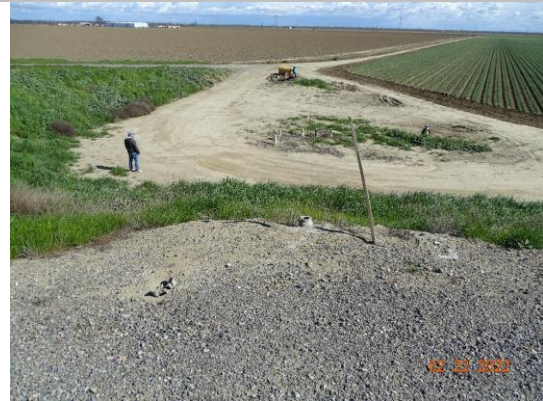
Photo 3 of 3 : UCIP_FA_2023_72789_109243.jpg

Land-Side: View of levee slope looking from crown. Water well in the field

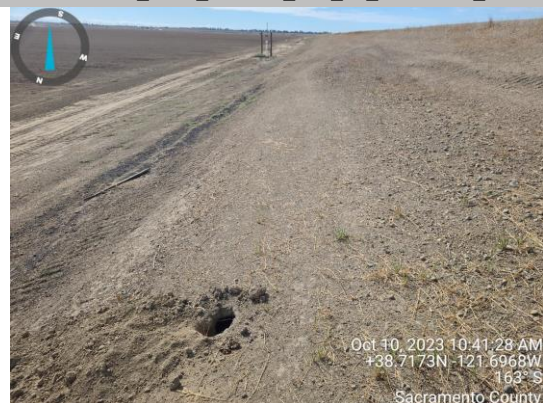
Photo 1 of 1 : FA_2023_ST0001_259_45_20231010_00064.jpg

View of rodent hole on the landside slope. Fall 2023.

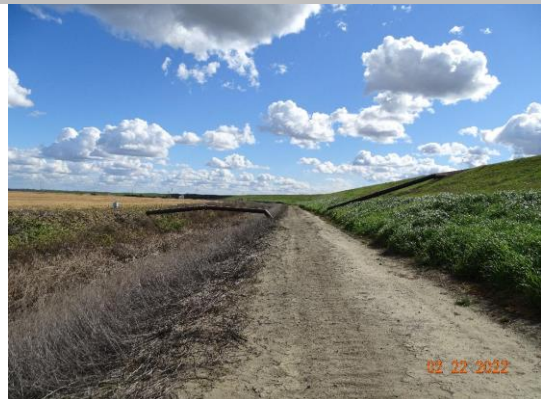
Photo 2 of 3 : UCIP_FA_2023_72795_109256.jpg

Land-Side: Pipe profile on landside

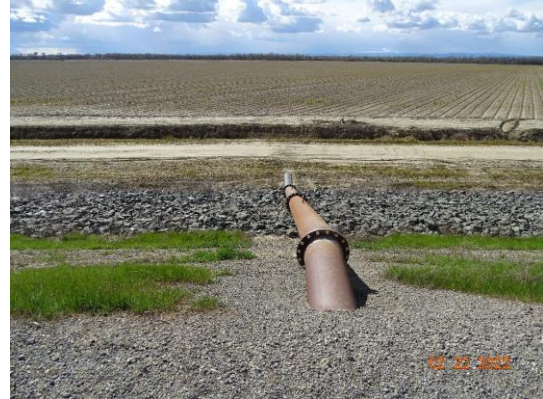
Photo 3 of 3 : UCIP_FA_2023_72795_109255.jpg

Water-Side: View of levee slope looking from crown. Pipe on levee slope

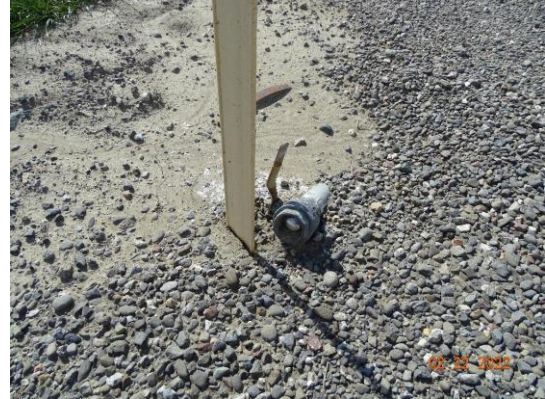
Photo 2 of 3 : UCIP_FA_2023_72797_109261.jpg

Water-Side: Air vent on levee shoulder

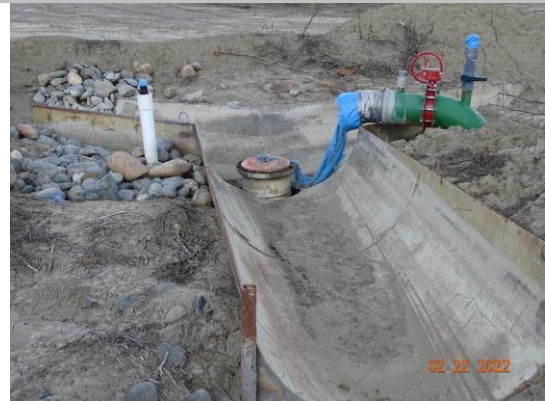
Photo 3 of 3 : UCIP_FA_2023_72797_109262.jpg

Water-Side: Capped pipe at irrigation ditch

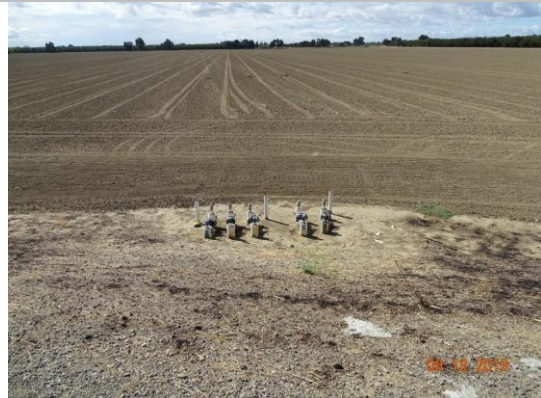
Photo 1 of 1 : FA_2023_ST0001_260_24_20230907_00012.jpg

View of the pumps, air valves, and bollards at the landside toe. Fall 2019.

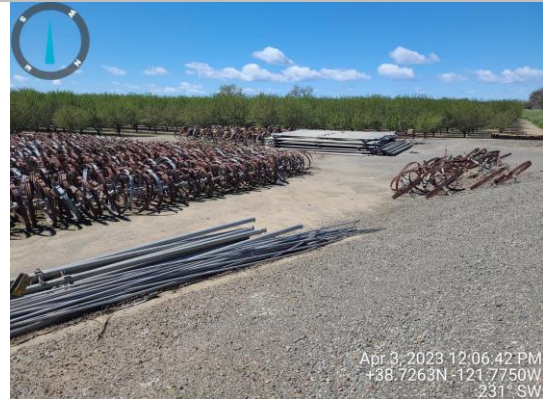
Photo 1 of 1 : FA_2023_ST0001_260_38_20230907_00017.jpg

View of pipes and equipment on the landside toe. Spring 2023.

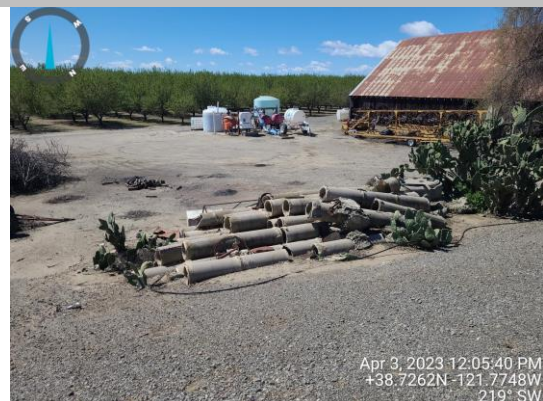
Photo 1 of 1 : FA_2023_ST0001_260_3_20230907_00004.jpg

View of pipes on the landside toe. Spring 2023.

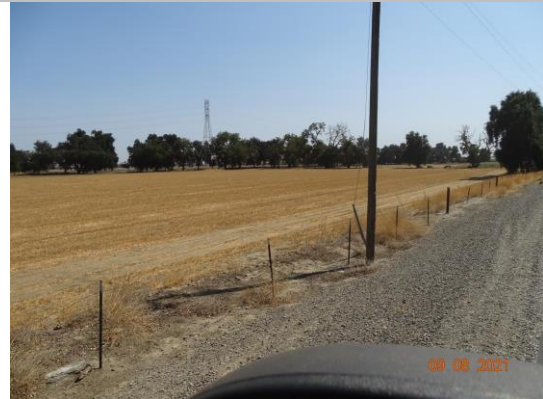
Photo 1 of 1 : FA_2023_ST0001_260_15_20230907_00009.jpg

View of fence at landside toe. Fall 2021.

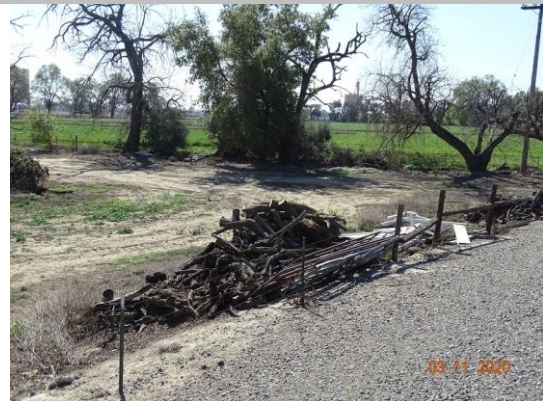
Photo 1 of 1 : FA_2023_ST0001_260_17_20230907_00011.jpg

View of firewood pile. Spring 2020.

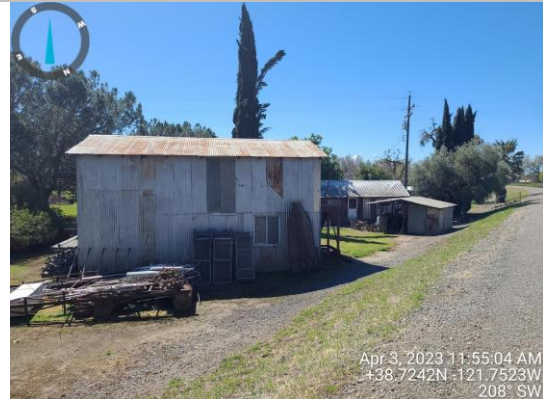
Photo 1 of 1 : FA_2023_ST0001_260_8_20230907_00005.jpg

View of building within the landside easement. Spring 2023.

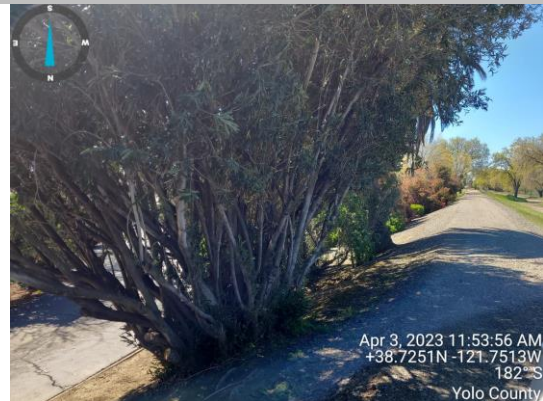
Photo 1 of 1 : FA_2023_ST0001_260_9_20230907_00006.jpg

View of vegetation on the landside slope. Spring 2023.

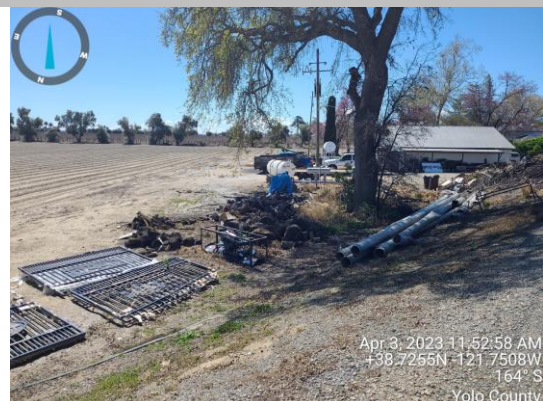
Photo 1 of 1 : FA_2023_ST0001_260_28_20230907_00015.jpg

View of equipment on the landside toe. Spring 2023.

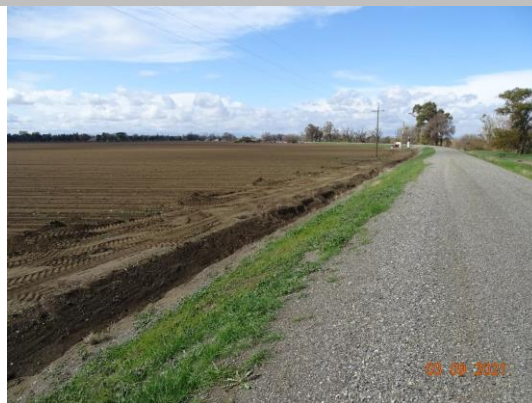
Photo 1 of 1 : FA_2023_ST0001_260_1_20230907_00001.jpg

View of irrigation ditch at the landside toe. Spring 2021.

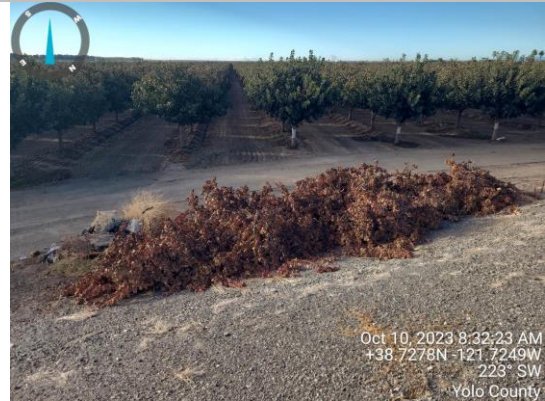
Photo 1 of 1 : FA_2023_ST0001_260_5_20231010_00021.jpg

View of the pruning pile on the landside slope. Fall 2023.

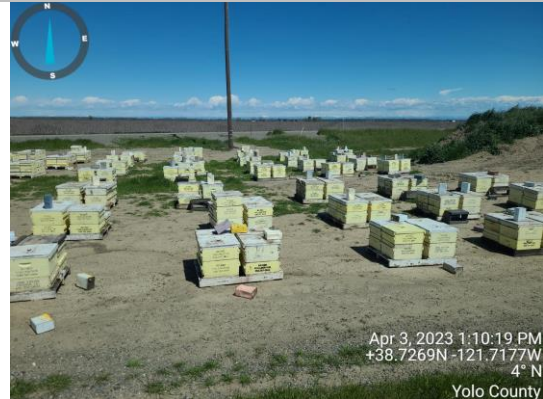
Photo 1 of 1 : FA_2023_ST0001_261_1_20230907_00001.jpg

Beehives within the landside easement. Spring 2023.

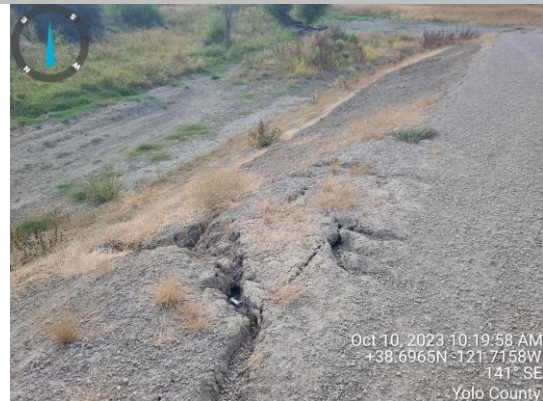
Photo 1 of 1 : FA_2023_ST0001_261_3_20231010_00003.jpg

View of erosion on the landside slope and toe. Fall 2023.
