**Flood Control Project Maintenance
Levee Inspections**

Fall 2024 Levee Maintenance Deficiency Summary Report

Sacramento River Basin

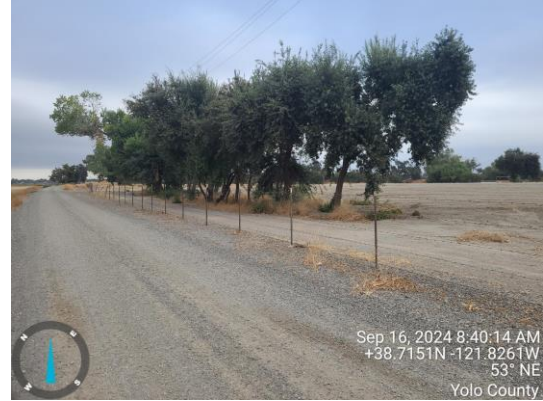
Photo 1 of 1 : FA_2024_ST0001_259_24_20240916_00060.jpg

View of the fence near the toe road. Fall 2024.

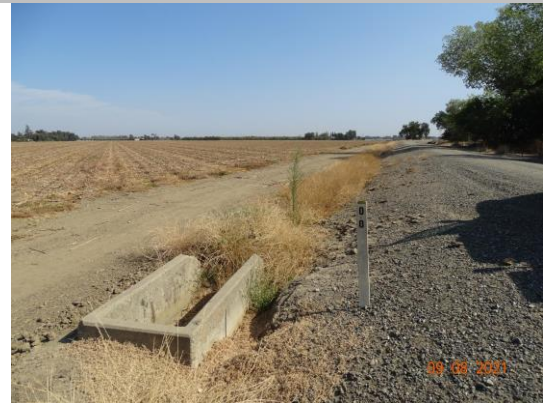
Photo 1 of 1 : FA_2024_ST0001_259_48_20240909_00025.jpg

LM Start	0.03	Rating **	M	Issue No.	48
LM End	0.16	Issue Type +	En	Location *	LS
Category	Earthen Levee			GPS Latitude/Longitude	
				Start	End
Item	Encroachments			38.715268 °	38.716647 °
				-121.825345 °	-121.823667 °
DWR ID	DWR_ST0001_01_s_2015_48				
Comment Code					
DT : Ditch					
Inspector Comment					
A ditch is located at the levee toe.

View of ditch at landside toe. Fall 2021.

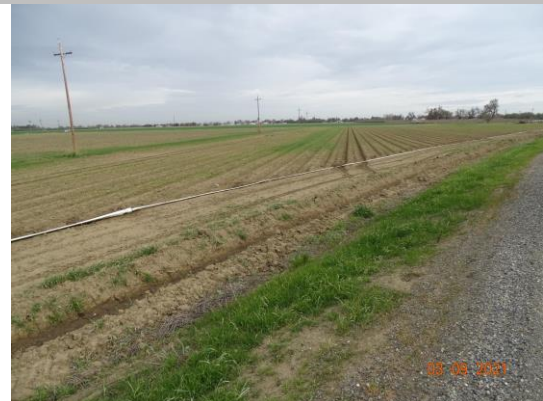
Photo 1 of 1 : FA_2024_ST0001_259_27_20240909_00013.jpg

LM Start	0.92	Rating **	M	Issue No.	27
LM End	1.09	Issue Type +	En	Location *	LS
Category	Earthen Levee			GPS Latitude/Longitude	
				Start	End
Item	Encroachments			38.719051°	38.720864°
				-121.815287°	-121.812980°
DWR ID	DWR_ST0001_01_f_2023_27				
Comment Code					
DT : Ditch					
Inspector Comment					
There is an irrigation ditch at the landside toe.

View of irrigation ditch near the landside toe. Spring 2021.

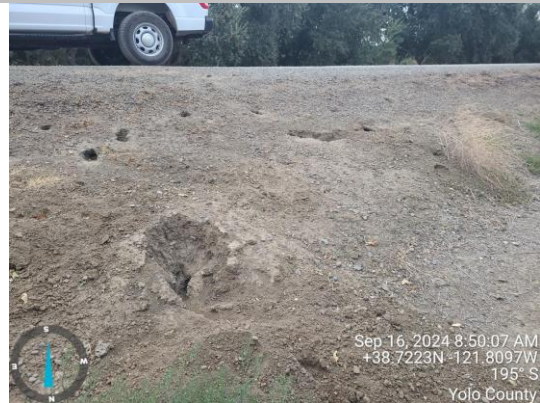
Photo 1 of 1 : FA_2024_ST0001_259_23_20240916_00061.jpg

View of rodent holes on the landside slope. Fall 2024.

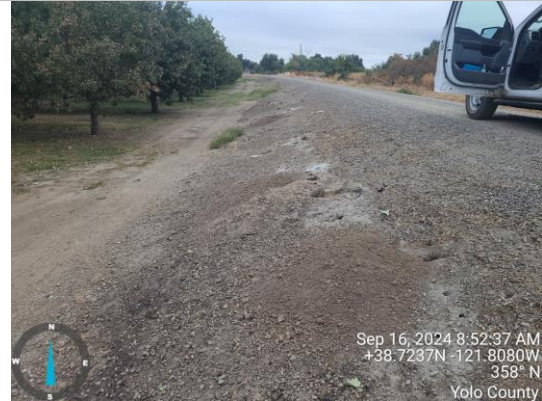
Photo 1 of 1 : FA_2024_ST0001_259_28_20240916_00062.jpg

View of rodent holes on the landside slope. Fall 2024.

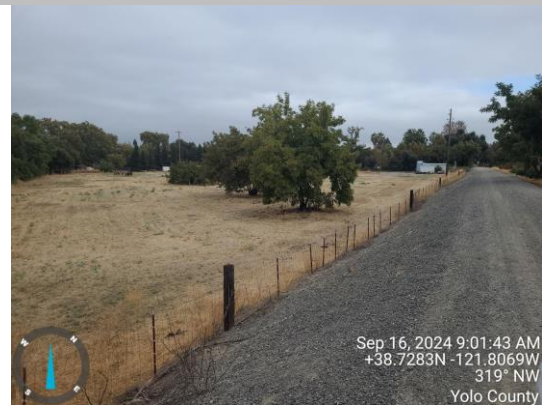
Photo 1 of 1 : FA_2024_ST0001_259_63_20240916_00063.jpg

LM Start	1.77	Rating **	M	Issue No.	63
LM End	1.90	Issue Type +	En	Location *	LS
Category	Earthen Levee			GPS Latitude/Longitude	
				Start	End
Item	Encroachments			38.728217 °	38.729944 °
				-121.806903 °	-121.806506 °
DWR ID	DWR_ST0001_01_s_2017_63				
Comment Code					
FE : Fence					
Inspector Comment

View of fence at the landside toe. Fall 2024.

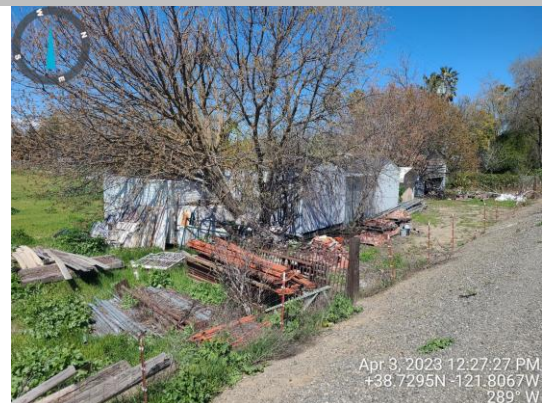
Photo 1 of 1 : FA_2024_ST0001_259_32_20240909_00015.jpg

LM Start	1.86	Rating **	M	Issue No.	32
LM End	1.86	Issue Type +	En	Location *	LS
Category	Earthen Levee			GPS Latitude/Longitude	
				Start	End
Item	Encroachments			38.729495°	38.729495°
				-121.806535°	-121.806535°
DWR ID	DWR_ST0001_01_s_2022_32				
Comment Code					
EQ : Equipment					
Inspector Comment					
Farm equipment and debris are located on the landside toe.

View of equipment on the landside easement. Spring 2023.

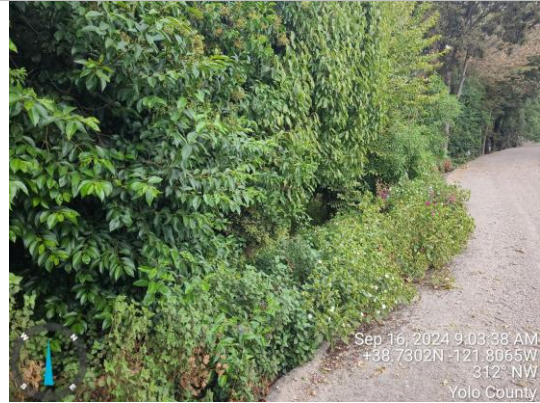
Photo 1 of 1 : FA_2024_ST0001_259_31_20240916_00064.jpg

View of vegetation blocking the landside slope. Fall 2024.

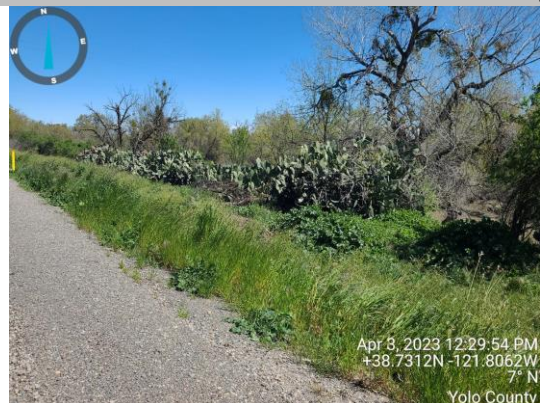
Photo 1 of 1 : FA_2024_ST0001_259_6_20240909_00001.jpg

View of cactus on the waterside slope. Spring 2023.

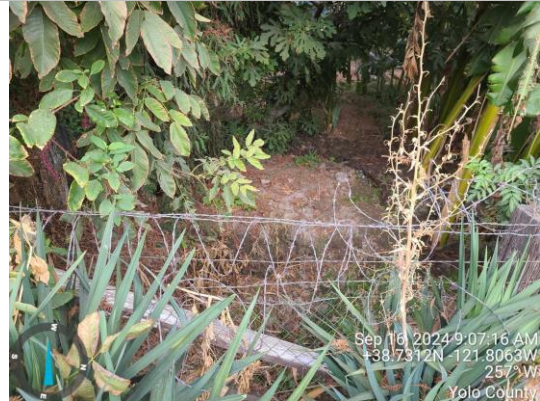
Photo 1 of 2 : FA_2024_ST0001_259_35_20240916_00065.jpg

Current view of the hole within the landside easement. Fall 2024.

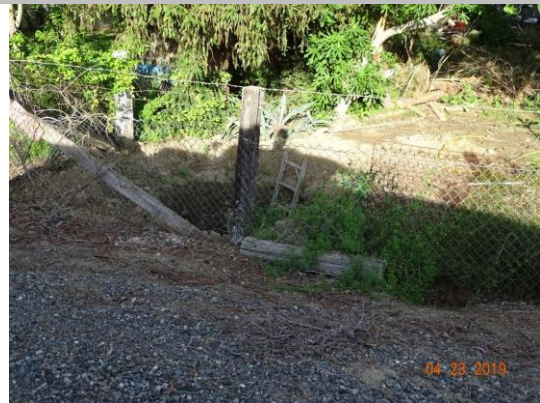
Photo 2 of 2 : FA_2024_ST0001_259_35_20240909_00018.jpg

View of the hole within the landside easement. Spring 2019.

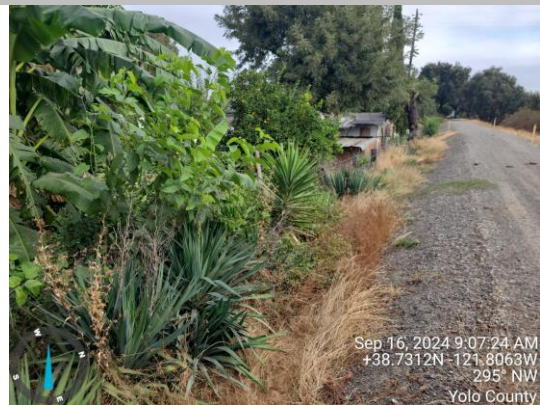
Photo 1 of 1 : FA_2024_ST0001_259_42_20240916_00066.jpg

LM Start	1.99	Rating **	M	Issue No.	42
LM End	2.02	Issue Type +	En	Location *	LS
Category	Earthen Levee			GPS Latitude/Longitude	
				Start	End
Item	Vegetation			38.731219 °	38.731640 °
				-121.806204 °	-121.806027 °
DWR ID	DWR_ST0001_01_f_2024_42				
Comment Code					
V6 : Landscaping					
Inspector Comment

View of landscaping on the landside slope. Fall 2024.

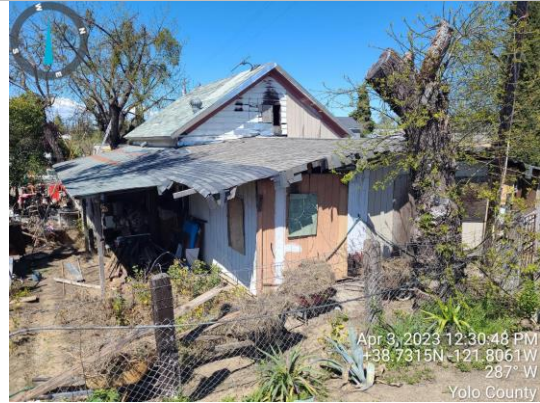
Photo 1 of 1 : FA_2024_ST0001_259_8_20240909_00002.jpg

View of building within landside easement. Spring 2023.

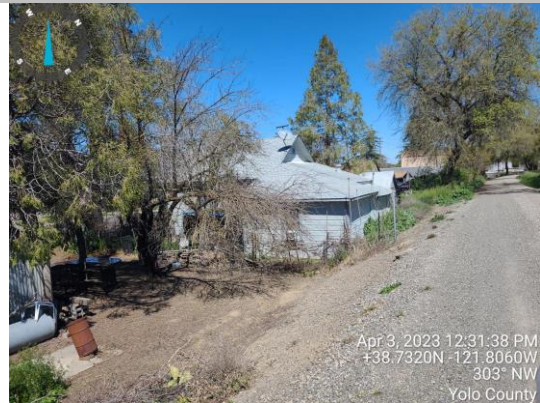
Photo 1 of 1 : FA_2024_ST0001_259_10_20240909_00003.jpg

View of house within landside easement. Spring 2023.

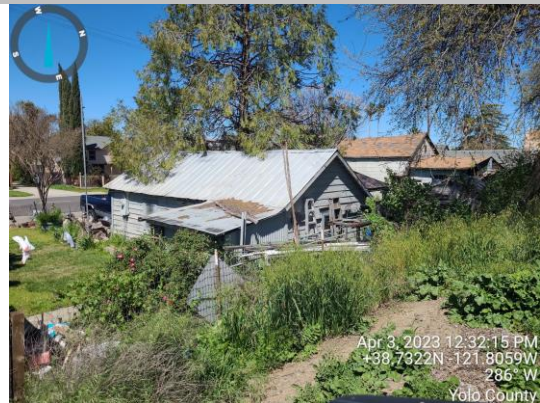
Photo 1 of 1 : FA_2024_ST0001_259_11_20240909_00004.jpg

View of building within landside easement. Spring 2023.

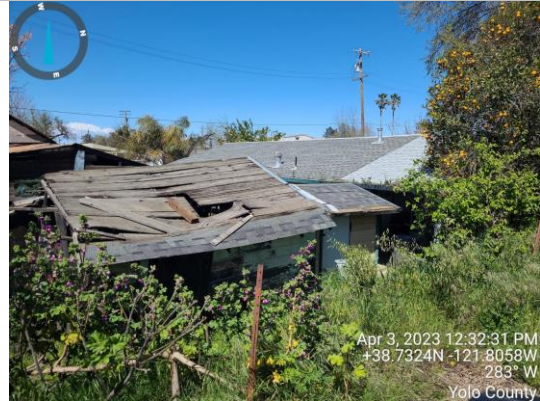
Photo 1 of 1 : FA_2024_ST0001_259_13_20240909_00006.jpg

View of building within landside easement. Spring 2023.

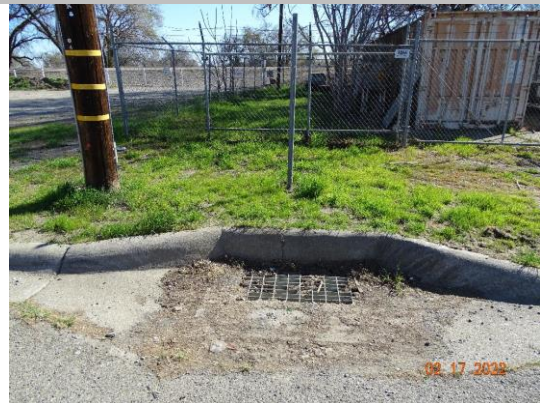
Photo 3 of 3 : UCIP_FA_2024_72523_108545.jpg

Comment Code					
Inspector Comment					
DS_ID:16269 FS_ID:72523 EP_NO: 13077A Repair Type: Non-Urgent EVAL Issue: 5, Pipe Damage Crossing Status: Found UCIP Comments: 09/23/2024 DMP internal video inspection has found moderate pipe defects. Crossing will be monitored until funding becomes available for rehabilitation. (O. Yakimov - DWR UCIP) 02/17/2022 Record remains No Action Needed. No issues observed during inspection. (O.Yakimov - DWR UCIP) 11/16/18 SMY Ted Skidgel W/S brush needs cleared FIELD_STRUCT_DESC: 30-inch square cast-in-place reinforced concrete drainage conduit through the levee, 19 feet below the crown. Screw gate on the waterside (WS) slope. Gate riser structure approximately 4 feet off the WS levee shoulder. Flap gate on the 30-inch pipe end at the discharge structure. Grated drain in the street parallel to the levee. (Construction of a storm drainage system authorized under Permit No. 13077, 1981 - Yolo County). (Revision of initial permit to use 30-inch cast-in-place square conduit authorized under Permit No. 13077-A, 1981 - Yolo County DPW). [Additional Reference(s): DWR Levee Log, 1993 (HLM 2.06), listed as a pipe through levee]. FS Date: 2/17/2022 3:17:46 PM

Land-Side: Onle of the inlets of street drainage system in parallel to the levee street

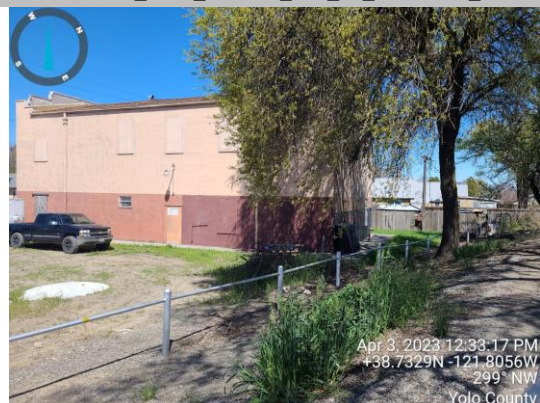
Photo 1 of 1 : FA_2024_ST0001_259_12_20240909_00005.jpg

View of building within landside easement. Spring 2023.

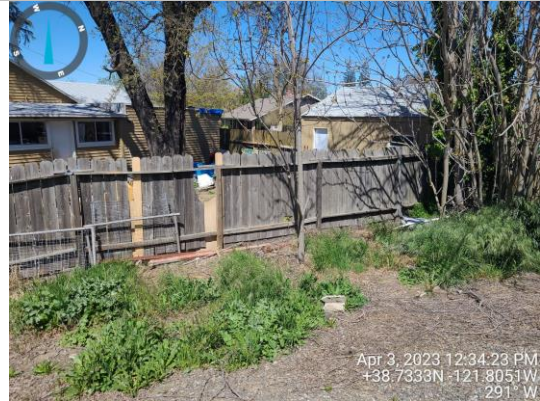
Photo 1 of 1 : FA_2024_ST0001_259_15_20240909_00007.jpg

View of the fence within landside easement. Spring 2023.

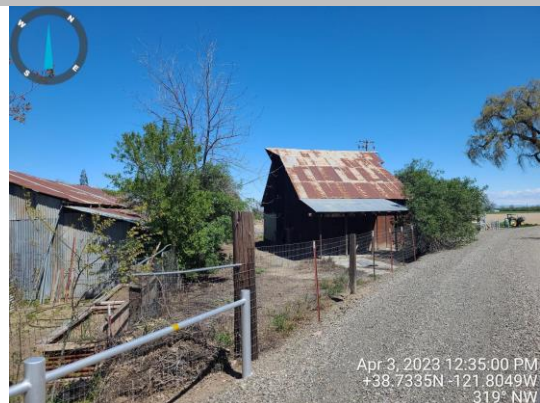
Photo 1 of 1 : FA_2024_ST0001_259_16_20240909_00008.jpg

View of horse barn and corral within landside easement. Spring 2023.

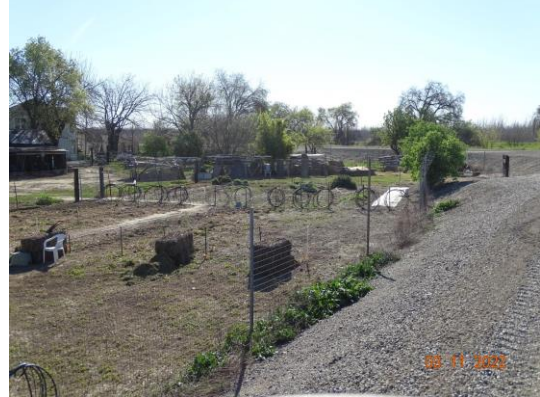
Photo 1 of 1 : FA_2024_ST0001_259_78_20240909_00032.jpg

Chain fence at the landside levee toe. Spring 2022.

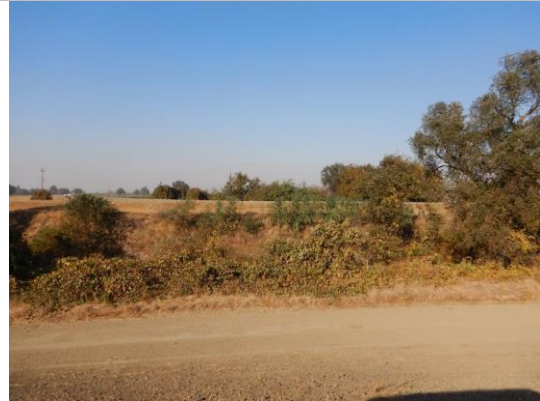
Photo 1 of 1 : FA_2024_ST0001_259_30_20240909_00014.jpg

LM Start	2.57	Rating **	A/W	Issue No.	30
LM End	2.61	Issue Type +	Ma	Location *	WS
Category	Supplemental			GPS Latitude/Longitude	
				Start	End
Item	2018 USACE Erosion Survey			38.732836 °	38.732685 °
				-121.797893 °	-121.797154 °
DWR ID	DWR_ST0001_01_s_2022_30				
Comment Code					
Inspector Comment					
2018 Site ID: CHC 2.4 L					
Status: Critical					
2018 Field Notes: No observed change.					
Site History: Site identified as CRITICAL in 2002. 2006 - Currently constructing a setback levee. New failures present and extensive. Downstream end of the setback levee did not extend far enough. Upstream end was repaired. 2007 - DWR repaired with a setback levee, but the levee did not go far enough downstream. 2012 - New cracks observed. 2013 - Fresh erosion on upper bank.

USACE 2018 Erosion Photo #1

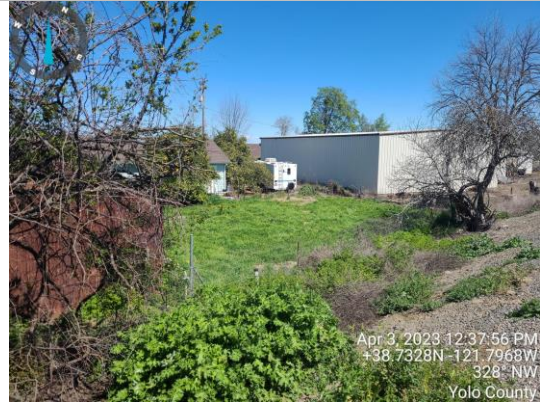
Photo 1 of 1 : FA_2024_ST0001_259_77_20240909_00031.jpg

View of wire fence on landside easement. Spring 2023.

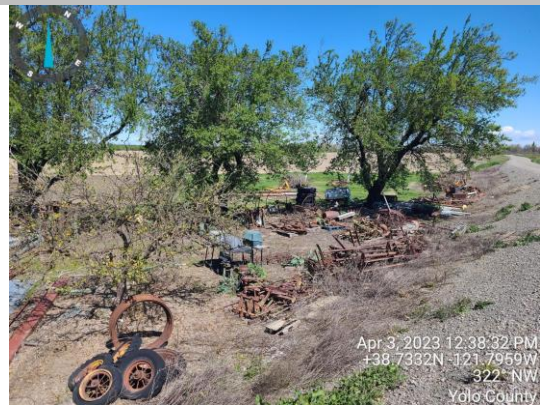
Photo 1 of 1 : FA_2024_ST0001_259_71_20240909_00030.jpg

View of equipment on landside toe. Spring 2023.

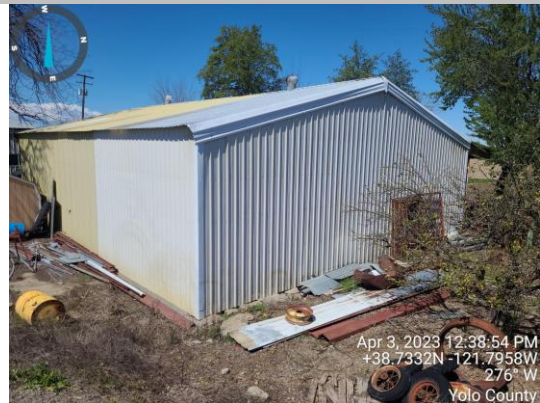
Photo 1 of 1 : FA_2024_ST0001_259_20_20240909_00009.jpg

View of building on landside easement. Spring 2023.

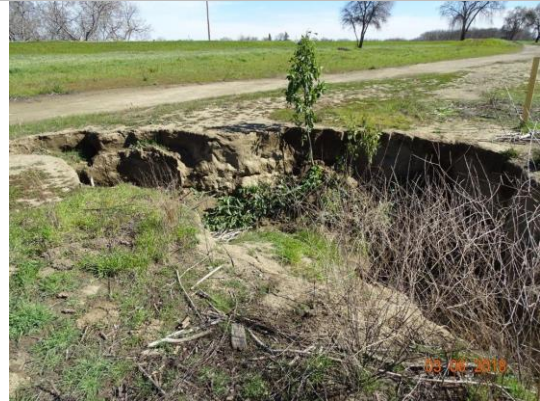
Photo 1 of 2 : FA_2024_ST0001_259_62_20240909_00027.jpg

View of erosion looking towards the landside levee slope, facing northeast. Spring 2018.

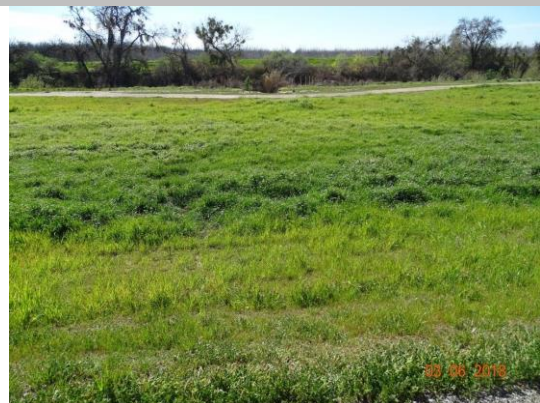
Photo 2 of 2 : FA_2024_ST0001_259_62_20240909_00028.jpg

View of erosion from levee crown, facing Cache Creek. Fall 2018.

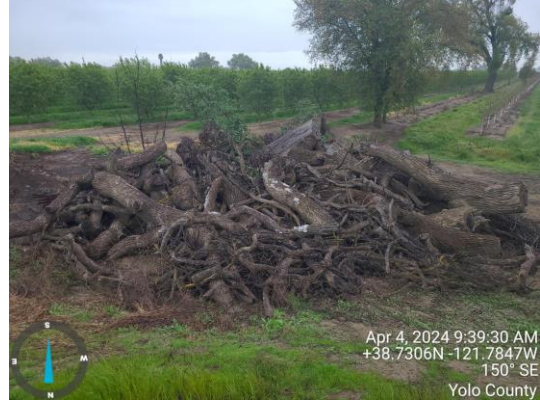
Photo 1 of 1 : FA_2024_ST0001_259_43_20240909_00023.jpg

View of tree at the landside toe. Spring 2024.

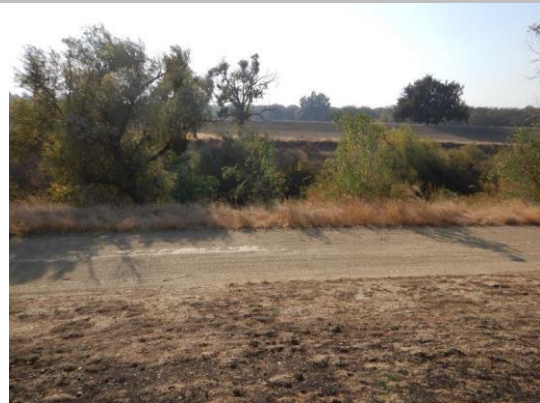
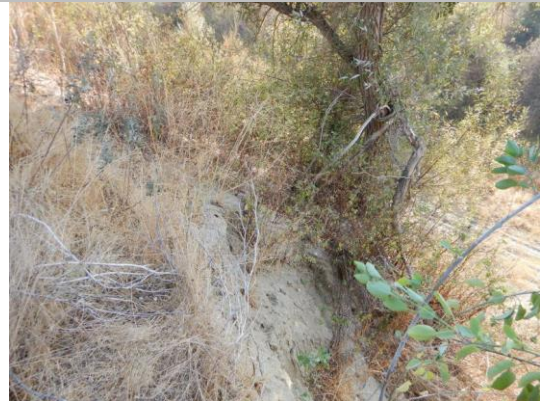
LM Start	3.71	Rating **	A/W	Issue No.	41
LM End	3.74	Issue Type +	Ma	Location *	WS
Category	Supplemental			GPS Latitude/Longitude	
				Start	End
Item	2018 USACE Erosion Survey			38.729664 °	38.729322 °
				-121.784222 °	-121.783842 °
DWR ID	DWR_ST0001_01_s_2022_41				
Comment Code					
Inspector Comment					
2018 Site ID: CHC 3.6 L					
Status: Eroding New					
2018 Field Notes: Erosion of entire bank slope. Possible tree popout.					
Slumping cracks along berm.					
Site History:

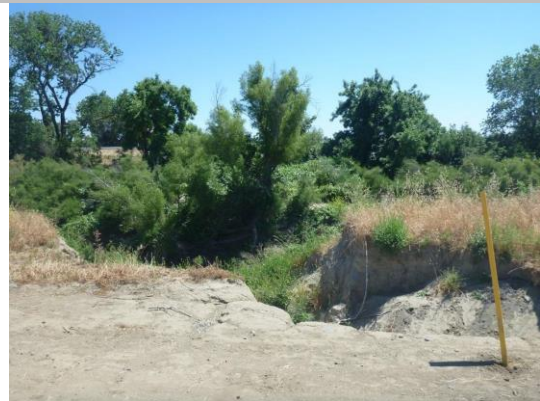
Photo 2 of 2 : LEVAL_FA_2024_249_959.jpg

View of erosion near waterside toe road.

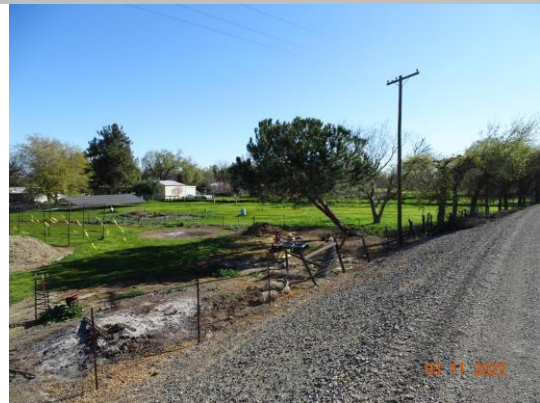
Photo 1 of 1 : FA_2024_ST0001_259_52_20240909_00026.jpg

Barbed wire fence at the landside levee toe. Spring 2022.

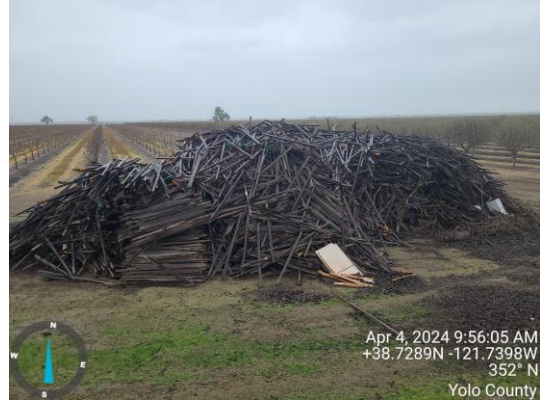
Photo 1 of 1 : FA_2024_ST0001_259_47_20240909_00024.jpg

View of debris pile at the landside toe. Spring 2024.

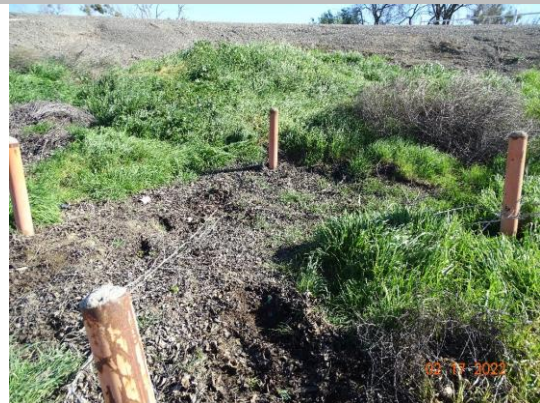
Photo 3 of 3 : UCIP_FA_2024_72622_108797.jpg

Comment Code					
Inspector Comment					
DS_ID:25072 FS_ID:72622 EP_NO: 7668 Repair Type: Non-Urgent EVAL Issue: 11, Maintenance Compliance Issue Crossing Status: Indicator Found UCIP Comments: 02/17/2022 Record is Non-Urgent. Manholes covered with debris. Markers are not installed on any side of levee. (O.Yakimov - DWR UCIP) FIELD_STRUCT_DESC: 4-inch telephone conduit of an unknown material through both levees and under Cache Creek, 6 feet below the crown. Conduit runs 10 feet west along County Road 102. Manhole just off the landside toe next to CO RD 102. (Telephone conduit authorized under Permit No. 7668, 1971 - Pacific Telephone and Telegraph Company [PT&T]). [Additional Reference(s): DWR Levee Log, 1993 (HLM 7.21)]. FS Date: 2/17/2022 11:22:31 AM

Land-Side: Manholes covered with vegetation and debris

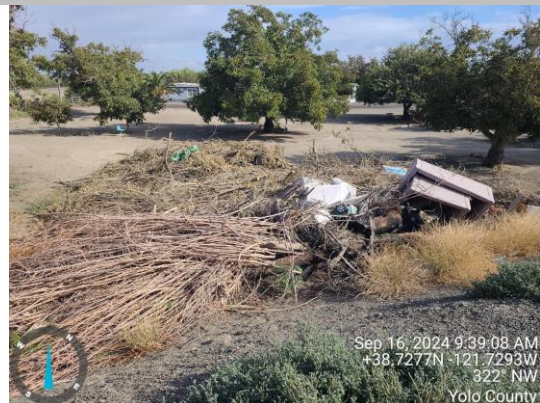
Photo 1 of 1 : FA_2024_ST0001_259_49_20240916_00067.jpg

View of debris pile at the landside toe. Fall 2024.

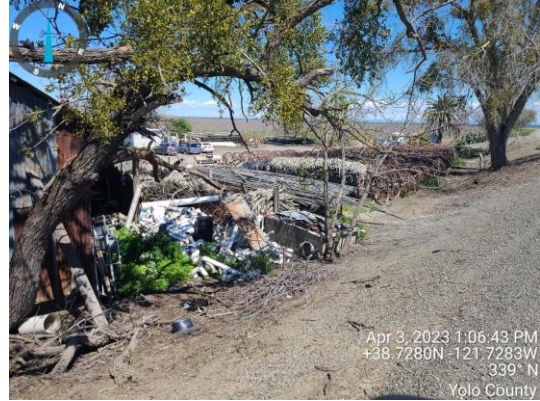
Photo 1 of 1 : FA_2024_ST0001_259_40_20240909_00020.jpg

View of equipment on landside toe. Spring 2023.

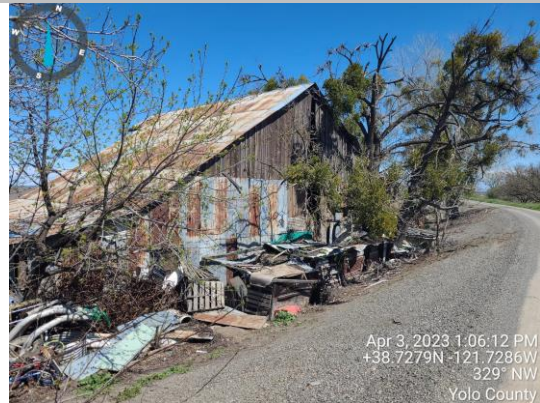
Photo 1 of 1 : FA_2024_ST0001_259_39_20240909_00019.jpg

View of building within landside easement. Spring 2023.

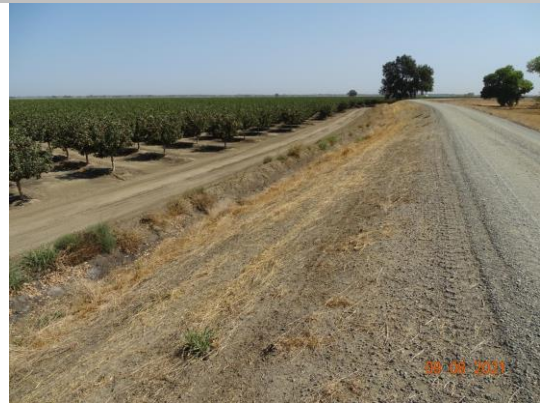
Photo 1 of 1 : FA_2024_ST0001_259_26_20240909_00012.jpg

View of ditch at landside toe. Fall 2021.

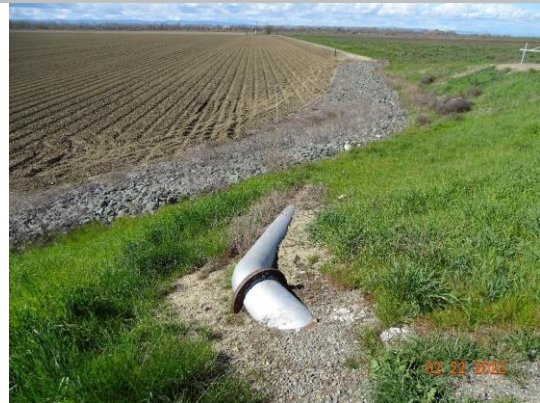
Photo 2 of 3 : UCIP_FA_2024_72789_109242.jpg

Water-Side: View of levee slope looking from crown. Pipe daylights on levee slope

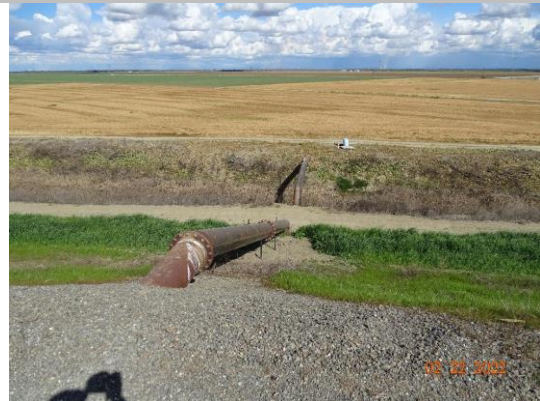
Photo 1 of 3 : UCIP_FA_2024_72795_109251.jpg

Land-Side: View of levee slope looking from crown. Pipe on the slope and over irrigation ditch

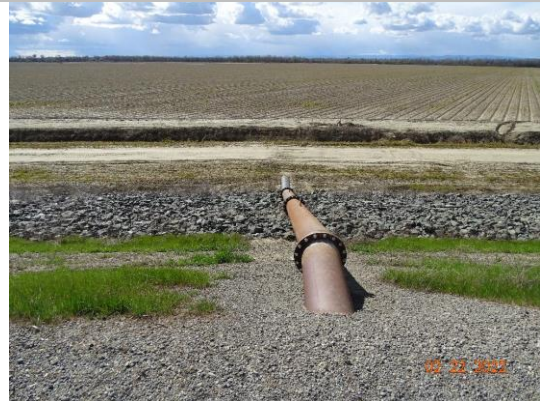
Photo 3 of 3 : UCIP_FA_2024_72795_109255.jpg

Water-Side: View of levee slope looking from crown. Pipe on levee slope

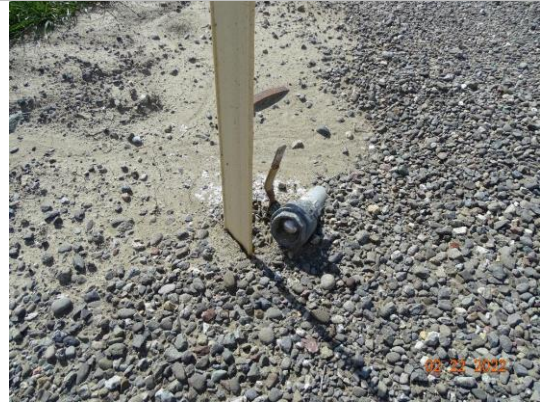
Photo 2 of 3 : UCIP_FA_2024_72797_109261.jpg

Water-Side: Air vent on levee shoulder

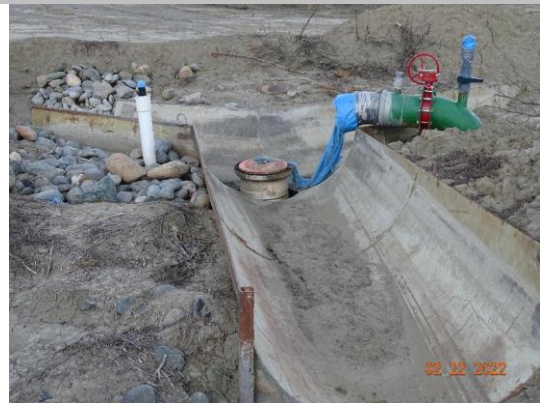
Photo 3 of 3 : UCIP_FA_2024_72797_109262.jpg

Water-Side: Capped pipe at irrigation ditch

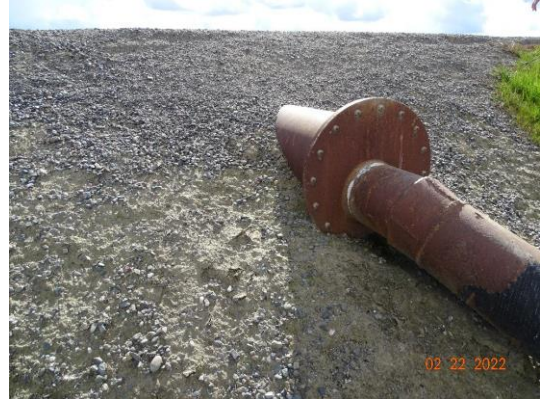
Photo 3 of 3 : UCIP_FA_2024_72802_109277.jpg

Land-Side: 11--inch pipe welder to flange joint on levee slope

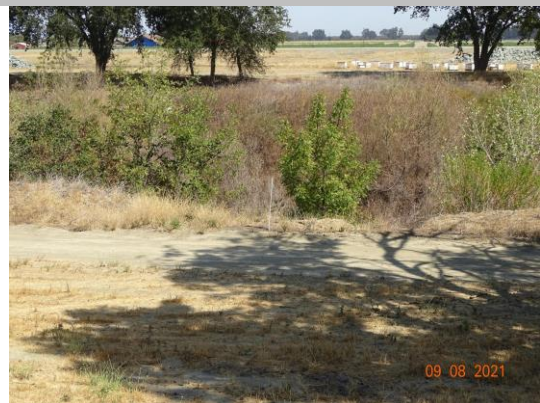
Photo 1 of 1 : FA_2024_ST0001_260_16_20240909_00012.jpg

View of erosion on waterside toe road. Fall 2021.

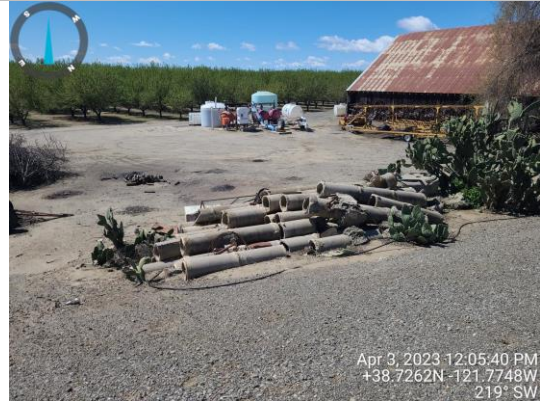
Photo 1 of 1 : FA_2024_ST0001_260_3_20240909_00004.jpg

View of pipes on the landside toe. Spring 2023.

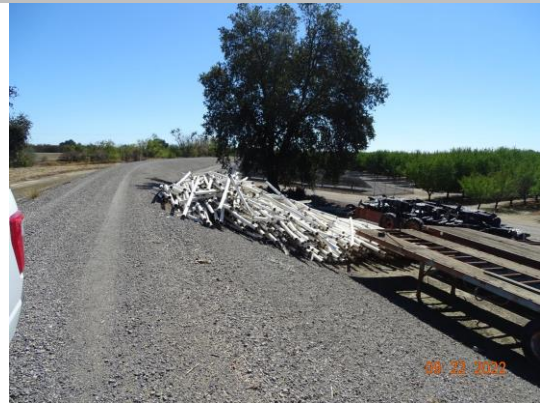
Photo 1 of 1 : FA_2024_ST0001_260_29_20240909_00018.jpg

View of equipment on the landside shoulder. Fall 2022.

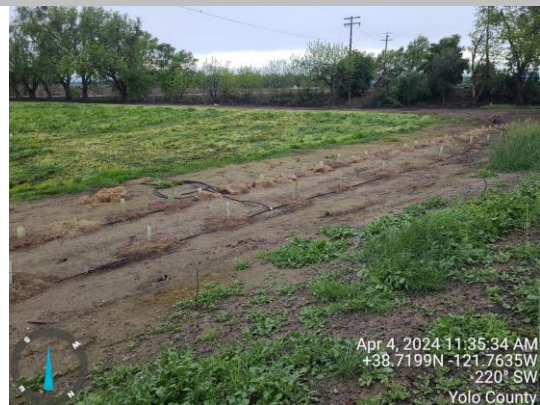
Photo 1 of 1 : FA_2024_ST0001_260_13_20240909_00010.jpg

View of plantings and drip system. Spring 2024.

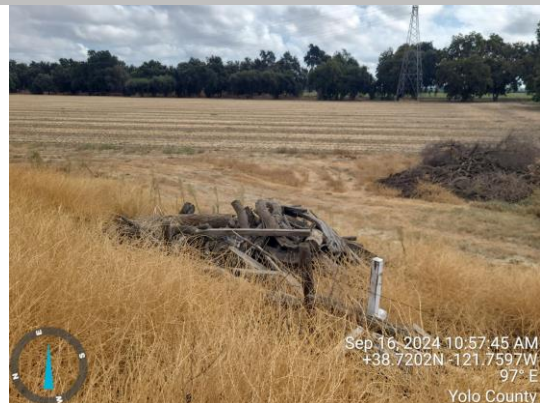
Photo 1 of 1 : FA_2024_ST0001_260_17_20240916_00023.jpg

View of firewood pile. Fall 2024.

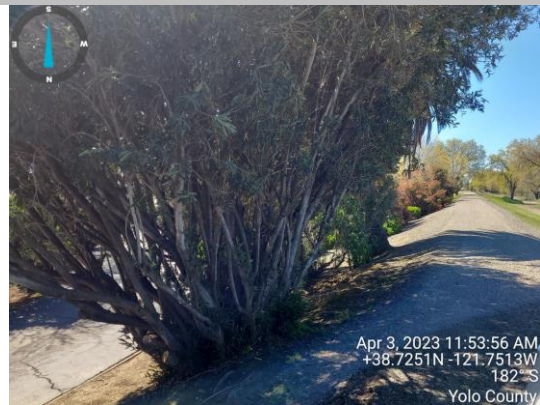
Photo 1 of 1 : FA_2024_ST0001_260_9_20240909_00007.jpg

View of vegetation on the landside slope. Spring 2023.

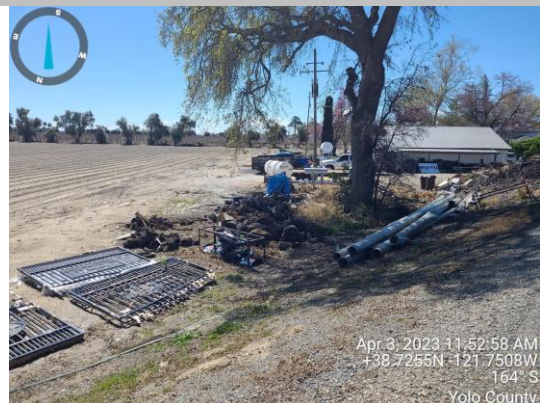
Photo 1 of 1 : FA_2024_ST0001_260_28_20240909_00017.jpg

View of equipment on the landside toe. Spring 2023.

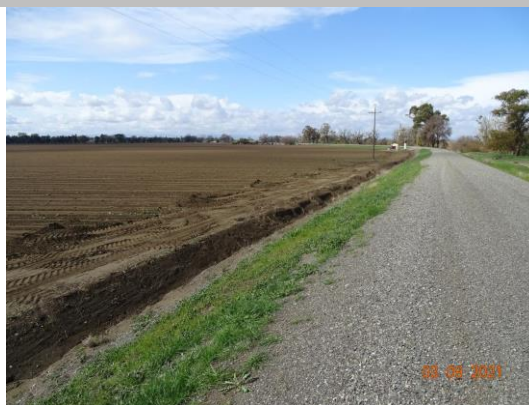
Photo 1 of 1 : FA_2024_ST0001_260_1_20240909_00001.jpg

View of irrigation ditch at the landside toe. Spring 2021.

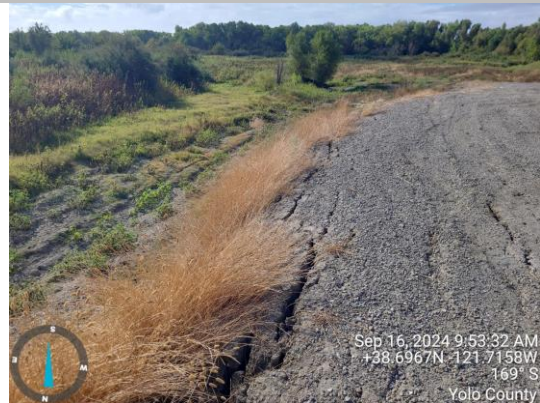
Photo 1 of 1 : FA_2024_ST0001_261_3_20240916_00001.jpg

View of bank caving on the landside slope. Fall 2024.
