**Flood Control Project Maintenance
Levee Inspections
LMA District Cover Sheet
Spring 2010 Levee Inspection Results**

Sacramento Maintenance Yard Cache Creek

Spring 2010 Levee Inspection Results

Waterway	Bank	Unit Miles
Unit No. 01 North Levee	Left	11.81

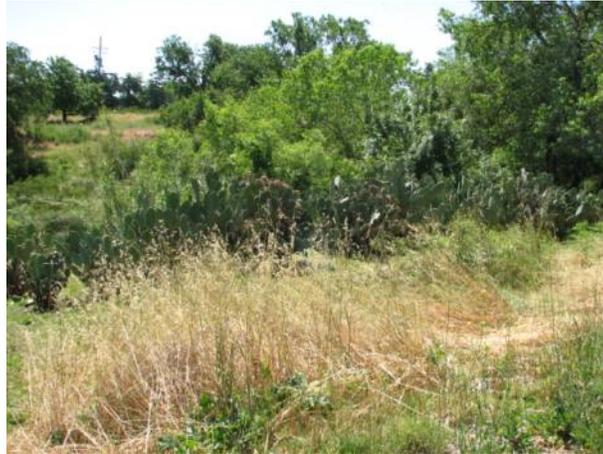
Levee Mile Report Line	8
Start Levee Mile	1.96
End Levee Mile	1.99
Location	Water Side
Category	Earthen Levee
Item	Encroachments
cactus garden	
johngw_s_20100512_152.jpg

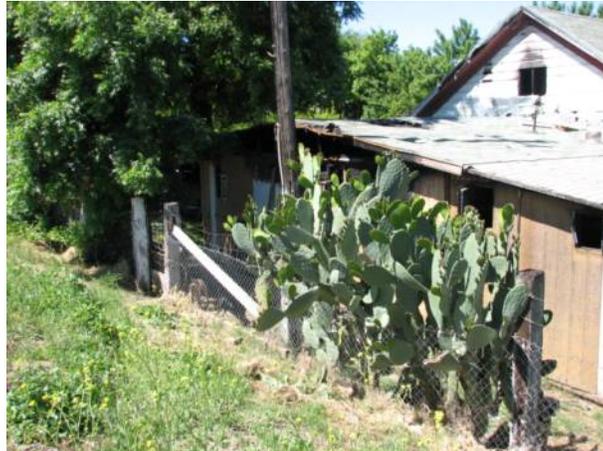
Levee Mile Report Line	10
Start Levee Mile	1.98
End Levee Mile	1.98
Location	Land Side
Category	Earthen Levee
Item	Encroachments
building and catus landside, town of Yolo	
johngw_s_20100512_153.jpg

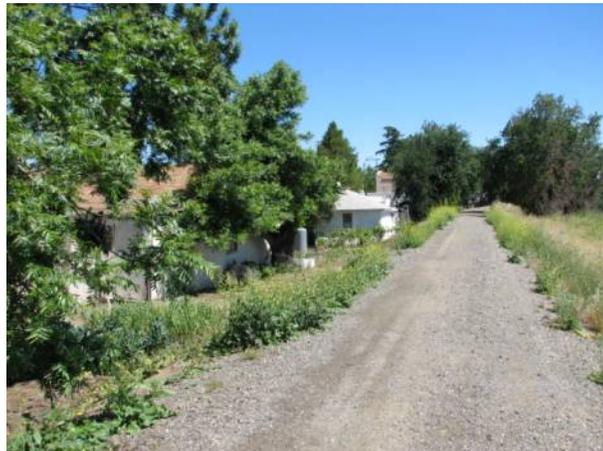
Levee Mile Report Line	11
Start Levee Mile	2.01
End Levee Mile	2.01
Location	Land Side
Category	Earthen Levee
Item	Encroachments
general photo of homes in the town of Yolo	
johngw_s_20100512_154.jpg

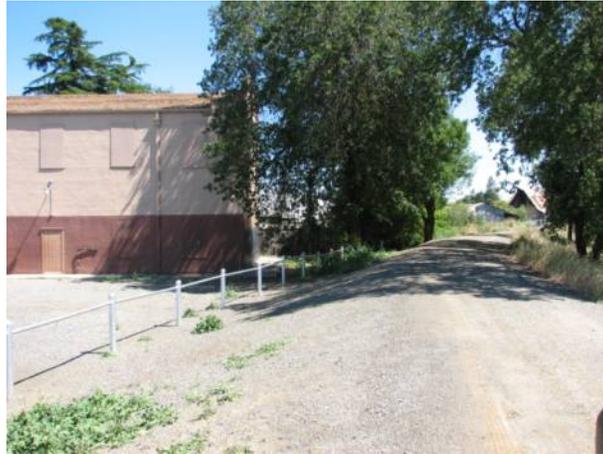
Levee Mile Report Line	14
Start Levee Mile	2.05
End Levee Mile	2.05
Location	Land Side
Category	Earthen Levee
Item	Encroachments
building close to toe	
johngw_s_20100512_155.jpg

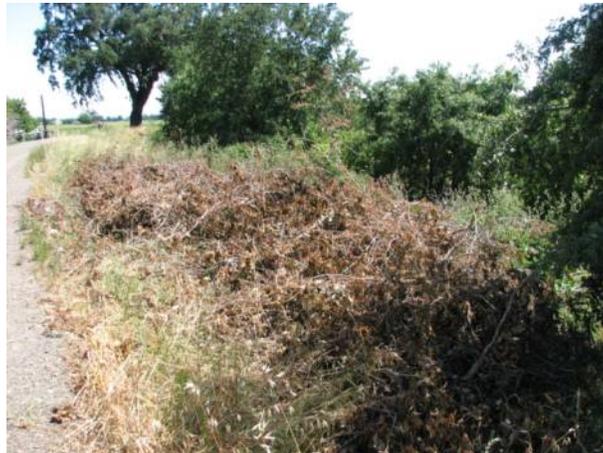
Levee Mile Report Line	18
Start Levee Mile	2.12
End Levee Mile	2.15
Location	Water Side
Category	Earthen Levee
Item	Encroachments
pile of prunings on waterside shoulder	
johngw_s_20100512_156.jpg

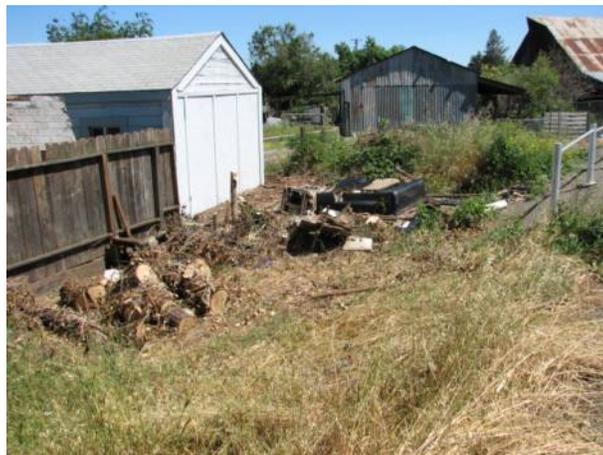
Levee Mile Report Line	19
Start Levee Mile	2.12
End Levee Mile	2.12
Location	Land Side
Category	Earthen Levee
Item	Encroachments
tree cut down and debris behind home	
johngw_s_20100512_157.jpg

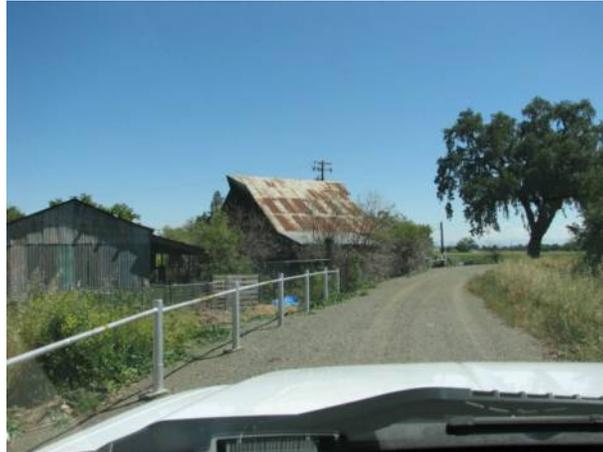
Levee Mile Report Line	20
Start Levee Mile	2.15
End Levee Mile	2.15
Location	Land Side
Category	Earthen Levee
Item	Encroachments
horse barn and corral	
johngw_s_20100512_158.jpg

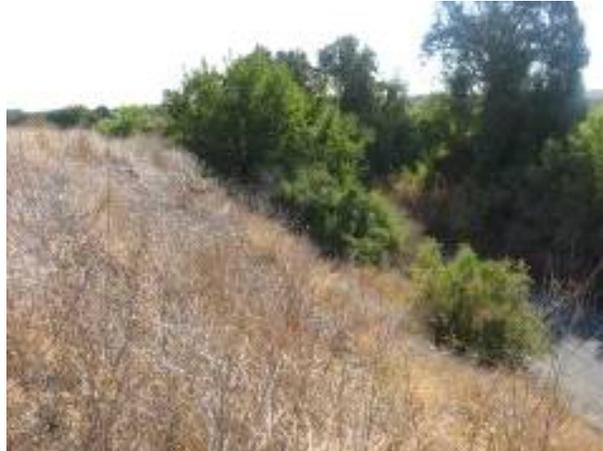
Levee Mile Report Line	21
Start Levee Mile	2.54
End Levee Mile	2.58
Location	Water Side
Category	Supplemental
Item	USACE Erosion Survey
2009: 15 ft berm, 1.5:1 slope, tree hazards, holes, and slumping, sands and silts, 4 ft/s [2009 SiteID:CHC_2-4_L]	
USACE2009_CHC_2-4_L_2009_09_23-D8P19_small.JPG

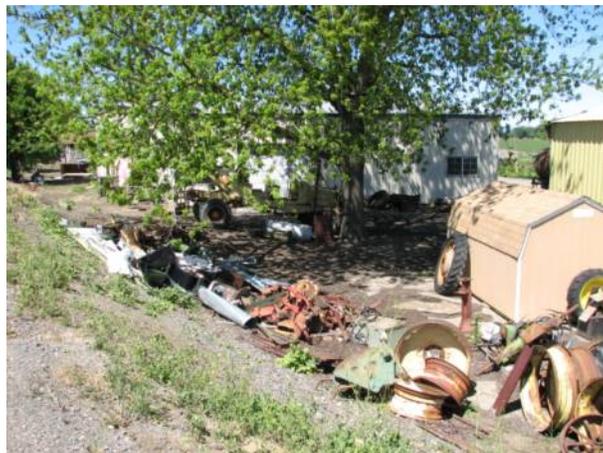
Levee Mile Report Line	22
Start Levee Mile	2.60
End Levee Mile	2.60
Location	Land Side
Category	Earthen Levee
Item	Encroachments
building and parts of tractors	
johngw_s_20100512_159.jpg

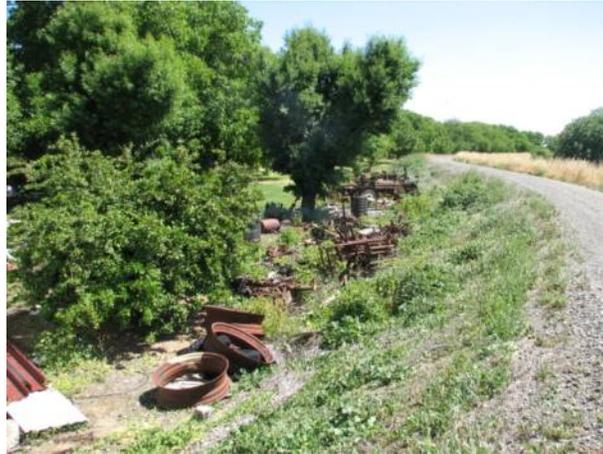
Levee Mile Report Line	24
Start Levee Mile	2.65
End Levee Mile	2.70
Location	Land Side
Category	Earthen Levee
Item	Encroachments
equipment and parts	
johngw_s_20100512_160.jpg

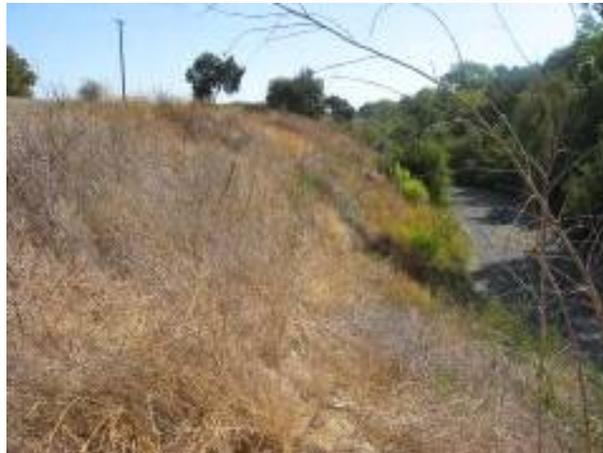
Levee Mile Report Line	27
Start Levee Mile	2.79
End Levee Mile	2.83
Location	Water Side
Category	Supplemental
Item	USACE Erosion Survey
2009: 15 ft berm, 1:1 slope, slumping, sands and silts, 5.89 ft/s [2009 SiteID:CHC_2-8_L]	
USACE2009_CHC_2-8_L_2009_09_23-D8P18_small.JPG

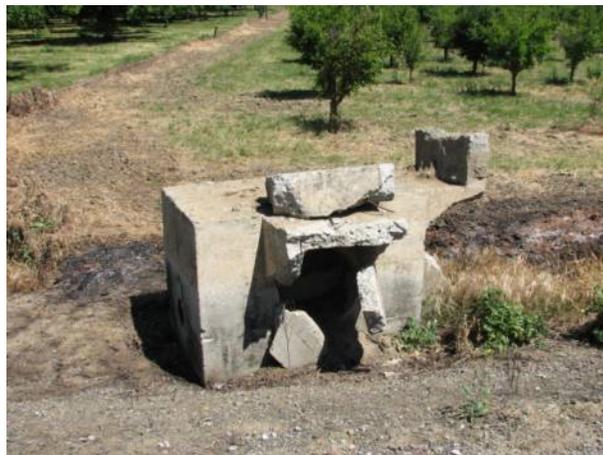
Levee Mile Report Line	28
Start Levee Mile	2.86
End Levee Mile	2.86
Location	Land Side
Category	Earthen Levee
Item	Encroachments
concrete debris	
johngw_s_20100512_161.jpg

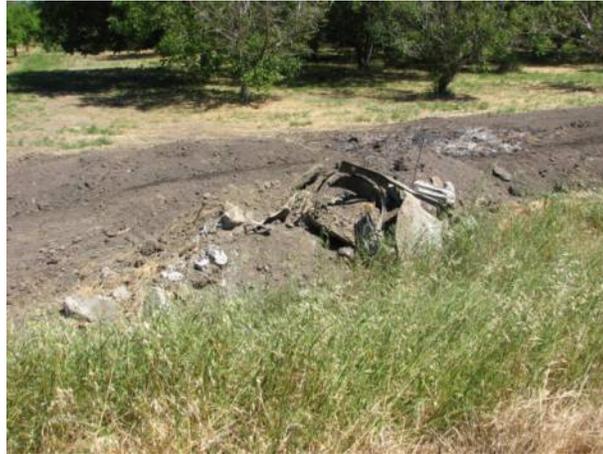
Levee Mile Report Line	30
Start Levee Mile	3.06
End Levee Mile	3.06
Location	Land Side
Category	Earthen Levee
Item	Encroachments
old burn pile left over debris	
johngw_s_20100512_162.jpg

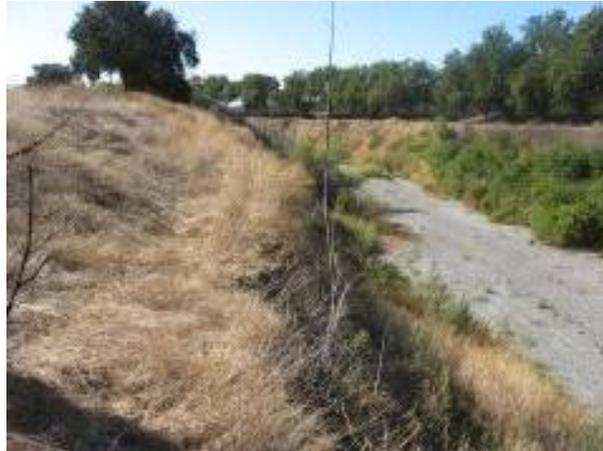
Levee Mile Report Line	31
Start Levee Mile	3.46
End Levee Mile	3.52
Location	Water Side
Category	Supplemental
Item	USACE Erosion Survey
2009: 15 ft berm, 1:1 slope, holes and slumping, sands and silts, 6.5 ft/s [2009 SiteID:CHC_3-4_L]	
USACE2009_CHC_3-4_L_2009_09_23-D8P17_small.JPG

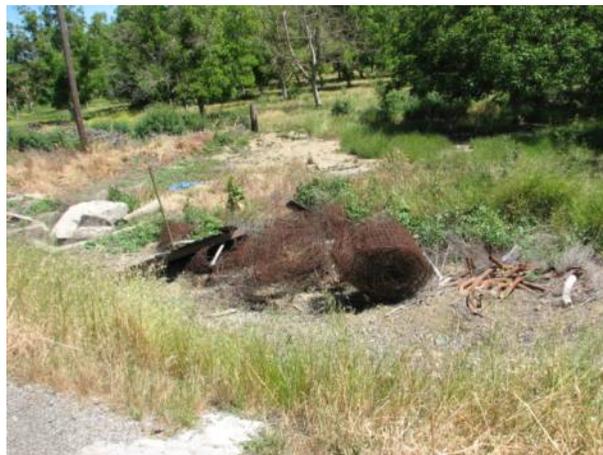
Levee Mile Report Line	33
Start Levee Mile	3.64
End Levee Mile	3.64
Location	Land Side
Category	Earthen Levee
Item	Encroachments
Trash dumped	
johngw_s_20100512_163.jpg

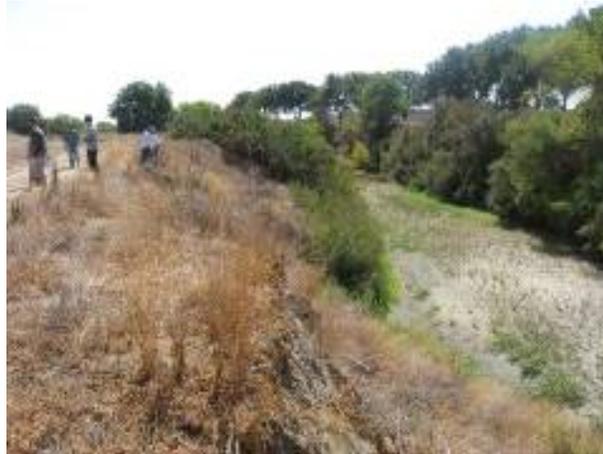
Levee Mile Report Line	34
Start Levee Mile	3.86
End Levee Mile	3.94
Location	Water Side
Category	Supplemental
Item	USACE Erosion Survey
2009: 10 ft berm, 1:1 slope, tree hazards and holes, sands and silts, 6 ft/s [2009 SiteID:CHC_3-9_L] USACE2009_CHC_3-9_L_2009_09_23-D8P16_small.JPG

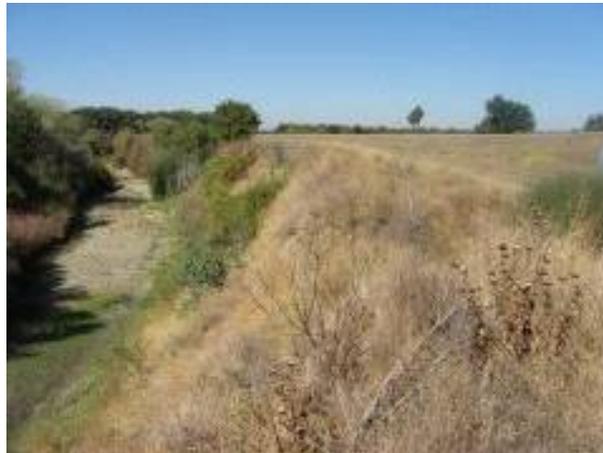
Levee Mile Report Line	35
Start Levee Mile	4.13
End Levee Mile	4.27
Location	Water Side
Category	Supplemental
Item	USACE Erosion Survey
2009: 3 ft berm, 1.5:1 slope, tree hazards and holes, sands and silts, 4 ft/s [2009 SiteID:CHC_4-2_L] USACE2009_CHC_4-2_L_2009_09_23-D8P12_small.JPG

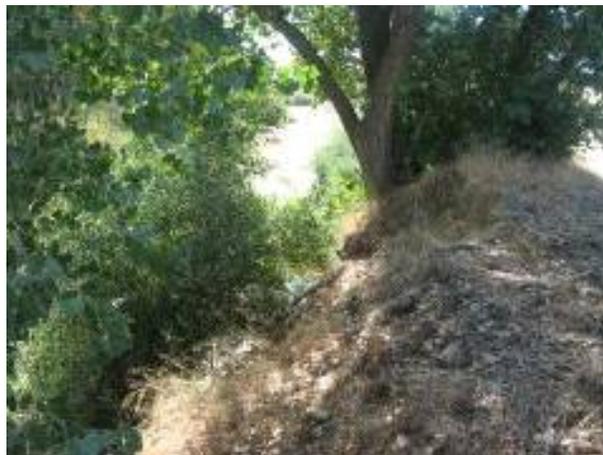
Levee Mile Report Line	38
Start Levee Mile	5.33
End Levee Mile	5.37
Location	Water Side
Category	Supplemental
Item	USACE Erosion Survey
2009: 15 ft berm, vertical slope, tree hazards, holes, and slumping, sands and silts, 9.39 ft/s [2009 SiteID:CHC_5-4_L] USACE2009_CHC_5-4_L_2009_09_23-D8P15_small.JPG

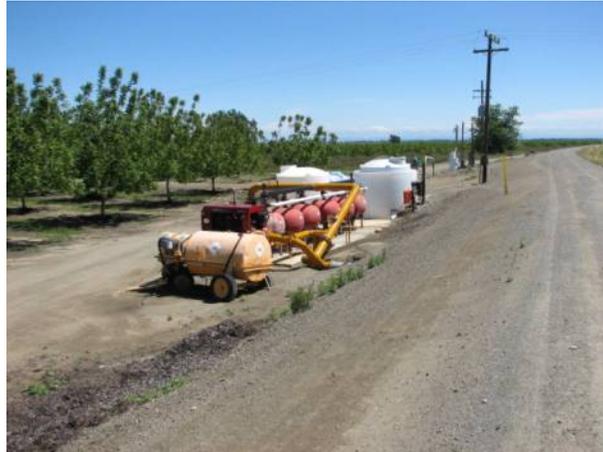
40	6.31	6.31	Earthen Levee	Encroachments	LS	PO	Tank Inspector Comments: filter tanks, concrete, slab fertilizer tanks and pipe through levee, no permit for pipe	38.728084 ° -121.746597 °	38.728084 ° -121.746597 °	31 Y
41	6.36	6.70	Earthen Levee	Encroachments	LS	PO	Agricultural Ditch	38.728372 ° -121.745548 °	38.728755 ° -121.739567 °	32
42	6.94	7.23	Earthen Levee	Encroachments	LS	PO	Agricultural Ditch	38.728372 ° -121.745547 °	38.727486 ° -121.730251 °	912 Y
43	7.29	7.29	Earthen Levee	Encroachments	LS	M	Prunings	38.727766 ° -121.729207 °	38.727766 ° -121.729207 °	915 Y
44	7.33	7.38	Earthen Levee	Encroachments	LS	M	Equipment	38.727878 ° -121.728553 °	38.728085 ° -121.727740 °	40 Y
45	7.33	7.33	Earthen Levee	Encroachments	LS	PO	Buildings	38.727870 ° -121.728527 °	38.727870 ° -121.728527 °	39 Y
46	7.40	8.03	Earthen Levee	Encroachments	LS	PO	Agricultural Ditch	38.728181 ° -121.727452 °	38.727199 ° -121.716907 °	913

Levee Mile Report Line	40
Start Levee Mile	6.31
End Levee Mile	6.31
Location	Land Side
Category	Earthen Levee
Item	Encroachments
pipe trough levee filterand fertilizer tanks	
johnngw_s_20100512_164.jpg

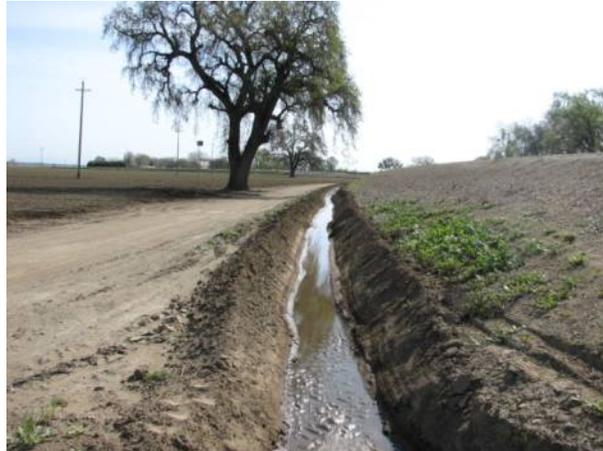
Levee Mile Report Line	42
Start Levee Mile	6.94
End Levee Mile	7.23
Location	Land Side
Category	Earthen Levee
Item	Encroachments
new ditch this spring	
johnngw_s_20100316_041.jpg

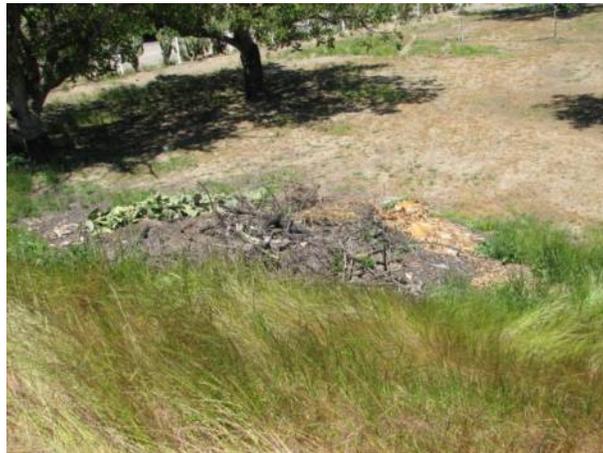
Levee Mile Report Line	43
Start Levee Mile	7.29
End Levee Mile	7.29
Location	Land Side
Category	Earthen Levee
Item	Encroachments
trash and burn pile	
johnngw_s_20100512_165.jpg

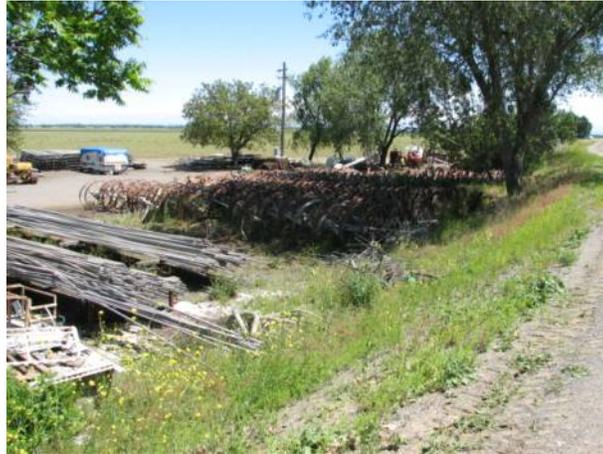
Levee Mile Report Line	44
Start Levee Mile	7.33
End Levee Mile	7.38
Location	Land Side
Category	Earthen Levee
Item	Encroachments
irrigation equipment	
johngw_s_20100512_166.jpg

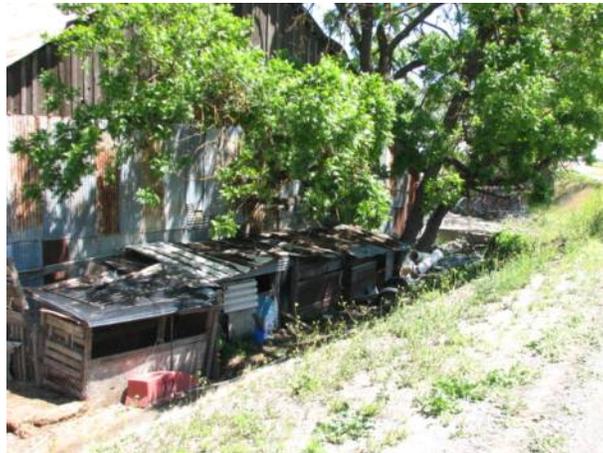
Levee Mile Report Line	45
Start Levee Mile	7.33
End Levee Mile	7.33
Location	Land Side
Category	Earthen Levee
Item	Encroachments
barn and livestock pins	
johngw_s_20100512_167.jpg

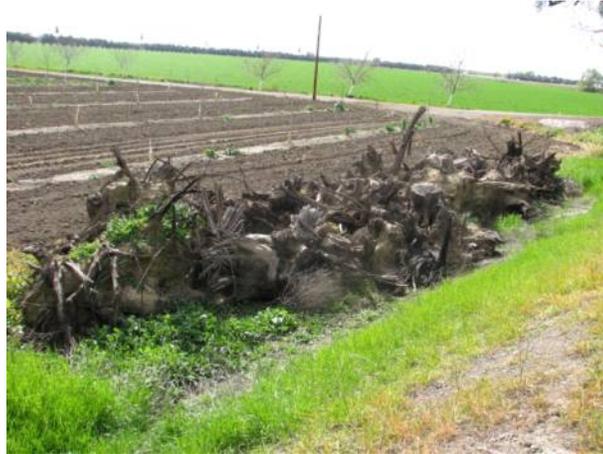
Levee Mile Report Line	3
Start Levee Mile	0.18
End Levee Mile	0.18
Location	Land Side
Category	Earthen Levee
Item	Encroachments
stumps against levee toe	
johngw_s_20100401_090.jpg

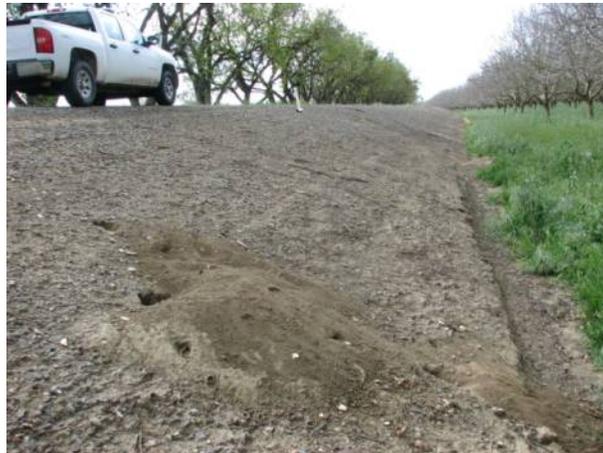
Levee Mile Report Line	6
Start Levee Mile	1.45
End Levee Mile	1.45
Location	Land Side
Category	Earthen Levee
Item	Animal Control
rodent activity	
johngw_s_20100401_091.jpg

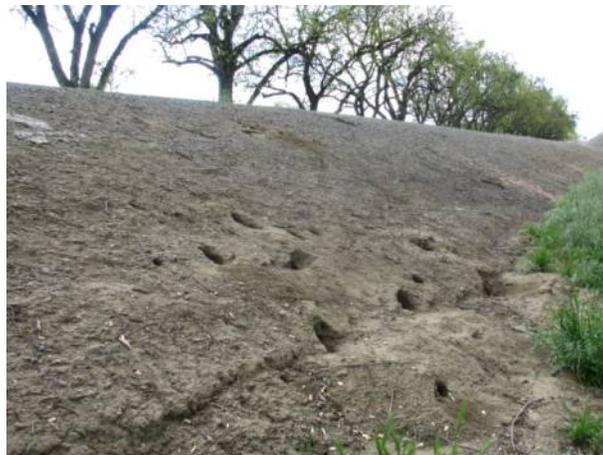
Levee Mile Report Line	6
Start Levee Mile	1.45
End Levee Mile	1.45
Location	Land Side
Category	Earthen Levee
Item	Animal Control
more holes bait station is in place	
johngw_s_20100401_092.jpg

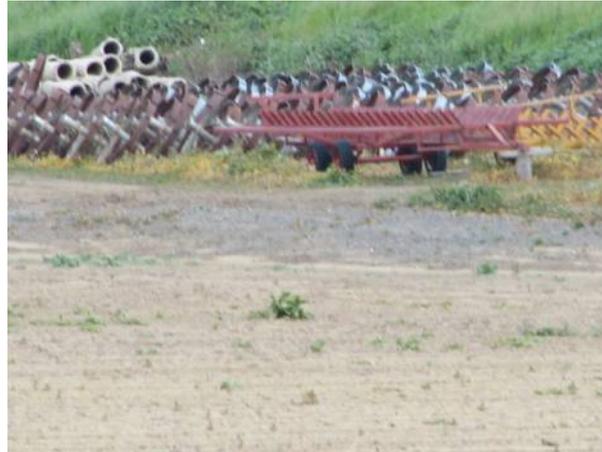
Levee Mile Report Line	9
Start Levee Mile	2.36
End Levee Mile	2.36
Location	Land Side
Category	Earthen Levee
Item	Encroachments
irrigation pipe	
johngw_s_20100401_093.jpg

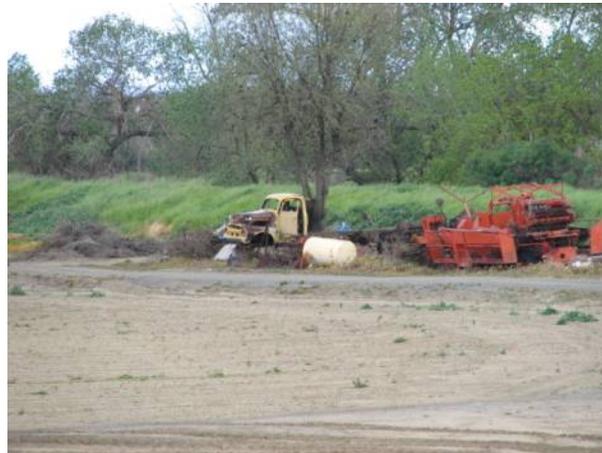
Levee Mile Report Line	10
Start Levee Mile	2.41
End Levee Mile	2.41
Location	Land Side
Category	Earthen Levee
Item	Encroachments
equipment next to toe	
johngw_s_20100401_094.jpg

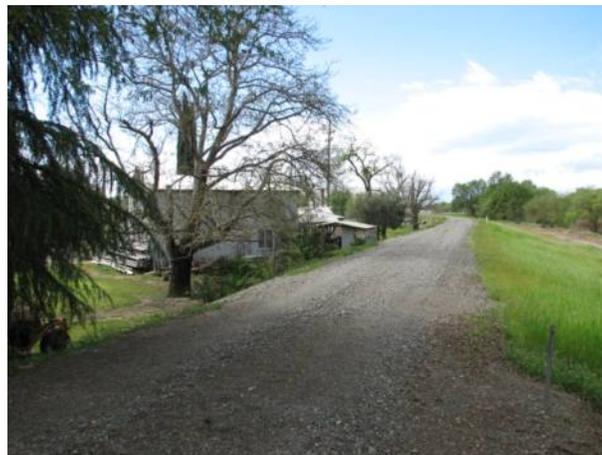
Levee Mile Report Line	15
Start Levee Mile	4.00
End Levee Mile	4.04
Location	Land Side
Category	Earthen Levee
Item	Encroachments
out building at toe	
johngw_s_20100401_095.jpg

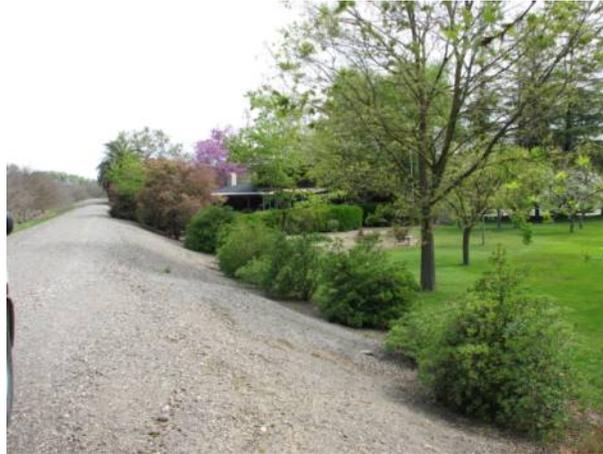
Levee Mile Report Line	16
Start Levee Mile	4.04
End Levee Mile	4.13
Location	Land Side
Category	Earthen Levee
Item	Encroachments
landscape	
johngw_s_20100401_096.jpg

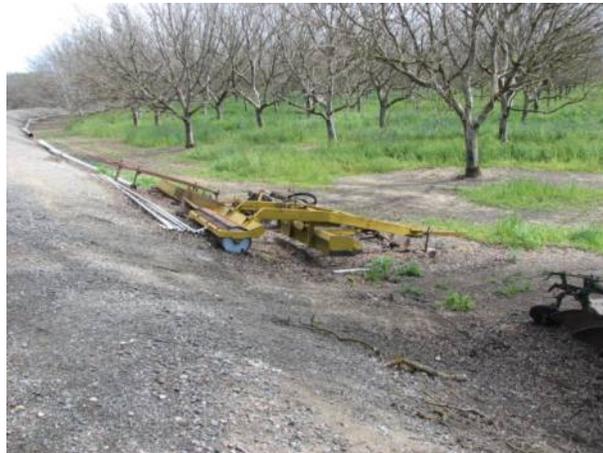
Levee Mile Report Line	17
Start Levee Mile	4.15
End Levee Mile	4.15
Location	Land Side
Category	Earthen Levee
Item	Encroachments
pipe run on toe along orchard	
johngw_s_20100401_097.jpg

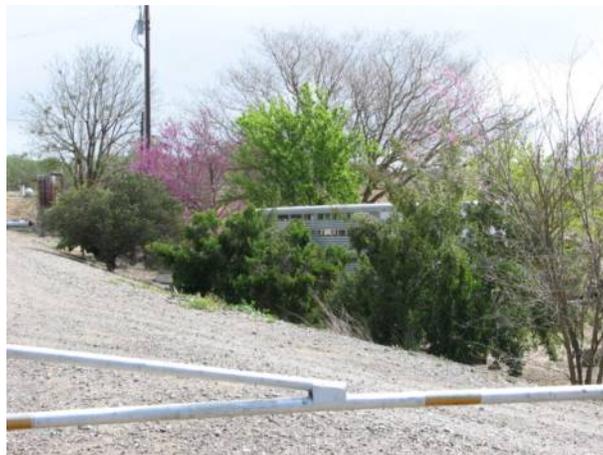
Levee Mile Report Line	18
Start Levee Mile	4.41
End Levee Mile	4.44
Location	Land Side
Category	Earthen Levee
Item	Encroachments
landscape on levee slope	
johngw_s_20100401_098.jpg

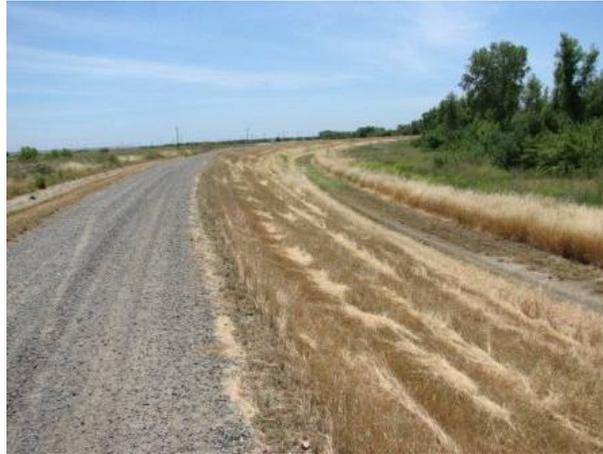
Levee Mile Report Line	1
Start Levee Mile	0.02
End Levee Mile	2.27
Location	Land Side
Category	Earthen Levee
Item	Vegetation
photo taken 6/8/2010 vegetation has been mowed	
johngw_s_20100608_244.jpg

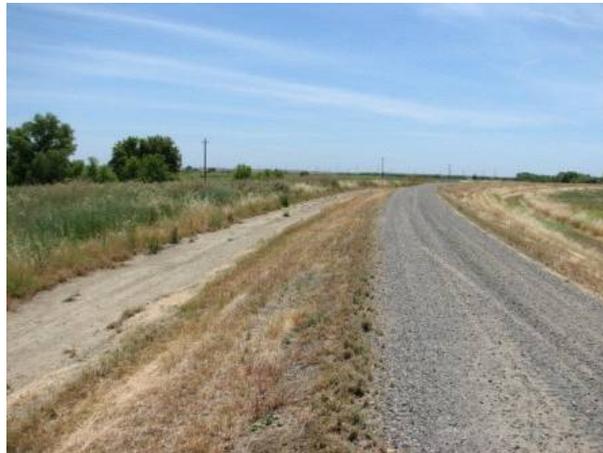
Levee Mile Report Line	2
Start Levee Mile	0.02
End Levee Mile	2.27
Location	Water Side
Category	Earthen Levee
Item	Vegetation
photo taken 6/8/2010 vegetation has been mowed	
johngw_s_20100608_245.jpg
