**Flood Control Project Maintenance  
Levee Inspections**  
**LMA District Cover Sheet**  
**Spring 2014 Levee Inspection Results**

**Sacramento Maintenance Yard Cache Creek**

**Spring 2014 Levee Inspection Results**

Waterway	Bank	Unit Miles
Unit No. 01 North Levee	Left	11.81

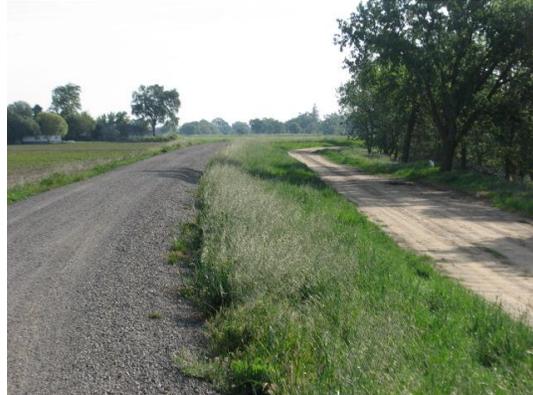
Photo 1 of 1 : johngw\_s\_20140502\_99001.jpg

Tall grasses partially blocks visibility. Spring 2014

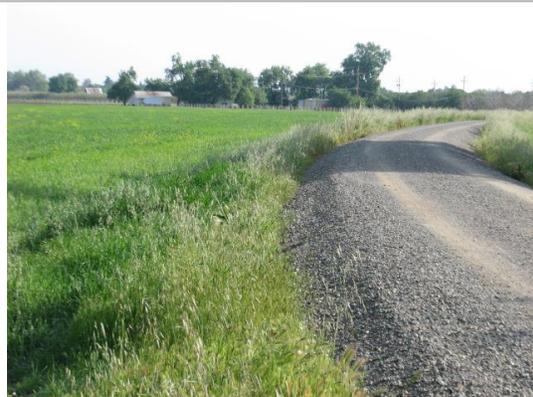
Photo 1 of 1 : johngw\_s\_20140502\_99002.jpg

Tall grasses partially blocks visibility. Spring 2014

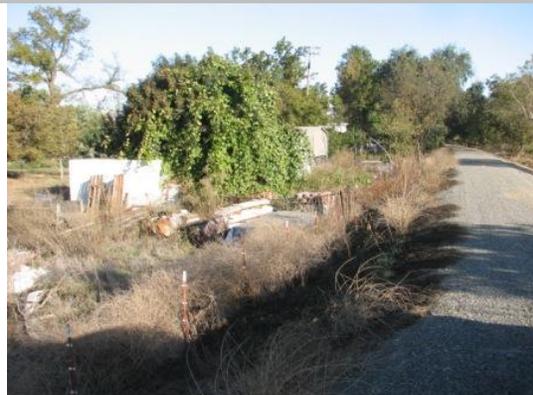
Photo 1 of 3 : johngw\_s\_20140306\_523.jpg

The owner has a lot of building material stored within the easement. Fall 2011

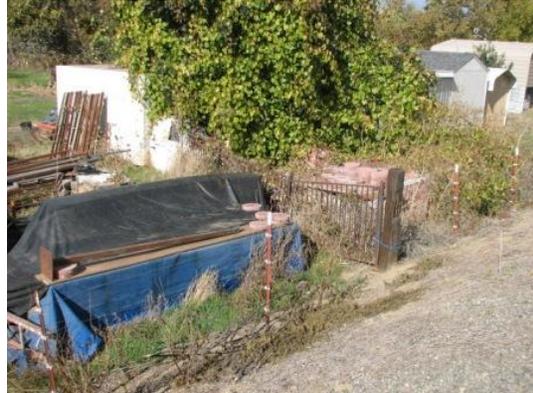
Photo 2 of 3 : johngw\_s\_20140306\_524.jpg

Building materials stacked along landside toe. Fall 2012

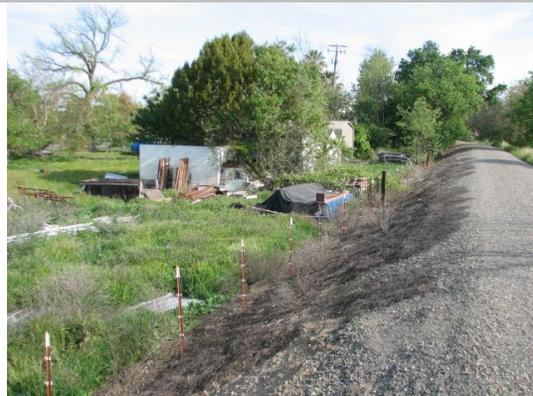
Photo 3 of 3 : johngw\_s\_20140502\_99003.jpg

The building material is along the toe of the levee. Spring 2014

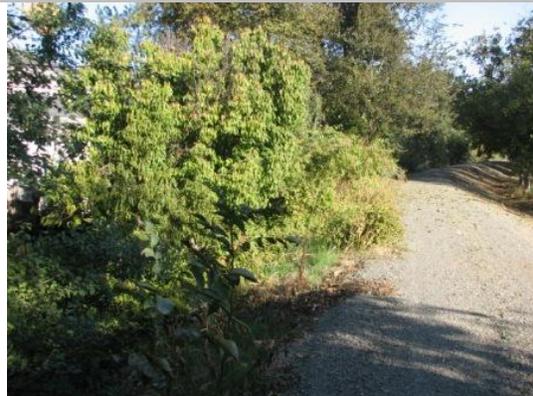
Photo 1 of 2 : johngw\_s\_20140306\_525.jpg

The landscape vegetation needs to be trimmed for visibility of the levee slope. Fall 2011

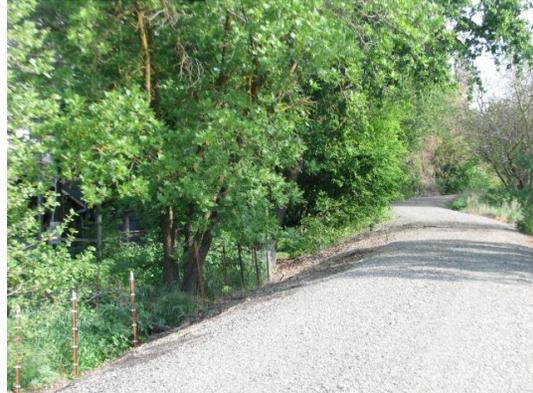
Photo 2 of 2 : johngw\_s\_20140502\_99004.jpg

The landscape needs to be trimmed up. Spring 2014

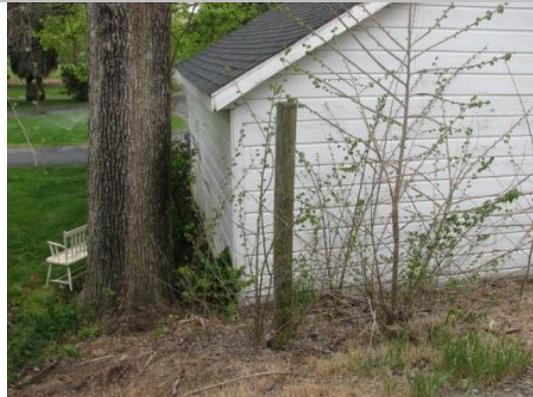
Photo 1 of 1 : johngw\_s\_20140306\_526.jpg

The building backs up to the landside levee toe of the levee.

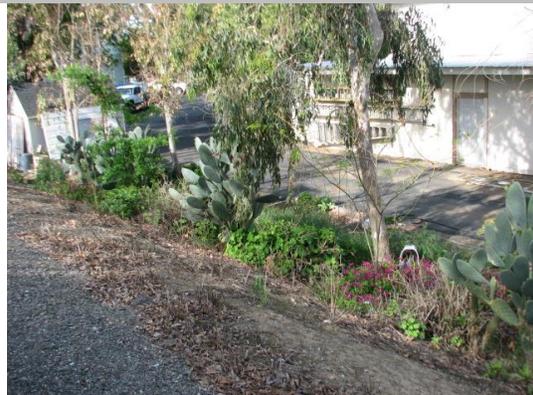
Photo 1 of 1 : johngw\_s\_20140502\_99005.jpg

LM Start	<b>1.94</b>	Rating **	M	Issue No.	<b>28</b>
LM End	<b>1.94</b>	Issue Type +	En	Location *	LS
Category	Earthen Levee		GPS Latitude/Longitude		
			Start	End	
Item	Vegetation		38.730860 °	38.730860 °	
			-121.806332 °	-121.806332 °	
DWR ID	DWR_ST0001_01_s_2014_28				
Action/Comments					
Landscaping					
Inspector Comments: Cactus at the toe of the levee.

The property owner has planted cactus along the toe of the levee. Spring 2014

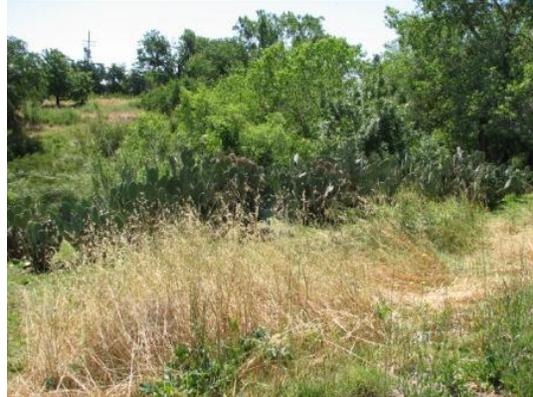
Photo 1 of 2 : johngw\_s\_20140306\_527.jpg

A cactus garden is planted on the waterside of the levee. There is some planted on the landside also.

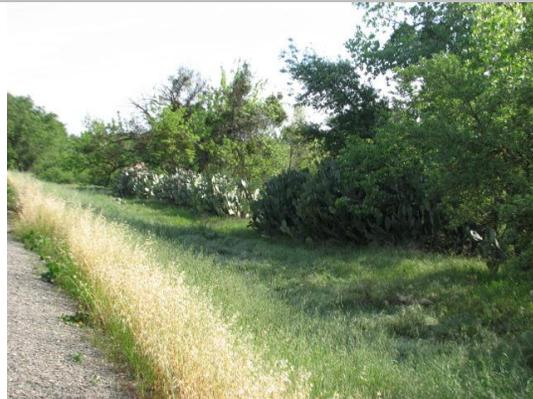
Photo 2 of 2 : johngw\_s\_20140502\_99006.jpg

In the background you can see the cactus garden on the berm area. Spring 2014

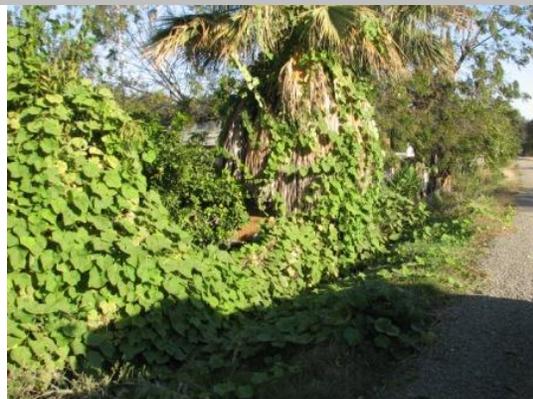
Photo 1 of 1 : johngw\_s\_20140306\_528.jpg

Wild grape and other plants are obstructing the view for inspection. Fall 2011

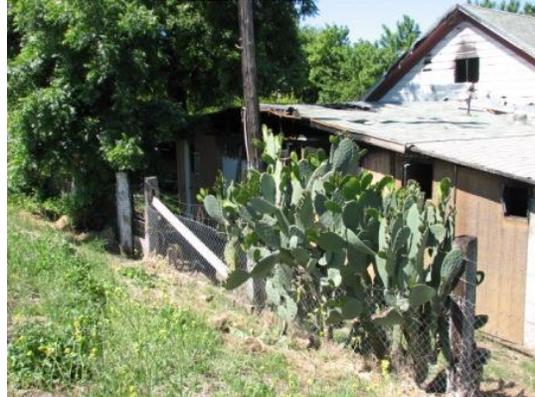
Photo 1 of 1 : johngw\_s\_20140306\_529.jpg

The building is in the easement of the levee. Cactus is planted at the toe obstructs visibility.

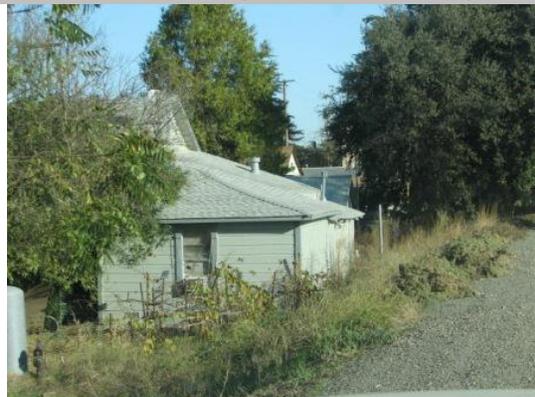
Photo 1 of 1 : johngw\_s\_20140306\_531.jpg

The house is in the easement of the levee toe. Fall 2011

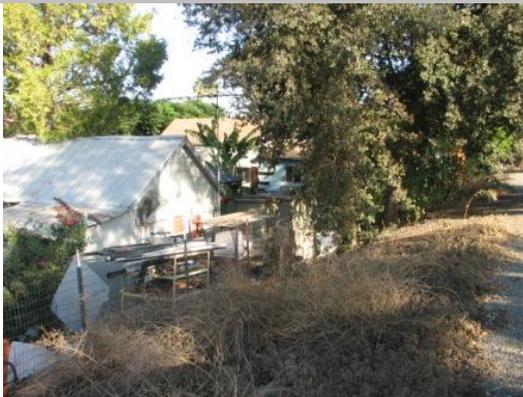
Photo 1 of 1 : johngw\_s\_20140306\_532.jpg

The building is in the easement of the levee. Fall 2011

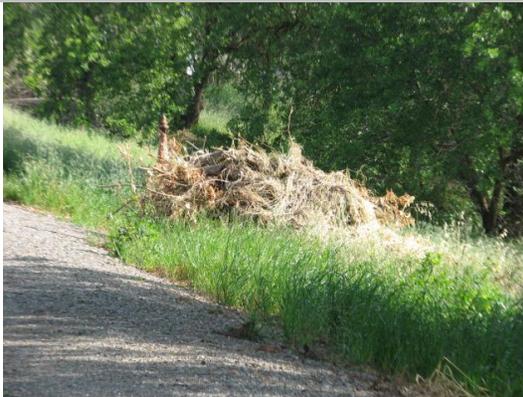
Photo 1 of 1 : johngw\_s\_20140502\_99007.jpg

A pile of debris has been placed on the waterside of the levee. Spring 2014

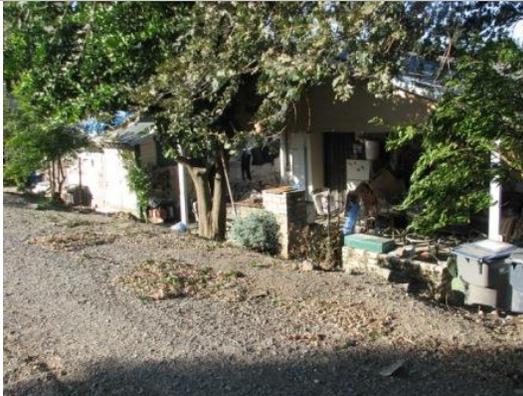
Photo 1 of 1 : johngw\_s\_20140306\_534.jpg

The building is in the easement of the levee. Fall 2011

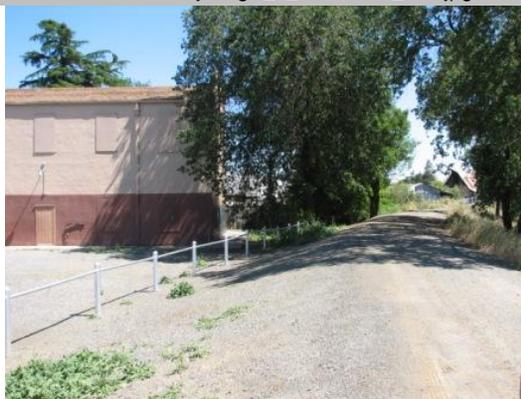
Photo 1 of 1 : johngw\_s\_20140306\_533.jpg

The building is in the easement of the levee.

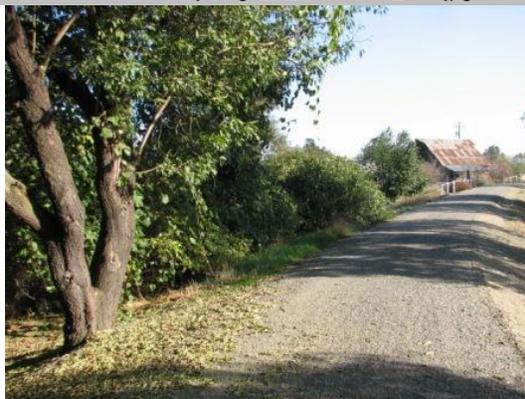
Photo 1 of 1 : johngw\_s\_20140306\_535.jpg

The shrubs block visibility of the levee slope. Fall 2011

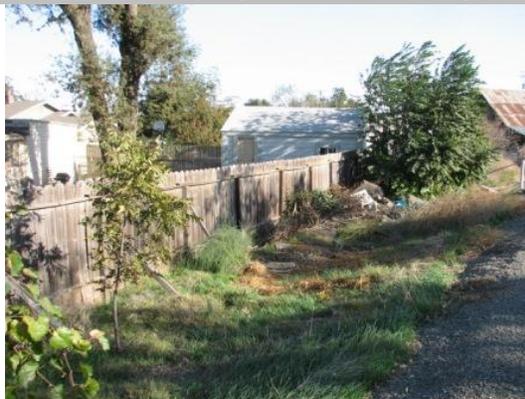
Photo 1 of 1 : johngw\_s\_20140306\_536.jpg

The fence blocks the visibility of the levee. Fall 2011

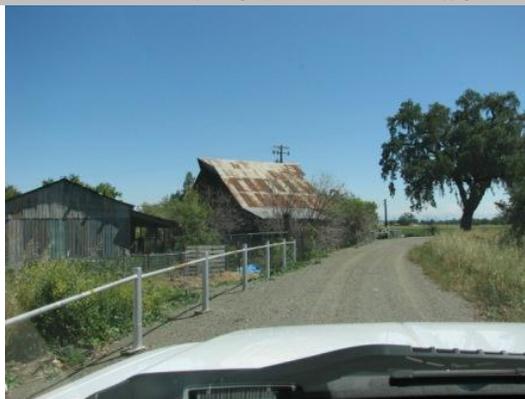
Photo 1 of 1 : johngw\_s\_20140306\_537.jpg

Horse barn and corral are within the easement of the levee.

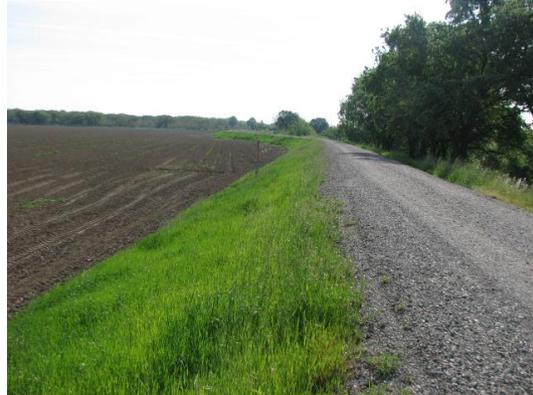
Photo 1 of 1 : johngw\_s\_20140502\_99008.jpg

Tall grasses partially blocks the visibility. Spring 2014

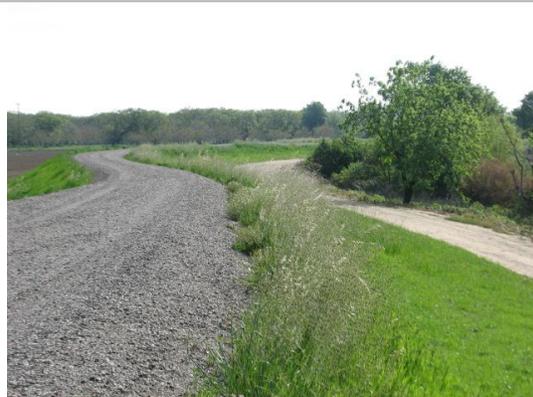
Photo 1 of 1 : johngw\_s\_20140502\_99009.jpg

Tall grasses partially blocks the visibility. Spring 2014

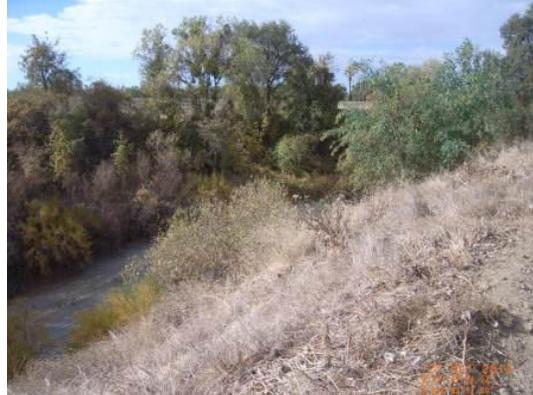
Photo 1 of 1 : USACE2013A\_CHC\_2-4\_L\_2.jpg

LM Start	<b>2.51</b>	Rating **	U	Issue No.	<b>25</b>
LM End	<b>2.51</b>	Issue Type +	Ma	Location *	WS
Category	Supplemental		GPS Latitude/Longitude		
			Start	End	
Item	USACE Erosion Survey		38.732685 °	38.732836 °	
			-121.797154 °	-121.797893 °	
DWR ID					
Action/Comments					
Inspector Comments: Site identified as CRITICAL in 2002. 2006 - Currently constructing a setback levee. New failures present and extensive. Downstream end of the setback levee did not extend far enough. Upstream end was repaired. 2007 - DWR repaired with a setback levee, but the levee did not go far enough downstream. 2012 - New cracks observed. 2013: Fresh erosion on upper bank. [2013 Site ID: CHC_2-4_L]

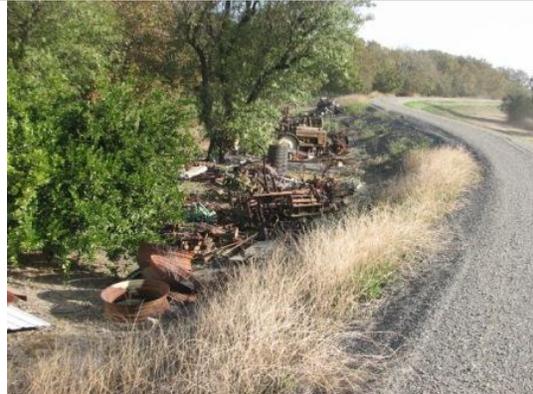
Photo 1 of 2 : johngw\_s\_20140306\_540.jpg

The equipment is stored at the toe of the levee. Fall 2011

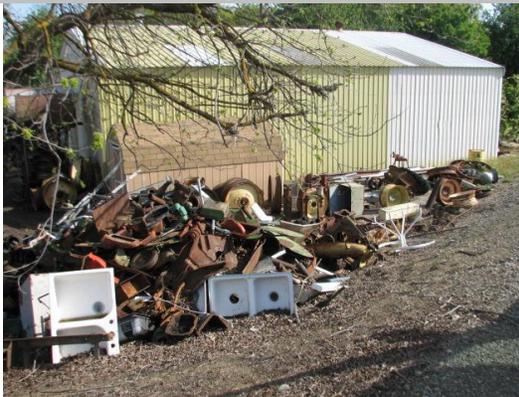
Photo 2 of 2 : johngw\_s\_20140502\_99010.jpg

Equipment and parts stacked along the levee toe and slope. Spring 2014

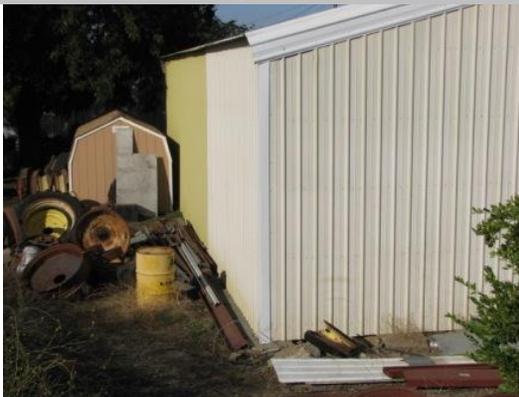
Photo 1 of 1 : johngw\_s\_20140306\_541.jpg

The corner of the shop is within the easement of the levee. Fall 2011

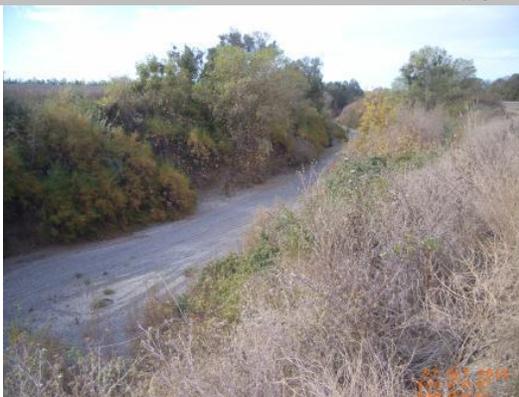
Photo 1 of 1 : USACE2013A\_CHC\_2-8\_L\_2.jpg

LM Start	<b>2.79</b>	Rating **	M	Issue No.	<b>30</b>
LM End	<b>2.83</b>	Issue Type +	Ma	Location *	WS
Category	Supplemental		GPS Latitude/Longitude		
			Start	End	
Item	USACE Erosion Survey		38.734067 °	38.734171 °	
			-121.793713 °	-121.792992 °	
DWR ID					
Action/Comments					
Inspector Comments: 2006 - Large new failure. 2008 - Plans for repair currently in the design phase. 2010 - Planned setback levee by CA DWR, 60% design complete, construction planned for 2012. 2011 - Construction delayed to 2013 - 2014. 2013: No observed changes. [2013 Site ID: CHC_2-8_L]

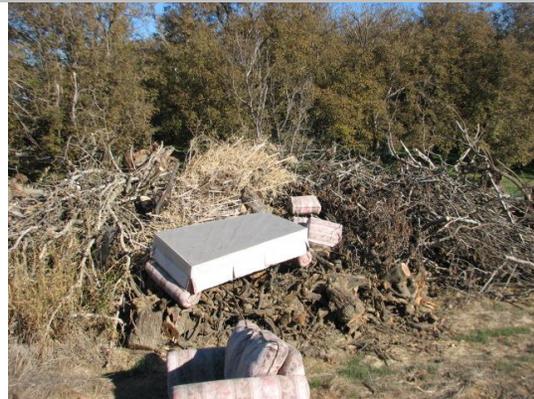
Photo 1 of 2 : johngw\_s\_20140306\_562.jpg

A pruning pile with some furniture is at the toe of the levee. Fall 2013

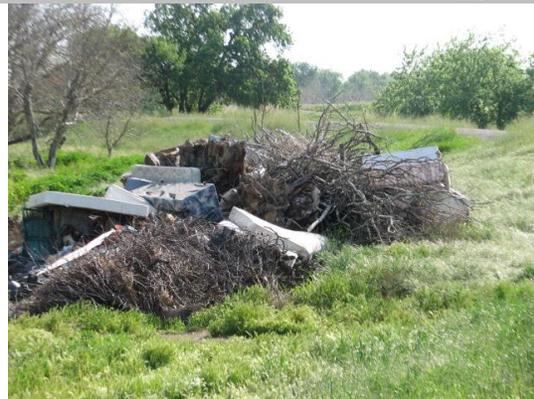
Photo 2 of 2 : johngw\_s\_20140502\_99011.jpg

Furniture and trimmings are stacked at the toe of the levee. Spring 2014

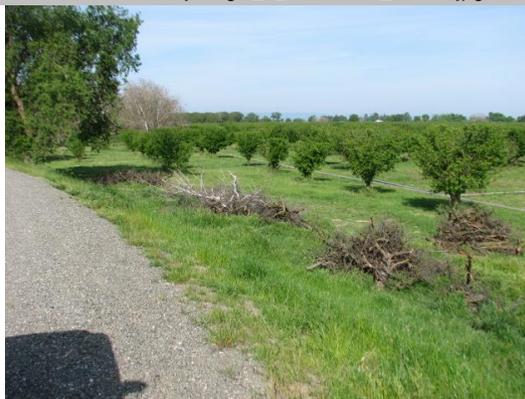
Photo 1 of 1 : johngw\_s\_20140502\_99012.jpg

A collection of piles are along the toe of the levee. Spring 2014

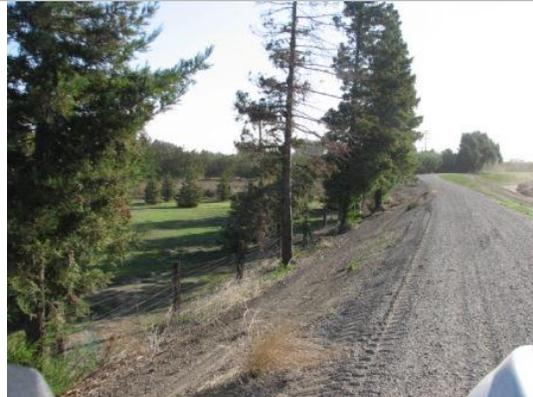
Photo 1 of 1 : johngw\_s\_20140306\_545.jpg

Landscape trees are planted along the levee to and on the slope. Some of the trees are trimmed up for visibility. Fall 2011

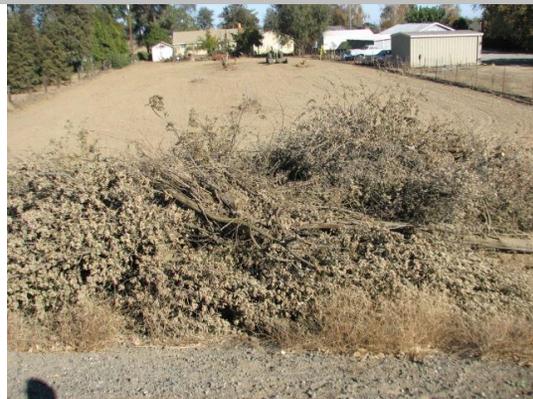
Photo 1 of 2 : johngw\_s\_20140306\_564.jpg

The pruning pile is at the toe of the levee. Fall 2013

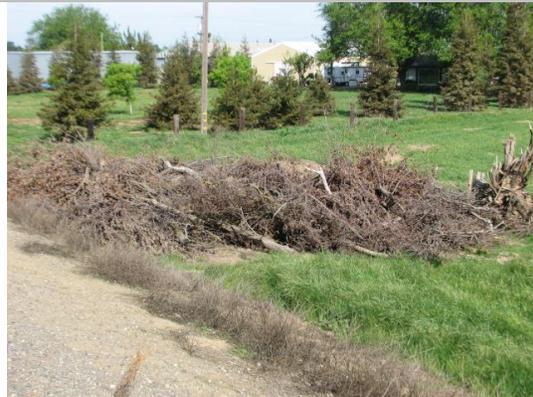
Photo 2 of 2 : johngw\_s\_20140502\_99013.jpg

A pruning pile at the toe of the levee. Spring 2014

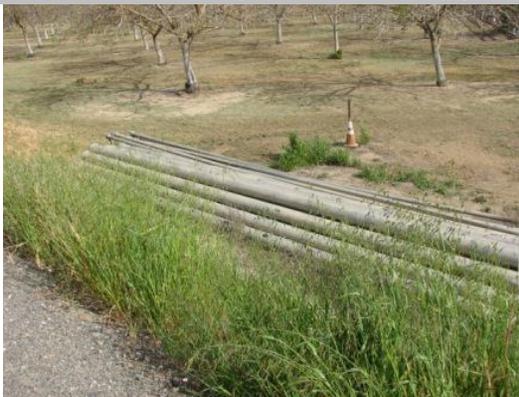
Photo 1 of 1 : johngw\_s\_20140306\_542.jpg

Aluminum irrigation pipe is placed along the landside levee toe.

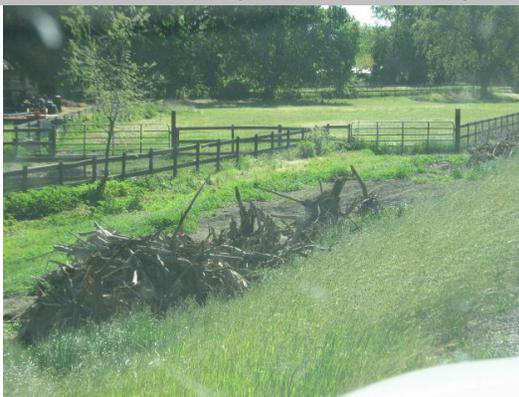
Photo 1 of 1 : johngw\_s\_20140306\_549.jpg

Pruning's and root balls at the toe of the levee. Spring 2013

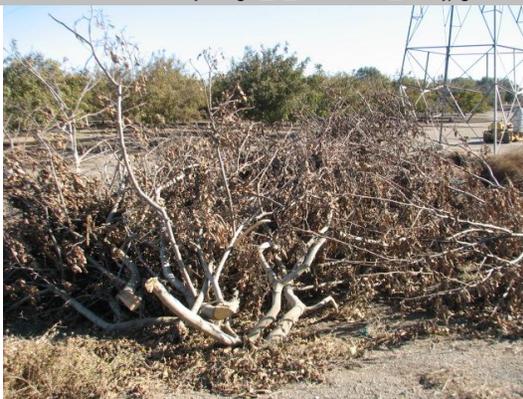
Photo 1 of 1 : johngw\_s\_20140306\_565.jpg

A large pruning pile is at the toe of the levee. Fall 2013

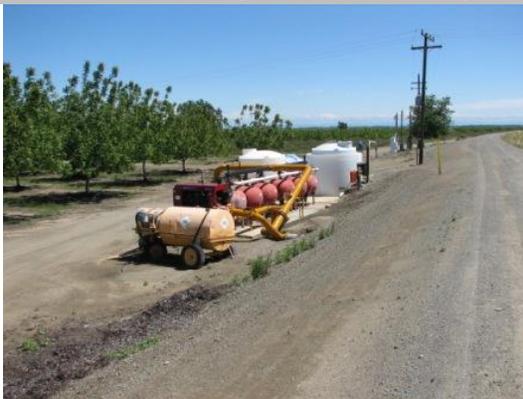
Photo 1 of 1 : johngw\_s\_20140306\_548.jpg

Pipe through levee, filter, and fertilizer tanks are within the easement of the levee.

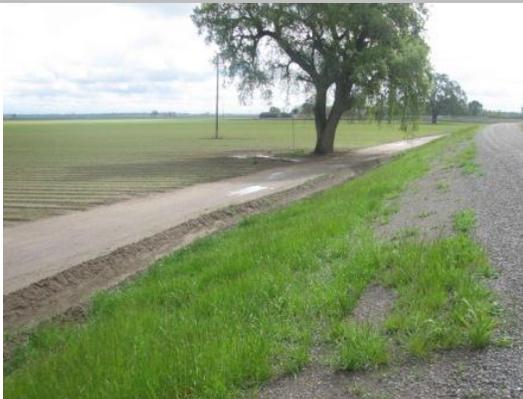
Photo 1 of 2 : johngw\_s\_20140306\_555.jpg

The farmer cuts an ag-ditch along the landside toe, photo taken spring 2012.

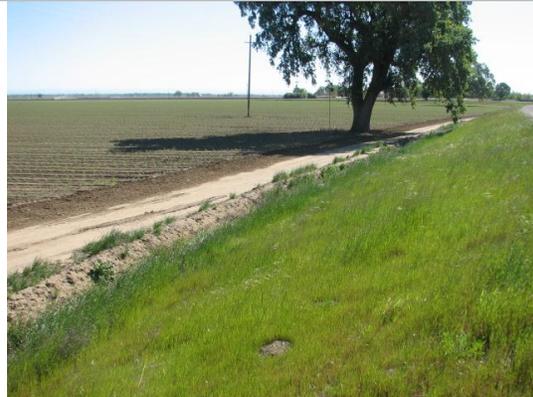
Photo 2 of 2 : johngw\_s\_20140306\_556.jpg

The farmer continues to v-ditch the toe of the levee. Spring 2013

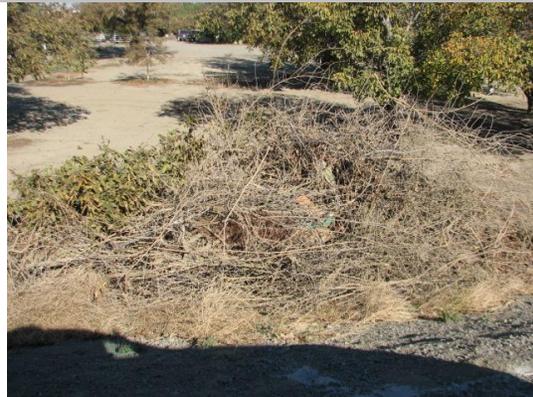
Photo 1 of 2 : johngw\_s\_20140306\_559.jpg

A pruning pile is at the toe of the levee. Fall 2013

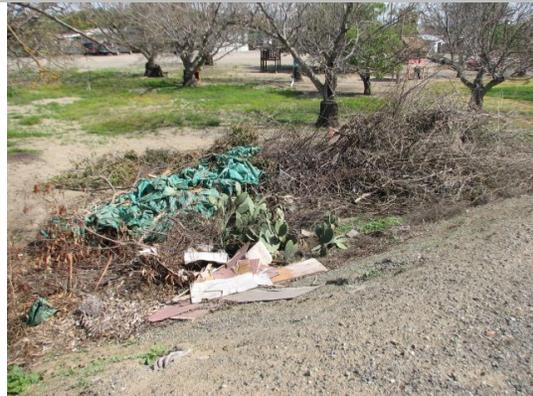
Photo 2 of 2 : johngw\_s\_20140502\_99015.jpg

The ongoing pruning and debris pile at the toe. Spring 2014

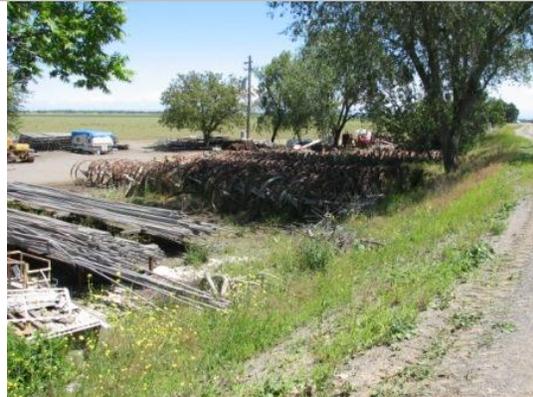
Photo 1 of 1 : johngw\_s\_20140306\_558.jpg

Irrigation pipe and equipment are within the easement of the levee.

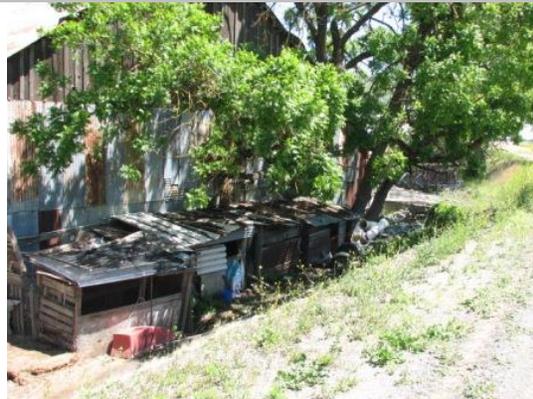
Photo 1 of 1 : johngw\_s\_20140306\_557.jpg

The barn and livestock pens are within the easement of the levee.

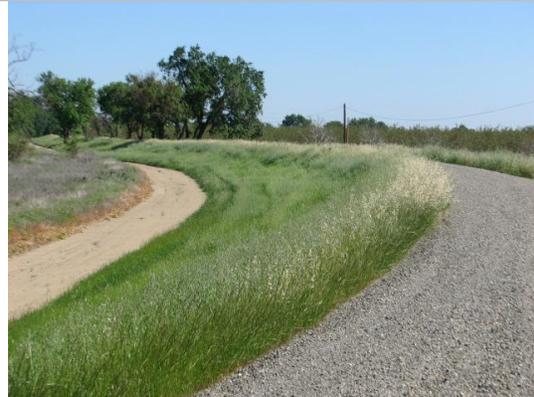
Photo 1 of 1 : johngw\_s\_20140502\_99016.jpg

Tall grasses partially blocks visibility. Spring 2014

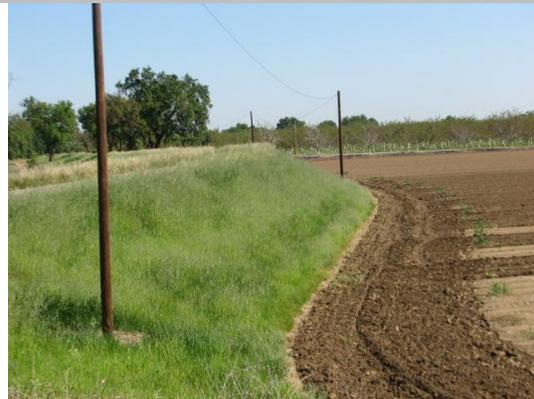
Photo 1 of 1 : johngw\_s\_20140502\_99017.jpg

Tall grasses partially blocks visibility of the levee slope. Spring 2014

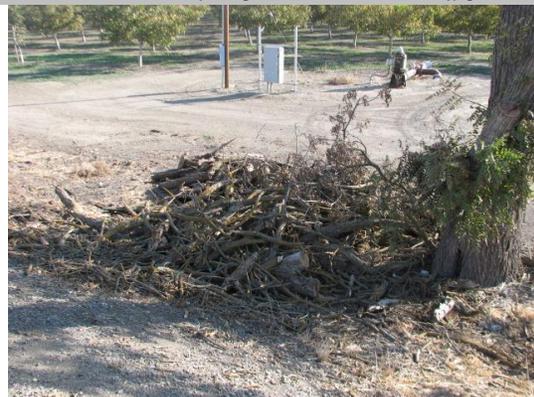
Photo 1 of 2 : johngw\_s\_20140306\_578.jpg

A pruning pile is within the easement of the levee. Fall 2013

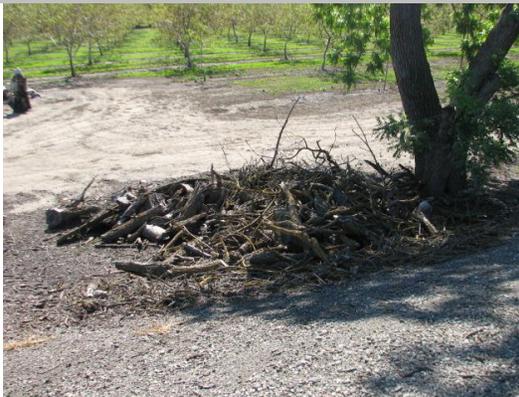
Photo 2 of 2 : johngw\_s\_20140502\_99018.jpg

A pruning pile is at the toe of the levee. Spring 2014

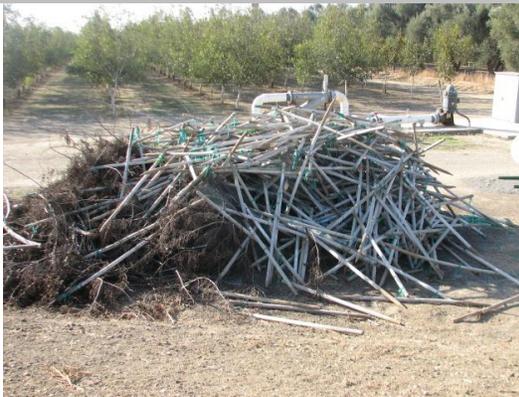
Photo 1 of 1 : johngw\_s\_20140306\_568.jpg

Tree stakes and prunings are at the toe of the levee. Fall 2013

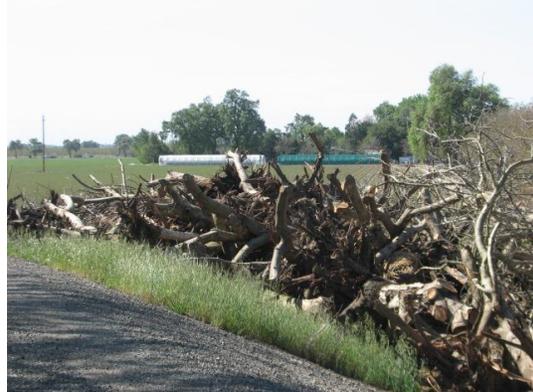
Photo 1 of 3 : johngw\_s\_20140306\_573.jpg

The pruning pile at the toe continues to grow. Spring 2013

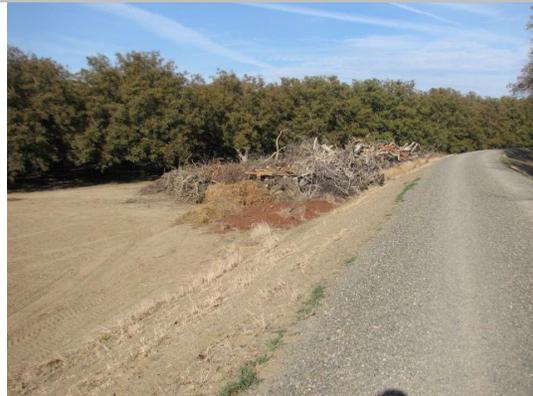
Photo 2 of 3 : johngw\_s\_20140306\_574.jpg

The never ending pruning pile is at the toe of the levee. Fall 2013

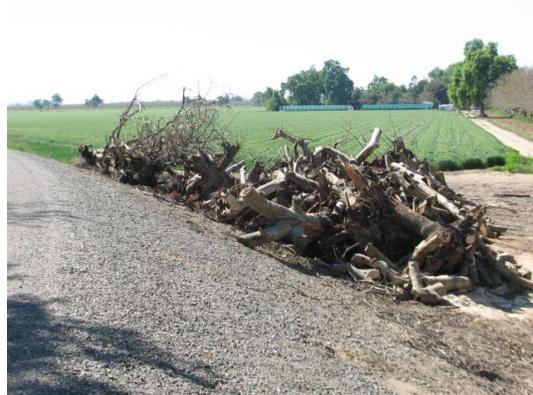
Photo 3 of 3 : johngw\_s\_20140502\_99020.jpg

A large pile of tree trimmings from the walnut orchard. Spring 2014

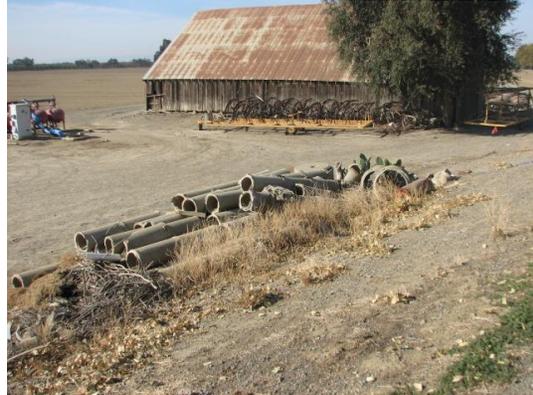
Photo 1 of 2 : johngw\_s\_20140306\_569.jpg

The concrete pipe is within the easement of the levee. Fall 2013

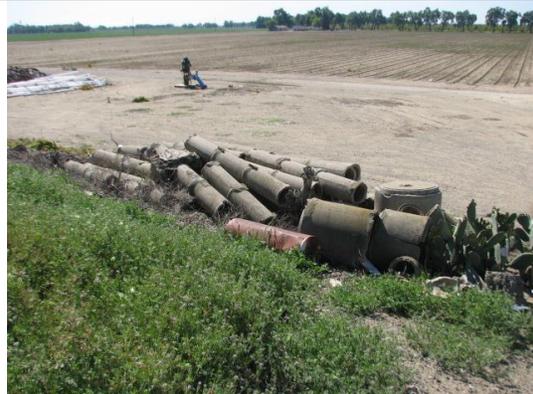
Photo 2 of 2 : johngw\_s\_20140502\_99021.jpg

the pile of concrete pipe is next to the toe of the levee. Spring 2014

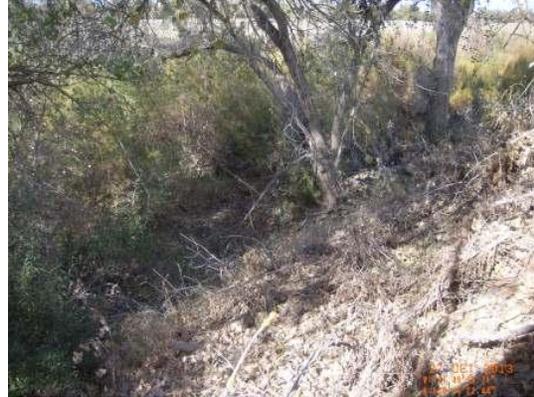
Photo 1 of 1 : USACE2013A\_CHC\_3-5\_R\_7.jpg

LM Start	<b>3.48</b>	Rating **	M	Issue No.	<b>13</b>
LM End	<b>3.56</b>	Issue Type +	Ma	Location *	WS
Category	Supplemental		GPS Latitude/Longitude		
			Start	End	
Item	USACE Erosion Survey		38.722138 °	38.723294 °	
			-121.759736 °	-121.759588 °	
DWR ID					
Action/Comments					
Inspector Comments: 2010 - Large slump on the upper berm, a tree has recently slid down the slope. 2011 - Large slump and new erosion. 2012 - Slightly steeper slopes and cracks observed. 2013: No observed changes. [2013 Site ID: CHC_3-5_R]

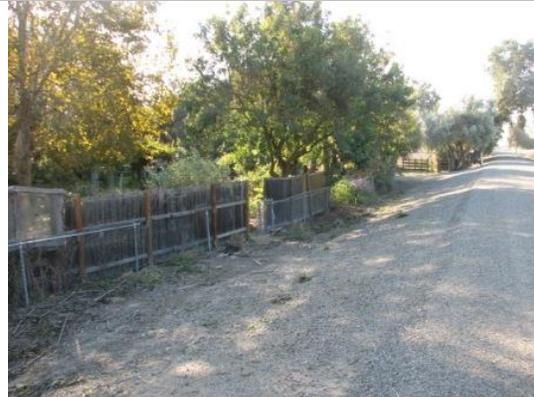
Photo 1 of 1 : johngw\_s\_20140306\_570.jpg

The landscaping and fence are obstructive to viewing the levee toe. Fall 2011

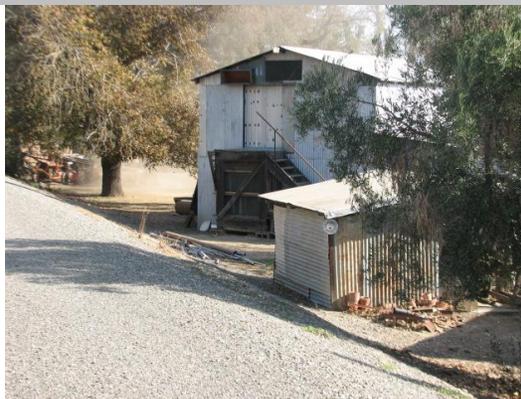
Photo 1 of 1 : johngw\_s\_20140306\_571.jpg

The out buildings are within the easement of the levee. Fall 2013

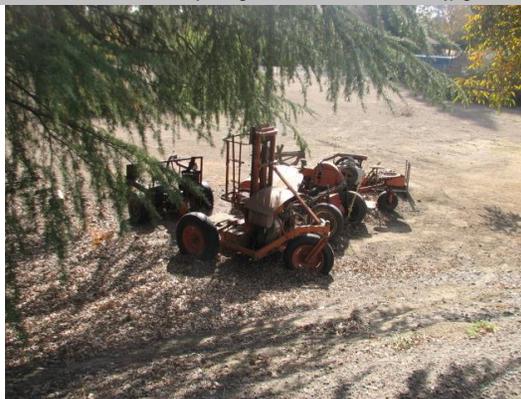
Photo 1 of 1 : johngw\_s\_20140306\_581.jpg

There are several pieces of equipment near the toe of the levee. Fall 2013

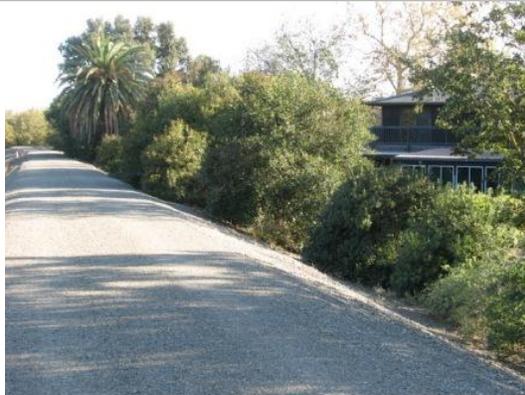
Photo 1 of 1 : johngw\_s\_20140306\_572.jpg

The landscape shrubs block visibility of the toe. Fall 2011

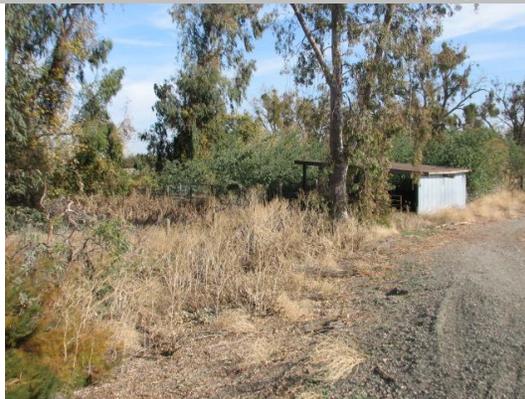
Photo 1 of 1 : johngw\_s\_20140306\_582.jpg

The horse corral and building are on the waterside berm. Fall 2013
