**Flood Control Project Maintenance
Levee Inspections**
LMA District Cover Sheet
Spring 2015 Levee Inspection Results

Sacramento Maintenance Yard Cache Creek

Spring 2015 Levee Inspection Results

Waterway	Bank	Unit Miles
Unit No. 01 North Levee	Left	11.69

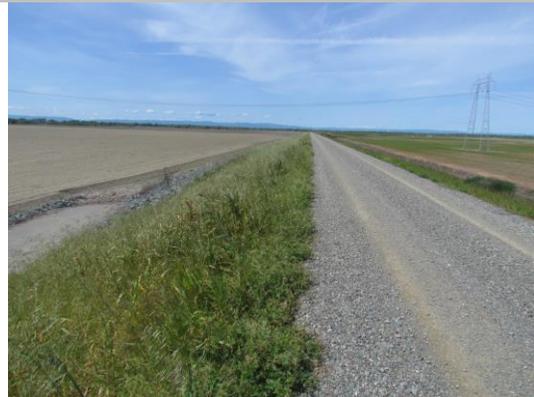
Photo 1 of 1 : SP_2015_ST0001_259_23_20150413_00038.jpg

View of vegetation on the waterward side of the levee looking upstream. Spring 2015.

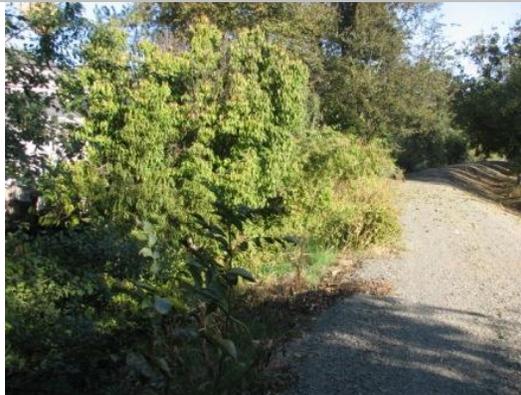
Photo 1 of 2 : SP_2015_ST0001_259_3_20150316_00004.jpg

The landscape vegetation needs to be trimmed for visibility of the levee slope. Fall 2011

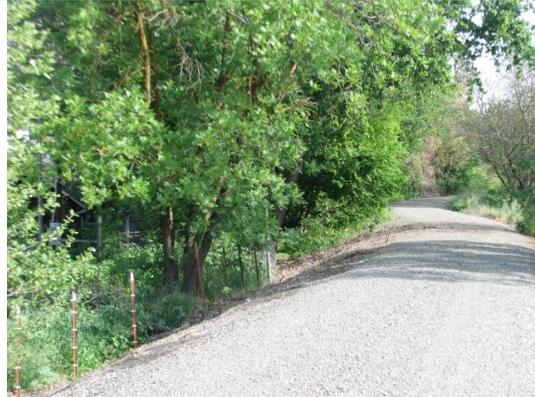
Photo 2 of 2 : SP_2015_ST0001_259_3_20150316_00005.jpg

The landscape needs to be trimmed up. Spring 2014

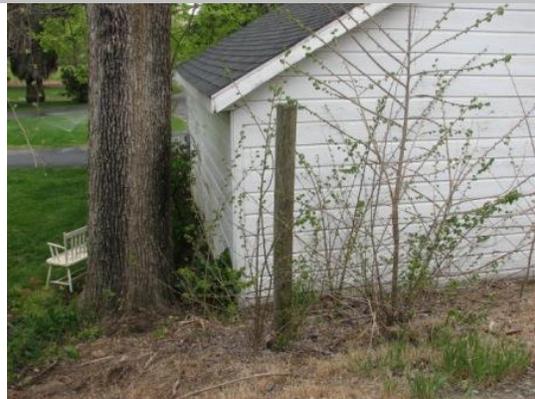
Photo 1 of 1 : SP_2015_ST0001_259_4_20150316_00006.jpg

LM Start	1.94	Rating **	M	Issue No.	4
LM End	1.94	Issue Type +	En	Location *	LS
Category	Earthen Levee		GPS Latitude/Longitude		
			Start	End	
Item	Encroachments		38.730528 °	38.730528 °	
			-121.806485 °	-121.806485 °	
DWR ID	DWR_ST0001_01_s_2012_4				
Action/Comments					
Building

The building backs up to the landside levee toe of the levee.

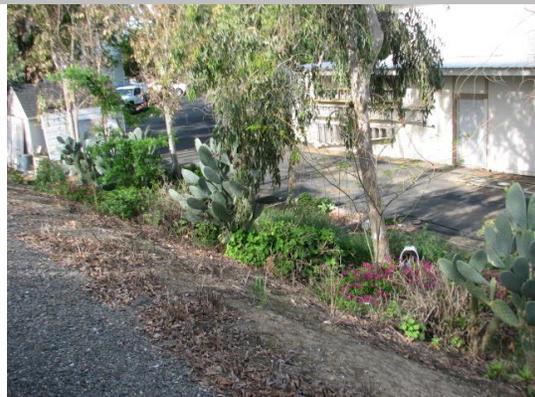
Photo 1 of 1 : SP_2015_ST0001_259_28_20150316_00025.jpg

LM Start	1.96	Rating **	M	Issue No.	28
LM End	1.96	Issue Type +	En	Location *	LS
Category	Earthen Levee		GPS Latitude/Longitude		
			Start	End	
Item	Vegetation		38.730860 °	38.730860 °	
			-121.806332 °	-121.806332 °	
DWR ID	DWR_ST0001_01_s_2014_28				
Action/Comments					
Landscaping					
Inspector Comments: Cactus at the toe of the levee.

The property owner has planted cactus along the toe of the levee. Spring 2014

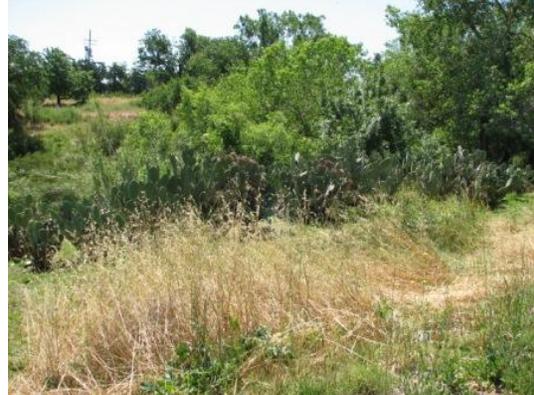
Photo 1 of 2 : SP_2015_ST0001_259_6_20150316_00007.jpg

A cactus garden is planted on the waterside of the levee. There is some planted on the landside also.

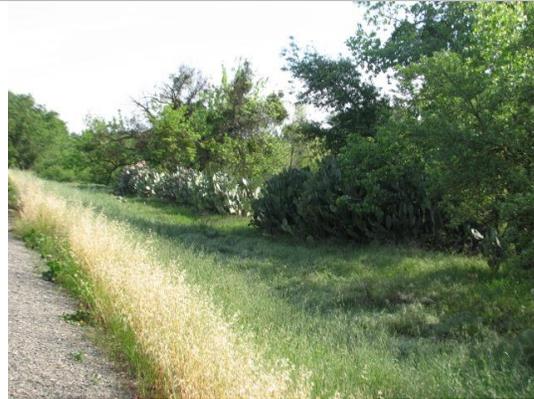
Photo 2 of 2 : SP_2015_ST0001_259_6_20150316_00008.jpg

In the background you can see the cactus garden on the berm area. Spring 2014

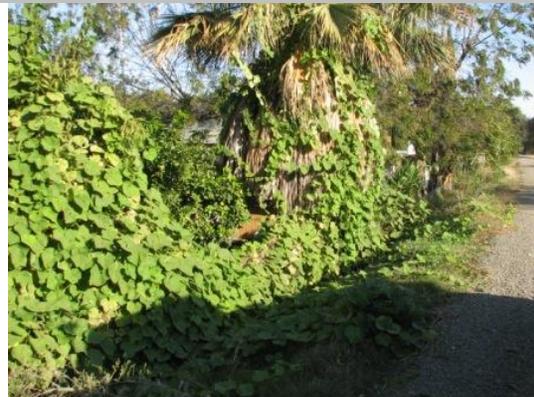
Photo 1 of 1 : SP_2015_ST0001_259_7_20150316_00009.jpg

LM Start	1.98	Rating **	M	Issue No.	7
LM End	2.02	Issue Type +	En	Location *	LS
Category	Earthen Levee		GPS Latitude/Longitude		
			Start	End	
Item	Vegetation		38.731198 °	38.731650 °	
			-121.806230 °	-121.806068 °	
DWR ID	DWR_ST0001_01_s_2012_7				
Action/Comments					
Landscaping

Wild grape and other plants are obstructing the view for inspection. Fall 2011

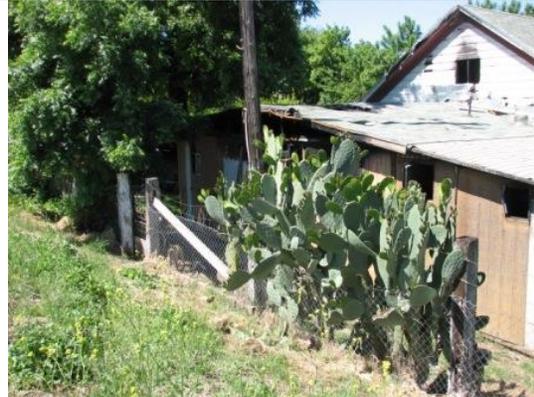
Photo 1 of 1 : SP_2015_ST0001_259_8_20150316_00010.jpg

The building is in the easement of the levee. Cactus planted at the toe obstructs visibility.

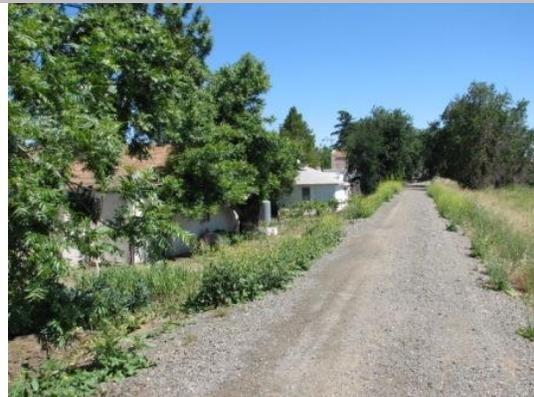
Photo 1 of 1 : SP_2015_ST0001_259_9_20150316_00011.jpg

LM Start	2.04	Rating **	M	Issue No.	9
LM End	2.04	Issue Type +	En	Location *	LS
Category	Earthen Levee		GPS Latitude/Longitude		
			Start	End	
Item	Encroachments		38.731927 °	38.731927 °	
			-121.805973 °	-121.805973 °	
DWR ID	DWR_ST0001_01_s_2012_9				
Action/Comments					
Building

A photo looking downstream of homes in the town of Yolo.

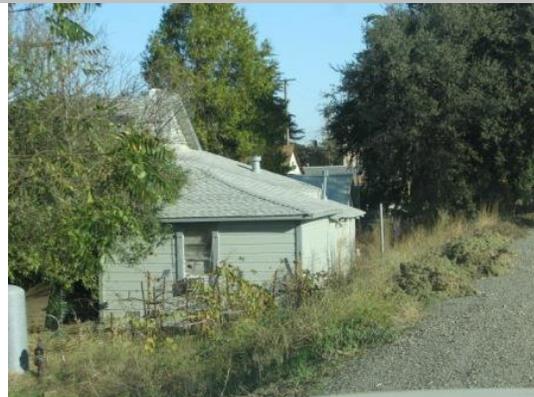
Photo 1 of 1 : SP_2015_ST0001_259_10_20150316_00012.jpg

LM Start	2.05	Rating **	M	Issue No.	10
LM End	2.05	Issue Type +	En	Location *	LS
Category	Earthen Levee		GPS Latitude/Longitude		
			Start	End	
Item	Encroachments		38.732162 °	38.732162 °	
			-121.805895 °	-121.805895 °	
DWR ID	DWR_ST0001_01_s_2012_10				
Action/Comments					
Building

The house is in the easement of the levee toe. Fall 2011

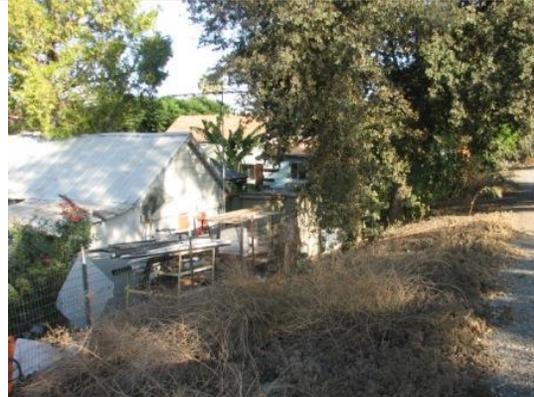
Photo 1 of 1 : SP_2015_ST0001_259_11_20150316_00013.jpg

The building is in the easement of the levee. Fall 2011

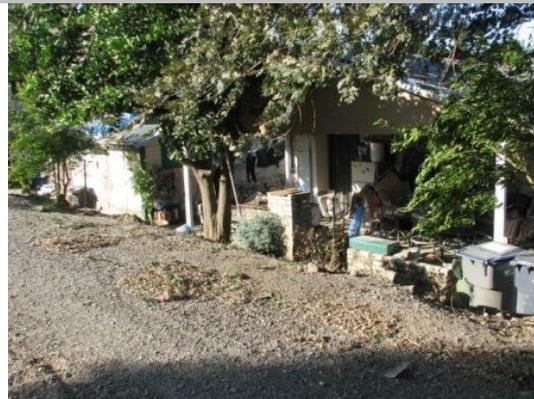
Photo 1 of 1 : SP_2015_ST0001_259_13_20150316_00015.jpg

LM Start	2.08	Rating **	M	Issue No.	13
LM End	2.08	Issue Type +	En	Location *	LS
Category	Earthen Levee		GPS Latitude/Longitude		
			Start	End	
Item	Encroachments		38.732537 °	38.732537 °	
			-121.805708 °	-121.805708 °	
DWR ID	DWR_ST0001_01_s_2012_13				
Action/Comments					
Building

The building is in the easement of the levee. Fall 2011

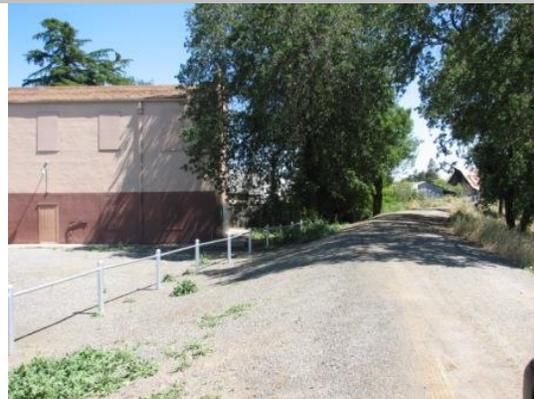
Photo 1 of 1 : SP_2015_ST0001_259_12_20150316_00014.jpg

The building is in the easement of the levee.

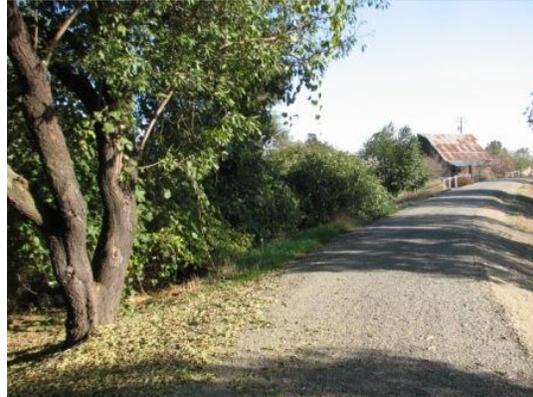
Photo 1 of 1 : SP_2015_ST0001_259_14_20150316_00016.jpg

The shrubs block visibility of the levee slope. Fall 2011

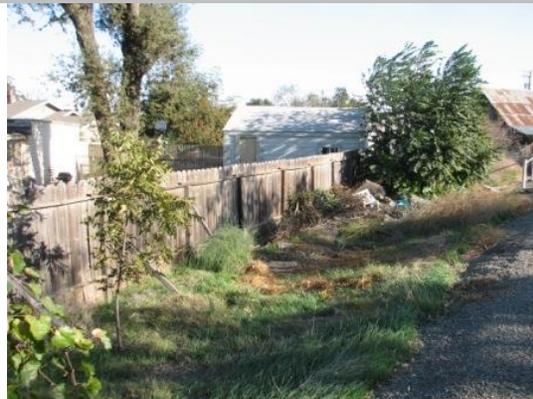
Photo 1 of 1 : SP_2015_ST0001_259_15_20150316_00017.jpg

LM Start	2.13	Rating **	M	Issue No.	15
LM End	2.15	Issue Type +	En	Location *	LS
Category	Earthen Levee			GPS Latitude/Longitude	
				Start	End
Item	Encroachments			38.733215 °	38.733350 °
				-121.805262 °	-121.805082 °
DWR ID	DWR_ST0001_01_s_2012_15				
Action/Comments					
Fence

The fence blocks the visibility of the levee. Fall 2011

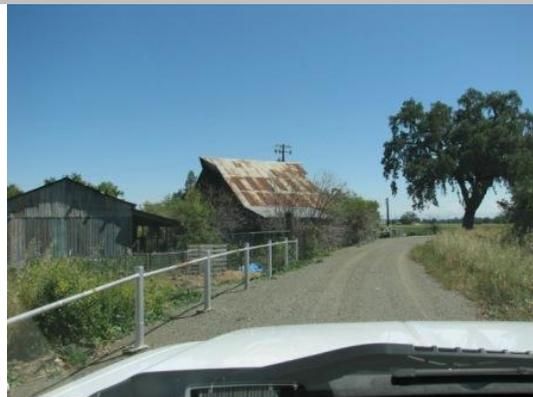
Photo 1 of 1 : SP_2015_ST0001_259_16_20150316_00018.jpg

LM Start	2.17	Rating **	M	Issue No.	16
LM End	2.17	Issue Type +	En	Location *	LS
Category	Earthen Levee			GPS Latitude/Longitude	
				Start	End
Item	Encroachments			38.733555 °	38.733555 °
				-121.804737 °	-121.804737 °
DWR ID	DWR_ST0001_01_s_2012_16				
Action/Comments					
Building

Horse barn and corral are within the easement of the levee.

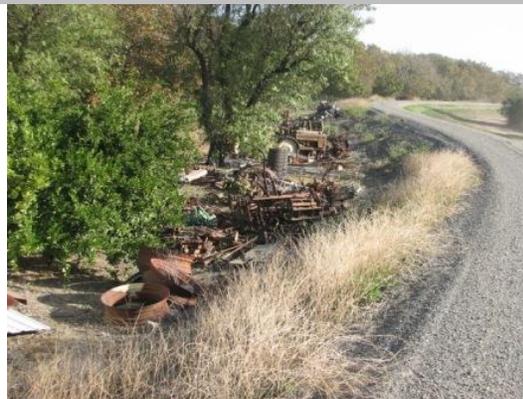
Photo 1 of 2 : SP_2015_ST0001_259_19_20150316_00020.jpg

The equipment is stored at the toe of the levee. Fall 2011

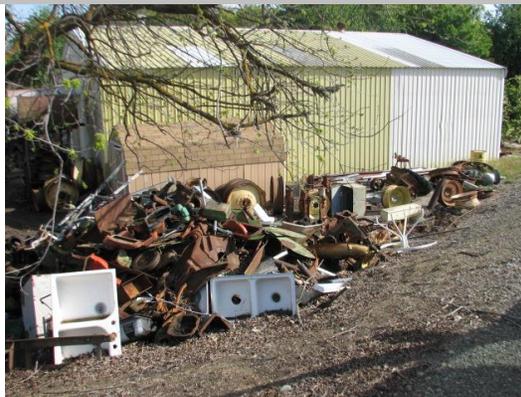
Photo 2 of 2 : SP_2015_ST0001_259_19_20150316_00021.jpg

Equipment and parts stacked along the levee toe and slope. Spring 2014

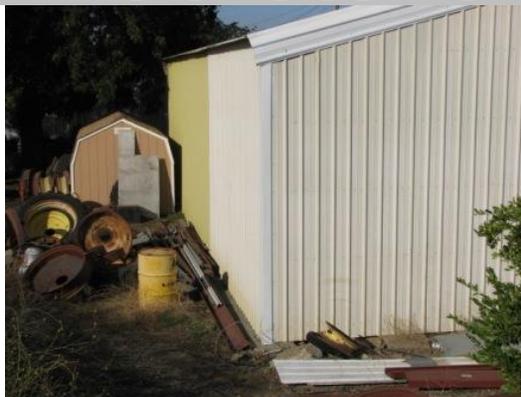
Photo 1 of 1 : SP_2015_ST0001_259_20_20150316_00022.jpg

The corner of the shop is within the easement of the levee. Fall 2011

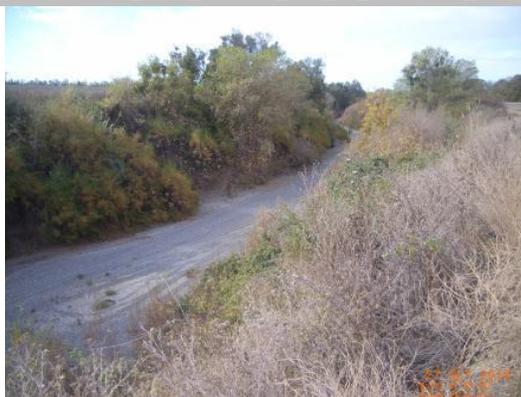
Photo 1 of 1 : SP_2015_ST0001_259_30_20150316_00026.jpg

LM Start	2.82	Rating **	M	Issue No.	30
LM End	2.86	Issue Type +	Ma	Location *	WS
Category	Supplemental			GPS Latitude/Longitude	
				Start	End
Item	USACE Erosion Survey			38.734067 °	38.734171 °
				-121.793713 °	-121.792992 °
DWR ID	DWR_ST0001_01_f_2014_30				
Action/Comments					
Inspector Comments: 2006 - Large new failure. 2008 - Plans for repair currently in the design phase. 2010 - Planned setback levee by CA DWR, 60% design complete, construction planned for 2012. 2011 - Construction delayed to 2013 - 2014. 2013: No observed changes. [2013 Site ID: CHC_2-8_L]

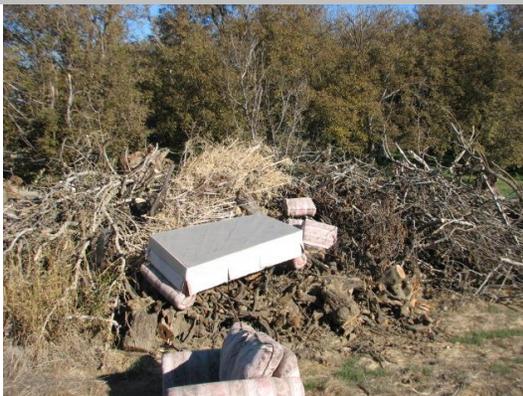
Photo 1 of 2 : SP_2015_ST0001_259_53_20150316_00034.jpg

A pruning pile with some furniture is at the toe of the levee. Fall 2013

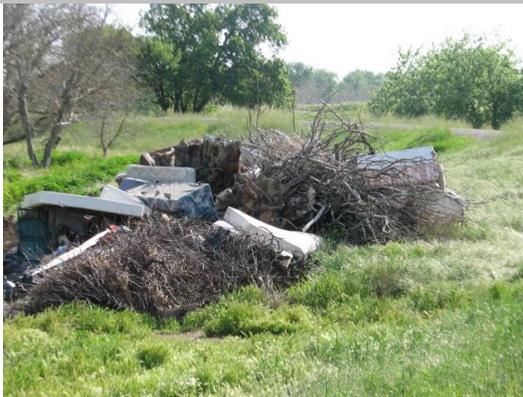
Photo 2 of 2 : SP_2015_ST0001_259_53_20150316_00035.jpg

Furniture and trimmings are stacked at the toe of the levee. Spring 2014

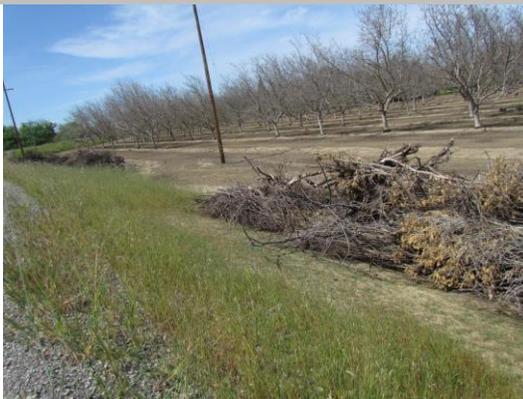
Photo 1 of 1 : SP_2015_ST0001_259_42_20150413_00041.jpg

View of prunings on the landward side of the levee looking upstream. Spring 2015.

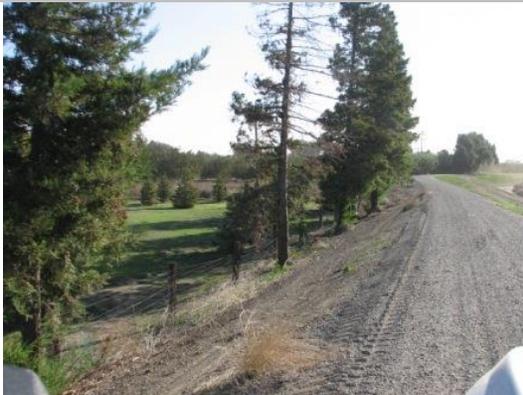
Photo 1 of 1 : SP_2015_ST0001_259_27_20150316_00024.jpg

Landscape trees are planted along the levee to and on the slope. Some of the trees are trimmed up for visibility. Fall 2011

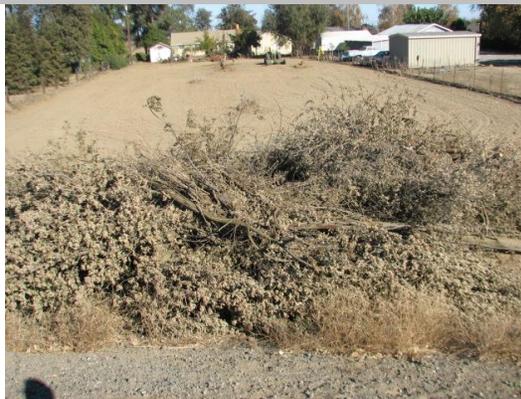
Photo 1 of 2 : SP_2015_ST0001_259_55_20150316_00036.jpg

The pruning pile is at the toe of the levee. Fall 2013

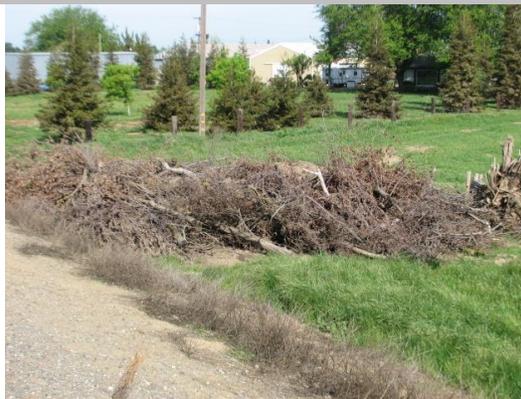
Photo 2 of 2 : SP_2015_ST0001_259_55_20150316_00037.jpg

A pruning pile at the toe of the levee. Spring 2014

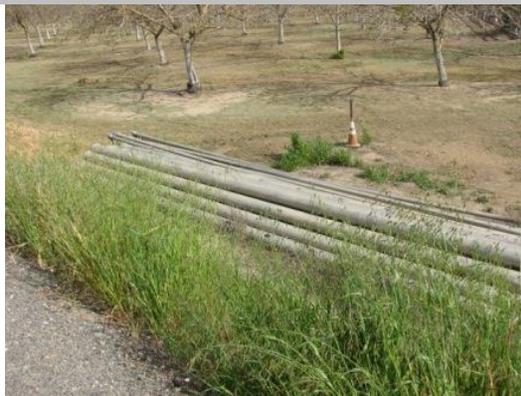
Photo 1 of 1 : SP_2015_ST0001_259_24_20150316_00023.jpg

Aluminum irrigation pipe is placed along the landside levee toe.

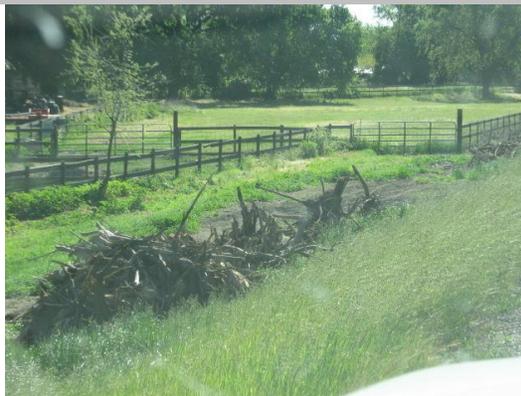
Photo 1 of 1 : SP_2015_ST0001_259_32_20150316_00027.jpg

Prunings and root balls at the toe of the levee. Spring 2013

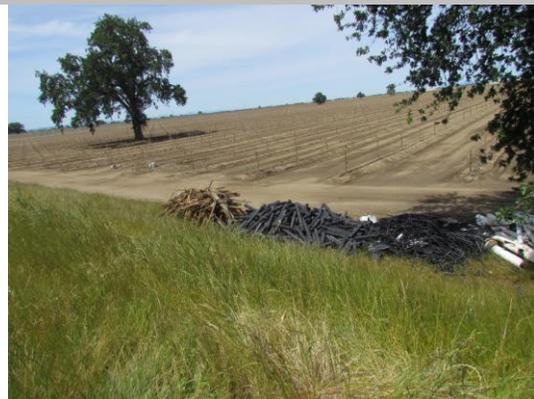
Photo 1 of 1 : SP_2015_ST0001_259_33_20150413_00040.jpg

View of the prunings on the landward side of the levee looking upstream. Spring 2015.

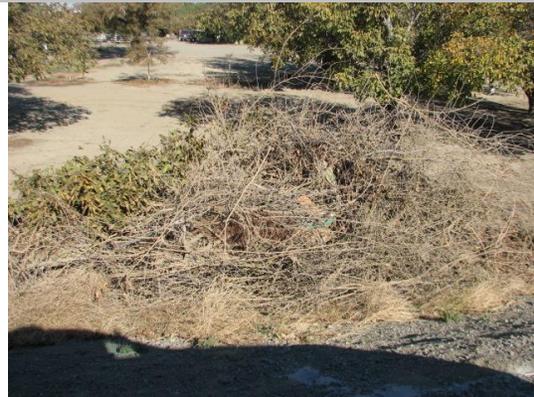
Photo 1 of 2 : SP_2015_ST0001_259_41_20150316_00031.jpg

A pruning pile is at the toe of the levee. Fall 2013

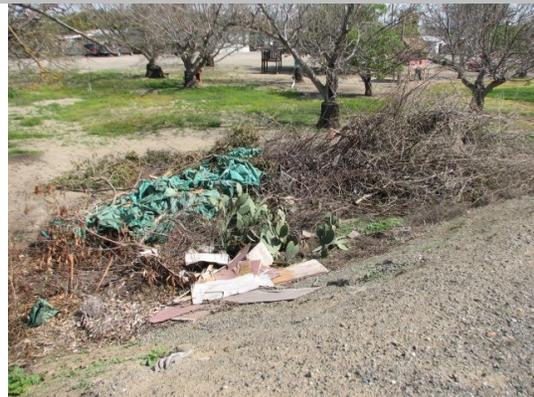
Photo 2 of 2 : SP_2015_ST0001_259_41_20150316_00032.jpg

The ongoing pruning and debris pile at the toe. Spring 2014

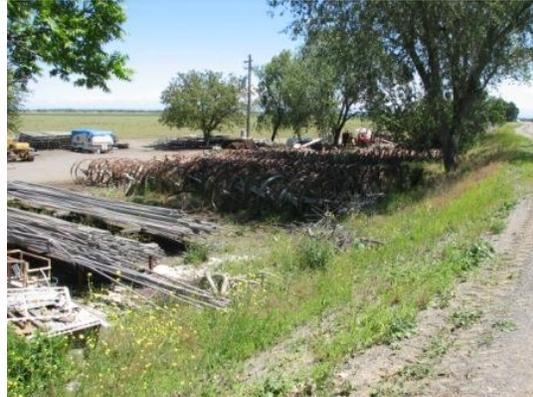
Photo 1 of 1 : SP_2015_ST0001_259_40_20150316_00030.jpg

Irrigation pipe and equipment are within the easement of the levee.

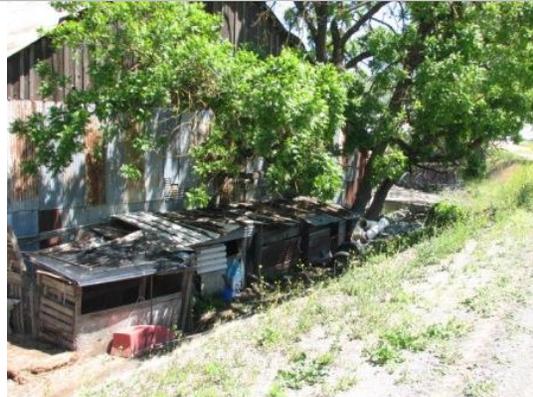
Photo 1 of 1 : SP_2015_ST0001_259_39_20150316_00029.jpg

The barn and livestock pens are within the easement of the levee.

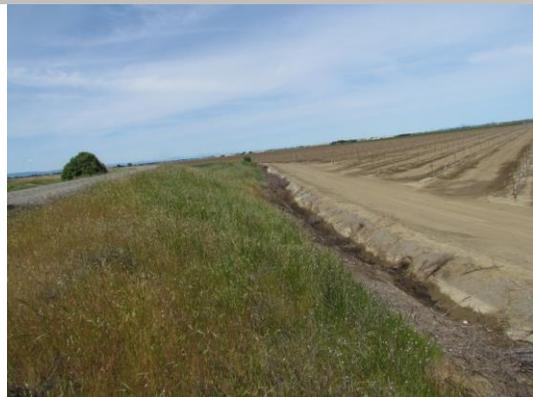
Photo 1 of 1 : SP_2015_ST0001_259_26_20150413_00039.jpg

View of ditch on the landward side of the levee looking upstream. Spring 2015.

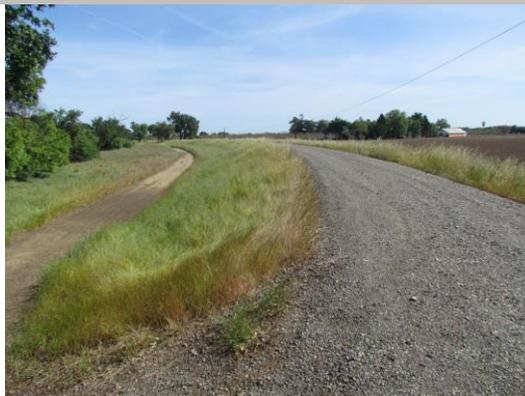
Photo 1 of 1 : SP_2015_ST0001_260_4_20150413_00019.jpg

View of the vegetation on the waterward side of the levee looking downstream. Spring 2015.

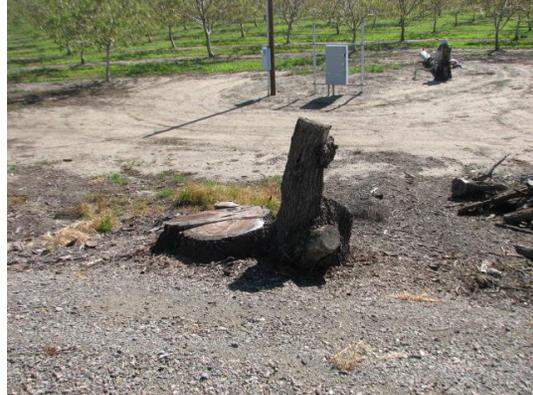
Photo 1 of 1 : SP_2015_ST0001_260_6_20150316_00004.jpg

A large black walnut tree stump is at the toe of the levee. Spring 2014

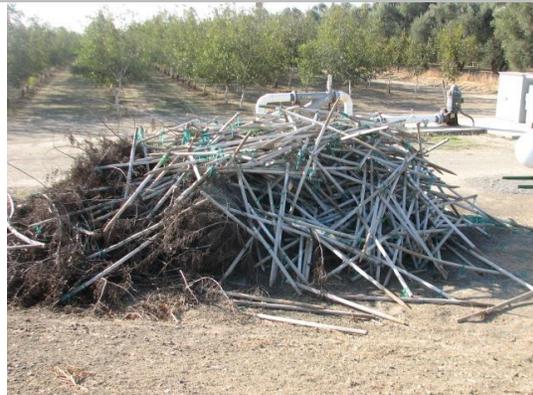
Photo 1 of 1 : SP_2015_ST0001_260_1_20150316_00001.jpg

Tree stakes and pruning's are at the toe of the levee. Fall 2013

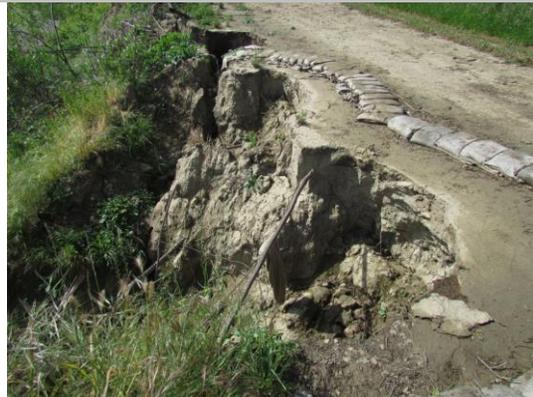
Photo 1 of 2 : SP_2015_ST0001_260_11_20150413_00020.jpg

View of the erosion on the channel looking downstream. Spring 2015.

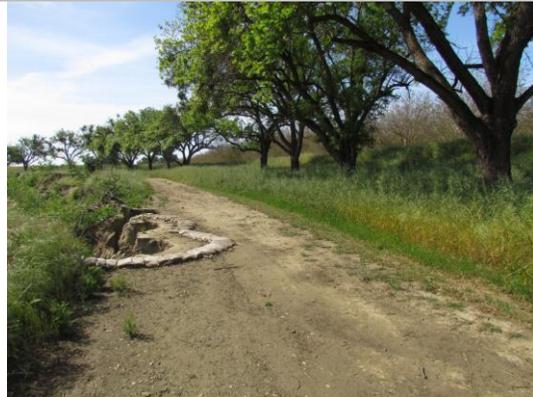
Photo 2 of 2 : SP_2015_ST0001_260_11_20150413_00021.jpg

The view of the erosion from a distance. Spring 2015.

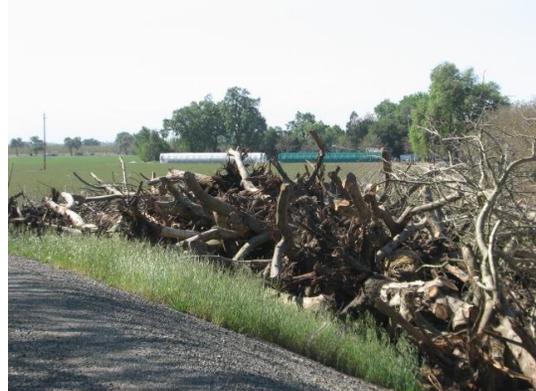
Photo 1 of 3 : SP_2015_ST0001_260_12_20150316_00008.jpg

The pruning pile at the toe continues to grow. Spring 2013

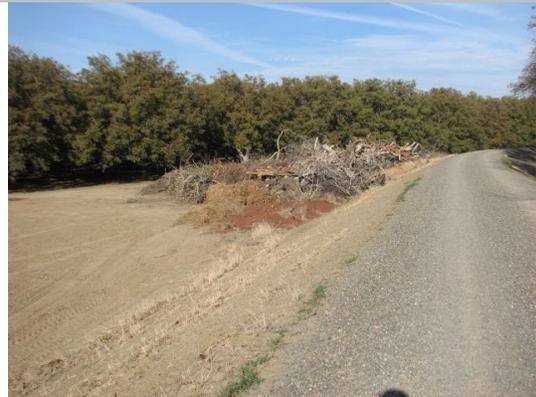
Photo 2 of 3 : SP_2015_ST0001_260_12_20150316_00009.jpg

The never ending pruning pile is at the toe of the levee. Fall 2013

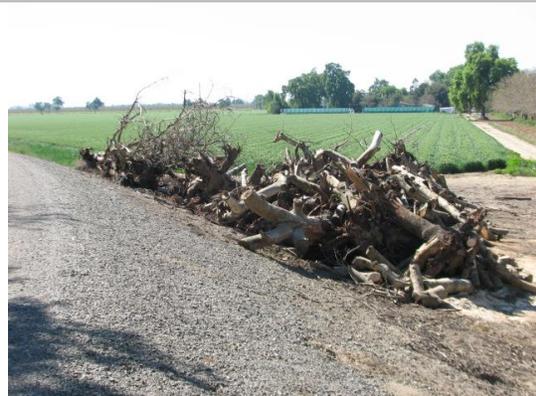
Photo 3 of 3 : SP_2015_ST0001_260_12_20150316_00010.jpg

A large pile of tree trimmings from the walnut orchard. Spring 2014

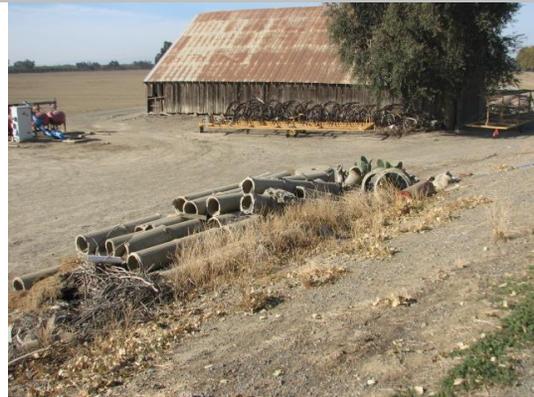
Photo 1 of 2 : SP_2015_ST0001_260_3_20150316_00002.jpg

The concrete pipe is within the easement of the levee. Fall 2013

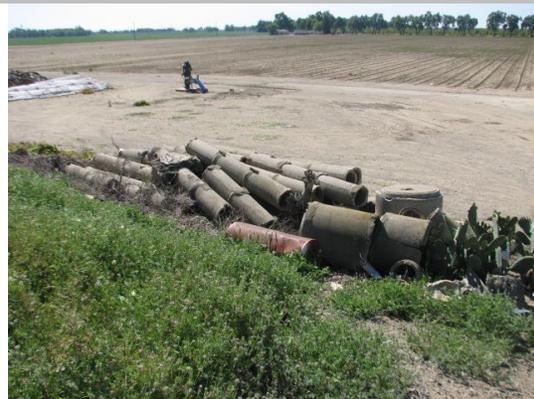
Photo 2 of 2 : SP_2015_ST0001_260_3_20150316_00003.jpg

the pile of concrete pipe is next to the toe of the levee. Spring 2014

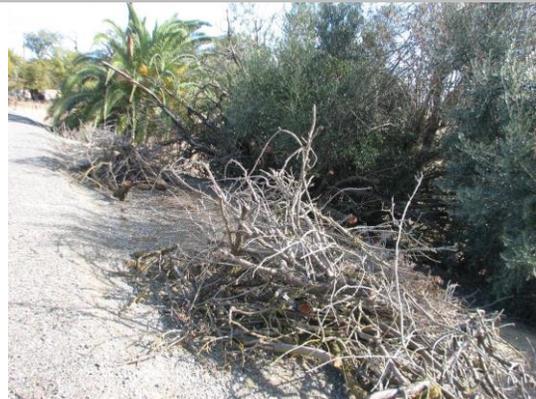
Photo 1 of 2 : SP_2015_ST0001_260_435_20150316_00018.jpg

Levee mile 3.28, landscaping and pruning pile. Fall 2014.

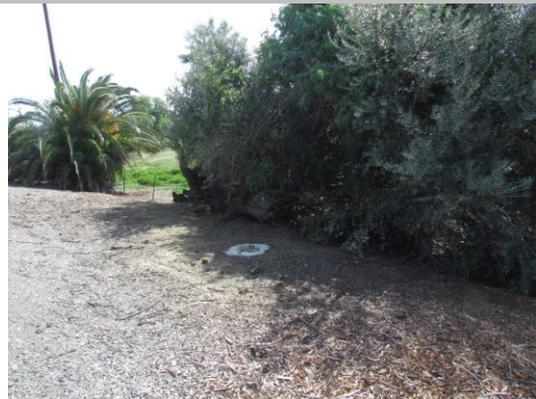
Photo 2 of 2 : SP_2015_ST0001_260_435_20150413_00022.jpg

View of the landscaping vegetation on the landward side of the levee looking downstream. The pile of pruning has been removed. Spring 2015.

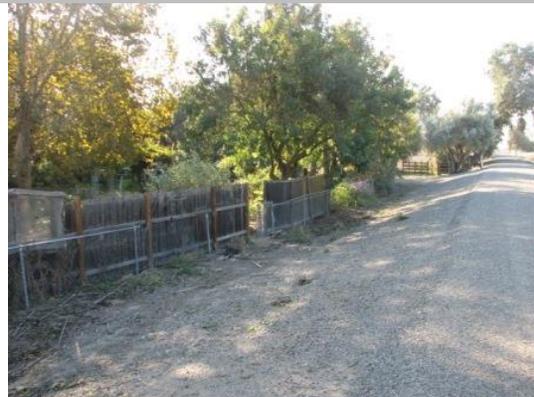
Photo 1 of 1 : SP_2015_ST0001_260_7_20150316_00005.jpg

The landscaping and fence are obstructive to viewing the levee toe. Fall 2011

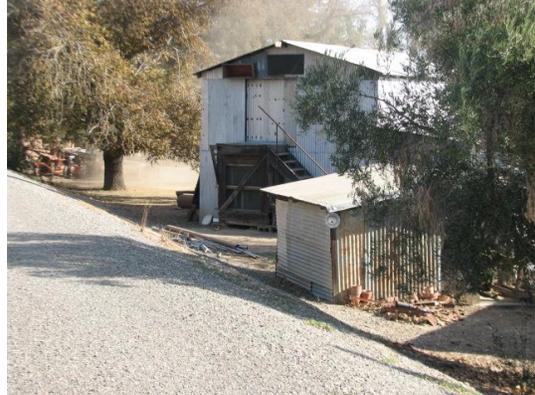
Photo 1 of 1 : SP_2015_ST0001_260_8_20150316_00006.jpg

The out buildings are within the easement of the levee. Fall 2013

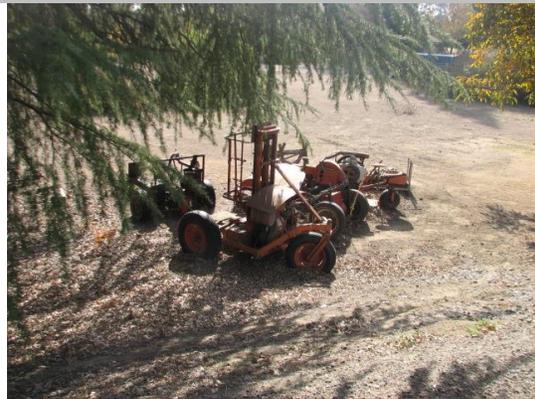
Photo 1 of 1 : SP_2015_ST0001_260_26_20150316_00015.jpg

The are several pieces of equipment near the toe of the levee. Fall 2013

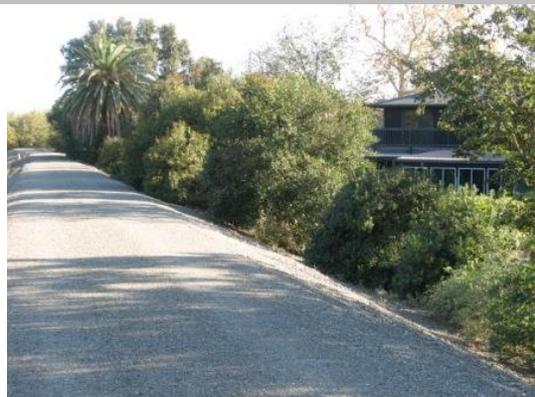
Photo 1 of 1 : SP_2015_ST0001_260_9_20150316_00007.jpg

The landscape shrubs block visibility of the toe. Fall 2011

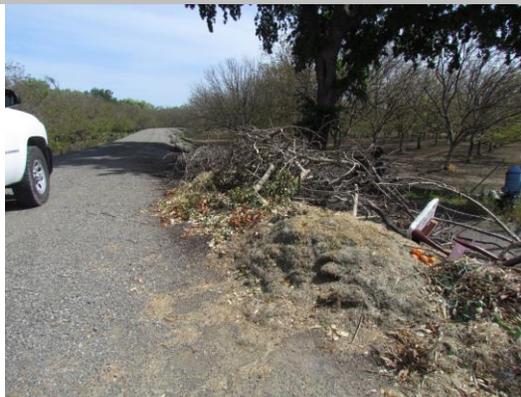
Photo 1 of 1 : SP_2015_ST0001_260_18_20150413_00023.jpg

View of the prunings on the landward side of the levee looking downstream. Spring 2015.

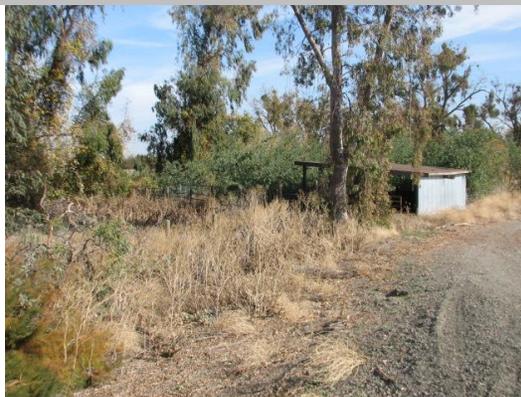
Photo 1 of 1 : SP_2015_ST0001_260_27_20150316_00016.jpg

The horse corral and building are on the waterside berm. Fall 2013

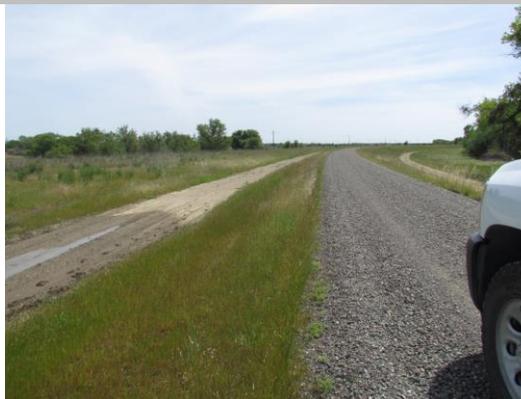
Photo 1 of 1 : SP_2015_ST0001_261_1_20150413_00001.jpg

View of vegetation on the landward side of the levee looking upstream. Spring 2015.
