**Flood Control Project Maintenance
Levee Inspections**
LMA District Cover Sheet
Spring 2016 Levee Inspection Results

Sacramento Maintenance Yard Cache Creek

Spring 2016 Levee Inspection Results

Waterway	Bank	Unit Miles
Unit No. 01 North Levee	Left	11.69

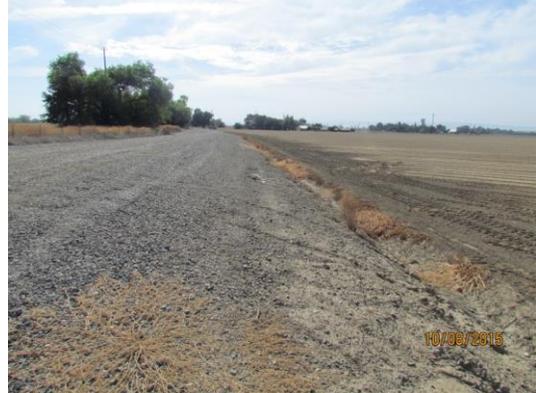
Photo 1 of 1 : SP_2016_ST0001_259_48_20160304_00041.jpg

View of the ditch on the landward side of the levee looking upstream. Fall 2015.

LM Start	0.19	Rating **	C	Issue No.	66
LM End	0.19	Issue Type +	Ma	Location *	WS
Category	Earthen Levee		GPS Latitude/Longitude		
			Start	End	
Item	Slope Stability		38.716904 °	38.716904 °	
			-121.823218 °	-121.823218 °	
DWR ID	DWR_ST0001_01_f_2015_66				
Comment Code					
S3 : Repair the levee slope damaged by vehicle traffic and prevent access where possible.					
Inspector Comment					
Issue has been corrected.

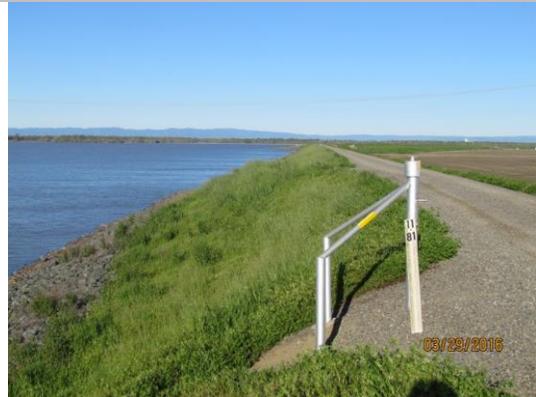
Photo 1 of 1 : SP_2016_ST0001_259_44_20160407_00073.jpg

View of the vegetation on the waterward side of the levee looking upstream. Spring 2016.

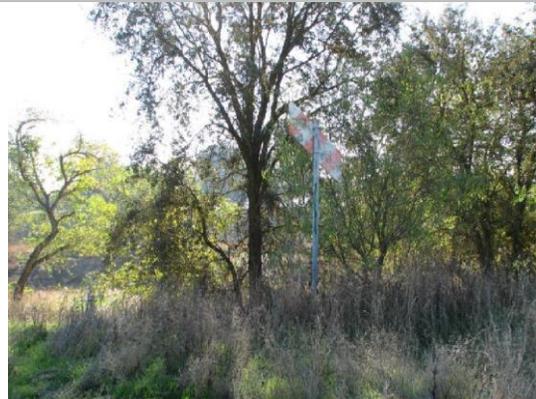
Photo 1 of 2 : UCIP_SP_2016_46679_60162.jpg

LM Start	1.37	Rating **	M	Issue No.	73
LM End	1.37	Issue Type +	En	Location *	LS
Category	Supplemental		GPS Latitude/Longitude		
			Start	End	
Item	DWR UCIP Field Study		38.722669°	38.722669°	
			-121.808792°	-121.808792°	
DWR ID					
Comment Code					
Inspector Comment					
FS_ID:46679 DS_ID:16270 EP_NO: 6790 Repair Type: Non-Urgent Crossing Status: Indicator Found UCIP Comments: May need additional signs on LS of levee. FIELD_STRUCT_DESC: 6-inch gas line through the levee at an unknown elevation and under channel. Gasline marker on WS slope (Permit No. 6790 - PG&E) FS Date: 10/5/2015 2:18:04 PM

Waterside view: gasline marker

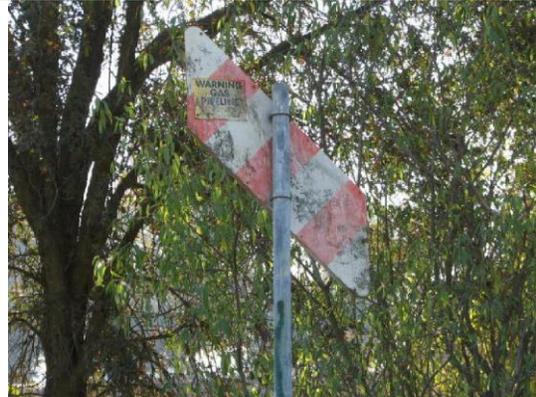
Photo 2 of 2 : UCIP_SP_2016_46679_60161.jpg

LM Start	1.37	Rating **	M	Issue No.	73 (cont)
LM End	1.37	Issue Type +	En	Location *	LS
Category	Supplemental			GPS Latitude/Longitude	
				Start	End
Item	DWR UCIP Field Study			38.722669 °	38.722669 °
				-121.808792 °	-121.808792 °
DWR ID					
Comment Code					
Inspector Comment					
FS_ID:46679 DS_ID:16270 EP_NO: 6790 Repair Type: Non-Urgent Crossing Status: Indicator Found UCIP Comments: May need additional signs on LS of levee. FIELD_STRUCT_DESC: 6-inch gas line through the levee at an unknown elevation and under channel. Gasline marker on WS slope (Permit No. 6790 - PG&E) FS Date: 10/5/2015 2:18:04 PM

Waterside view: closer look at gasline marker

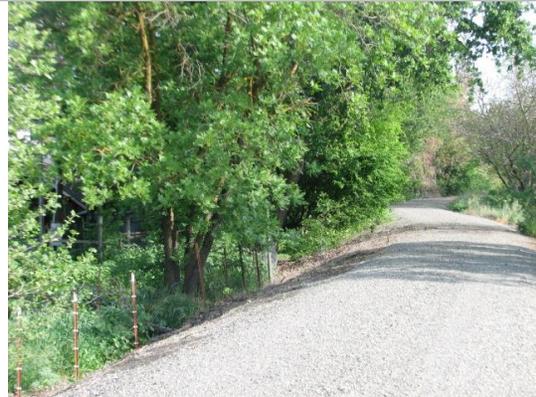
Photo 1 of 2 : SP_2016_ST0001_259_3_20160304_00002.jpg

LM Start	1.89	Rating **	M	Issue No.	3
LM End	1.98	Issue Type +	En	Location *	LS
Category	Earthen Levee			GPS Latitude/Longitude	
				Start	End
Item	Vegetation			38.729828 °	38.731143 °
				-121.806532 °	-121.806255 °
DWR ID	DWR_ST0001_01_s_2012_3				
Comment Code					
V6 : Landscaping					
Inspector Comment

The landscape needs to be trimmed up. Spring 2014

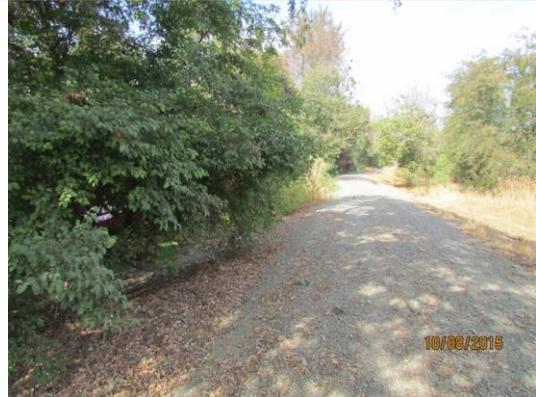
Photo 2 of 2 : SP_2016_ST0001_259_3_20160304_00003.jpg

View of the landscaping that needs to be trimmed on the landward side of the levee looking downstream. Fall 2015.

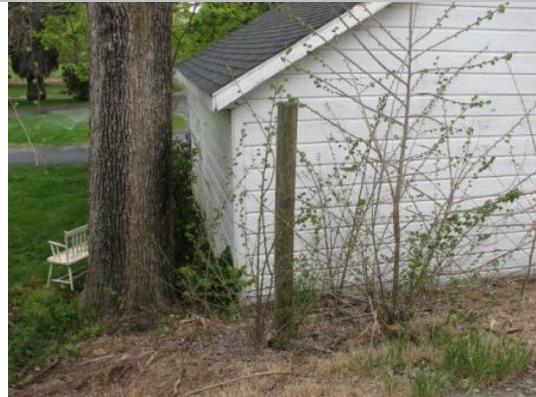
Photo 1 of 1 : SP_2016_ST0001_259_4_20160304_00004.jpg

LM Start	1.94	Rating **	M	Issue No.	4
LM End	1.94	Issue Type +	En	Location *	LS
Category	Earthen Levee			GPS Latitude/Longitude	
				Start	End
Item	Encroachments			38.730528 °	38.730528 °
				-121.806485 °	-121.806485 °
DWR ID	DWR_ST0001_01_s_2012_4				
Comment Code					
BU : Building					
Inspector Comment

The building backs up to the landside levee toe of the levee.

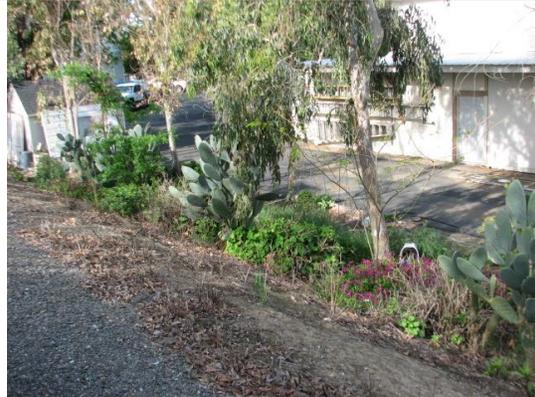
Photo 1 of 1 : SP_2016_ST0001_259_28_20160304_00027.jpg

The property owner has planted cactus along the toe of the levee. Spring 2014

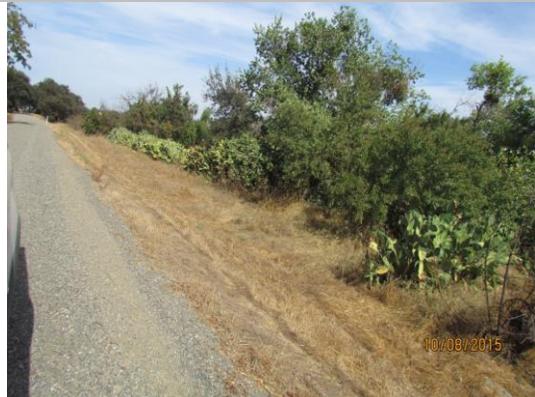
Photo 1 of 1 : SP_2016_ST0001_259_6_20160304_00005.jpg

View of the cactus landscaping on the waterward side of the levee looking downstream. Fall 2015.

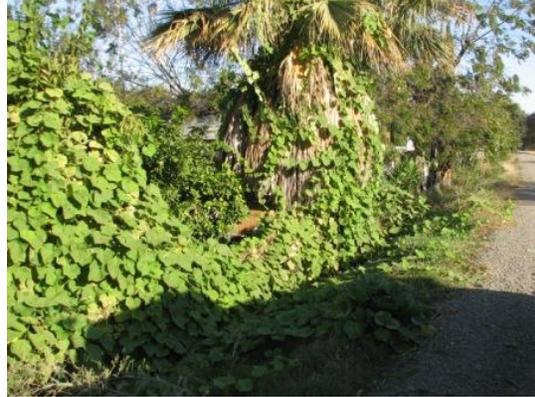
Photo 1 of 2 : SP_2016_ST0001_259_7_20160304_00006.jpg

Wild grape and other plants are obstructing the view for inspection. Fall 2011

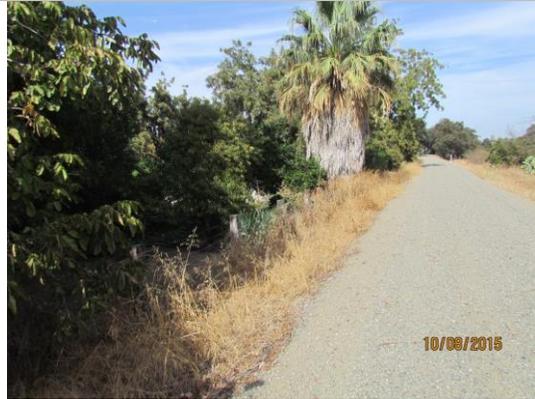
Photo 2 of 2 : SP_2016_ST0001_259_7_20160304_00007.jpg

View of the landscaping on the landward side of the levee looking downstream. Fall 2015.

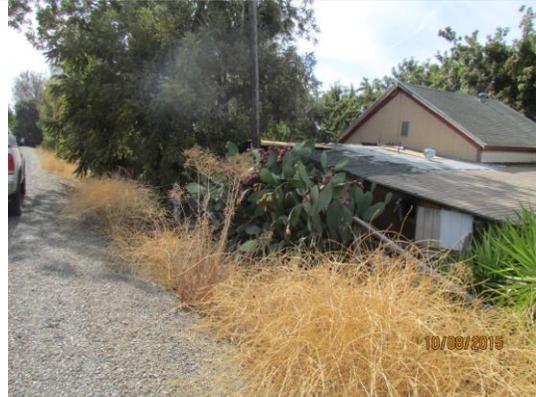
Photo 1 of 1 : SP_2016_ST0001_259_8_20160304_00008.jpg

View of the building on the landward side of the levee looking upstream. Cactus planted at the toe obstructs visibility. Fall 2015.

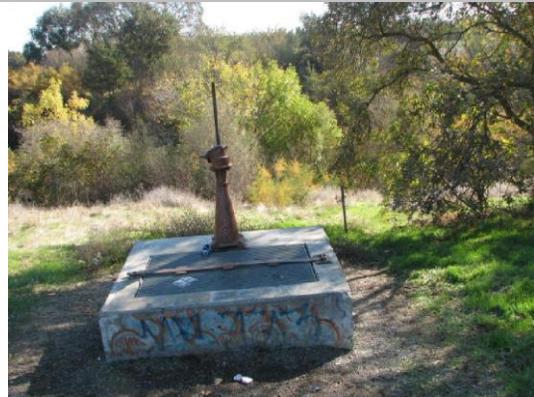
Photo 1 of 2 : UCIP_SP_2016_46680_61122.jpg

LM Start	2.09	Rating **	M	Issue No.	74
LM End	2.09	Issue Type +	En	Location *	LS
Category	Supplemental		GPS Latitude/Longitude		
			Start	End	
Item	DWR UCIP Field Study		38.732665 °	38.732665 °	
			-121.805604 °	-121.805604 °	
DWR ID					
Comment Code					
Inspector Comment					
FS_ID:46680 DS_ID:16269 EP_NO: 13077A Repair Type: Non-Urgent Crossing Status: Found UCIP Comments: A pump house located LS across the road. A debris is blocking the outlet channel of the pipe. It needs to be removed (an abandoned sofa). removed debri summer of 2013 FIELD_STRUCT_DESC: Pipe through the levee, screw gate on waterward slope. One of two pipes (30" diameter and 10" diameter) of a storm drainage system. A gate riser structure approximately 4 ft waterward of the waterside levee shoulder. A flap gate on the pipeline at the discharge structure. FS Date: 10/5/2015 2:22:58 PM

Waterside view: a concrete control box with slide gate

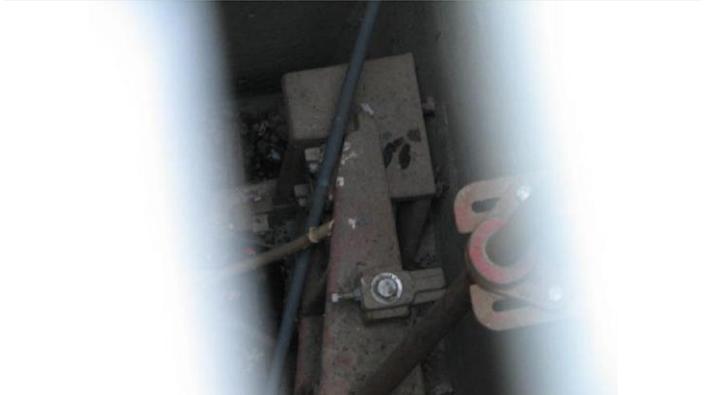
Photo 2 of 2 : UCIP_SP_2016_46680_61120.jpg

Waterside view: inside the control box

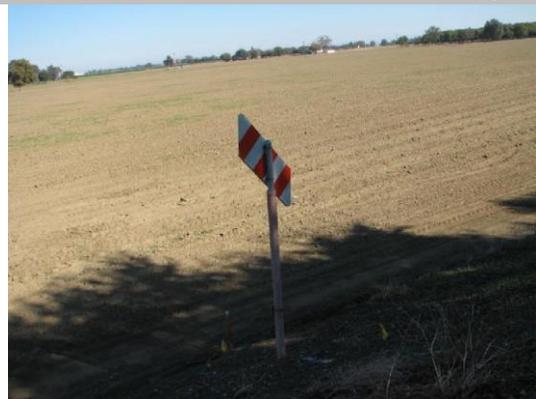
Photo 2 of 2 : UCIP_SP_2016_46681_60163.jpg

LM Start	2.26	Rating **	M	Issue No.	75
LM End	2.26	Issue Type +	En	Location *	LS
Category	Supplemental			GPS Latitude/Longitude	
				Start	End
Item	DWR UCIP Field Study			38.733675 °	38.733675 °
				-121.803009 °	-121.803009 °
DWR ID					
Comment Code					
Inspector Comment					
FS_ID:46681 DS_ID:16268 EP_NO: 2415 Repair Type: Non-Urgent Crossing Status: Indicator Found UCIP Comments: May need to install gasoline marker on WS slope. FIELD_STRUCT_DESC: 20-inch gas line through the levee 4.0 feet below the crown. Two cutoff walls. Gasline indicator found on landside of the levee (Permit No. 2415 - PG&E) FS Date: 10/5/2015 2:23:47 PM

Landside view: gasoline indicator

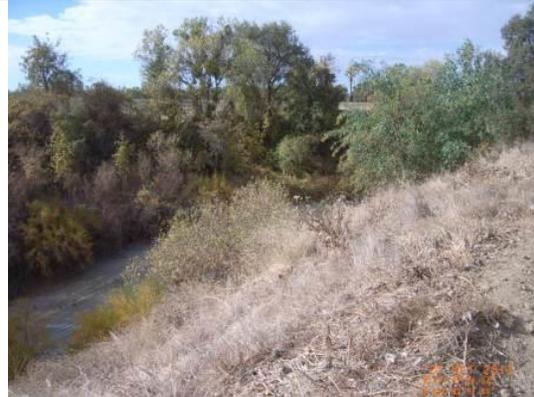
Photo 1 of 1 : SP_2016_ST0001_259_17_20160304_00018.jpg

LM Start	2.57	Rating **	A/W	Issue No.	17
LM End	2.61	Issue Type +	Ma	Location *	WS
Category	Supplemental			GPS Latitude/Longitude	
				Start	End
Item	2015 USACE Erosion Survey, DRAFT			38.732836 °	38.732685 °
				-121.797893 °	-121.797154 °
DWR ID	DWR_ST0001_01_s_2016_17				
Comment Code					
Inspector Comment					
Site identified as CRITICAL in 2002. 2006 - Currently constructing a setback levee. New failures present and extensive. Downstream end of the setback levee did not extend far enough. Upstream end was repaired. 2007 - DWR repaired with a setback levee, but the levee did not go far enough downstream. 2012 - New cracks observed. 2013 - Fresh erosion on upper bank. 2015: No observed changes. [2015 Site ID: CHC_2-4_L]

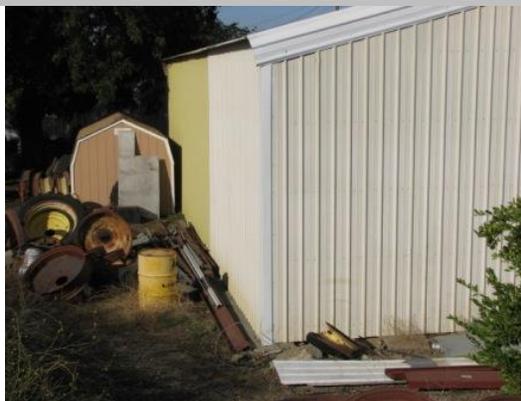
Photo 1 of 2 : SP_2016_ST0001_259_20_20160304_00021.jpg

The corner of the shop is within the easement of the levee. Fall 2011

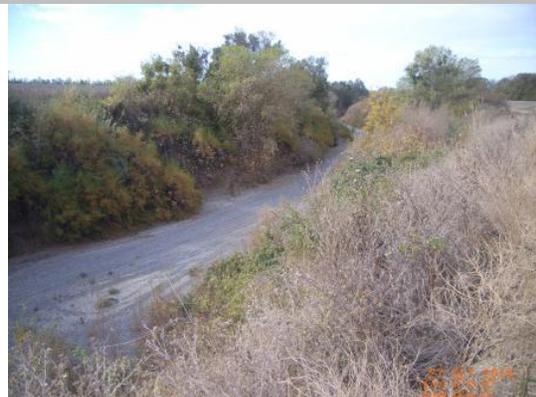
Photo 1 of 1 : SP_2016_ST0001_259_38_20160304_00033.jpg

LM Start	2.82	Rating **	A/W	Issue No.	38
LM End	2.86	Issue Type +	Ma	Location *	WS
Category	Supplemental			GPS Latitude/Longitude	
				Start	End
Item	2015 USACE Erosion Survey, DRAFT			38.734067 °	38.734171 °
				-121.793713 °	-121.792992 °
DWR ID	DWR_ST0001_01_s_2016_38				
Comment Code					
Inspector Comment					
2006 - Large new failure. 2008 - Plans for repair currently in the design phase. 2010 - Planned setback levee by CA DWR, 60% design complete, construction planned for 2012. 2011 - Construction delayed to 2013 - 2014. 2015: No observed changes. [2015 Site ID: CHC_2-8_L]

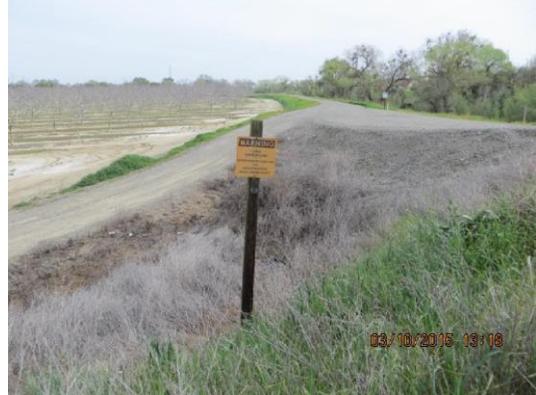
Photo 1 of 2 : UCIP_SP_2016_46685_73501.jpg

LM Start	4.98	Rating **	M	Issue No.	76
LM End	4.98	Issue Type +	En	Location *	LS
Category	Supplemental			GPS Latitude/Longitude	
				Start	End
Item	DWR UCIP Field Study			38.721038 °	38.721038 °
				-121.764180 °	-121.764180 °
DWR ID					
Comment Code					
Inspector Comment					
FS_ID:46685 DS_ID:16265 EP_NO: 7232 Repair Type: Non-Urgent Crossing Status: Indicator Found UCIP Comments: May need marker on WS. FIELD_STRUCT_DESC: Submarine Communication cable through the levee 2.5-feet below the crown. Communication marker located on eastside of highway 113 on LS toe. (Permit No. 7232 - PT&T). FS Date: 10/5/2015 2:26:16 PM

Sign on LS toe.

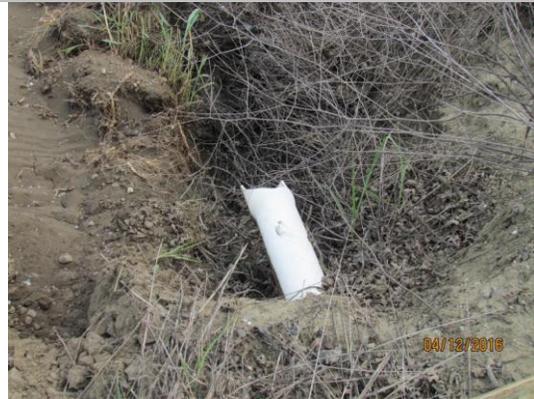
Photo 1 of 3 : SP_2016_ST0001_259_19_20160413_00078.jpg

The PVC pipe is at the end of the ditch at levee mile 6.91. Spring 2016.

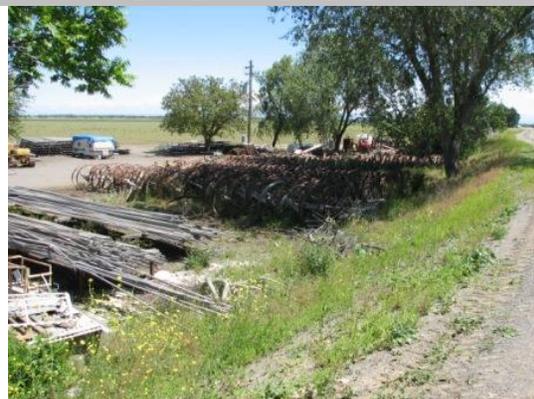
Photo 1 of 2 : SP_2016_ST0001_259_40_20160304_00035.jpg

Irrigation pipe and equipment are within the easement of the levee.

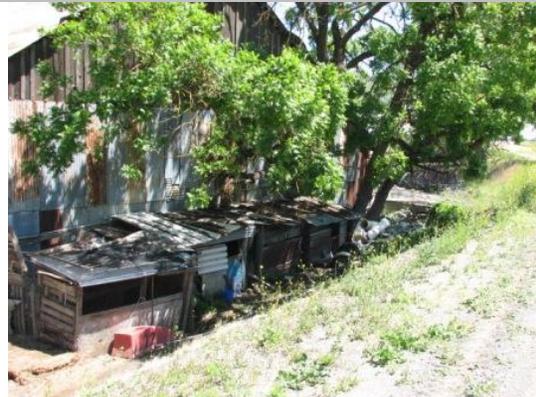
Photo 1 of 1 : SP_2016_ST0001_259_39_20160304_00034.jpg

The barn and livestock pens are within the easement of the levee.

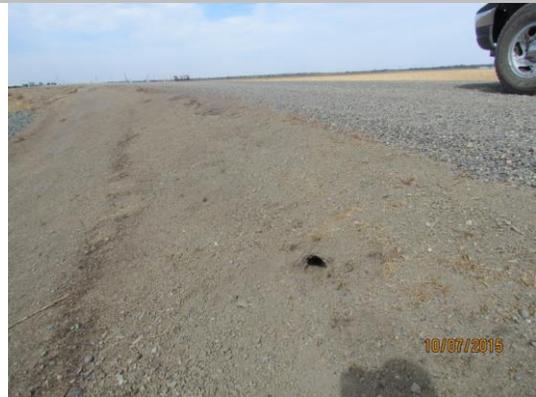
Photo 1 of 2 : SP_2016_ST0001_259_37_20160304_00031.jpg

View of the rodent hole on the waterward side of the levee looking upstream. Fall 2015.

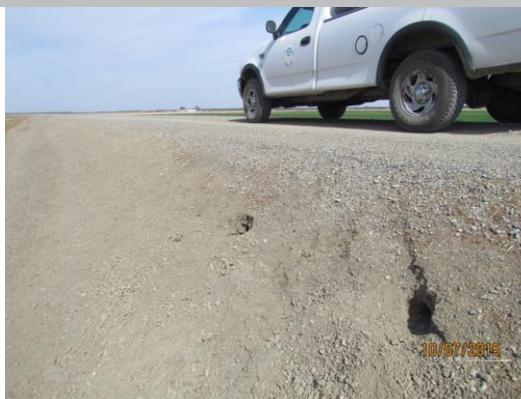
Photo 1 of 1 : SP_2016_ST0001_259_35_20160304_00030.jpg

View of the rodent hole on the waterward side of the levee looking upstream. Fall 2015.

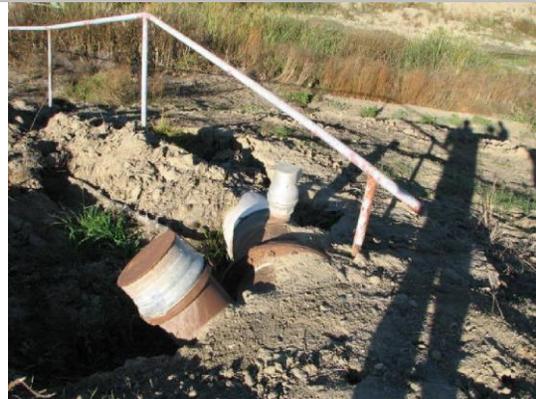
Photo 2 of 2 : UCIP_SP_2016_46707_60147.jpg

Landside view: pipe daylight on LS levee slope

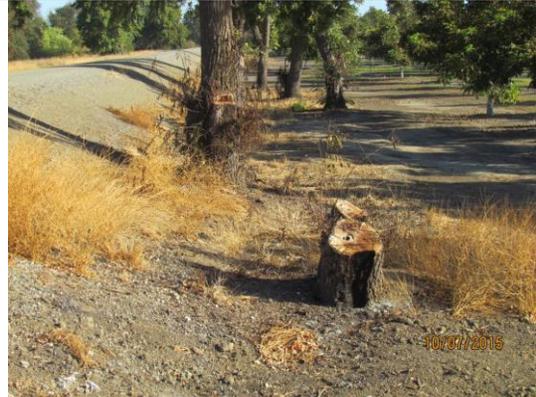
Photo 1 of 1 : SP_2016_ST0001_260_10_20160304_00008.jpg

View of the tree stump at the landward side of the levee looking downstream. Fall 2015.

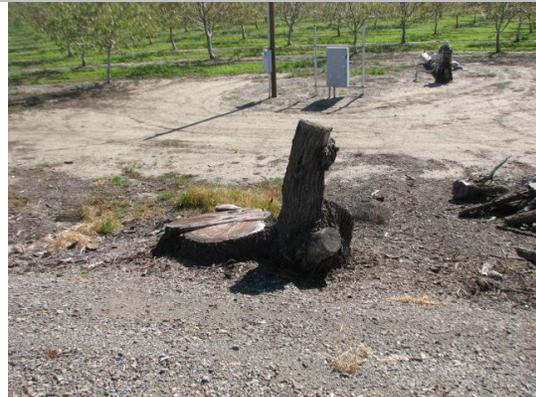
Photo 1 of 1 : SP_2016_ST0001_260_6_20160304_00004.jpg

A large black walnut tree stump is at the toe of the levee. Spring 2014

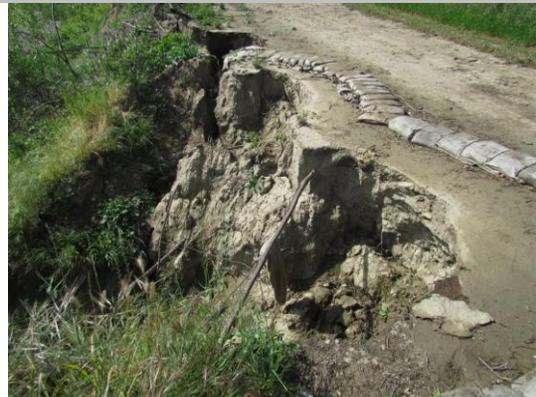
Photo 1 of 2 : SP_2016_ST0001_260_11_20160304_00009.jpg

View of the erosion on the channel looking downstream. Spring 2015.

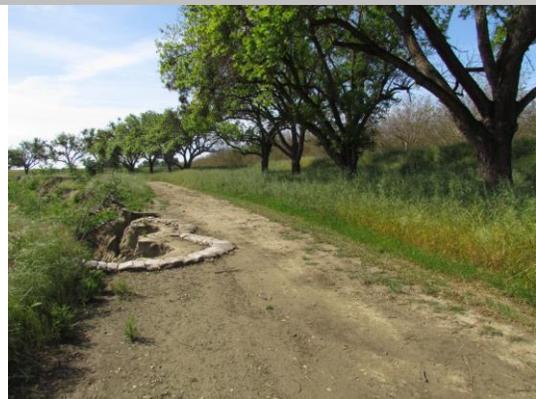
Photo 2 of 2 : SP_2016_ST0001_260_11_20160304_00010.jpg

The view of the erosion from a distance. Spring 2015.

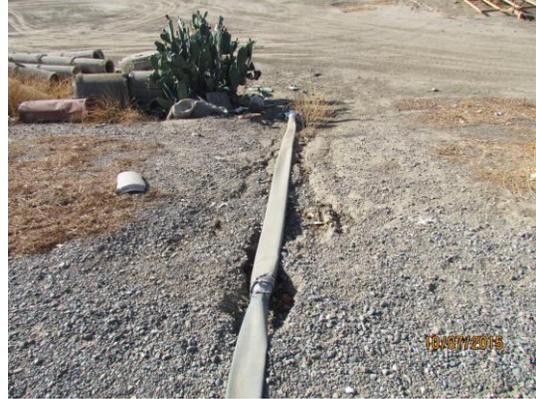
Photo 1 of 2 : SP_2016_ST0001_260_19_20160304_00014.jpg

The erosion is under the hose on the landward side of the levee. Fall 2015.

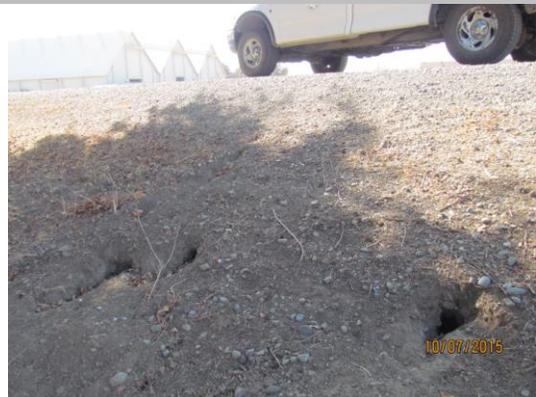
Photo 1 of 1 : SP_2016_ST0001_260_23_20160304_00019.jpg

View of the animal holes on the waterward side of the levee. Fall 2015.
