**Flood Control Project Maintenance
Levee Inspections**

Maintenance Issue Types Only, Levee Inspection Report By Mile - Spring 2015

Sacramento Maintenance Yard Cache Creek

Waterway	Bank	Unit Miles	Inspection Start/End	Inspector
Unit No. 01 North Levee	Left	11.69	04/09/2015 04/09/2015	Jai Lor

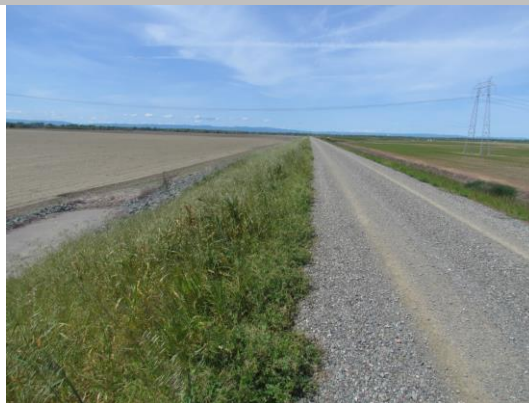
Photo 1 of 1 : SP_2015_ST0001_259_23_20150413_00038.jpg

LM Start	0.14	Rating **	M	Issue No.	23
LM End	11.64	Issue Type +	Ma	Location *	WS
Category	Earthen Levee			GPS Latitude/Longitude	
				Start	End
Item	Vegetation			38.716392 °	38.698572 °
				-121.824078 °	-121.675012 °
DWR ID	DWR_ST0001_01_s _ 2015_23				
Action/Comments					
Control annual grass and weeds on the levee slopes and easements.

View of vegetation on the waterward side of the levee looking upstream.
Spring 2015.

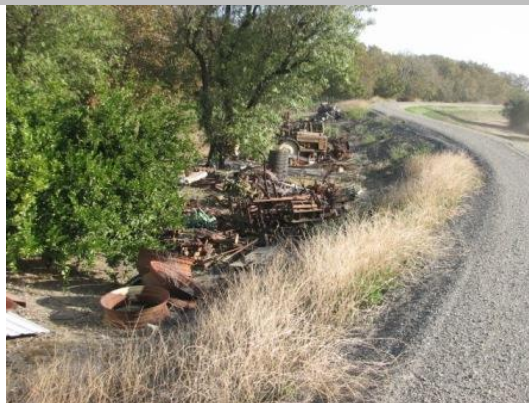
Photo 1 of 2 : SP_2015_ST0001_259_19_20150316_00020.jpg

LM Start	2.68	Rating **	M	Issue No.	19
LM End	2.72	Issue Type +	Ma	Location *	LS
Category	Earthen Levee			GPS Latitude/Longitude	
				Start	End
Item	Encroachments			38.733080 °	38.733492 °
				-121.796013 °	-121.795293 °
DWR ID	DWR_ST0001_01_s_2012_19				
Action/Comments					
Equipment

The equipment is stored at the toe of the levee. Fall 2011

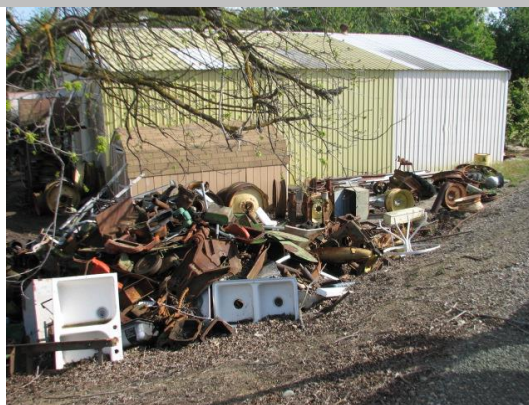
Photo 2 of 2 : SP_2015_ST0001_259_19_20150316_00021.jpg

Equipment and parts stacked along the levee toe and slope. Spring 2014

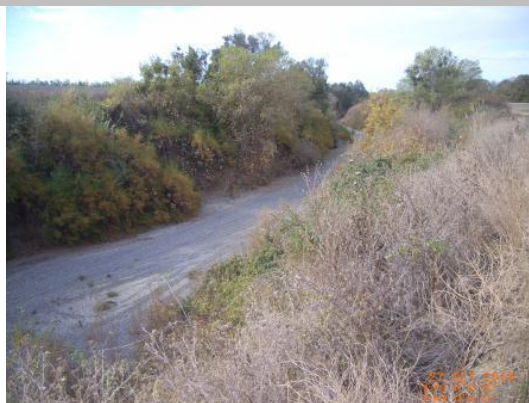
Photo 1 of 1 : SP_2015_ST0001_259_30_20150316_00026.jpg

LM Start	2.82	Rating **	M	Issue No.	30
LM End	2.86	Issue Type +	Ma	Location *	WS
Category	Supplemental			GPS Latitude/Longitude	
				Start	End
Item	USACE Erosion Survey			38.734067 °	38.734171 °
				-121.793713 °	-121.792992 °
DWR ID	DWR_ST0001_01_f_2014_30				
Action/Comments					
Inspector Comments: 2006 - Large new failure. 2008 - Plans for repair currently in the design phase. 2010 - Planned setback levee by CA DWR, 60% design complete, construction planned for 2012. 2011 - Construction delayed to 2013 - 2014. 2013: No observed changes. [2013 Site ID: CHC_2-8_L]

USACE 2013 Photo #1

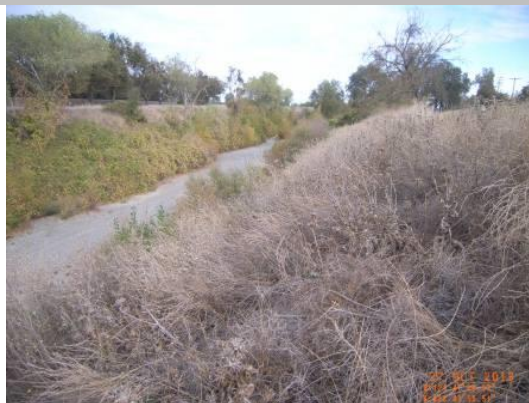
Photo 1 of 1 : SP_2015_ST0001_259_18_20150316_00019.jpg

LM Start	3.48	Rating **	M	Issue No.	18
LM End	3.57	Issue Type +	Ma	Location *	WS
Category	Supplemental			GPS Latitude/Longitude	
				Start	End
Item	USACE Erosion Survey			38.732942 °	38.731626 °
				-121.784965 °	-121.785231 °
DWR ID	DWR_ST0001_01_f_2014_18				
Action/Comments					
Inspector Comments: 2006 - Some significant new erosion, especially fresh upper bank slumping. Still substantial berm. 2010 - Site extended downstream, some new erosion, heavily vegetated and hard to see. Planned setback levee by CA DWR, 60% design complete, construction planned for 2012. 2011 - Construction delayed to 2013 - 2014. 2013: No observed changes. [2013 Site ID: CHC_3-4_L]

USACE 2013 Photo #1

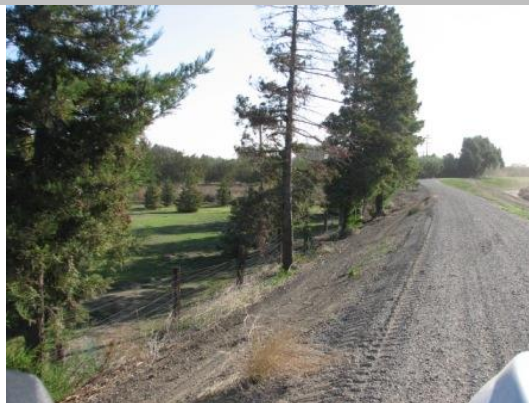
Photo 1 of 1 : SP_2015_ST0001_259_27_20150316_00024.jpg

LM Start	4.28	Rating **	M	Issue No.	27
LM End	4.43	Issue Type +	Ma	Location *	LS
Category	Earthen Levee			GPS Latitude/Longitude	
				Start	End
Item	Vegetation			38.727047 °	38.726113 °
				-121.774413 °	-121.771929 °
DWR ID	DWR_ST0001_01_s_2012_27				
Action/Comments					
Landscaping

Landscape trees are planted along the levee to and on the slope. Some of the trees are trimmed up for visibility. Fall 2011

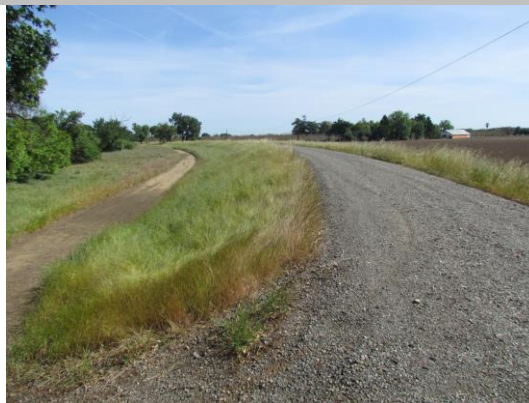
Photo 1 of 1 : SP_2015_ST0001_260_4_20150413_00019.jpg

LM Start	0.02	Rating **	M	Issue No.	4
LM End	4.32	Issue Type +	Ma	Location *	WS
Category	Earthen Levee			GPS Latitude/Longitude	
				Start	End
Item	Vegetation			38.727372 °	38.726432 °
				-121.806047 °	-121.749063 °
DWR ID	DWR_ST0001_02_s _ 2015_4				
Action/Comments					
Control annual grass and weeds on the levee slopes and easements.

View of the vegetation on the waterward side of the levee looking downstream. Spring 2015.

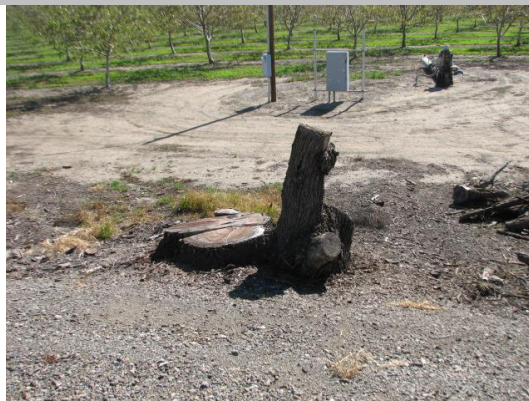
Photo 1 of 1 : SP_2015_ST0001_260_6_20150316_00004.jpg

LM Start	0.27	Rating **	N	Issue No.	6
LM End	0.27	Issue Type +	Ma	Location *	LS
Category	Earthen Levee			GPS Latitude/Longitude	
				Start	End
Item	Trim / Thin Trees			38.730723 °	38.730723 °
				-121.804972 °	-121.804972 °
DWR ID	DWR_ST0001_02_s _ 2014_6				
Action/Comments					
Tree stumps.

A large black walnut tree stump is at the toe of the levee. Spring 2014

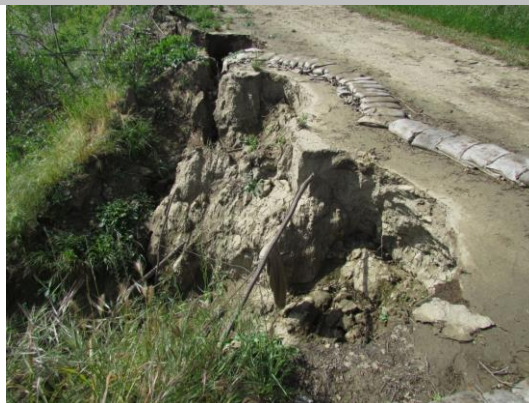
Photo 1 of 2 : SP_2015_ST0001_260_11_20150413_00020.jpg

LM Start	1.60	Rating **	A/W	Issue No.	11
LM End	1.60	Issue Type +	Ma	Location *	WS
Category	Earthen Levee			GPS Latitude/Longitude	
				Start	End
Item	Erosion / Bank Caving			38.731652 °	38.731652 °
				-121.786253 °	-121.786253 °
DWR ID	DWR_ST0001_02_s_2015_11				
Action/Comments					
Inspector Comments: The erosion is down by the channel and does not appear to be in the levee prism.

View of the erosion on the channel looking downstream. Spring 2015.

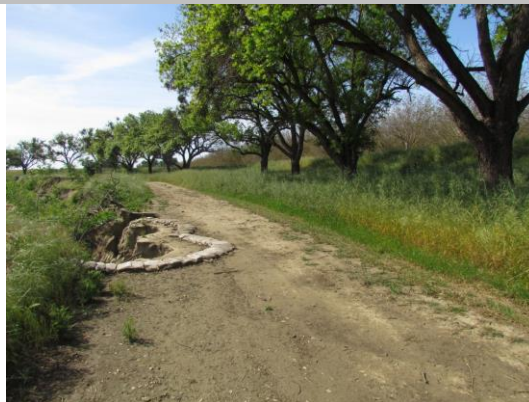
Photo 2 of 2 : SP_2015_ST0001_260_11_20150413_00021.jpg

The view of the erosion from a distance. Spring 2015.

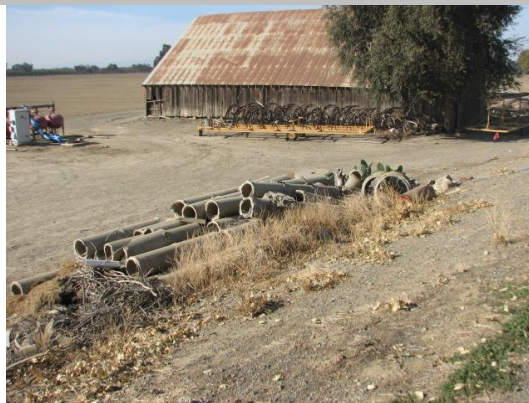
Photo 1 of 2 : SP_2015_ST0001_260_3_20150316_00002.jpg

LM Start	2.40	Rating **	M	Issue No.	3
LM End	2.40	Issue Type +	Ma	Location *	LS
Category	Earthen Levee			GPS Latitude/Longitude	
				Start	End
Item	Encroachments			38.726182 °	38.726182 °
				-121.774835 °	-121.774835 °
DWR ID	DWR_ST0001_02_s_2012_3				
Action/Comments					
Debris

The concrete pipe is within the easement of the levee. Fall 2013

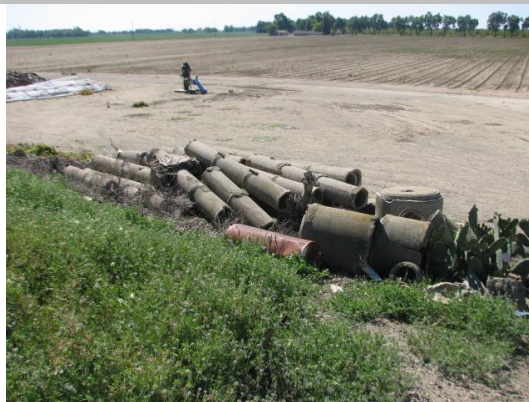
Photo 2 of 2 : SP_2015_ST0001_260_3_20150316_00003.jpg

the pile of concrete pipe is next to the toe of the levee. Spring 2014

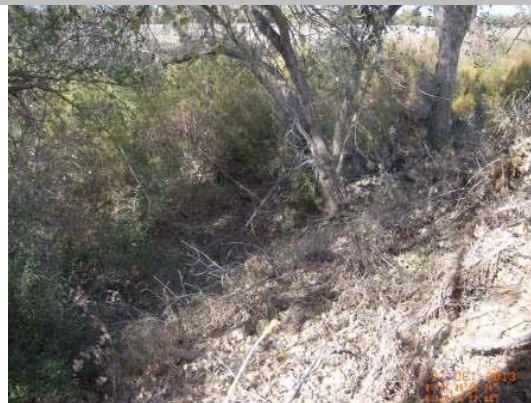
Photo 1 of 1 : SP_2015_ST0001_260_13_20150316_00011.jpg

LM Start	3.53	Rating **	M	Issue No.	13
LM End	3.60	Issue Type +	Ma	Location *	WS
Category	Supplemental			GPS Latitude/Longitude	
				Start	End
Item	USACE Erosion Survey			38.722138 °	38.723294 °
				-121.759736 °	-121.759588 °
DWR ID	DWR_ST0001_02_f_2014_13				
Action/Comments					
Inspector Comments: 2010 - Large slump on the upper berm, a tree has recently slid down the slope. 2011 - Large slump and new erosion. 2012 - Slightly steeper slopes and cracks observed. 2013: No observed changes. [2013 Site ID: CHC_3-5_R]

USACE 2013 Photo #1

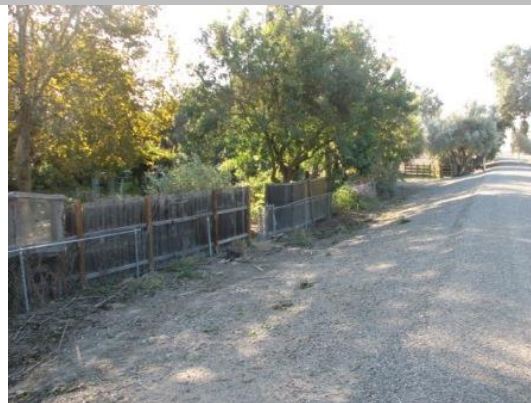
Photo 1 of 1 : SP_2015_ST0001_260_7_20150316_00005.jpg

LM Start	3.53	Rating **	A/W	Issue No.	7
LM End	3.62	Issue Type +	Ma	Location *	LS
Category	Earthen Levee			GPS Latitude/Longitude	
				Start	End
Item	Vegetation			38.722228 °	38.723322 °
				-121.759663 °	-121.759317 °
DWR ID	DWR_ST0001_02_s_2012_7				
Action/Comments					
Landscaping

The landscaping and fence are obstructive to viewing the levee toe. Fall 2011

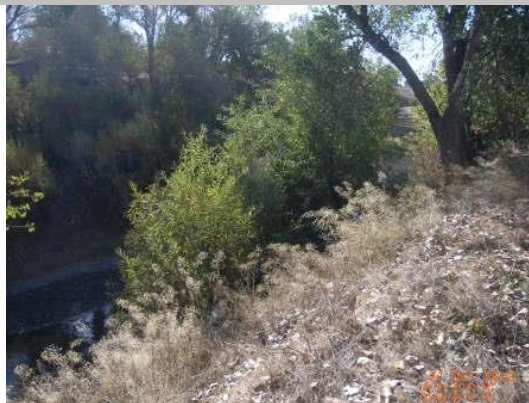
Photo 1 of 1 : SP_2015_ST0001_260_14_20150316_00012.jpg

LM Start	3.58	Rating **	M	Issue No.	14
LM End	3.59	Issue Type +	Ma	Location *	WS
Category	Supplemental			GPS Latitude/Longitude	
				Start	End
Item	USACE Erosion Survey			38.722933 °	38.723467 °
				-121.760561 °	-121.760436 °
DWR ID	DWR_ST0001_02_f_2014_14				
Action/Comments					
Inspector Comments: 2009 - Erosion into the levee slope. 2010 - Minor new erosion. 2011 - New erosion and a freshly fallen tree. 2012 - New animal holes and slightly steeper slopes. 2013: New tree popout and 2 feet of erosion along the top bank. [2013 Site ID: CHC_5-4_L]

USACE 2013 Photo #1

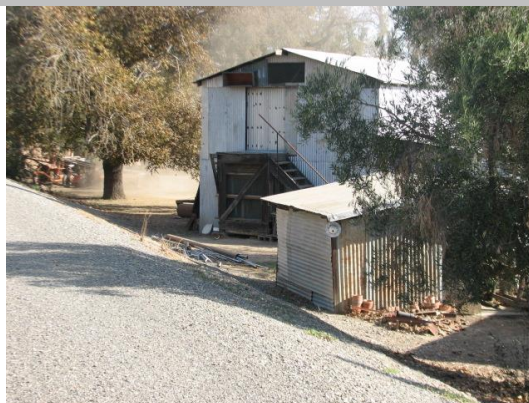
Photo 1 of 1 : SP_2015_ST0001_260_8_20150316_00006.jpg

LM Start	4.06	Rating **	M	Issue No.	8
LM End	4.06	Issue Type +	Ma	Location *	LS
Category	Earthen Levee			GPS Latitude/Longitude	
				Start	End
Item	Encroachments			38.723997 °	38.723997 °
				-121.752505 °	-121.752505 °
DWR ID	DWR_ST0001_02_s_2012_8				
Action/Comments					
Building

The out buildings are within the easement of the levee. Fall 2013

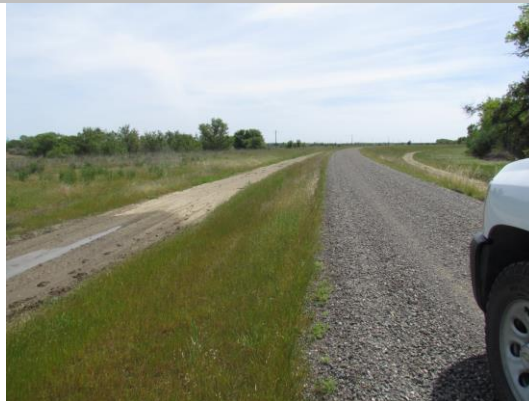
Photo 1 of 1 : SP_2015_ST0001_261_1_20150413_00001.jpg

LM Start	0.07	Rating **	M	Issue No.	1
LM End	2.25	Issue Type +	Ma	Location *	LS
Category	Earthen Levee			GPS Latitude/Longitude	
				Start	End
Item	Vegetation			38.726608 °	38.695600 °
				-121.717247 °	-121.715952 °
DWR ID	DWR_ST0001_04_s _ 2015_1				
Action/Comments					
Control annual grass and weeds on the levee slopes and easements.

View of vegetation on the landward side of the levee looking upstream.
Spring 2015.
