**Flood Control Project Maintenance
Levee Inspections**

Maintenance Issue Types Only, Levee Inspection Report By Mile - Spring 2016

Sacramento Maintenance Yard Cache Creek

Waterway	Bank	Unit Miles	Inspection Start/End	Inspector
Unit No. 01 North Levee	Left	11.69	03/29/2016 03/29/2016	Jai Lor

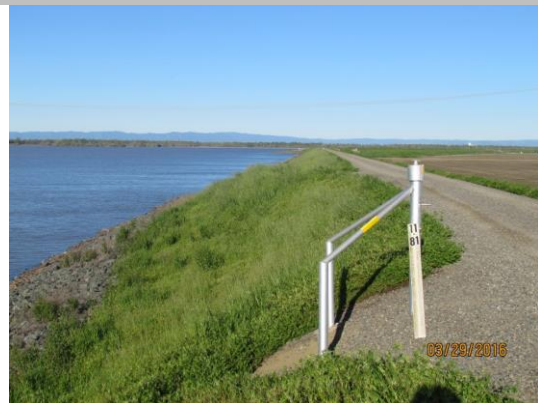
Photo 1 of 1 : SP_2016_ST0001_259_44_20160407_00073.jpg

LM Start	0.93	Rating **	M	Issue No.	44
LM End	11.68	Issue Type +	Ma	Location *	WS
Category	Earthen Levee			GPS Latitude/Longitude	
				Start	End
Item	Vegetation			38.719244 °	38.698604 °
				-121.815124 °	-121.674239 °
DWR ID	DWR_ST0001_01_s_2016_44				
Comment Code					
V1 : Control annual grass and weeds on the levee slopes and easements.					
Inspector Comment

View of the vegetation on the waterward side of the levee looking upstream. Spring 2016.

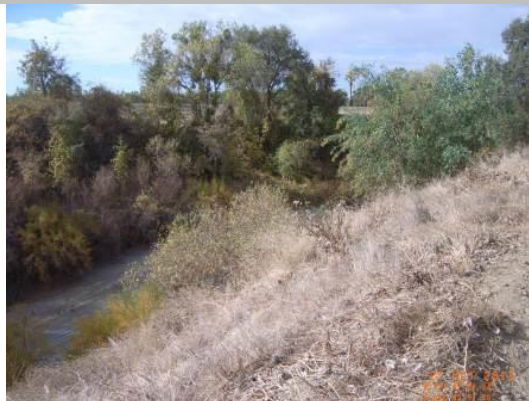
Photo 1 of 1 : SP_2016_ST0001_259_17_20160304_00018.jpg

LM Start	2.57	Rating **	A/W	Issue No.	17
LM End	2.61	Issue Type +	Ma	Location *	WS
Category	Supplemental			GPS Latitude/Longitude	
				Start	End
Item	2015 USACE Erosion Survey, DRAFT			38.732836 °	38.732685 °
				-121.797893 °	-121.797154 °
DWR ID	DWR_ST0001_01_s_2016_17				
Comment Code					
Inspector Comment					
Site identified as CRITICAL in 2002. 2006 - Currently constructing a setback levee. New failures present and extensive. Downstream end of the setback levee did not extend far enough. Upstream end was repaired. 2007 - DWR repaired with a setback levee, but the levee did not go far enough downstream. 2012 - New cracks observed. 2013 - Fresh erosion on upper bank. 2015: No observed changes. [2015 Site ID: CHC_2-4_L]

USACE 2013 Photo #1

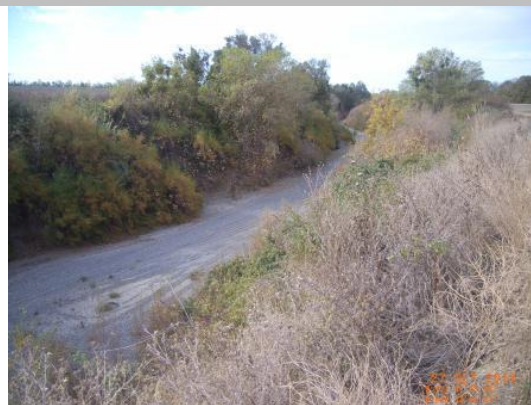
Photo 1 of 1 : SP_2016_ST0001_259_38_20160304_00033.jpg

LM Start	2.82	Rating **	A/W	Issue No.	38
LM End	2.86	Issue Type +	Ma	Location *	WS
Category	Supplemental			GPS Latitude/Longitude	
				Start	End
Item	2015 USACE Erosion Survey, DRAFT			38.734067 °	38.734171 °
				-121.793713 °	-121.792992 °
DWR ID	DWR_ST0001_01_s_2016_38				
Comment Code					
Inspector Comment					
2006 - Large new failure. 2008 - Plans for repair currently in the design phase. 2010 - Planned setback levee by CA DWR, 60% design complete, construction planned for 2012. 2011 - Construction delayed to 2013 - 2014. 2015: No observed changes. [2015 Site ID: CHC_2-8_L]

USACE 2013 Photo #1

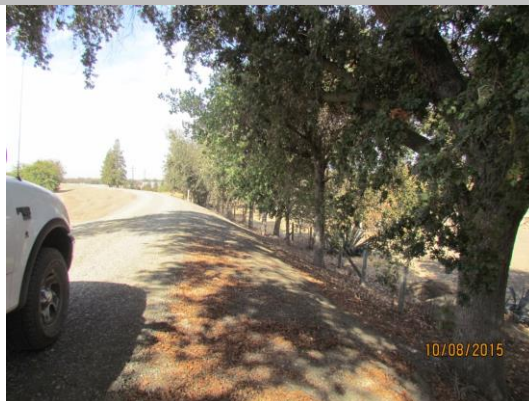
Photo 1 of 1 : SP_2016_ST0001_259_27_20160304_00026.jpg

LM Start	4.28	Rating **	M	Issue No.	27
LM End	4.43	Issue Type +	Ma	Location *	LS
Category	Earthen Levee			GPS Latitude/Longitude	
				Start	End
Item	Vegetation			38.727047 °	38.726113 °
				-121.774413 °	-121.771929 °
DWR ID	DWR_ST0001_01_s_2012_27				
Comment Code					
V6 : Landscaping					
Inspector Comment

View of the landscape trees on the landward side of the levee looking upstream. Fall 2015.

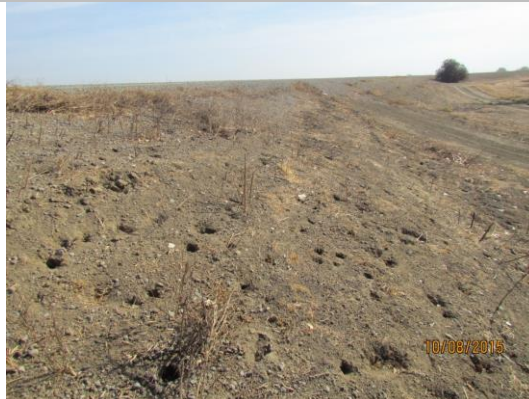
Photo 1 of 1 : SP_2016_ST0001_259_54_20160304_00047.jpg

LM Start	7.60	Rating **	M	Issue No.	54
LM End	7.60	Issue Type +	Ma	Location *	WS
Category	Earthen Levee			GPS Latitude/Longitude	
				Start	End
Item	Animal Control			38.729218 °	38.729218 °
				-121.723325 °	-121.723325 °
DWR ID	DWR_ST0001_01_f_2015_54				
Comment Code					
A3 : No rodents visible, but rodent burrows visible; need to backfill and compact or grout burrows.					
Inspector Comment

View of the rodent holes on the waterward side of the levee looking downstream. Fall 2015.

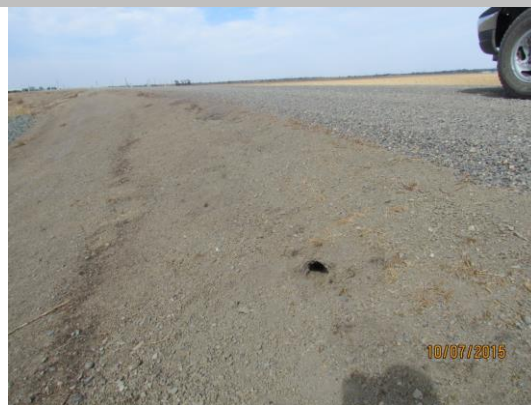
Photo 1 of 2 : SP_2016_ST0001_259_37_20160304_00031.jpg

LM Start	9.38	Rating **	M	Issue No.	37
LM End	9.38	Issue Type +	Ma	Location *	WS
Category	Earthen Levee			GPS Latitude/Longitude	
				Start	End
Item	Animal Control			38.719392 °	38.719392 °
				-121.696879 °	-121.696879 °
DWR ID	DWR_ST0001_01_f_2015_37				
Comment Code					
A3 : No rodents visible, but rodent burrows visible; need to backfill and compact or grout burrows.					
Inspector Comment

View of the rodent hole on the waterward side of the levee looking upstream. Fall 2015.

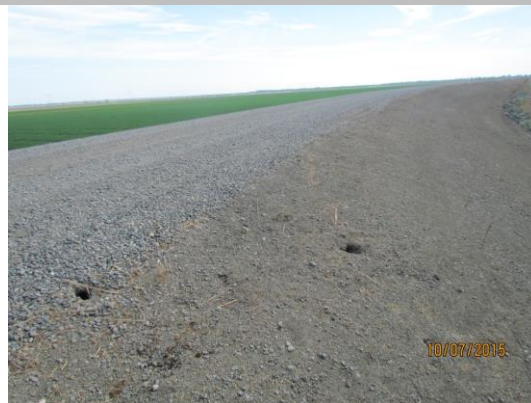
Photo 2 of 2 : SP_2016_ST0001_259_37_20160304_00032.jpg

LM Start	9.38	Rating **	M	Issue No.	37 (cont)
LM End	9.38	Issue Type +	Ma	Location *	WS

View of the rodent hole on the waterward side of the levee looking downstream. Fall 2015.

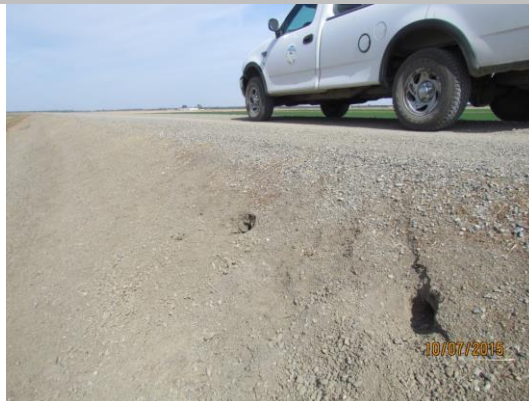
Photo 1 of 1 : SP_2016_ST0001_259_35_20160304_00030.jpg

LM Start	9.72	Rating **	M	Issue No.	35
LM End	9.72	Issue Type +	Ma	Location *	WS
Category	Earthen Levee			GPS Latitude/Longitude	
				Start	End
Item	Animal Control			38.714413 °	38.714413 °
				-121.697168 °	-121.697168 °
DWR ID	DWR_ST0001_01_f_2015_35				
Comment Code					
A3 : No rodents visible, but rodent burrows visible; need to backfill and compact or grout burrows.					
Inspector Comment

View of the rodent hole on the waterward side of the levee looking upstream. Fall 2015.

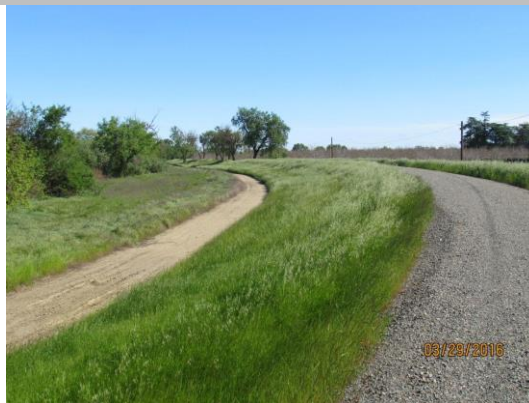
Photo 1 of 1 : SP_2016_ST0001_260_4_20160407_00024.jpg

LM Start	0.03	Rating **	M	Issue No.	4
LM End	4.11	Issue Type +	Ma	Location *	WS
Category	Earthen Levee			GPS Latitude/Longitude	
				Start	End
Item	Vegetation			38.727475 °	38.724525 °
				-121.806003 °	-121.751916 °
DWR ID	DWR_ST0001_02_s_2016_4				
Comment Code					
V1 : Control annual grass and weeds on the levee slopes and easements.					
Inspector Comment

View of the vegetation on the waterward side of the levee looking downstream. Spring 2016.

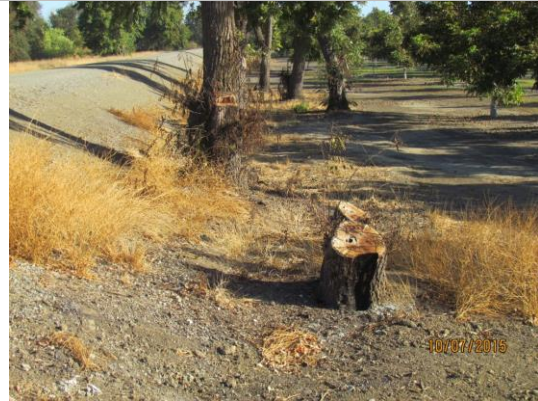
Photo 1 of 1 : SP_2016_ST0001_260_10_20160304_00008.jpg

LM Start	0.18	Rating **	N	Issue No.	10
LM End	0.18	Issue Type +	Ma	Location *	LS
Category	Earthen Levee			GPS Latitude/Longitude	
				Start	End
Item	Trim / Thin Trees			38.729560 °	38.729560 °
				-121.805231 °	-121.805231 °
DWR ID	DWR_ST0001_02_f_2015_10				
Comment Code					
T5 : Tree stumps.					
Inspector Comment					
The stump is located at the levee toe.

View of the tree stump at the landward side of the levee looking downstream. Fall 2015.

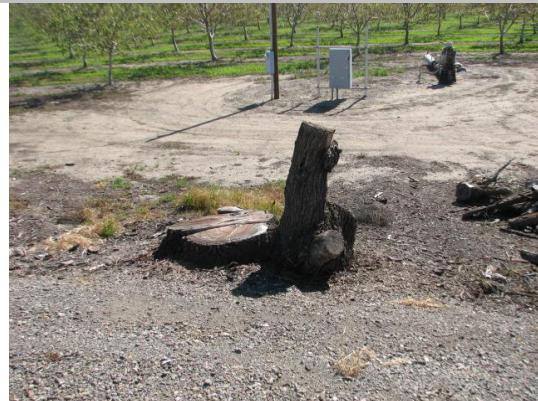
Photo 1 of 1 : SP_2016_ST0001_260_6_20160304_00004.jpg

LM Start	0.27	Rating **	N	Issue No.	6
LM End	0.27	Issue Type +	Ma	Location *	LS
Category	Earthen Levee			GPS Latitude/Longitude	
				Start	End
Item	Trim / Thin Trees			38.730723 °	38.730723 °
				-121.804972 °	-121.804972 °
DWR ID	DWR_ST0001_02_s_2014_6				
Comment Code					
T5 : Tree stumps.					
Inspector Comment

A large black walnut tree stump is at the toe of the levee. Spring 2014

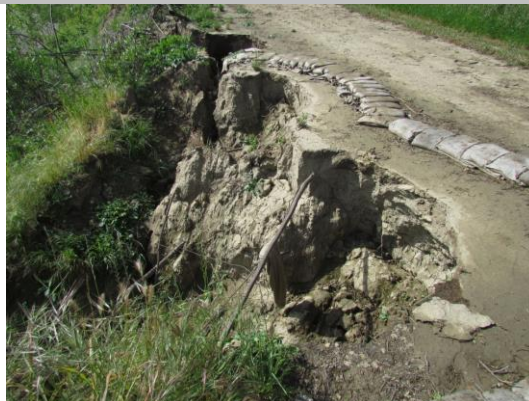
Photo 1 of 2 : SP_2016_ST0001_260_11_20160304_00009.jpg

LM Start	1.60	Rating **	A/W	Issue No.	11
LM End	1.60	Issue Type +	Ma	Location *	WS
Category	Earthen Levee			GPS Latitude/Longitude	
				Start	End
Item	Erosion / Bank Caving			38.731652 °	38.731652 °
				-121.786253 °	-121.786253 °
DWR ID	DWR_ST0001_02_s_2015_11				
Comment Code					
Inspector Comment					
The erosion is down by the channel and does not appear to be in the levee prism.

View of the erosion on the channel looking downstream. Spring 2015.

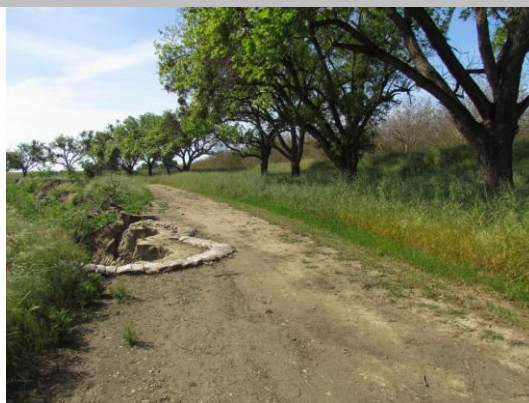
Photo 2 of 2 : SP_2016_ST0001_260_11_20160304_00010.jpg

LM Start	1.60	Rating **	A/W	Issue No.	11 (cont)
LM End	1.60	Issue Type +	Ma	Location *	WS

The view of the erosion from a distance. Spring 2015.

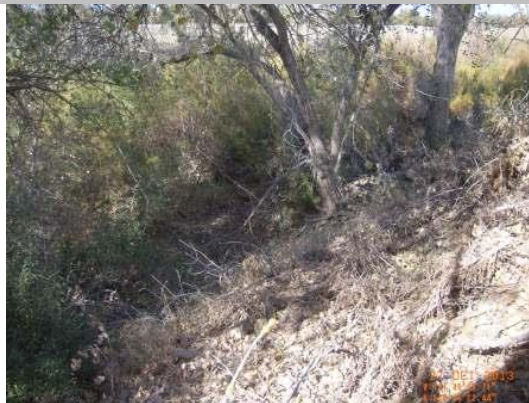
Photo 1 of 1 : SP_2016_ST0001_260_2_20160304_00002.jpg

LM Start	3.53	Rating **	M	Issue No.	2
LM End	3.60	Issue Type +	Ma	Location *	WS
Category	Supplemental			GPS Latitude/Longitude	
				Start	End
Item	2015 USACE Erosion Survey, DRAFT			38.722138 °	38.723294 °
				-121.759736 °	-121.759588 °
DWR ID	DWR_ST0001_02_s_2016_2				
Comment Code					
Inspector Comment					
2010 - Large slump on the upper berm, a tree has recently slid down the slope. 2011 - Large slump and new erosion. 2012 - Slightly steeper slopes and cracks observed. 2015: No observed changes. [2015 Site ID: CHC_3-5_R]

USACE 2013 Photo #1

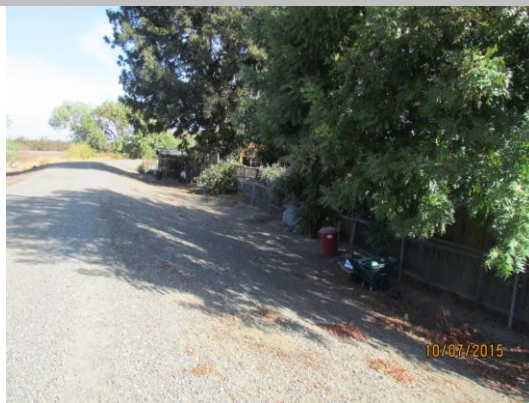
Photo 1 of 1 : SP_2016_ST0001_260_7_20160304_00005.jpg

LM Start	3.53	Rating **	A/W	Issue No.	7
LM End	3.62	Issue Type +	Ma	Location *	LS
Category	Earthen Levee			GPS Latitude/Longitude	
				Start	End
Item	Vegetation			38.722228 °	38.723322 °
				-121.759663 °	-121.759317 °
DWR ID	DWR_ST0001_02_s_2012_7				
Comment Code					
V6 : Landscaping					
Inspector Comment

View of the landscaping and fence on the landward side of the levee looking downstream. Fall 2015.

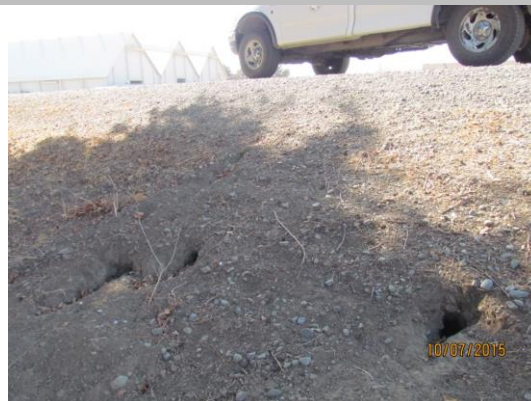
Photo 1 of 1 : SP_2016_ST0001_260_23_20160304_00019.jpg

LM Start	3.85	Rating **	M	Issue No.	23
LM End	3.85	Issue Type +	Ma	Location *	WS
Category	Earthen Levee			GPS Latitude/Longitude	
				Start	End
Item	Animal Control			38.722583 °	38.722583 °
				-121.755458 °	-121.755458 °
DWR ID	DWR_ST0001_02_f_2015_23				
Comment Code					
A3 : No rodents visible, but rodent burrows visible; need to backfill and compact or grout burrows.					
Inspector Comment

View of the animal holes on the waterward side of the levee. Fall 2015.

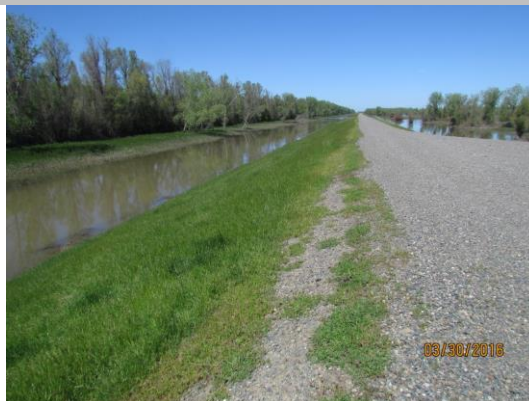
Photo 1 of 1 : SP_2016_ST0001_261_1_20160411_00001.jpg

LM Start	0.00	Rating **	M	Issue No.	1
LM End	2.25	Issue Type +	Ma	Location *	LS
Category	Earthen Levee			GPS Latitude/Longitude	
				Start	End
Item	Vegetation			38.727196 °	38.695490 °
				-121.718264 °	-121.715930 °
DWR ID	DWR_ST0001_04_s_2016_1				
Comment Code					
V1 : Control annual grass and weeds on the levee slopes and easements.					
Inspector Comment					
Both sides of the levee are waterward side. This side is on the Cache Creek side.

View of the vegetation on the slope of the levee looking upstream.
Spring 2016.

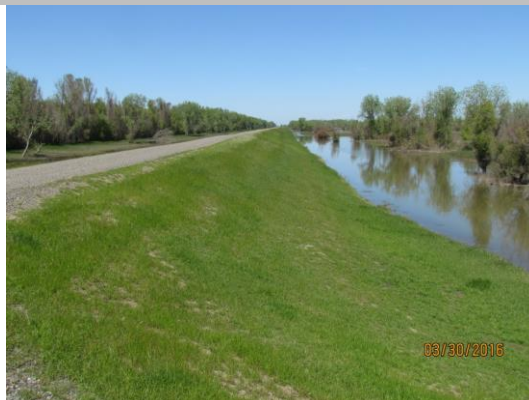
Photo 1 of 1 : SP_2016_ST0001_261_2_20160411_00002.jpg

LM Start	0.02	Rating **	M	Issue No.	2
LM End	2.25	Issue Type +	Ma	Location *	WS
Category	Earthen Levee			GPS Latitude/Longitude	
				Start	End
Item	Vegetation			38.727022 °	38.695490 °
				-121.717916 °	-121.715930 °
DWR ID	DWR_ST0001_04_s_2016_2				
Comment Code					
V1 : Control annual grass and weeds on the levee slopes and easements.					
Inspector Comment					
This side is on the Cache Creek Settling Basin.

View of the vegetation on the slope of the levee looking upstream.
Spring 2016.
