**Flood Control Project Maintenance  
Levee Inspections**

## Maintenance Issue Types Only, Levee Inspection Report By Mile - Spring 2017

### Sacramento Maintenance Yard Cache Creek

Waterway	Bank	Unit Miles	Inspection Start/End	Inspector
Unit No. 01 North Levee	Left	11.69	04/04/2017 04/04/2017	Zach Jojola

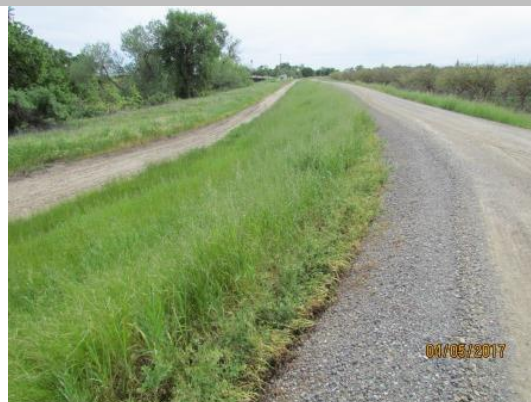
Photo 1 of 1 : SP\_2017\_ST0001\_259\_84\_20170413\_00118.jpg

LM Start	0.61	Rating **	U	Issue No.	84
LM End	1.66	Issue Type +	Ma	Location *	WS
Category	Earthen Levee		GPS Latitude/Longitude		
			Start	End	
Item	Vegetation		38.716261 °	38.726576 °	
			-121.817242 °	-121.807469 °	
DWR ID	DWR_ST0001_01_s_2017_84				
Comment Code					
V1 : Control annual grass and weeds on the levee slopes and easements.					
Inspector Comment

Tall grass on waterside levee slope, blocking visibility. Spring 2017.

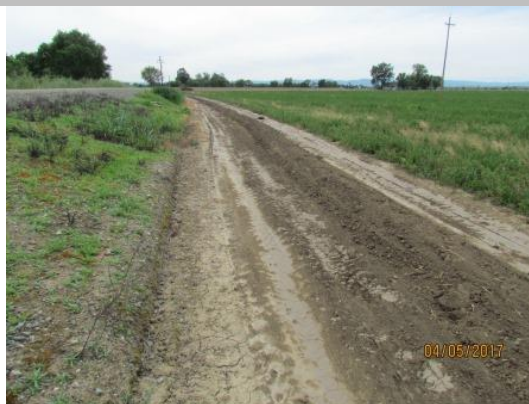
Photo 1 of 2 : SP\_2017\_ST0001\_259\_47\_20170413\_00120.jpg

Updated photo of tilling at landside levee toe, looking upstream. Spring 2017.

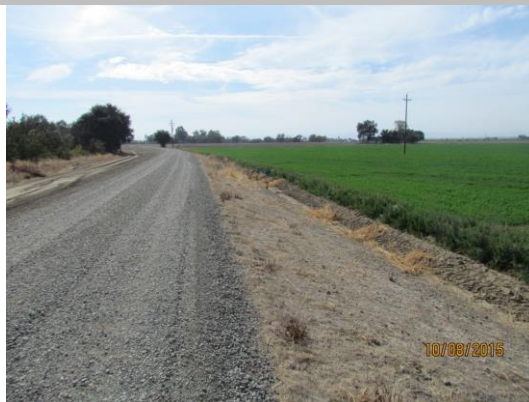
Photo 2 of 2 : SP\_2017\_ST0001\_259\_47\_20170320\_00038.jpg

LM Start	<b>0.93</b>	Rating **	M	Issue No.	<b>47 (cont)</b>
LM End	<b>1.02</b>	Issue Type +	Ma	Location *	LS

View of tilling on the landward side of the levee looking upstream. Fall 2015.

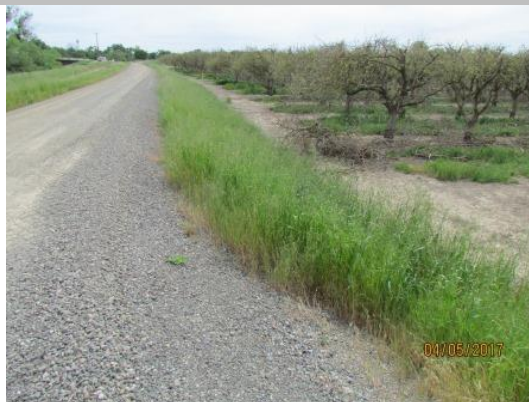
Photo 1 of 1 : SP\_2017\_ST0001\_259\_83\_20170413\_00119.jpg

Tall grass on landside levee slope, blocking visibility. Spring 2017.

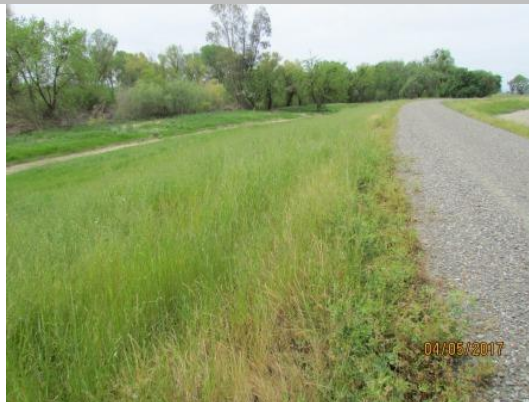
Photo 1 of 1 : SP\_2017\_ST0001\_259\_67\_20170413\_00103.jpg

LM Start	1.77	Rating **	U	Issue No.	67
LM End	7.20	Issue Type +	Ma	Location *	WS
Category	Earthen Levee			GPS Latitude/Longitude	
				Start	End
Item	Vegetation			38.728206 °	38.727486 °
				-121.806907 °	-121.730271 °
DWR ID	DWR_ST0001_01_s_2017_67				
Comment Code					
V1 : Control annual grass and weeds on the levee slopes and easements.					
Inspector Comment

Tall grass on waterside levee slope, blocking visibility. Spring 2017.

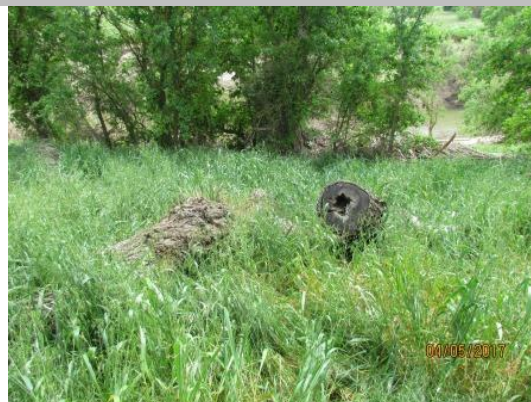
Photo 1 of 1 : SP\_2017\_ST0001\_259\_81\_20170413\_00116.jpg

Dead tree stumps on waterside levee slope. Spring 2017.

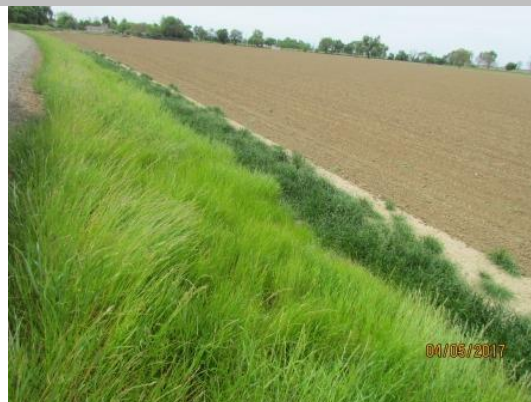
Photo 1 of 1 : SP\_2017\_ST0001\_259\_80\_20170413\_00115.jpg

LM Start	2.20	Rating **	U	Issue No.	80
LM End	2.41	Issue Type +	Ma	Location *	LS
Category	Earthen Levee			GPS Latitude/Longitude	
				Start	End
Item	Vegetation			38.733705 °	38.733699 °
				-121.804128 °	-121.800311 °
DWR ID	DWR_ST0001_01_s_2017_80				
Comment Code					
V1 : Control annual grass and weeds on the levee slopes and easements.					
Inspector Comment

Tall grass on landside levee slope, blocking visibility. Spring 2017.

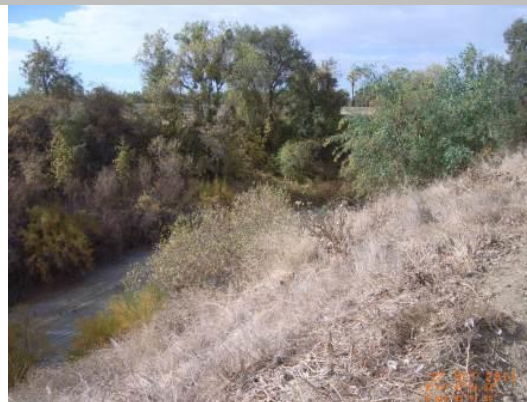
Photo 1 of 1 : SP\_2017\_ST0001\_259\_17\_20170320\_00019.jpg

LM Start	2.57	Rating **	A/W	Issue No.	17
LM End	2.61	Issue Type +	Ma	Location *	WS
Category	Supplemental			GPS Latitude/Longitude	
				Start	End
Item	2015 USACE Erosion Survey, DRAFT			38.732836 °	38.732685 °
				-121.797893 °	-121.797154 °
DWR ID	DWR_ST0001_01_s _ 2016_17				
Comment Code					
Inspector Comment					
Site identified as CRITICAL in 2002. 2006 - Currently constructing a setback levee. New failures present and extensive. Downstream end of the setback levee did not extend far enough. Upstream end was repaired. 2007 - DWR repaired with a setback levee, but the levee did not go far enough downstream. 2012 - New cracks observed. 2013 - Fresh erosion on upper bank. 2015: No observed changes. [2015 Site ID: CHC 2-4 L]

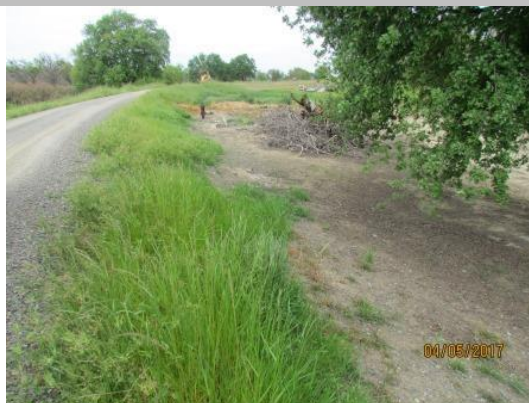
Photo 1 of 1 : SP\_2017\_ST0001\_259\_76\_20170413\_00111.jpg

Tall grass on landside levee slope, blocking visibility. Spring 2017.

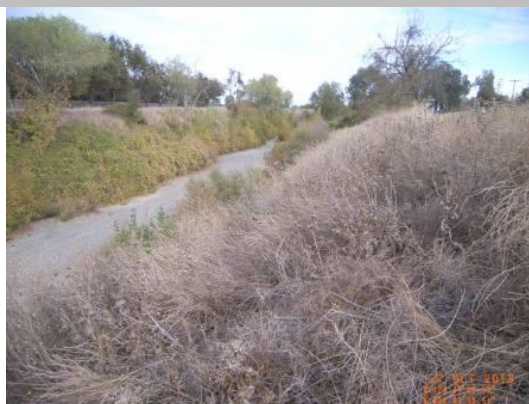
Photo 1 of 1 : SP\_2017\_ST0001\_259\_1\_20170320\_00001.jpg

LM Start	3.48	Rating **	A/W	Issue No.	1
LM End	3.57	Issue Type +	Ma	Location *	WS
Category	Supplemental			GPS Latitude/Longitude	
				Start	End
Item	2015 USACE Erosion Survey, DRAFT			38.732942 °	38.731626 °
				-121.784965 °	-121.785231 °
DWR ID	DWR_ST0001_01_s_2016_1				
Comment Code					
Inspector Comment					
2006 - Some significant new erosion, especially fresh upper bank slumping. Still substantial berm. 2010 - Site extended downstream, some new erosion, heavily vegetated and hard to see. Planned setback levee by CA DWR, 60% design complete, construction planned for 2012. 2011 - Construction delayed to 2013 - 2014. 2015: No observed changes. [2015 Site ID: CHC_3-4_L]

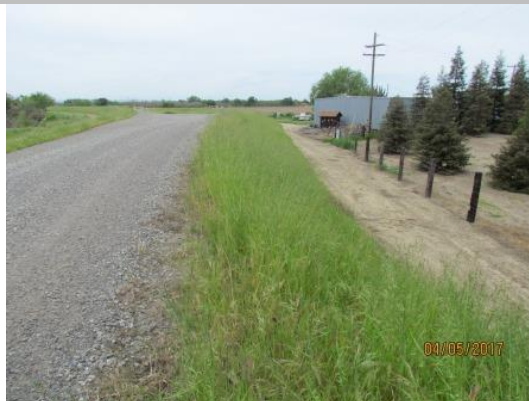
Photo 1 of 1 : SP\_2017\_ST0001\_259\_74\_20170413\_00109.jpg

Tall grass on landside levee slope, blocking visibility. Spring 2017.

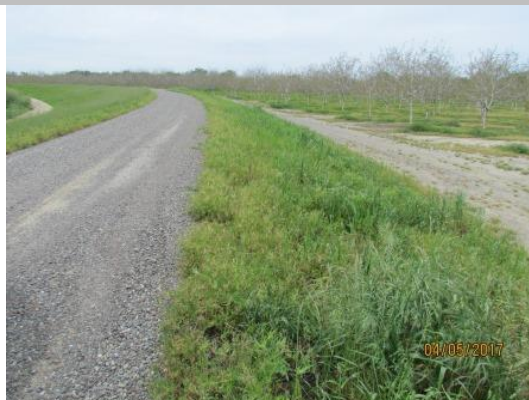
Photo 1 of 1 : SP\_2017\_ST0001\_259\_73\_20170413\_00108.jpg

LM Start	4.43	Rating **	U	Issue No.	73
LM End	5.48	Issue Type +	Ma	Location *	LS
Category	Earthen Levee			GPS Latitude/Longitude	
				Start	End
Item	Vegetation			38.726160 °	38.724525 °
				-121.772056 °	-121.759158 °
DWR ID	DWR_ST0001_01_s_2017_73				
Comment Code					
V1 : Control annual grass and weeds on the levee slopes and easements.					
Inspector Comment

Tall grass on landside levee slope, blocking visibility. Spring 2017.

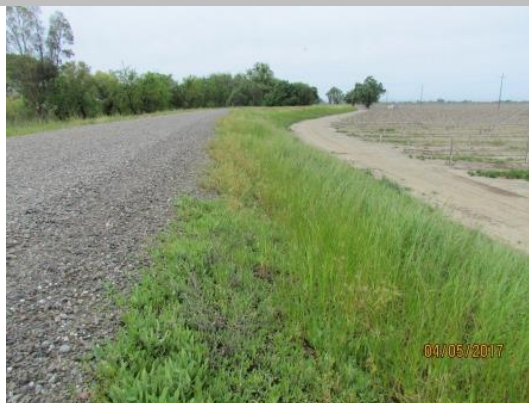
Photo 1 of 1 : SP\_2017\_ST0001\_259\_66\_20170413\_00104.jpg

Tall grass on landside levee slope, blocking visibility. Spring 2017.

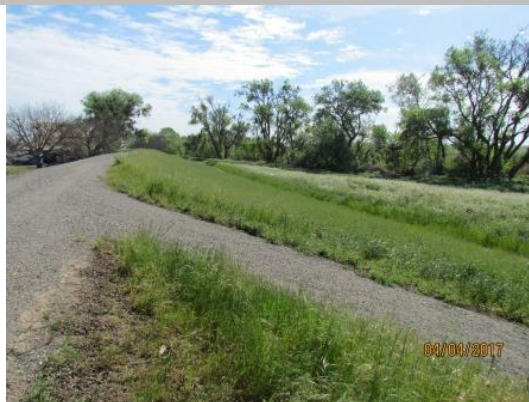
Photo 1 of 1 : SP\_2017\_ST0001\_259\_33\_20170413\_00097.jpg

LM Start	7.24	Rating **	U	Issue No.	33
LM End	10.20	Issue Type +	Ma	Location *	WS
Category	Earthen Levee			GPS Latitude/Longitude	
				Start	End
Item	Vegetation			38.727670 °	38.707483 °
				-121.729579 °	-121.697642 °
DWR ID	DWR_ST0001_01_s_2017_33				
Comment Code					
V1 : Control annual grass and weeds on the levee slopes and easements.					
Inspector Comment

Tall grass on waterside slope, blocking visibility. Spring 2017.

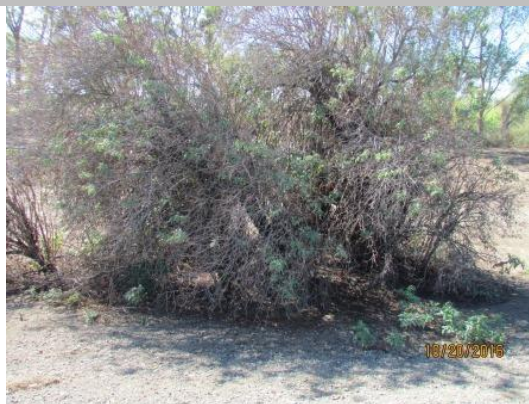
Photo 1 of 1 : SP\_2017\_ST0001\_259\_29\_20170320\_00028.jpg

View of an elderberry tree on waterward side. Fall 2016.

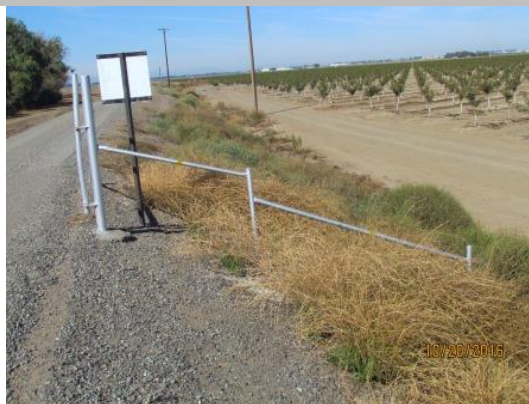
Photo 1 of 1 : SP\_2017\_ST0001\_259\_41\_20170320\_00034.jpg

LM Start	7.86	Rating **	M	Issue No.	41
LM End	7.89	Issue Type +	Ma	Location *	LS
Category	Earthen Levee			GPS Latitude/Longitude	
				Start	End
Item	Vegetation			38.727543 °	38.727341 °
				-121.719083 °	-121.718676 °
DWR ID	DWR_ST0001_01_f_2016_41				
Comment Code					
V2 : Remove the wild growth other than native grasses from the levee slopes.					
Inspector Comment

Vegetation on LS slope. Fall 2016.

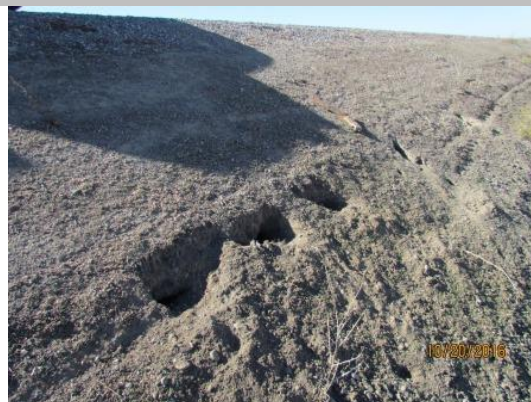
Photo 1 of 1 : SP\_2017\_ST0001\_259\_34\_20170320\_00029.jpg

Rodent holes on landside slope of the levee. Fall 2016.

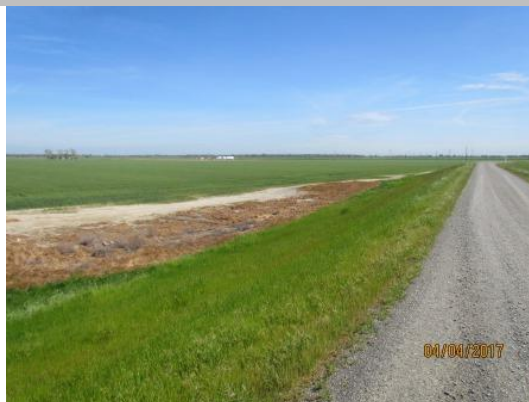
Photo 1 of 1 : SP\_2017\_ST0001\_259\_46\_20170413\_00099.jpg

Tall grass on landside levee slope, blocking visibility. Spring 2017.

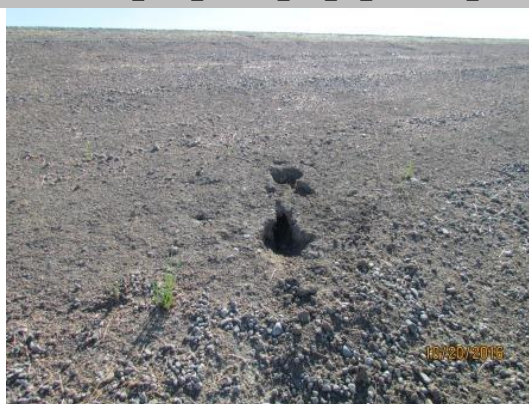
Photo 1 of 1 : SP\_2017\_ST0001\_259\_25\_20170320\_00023.jpg

LM Start	10.00	Rating **	M	Issue No.	25
LM End	10.00	Issue Type +	Ma	Location *	WS
Category	Earthen Levee			GPS Latitude/Longitude	
				Start	End
Item	Animal Control			38.710321 °	38.710321 °
				-121.697494 °	-121.697494 °
DWR ID	DWR_ST0001_01_f_2015_25				
Comment Code					
A3 : No rodents visible, but rodent burrows visible; need to backfill and compact or grout burrows.					
Inspector Comment

Rodent burrows on waterside slope of the levee. Fall 2016.

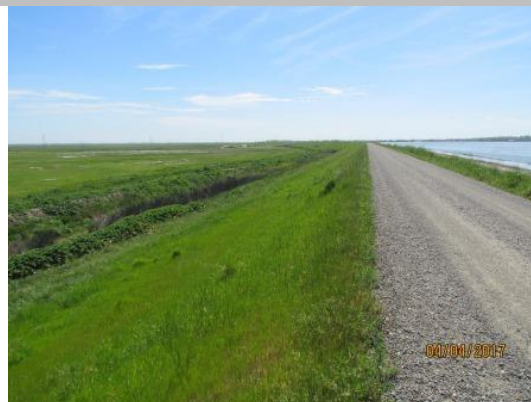
Photo 1 of 1 : SP\_2017\_ST0001\_259\_61\_20170413\_00100.jpg

Tall grass on landside slope, blocking visibility. Spring 2017.

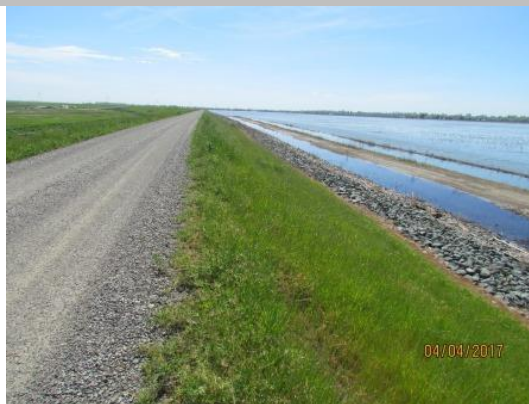
Photo 1 of 1 : SP\_2017\_ST0001\_259\_65\_20170413\_00101.jpg

Tall grass on waterside levee slope, blocking visibility. Spring 2017.

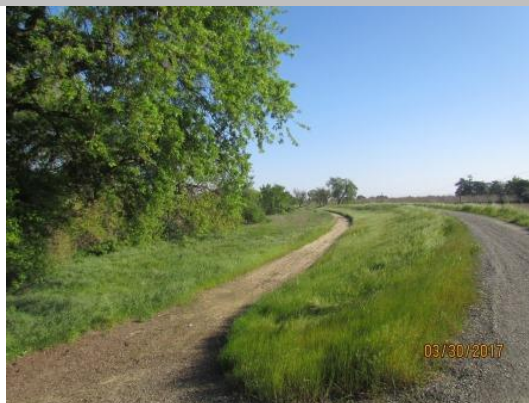
Photo 1 of 1 : SP\_2017\_ST0001\_260\_19\_20170413\_00046.jpg

Tall grass on waterside levee slope, blocking visibility. Spring 2017.

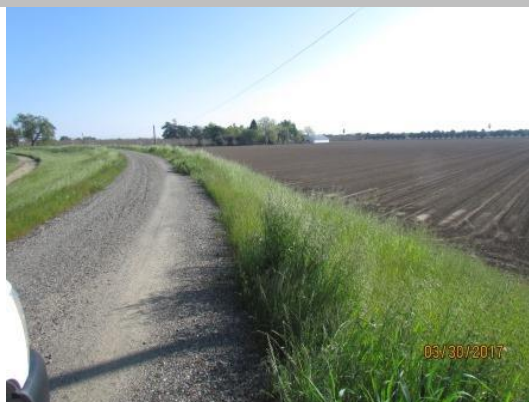
Photo 1 of 1 : SP\_2017\_ST0001\_260\_16\_20170413\_00047.jpg

LM Start	0.02	Rating **	U	Issue No.	16
LM End	0.22	Issue Type +	Ma	Location *	LS
Category	Earthen Levee			GPS Latitude/Longitude	
				Start	End
Item	Vegetation			38.727386 °	38.730089 °
				-121.806113 °	-121.805107 °
DWR ID	DWR_ST0001_02_s_2017_16				
Comment Code					
V1 : Control annual grass and weeds on the levee slopes and easements.					
Inspector Comment

Tall grass on landside levee slope, blocking visibility. Spring 2017.

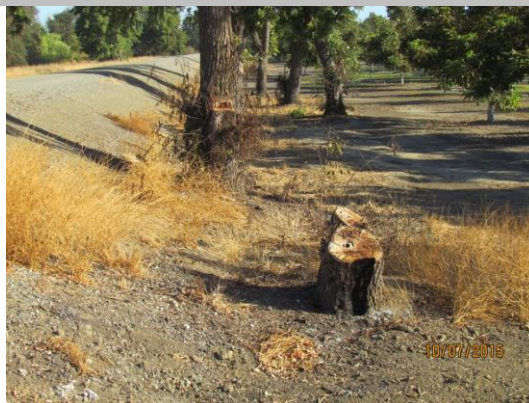
Photo 1 of 1 : SP\_2017\_ST0001\_260\_10\_20170320\_00011.jpg

View of the tree stump at the landward side of the levee looking downstream. Fall 2015.

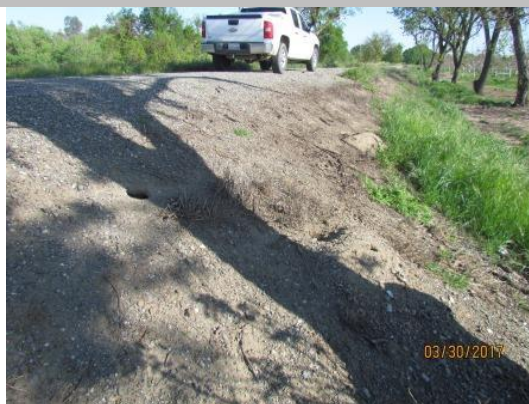
Photo 1 of 1 : SP\_2017\_ST0001\_260\_21\_20170413\_00048.jpg

Rodent burrows on landside levee slope. Spring 2017.

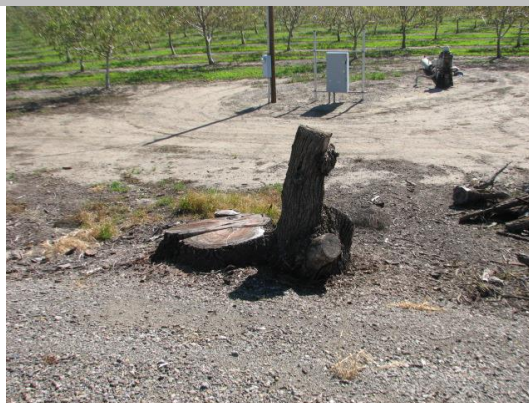
Photo 1 of 1 : SP\_2017\_ST0001\_260\_6\_20170320\_00007.jpg

A large black walnut tree stump is at the toe of the levee. Spring 2014

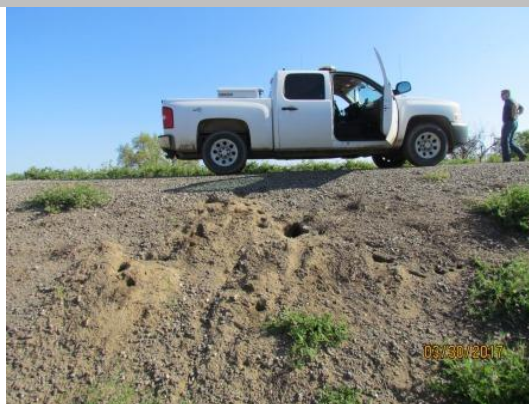
Photo 1 of 1 : SP\_2017\_ST0001\_260\_24\_20170413\_00050.jpg

Burrow holes on landside slope. Spring 2017.

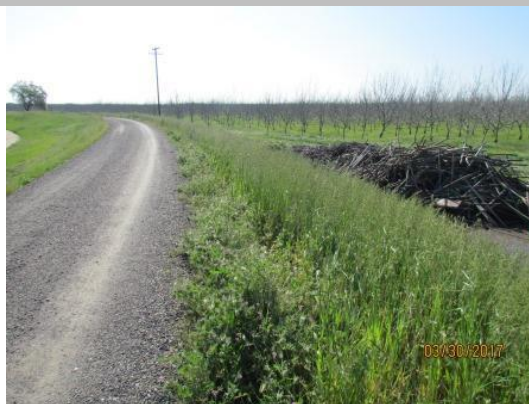
Photo 1 of 1 : SP\_2017\_ST0001\_260\_25\_20170413\_00051.jpg

Tall grass on landside slope blocking visibility. Spring 2017.

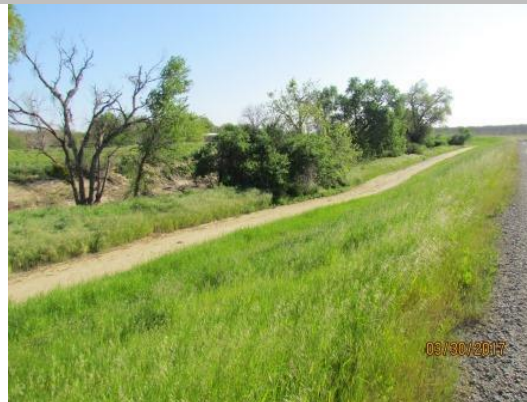
Photo 1 of 1 : SP\_2017\_ST0001\_260\_29\_20170413\_00052.jpg

Tall grass on waterside levee slope blocking visibility. Spring 2017.

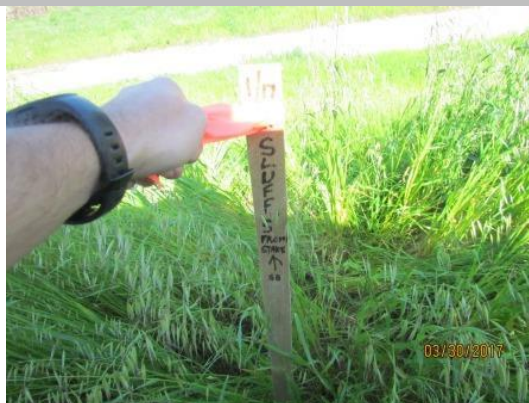
Photo 1 of 1 : SP\_2017\_ST0001\_260\_30\_20170413\_00053.jpg

Sluffing recorded on January 17, 2017. Continue to monitor. Spring 2017.

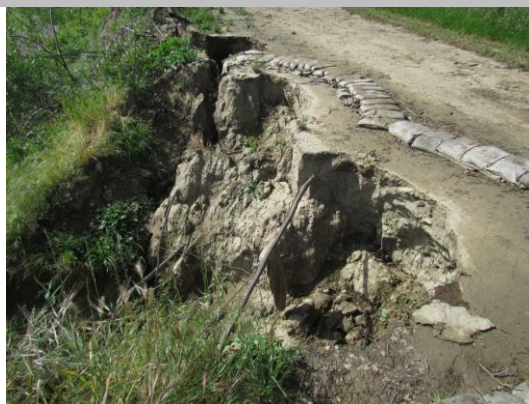
Photo 1 of 2 : SP\_2017\_ST0001\_260\_11\_20170320\_00012.jpg

View of the erosion on the channel looking downstream. Spring 2015.

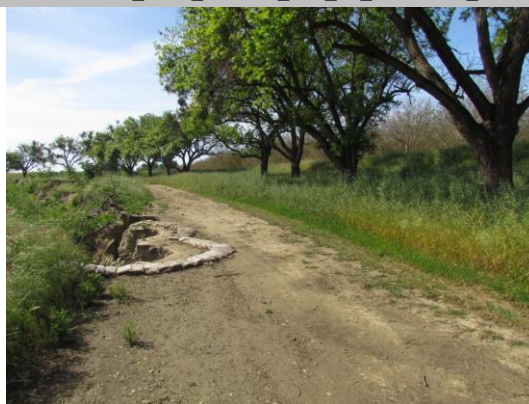
Photo 2 of 2 : SP\_2017\_ST0001\_260\_11\_20170320\_00013.jpg

The view of the erosion from a distance. Spring 2015.

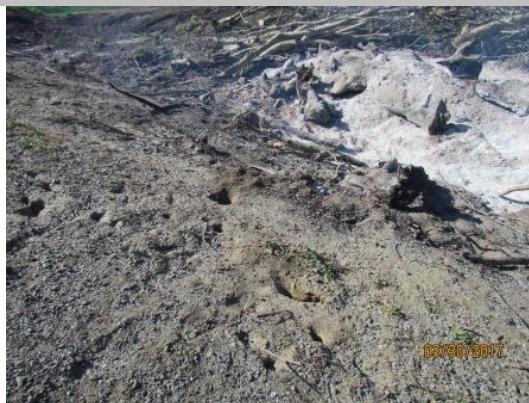
Photo 1 of 1 : SP\_2017\_ST0001\_260\_31\_20170413\_00054.jpg

Rodent holes on landside slope, near burn pile. Spring 2017.

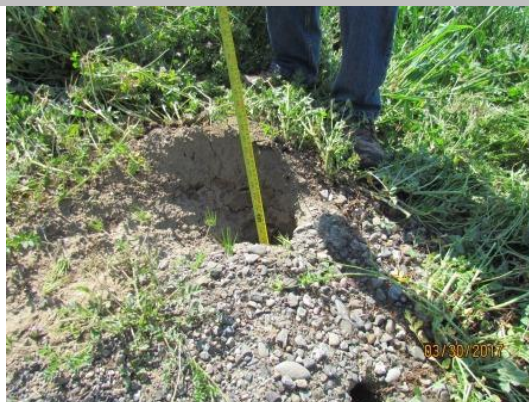
Photo 1 of 1 : SP\_2017\_ST0001\_260\_33\_20170413\_00055.jpg

11' deep rodent hole on landside slope. Spring 2017.

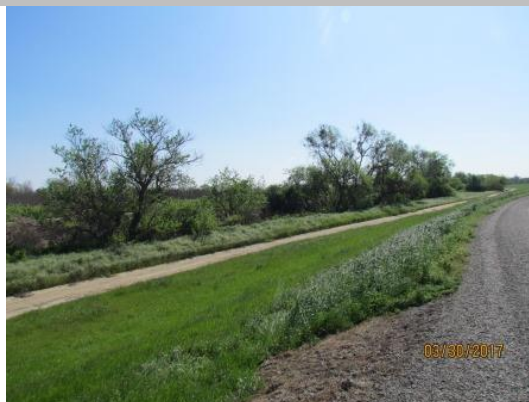
Photo 1 of 1 : SP\_2017\_ST0001\_260\_34\_20170413\_00056.jpg

Tall grass on waterside slope blocking visibility. Spring 2017.

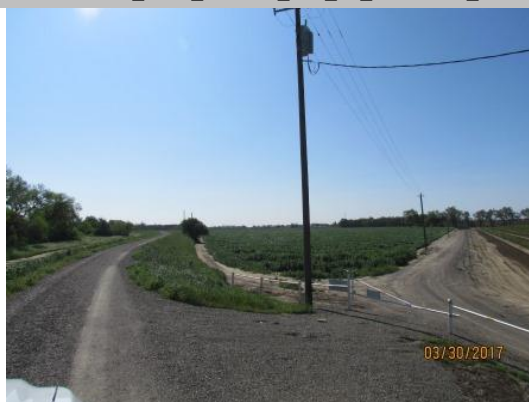
Photo 1 of 1 : SP\_2017\_ST0001\_260\_35\_20170413\_00057.jpg

Tall grass on landside slope blocking visibility. Spring 2017.

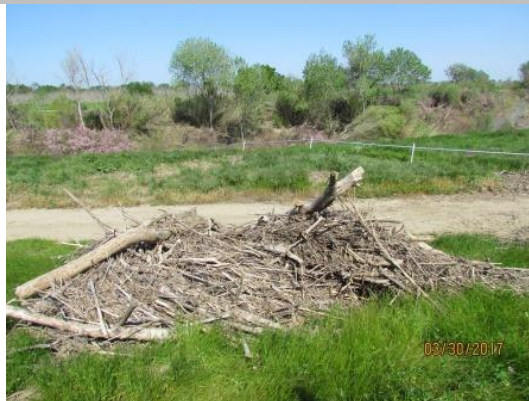
Photo 1 of 1 : SP\_2017\_ST0001\_260\_41\_20170413\_00060.jpg

Prunings on wateside levee slope. Spring 2017.

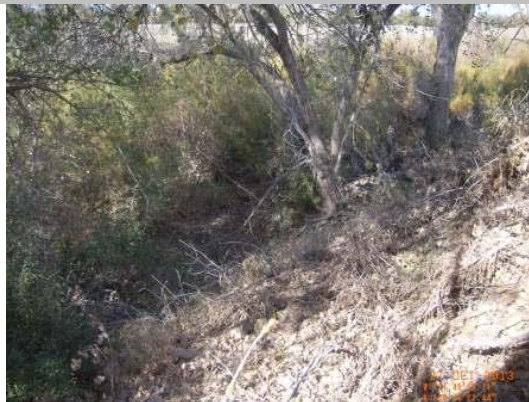
Photo 1 of 1 : SP\_2017\_ST0001\_260\_2\_20170320\_00002.jpg

LM Start	3.53	Rating **	A/W	Issue No.	2
LM End	3.60	Issue Type +	Ma	Location *	WS
Category	Supplemental			GPS Latitude/Longitude	
				Start	End
Item	2015 USACE Erosion Survey, DRAFT			38.722138 °	38.723294 °
				-121.759736 °	-121.759588 °
DWR ID	DWR_ST0001_02_s_2016_2				
Comment Code					
Inspector Comment					
2010 - Large slump on the upper berm, a tree has recently slid down the slope. 2011 - Large slump and new erosion. 2012 - Slightly steeper slopes and cracks observed. 2015: No observed changes. [2015 Site ID: CHC_3-5_R]

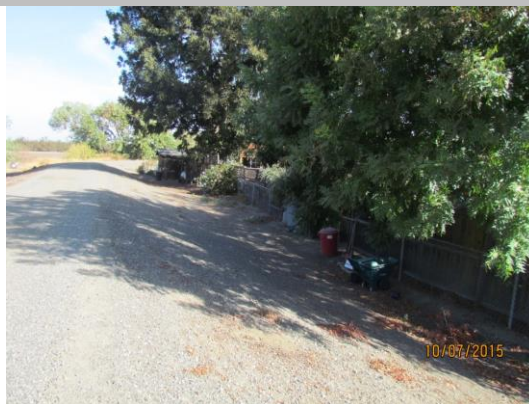
Photo 1 of 1 : SP\_2017\_ST0001\_260\_7\_20170320\_00008.jpg

View of the landscaping and fence on the landward side of the levee looking downstream. Fall 2015.

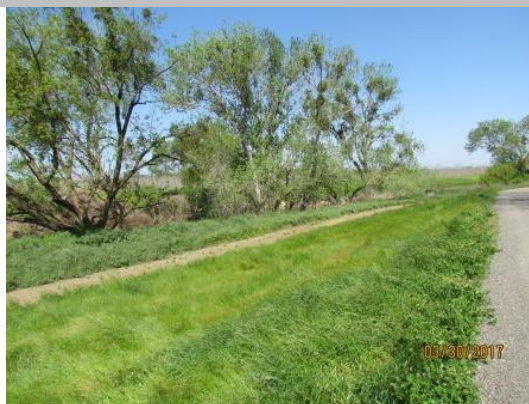
Photo 1 of 1 : SP\_2017\_ST0001\_260\_43\_20170413\_00061.jpg

Tall grass on waterside levee slope blocking visibility. Spring 2017.

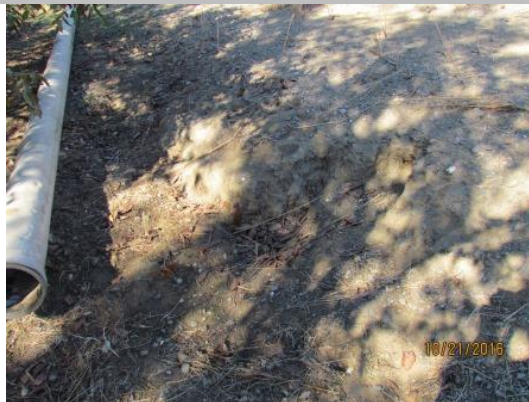
Photo 1 of 1 : SP\_2017\_ST0001\_260\_4\_20170320\_00005.jpg

LM Start	4.42	Rating **	M	Issue No.	4
LM End	4.42	Issue Type +	Ma	Location *	LS
Category	Earthen Levee			GPS Latitude/Longitude	
				Start	End
Item	Erosion / Bank Caving			38.726840 °	38.726840 °
				-121.747228 °	-121.747228 °
DWR ID	DWR_ST0001_02_f_2016_4				
Comment Code					
E2 : Schedule repair of erosion site prior to the next inspection.					
Inspector Comment					
Erosion on LS slope near levee toe.

Erosion on LS levee slope toward the toe. Fall 2016.

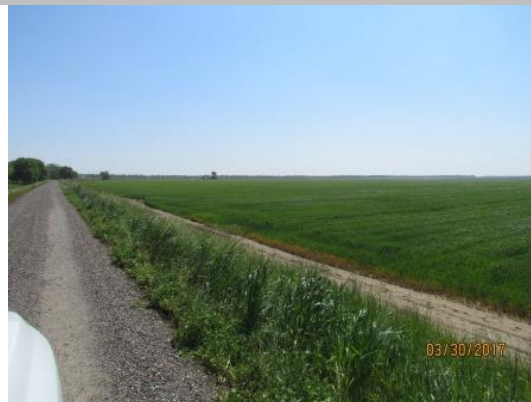
Photo 1 of 1 : SP\_2017\_ST0001\_260\_49\_20170413\_00062.jpg

Tall grass on landside levee slope blocking visibility. Spring 2017.

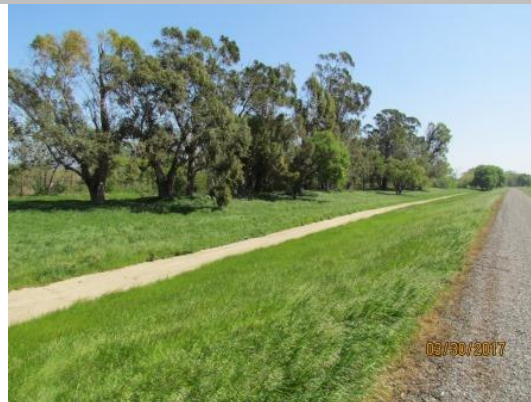
Photo 1 of 1 : SP\_2017\_ST0001\_260\_50\_20170413\_00063.jpg

Tall grass on waterside levee slope blocking visibility. Spring 2017.

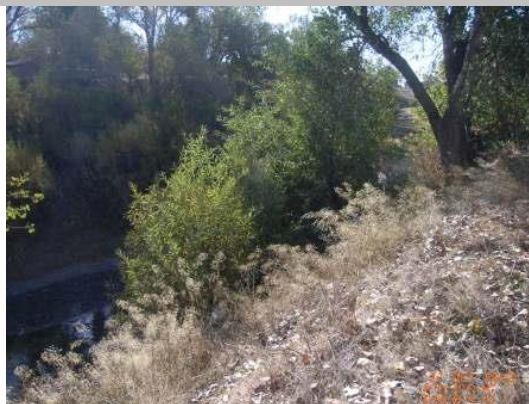
Photo 1 of 1 : SP\_2017\_ST0001\_260\_13\_20170320\_00015.jpg

LM Start	5.33	Rating **	A/W	Issue No.	13
LM End	5.37	Issue Type +	Ma	Location *	WS
Category	Supplemental			GPS Latitude/Longitude	
				Start	End
Item	2015 USACE Erosion Survey, DRAFT			38.722933 °	38.723467 °
				-121.760561 °	-121.760436 °
DWR ID	DWR_ST0001_02_s_2016_13				
Comment Code					
Inspector Comment					
2009 - Erosion into the levee slope. 2010 - Minor new erosion. 2011 - New erosion and a freshly fallen tree. 2012 - New animal holes and slightly steeper slopes. 2013 - New tree popout and 2 feet of erosion along the top bank. 2015: No observed changes. [2015 Site ID: CHC_5-4_L]

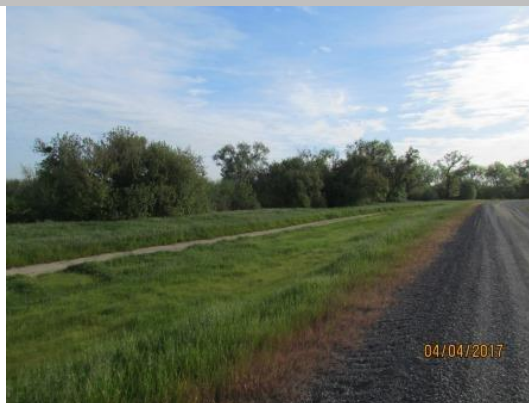
Photo 1 of 1 : SP\_2017\_ST0001\_260\_52\_20170413\_00064.jpg

Tall grass on waterside levee slope, blocking visibility. Spring 2017.

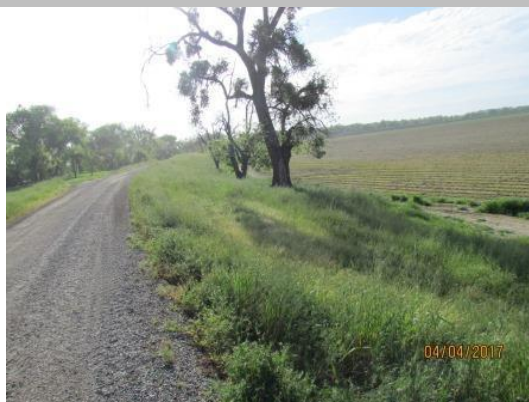
Photo 1 of 1 : SP\_2017\_ST0001\_260\_53\_20170413\_00065.jpg

Tall grass on landside levee slope, blocking visibility. Spring 2017.

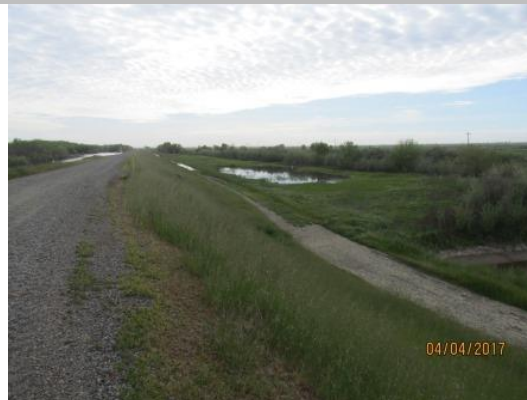
Photo 1 of 1 : SP\_2017\_ST0001\_260\_56\_20170413\_00066.jpg

Tall grass on landside levee slope, blocking visibility. Spring 2017.

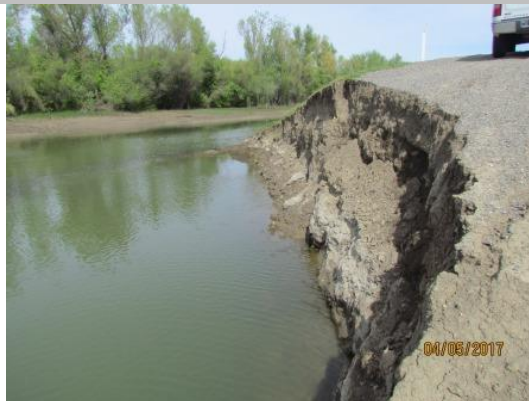
Photo 1 of 1 : SP\_2017\_ST0001\_261\_3\_20170413\_00004.jpg

Scour on waterside levee slope at end of Unit 04 levee. Doesn't appear to be an imminent threat at this time. Spring 2017.
