**Flood Control Project Maintenance
Levee Inspections**

Maintenance Issue Types Only, Levee Inspection Report By Mile - Spring 2018

Sacramento Maintenance Yard Cache Creek

Waterway	Bank	Unit Miles	Inspection Start/End	Inspector
Unit No. 01 North Levee	Left	11.69	03/06/2018 03/06/2018	Zach Jojola

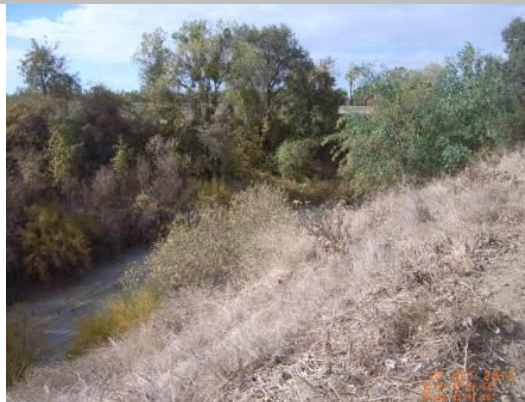
Photo 1 of 1 : SP_2018_ST0001_259_17_20180306_00019.jpg

LM Start	2.57	Rating **	A/W	Issue No.	17
LM End	2.61	Issue Type +	Ma	Location *	WS
Category	Supplemental			GPS Latitude/Longitude	
				Start	End
Item	2015 USACE Erosion Survey, DRAFT			38.732836 °	38.732685 °
				-121.797893 °	-121.797154 °
DWR ID	DWR_ST0001_01_s_2016_17				
Comment Code					
Inspector Comment					
Site identified as CRITICAL in 2002. 2006 - Currently constructing a setback levee. New failures present and extensive. Downstream end of the setback levee did not extend far enough. Upstream end was repaired. 2007 - DWR repaired with a setback levee, but the levee did not go far enough downstream. 2012 - New cracks observed. 2013 - Fresh erosion on upper bank. 2015: No observed changes. [2015 Site ID: CHC 2-4 L]

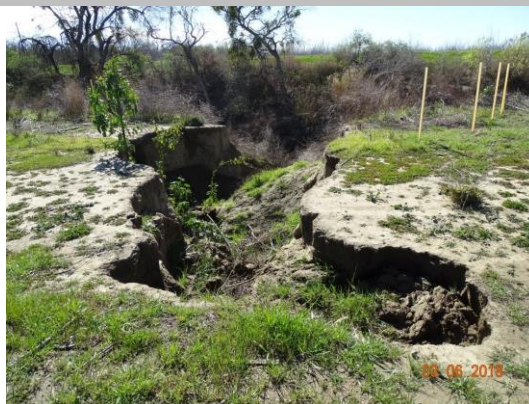
Photo 1 of 5 : SP_2018_ST0001_259_62_20180308_00072.jpg

LM Start	2.84	Rating **	A/W	Issue No.	62
LM End	2.84	Issue Type +	Ma	Location *	WS
Category	Earthen Levee		GPS Latitude/Longitude		
			Start	End	
Item	Erosion / Bank Caving		38.734514 °	38.734514 °	
			-121.793418 °	-121.793418 °	
DWR ID	DWR_ST0001_01_s _ 2018_62				
Comment Code					
E1 : Note and monitor erosion site.					
Inspector Comment					
Erosion on waterside berm and toe road.

View of erosion on toe road, looking towards Cache Creek. Spring 2018.

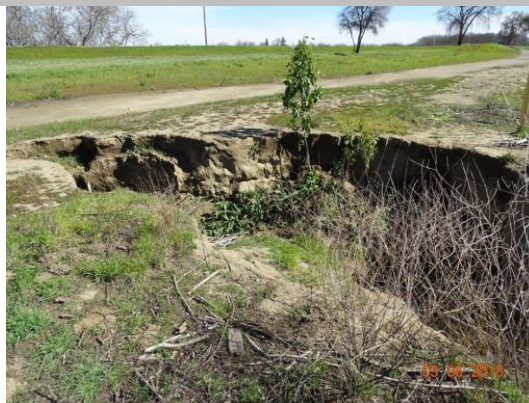
Photo 2 of 5 : SP_2018_ST0001_259_62_20180308_00073.jpg

LM Start	2.84	Rating **	A/W	Issue No.	62 (cont)	
LM End	2.84	Issue Type +	Ma	Location *	WS	
Category	Earthen Levee			GPS Latitude/Longitude		
				Start		End
Item	Erosion / Bank Caving			38.734514 °		38.734514 °
				-121.793418 °		-121.793418 °
DWR ID	DWR_ST0001_01_s_2018_62					
Comment Code						
E1 : Note and monitor erosion site.						
Inspector Comment						
Erosion on waterside berm and toe road.

View of erosion looking towards the landside levee slope, facing northeast. Spring 2018.

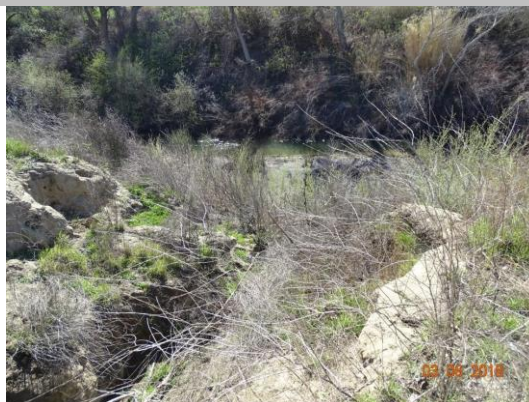
Photo 3 of 5 : SP_2018_ST0001_259_62_20180308_00074.jpg

Downslope view of erosion, facing Cache Creek. Spring 2018.

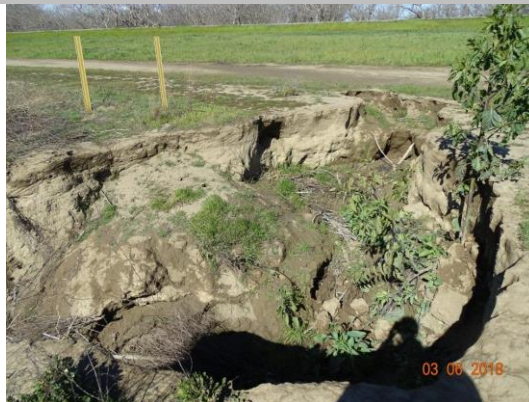
Photo 4 of 5 : SP_2018_ST0001_259_62_20180308_00071.jpg

Additional view of erosion, looking northwest. Spring 2018.

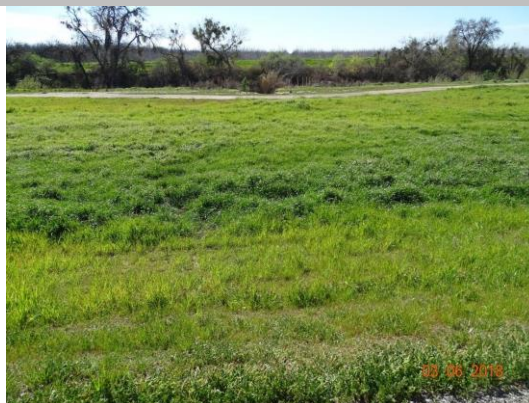
Photo 5 of 5 : SP_2018_ST0001_259_62_20180308_00075.jpg

LM Start	2.84	Rating **	A/W	Issue No.	62 (cont)	
LM End	2.84	Issue Type +	Ma	Location *	WS	
Category	Earthen Levee			GPS Latitude/Longitude		
				Start		End
Item	Erosion / Bank Caving			38.734514 °		38.734514 °
				-121.793418 °		-121.793418 °
DWR ID	DWR_ST0001_01_s_2018_62					
Comment Code						
E1 : Note and monitor erosion site.						
Inspector Comment						
Erosion on waterside berm and toe road.

View of erosion from levee crown, facing Cache Creek. Fall 2018.

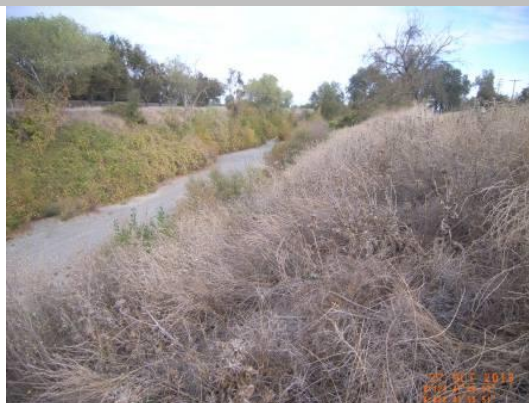
Photo 1 of 1 : SP_2018_ST0001_259_1_20180306_00001.jpg

LM Start	3.48	Rating **	A/W	Issue No.	1
LM End	3.57	Issue Type +	Ma	Location *	WS
Category	Supplemental			GPS Latitude/Longitude	
				Start	End
Item	2015 USACE Erosion Survey, DRAFT			38.732942 °	38.731626 °
				-121.784965 °	-121.785231 °
DWR ID	DWR_ST0001_01_s _ 2016_1				
Comment Code					
Inspector Comment					
2006 - Some significant new erosion, especially fresh upper bank slumping. Still substantial berm. 2010 - Site extended downstream, some new erosion, heavily vegetated and hard to see. Planned setback levee by CA DWR, 60% design complete, construction planned for 2012. 2011 - Construction delayed to 2013 - 2014. 2015: No observed changes. [2015 Site ID: CHC 3-4 L]

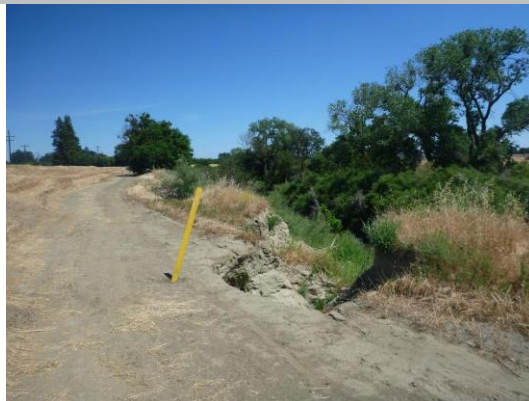
Photo 3 of 3 : LEVAL_SP_2018_249_960.jpg

LM Start	4.22	Rating **	A/W	Issue No.	34 (cont)
LM End	4.23	Issue Type +	Ma	Location *	WS
Category	Supplemental			GPS Latitude/Longitude	
				Start	End
Item	2017 Storm Damage			38.727207 °	38.727187 °
				-121.775521 °	-121.775450 °
DWR ID	DWR_ST0001_01_f_2017_34				
Comment Code					
Inspector Comment					
Levee Evaluation Comments					
Description:					
Site ID No:249					
Site Designation:LMA-57					
Repair Type: Erosion					
Rating:Area of Concern					
Field Date:6/2/2017					
Notes: setback levee site; remaining berm greater than 86 feet, no section taken, photo only.

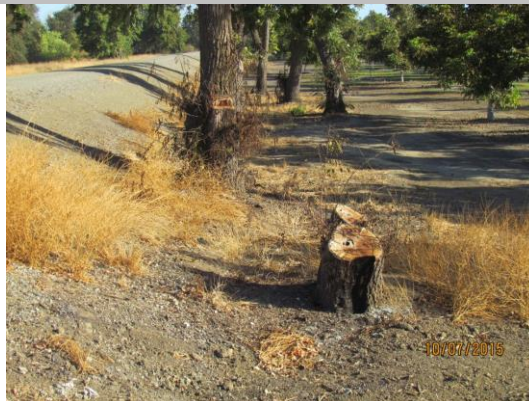
Photo 1 of 1 : SP_2018_ST0001_260_10_20180306_00011.jpg

LM Start	0.18	Rating **	N	Issue No.	10
LM End	0.18	Issue Type +	Ma	Location *	LS
Category	Earthen Levee			GPS Latitude/Longitude	
				Start	End
Item	Trim / Thin Trees			38.729560 °	38.729560 °
				-121.805231 °	-121.805231 °
DWR ID	DWR_ST0001_02_f_2015_10				
Comment Code					
T5 : Tree stumps.					
Inspector Comment					
The stump is located at the levee toe.

View of the tree stump at the landward side of the levee looking downstream. Fall 2015.

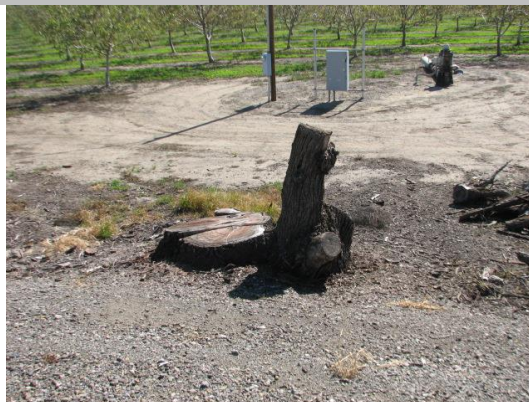
Photo 1 of 1 : SP_2018_ST0001_260_6_20180306_00007.jpg

LM Start	0.27	Rating **	N	Issue No.	6
LM End	0.27	Issue Type +	Ma	Location *	LS
Category	Earthen Levee			GPS Latitude/Longitude	
				Start	End
Item	Trim / Thin Trees			38.730723 °	38.730723 °
				-121.804972 °	-121.804972 °
DWR ID	DWR_ST0001_02_s_2014_6				
Comment Code					
T5 : Tree stumps.					
Inspector Comment

A large black walnut tree stump is at the toe of the levee. Spring 2014

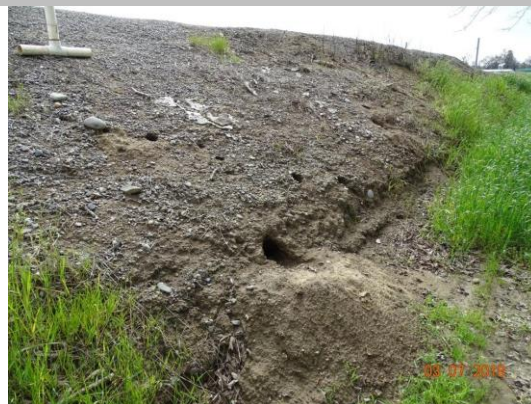
Photo 1 of 1 : SP_2018_ST0001_260_38_20180308_00025.jpg

LM Start	1.65	Rating **	M	Issue No.	38
LM End	1.65	Issue Type +	Ma	Location *	LS
Category	Earthen Levee			GPS Latitude/Longitude	
				Start	End
Item	Animal Control			38.730984 °	38.730984 °
				-121.786225 °	-121.786225 °
DWR ID	DWR_ST0001_02_s _ 2018_38				
Comment Code					
A3 : No rodents visible, but rodent burrows visible; need to backfill and compact or grout burrows.					
Inspector Comment					
Multiple rodent holes on the landside slope and at the toe.

View of rodent holes on the landside slope. Spring 2018.

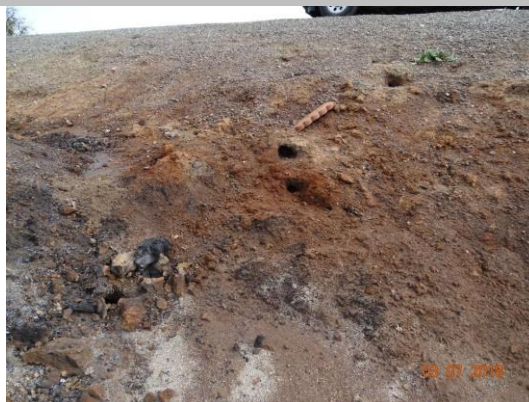
Photo 1 of 1 : SP_2018_ST0001_260_35_20180308_00024.jpg

LM Start	1.68	Rating **	A/W	Issue No.	35
LM End	1.68	Issue Type +	Ma	Location *	LS
Category	Earthen Levee			GPS Latitude/Longitude	
				Start	End
Item	Animal Control			38.730596 °	38.730596 °
				-121.786041 °	-121.786041 °
DWR ID	DWR_ST0001_02_s_2018_35				
Comment Code					
A3 : No rodents visible, but rodent burrows visible; need to backfill and compact or grout burrows.					
Inspector Comment					
Multiple rodents holes baited by the Sac Yard on landside slope near pruning pile. Recommend backfilling and monitoring.

View of rodent holes on the landside slope. Spring 2018.

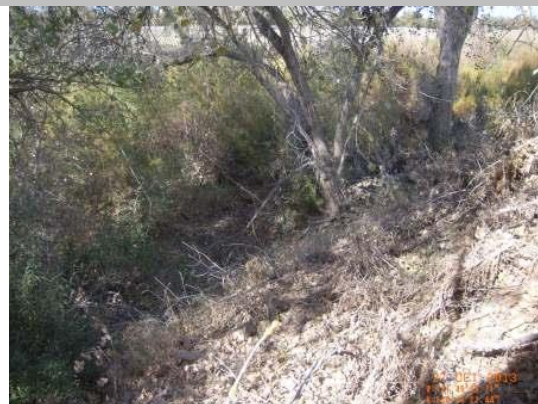
Photo 1 of 1 : SP_2018_ST0001_260_2_20180306_00002.jpg

LM Start	3.53	Rating **	A/W	Issue No.	2
LM End	3.60	Issue Type +	Ma	Location *	WS
Category	Supplemental			GPS Latitude/Longitude	
				Start	End
Item	2015 USACE Erosion Survey, DRAFT			38.722138 °	38.723294 °
				-121.759736 °	-121.759588 °
DWR ID	DWR_ST0001_02_s _ 2016_2				
Comment Code					
Inspector Comment					
2010 - Large slump on the upper berm, a tree has recently slid down the slope. 2011 - Large slump and new erosion. 2012 - Slightly steeper slopes and cracks observed. 2015: No observed changes. [2015 Site ID: CHC_3-5_R]

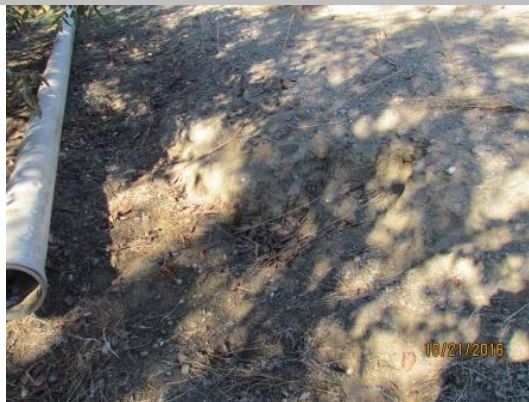
Photo 1 of 1 : SP_2018_ST0001_260_4_20180306_00005.jpg

LM Start	4.42	Rating **	A/W	Issue No.	4
LM End	4.42	Issue Type +	Ma	Location *	LS
Category	Earthen Levee			GPS Latitude/Longitude	
				Start	End
Item	Erosion / Bank Caving			38.726840 °	38.726840 °
				-121.747228 °	-121.747228 °
DWR ID	DWR_ST0001_02_f_2016_4				
Comment Code					
E1 : Note and monitor erosion site.					
Inspector Comment					
Erosion on LS slope near levee toe. It does not appear to pose a significant threat. Recommend monitoring.

Erosion on LS levee slope toward the toe. Fall 2016.

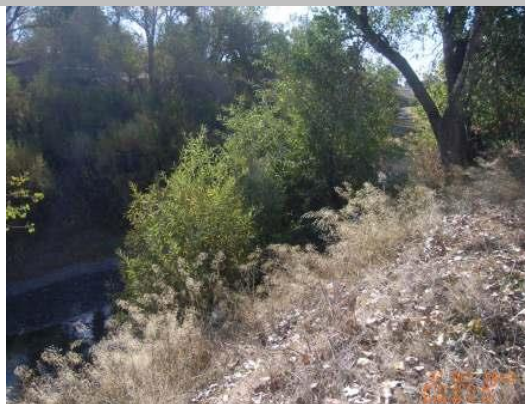
Photo 1 of 1 : SP_2018_ST0001_260_13_20180306_00013.jpg

LM Start	5.33	Rating **	A/W	Issue No.	13
LM End	5.37	Issue Type +	Ma	Location *	WS
Category	Supplemental			GPS Latitude/Longitude	
				Start	End
Item	2015 USACE Erosion Survey, DRAFT			38.722933 °	38.723467 °
				-121.760561 °	-121.760436 °
DWR ID	DWR_ST0001_02_s_2016_13				
Comment Code					
Inspector Comment					
2009 - Erosion into the levee slope. 2010 - Minor new erosion. 2011 - New erosion and a freshly fallen tree. 2012 - New animal holes and slightly steeper slopes. 2013 - New tree popout and 2 feet of erosion along the top bank. 2015: No observed changes. [2015 Site ID: CHC_5-4_L]

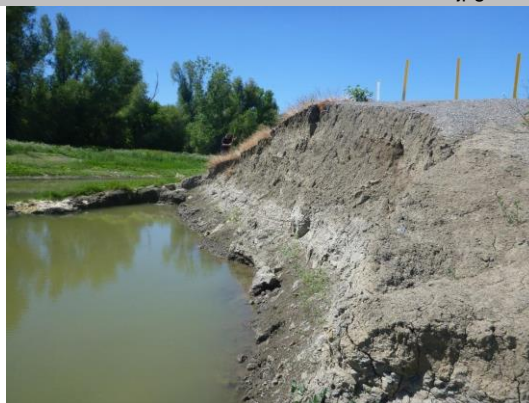
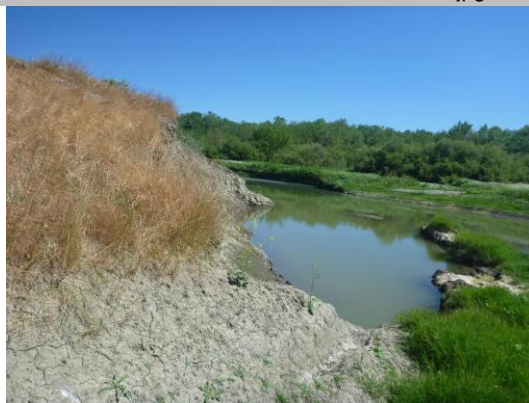
LM Start	2.26	Rating **	M	Issue No.	1
LM End	2.26	Issue Type +	Ma	Location *	
Category	Supplemental			GPS Latitude/Longitude	
				Start	End
Item	2017 Storm Damage			38.695424 °	38.695253 °
				-121.715914 °	-121.715926 °
DWR ID	DWR_ST0001_04 f 2017 1

Repair Type: Erosion

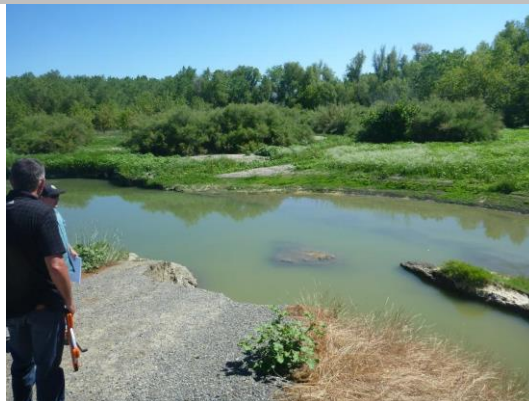
Photo 3 of 3 : LEVAL_SP_2018_250_973.jpg

LM Start	2.26	Rating **	M	Issue No.	1 (cont)	
LM End	2.26	Issue Type +	Ma	Location *		
Category	Supplemental			GPS Latitude/Longitude		
				Start	End	
Item	2017 Storm Damage			38.695424 °	38.695253 °	
				-121.715914 °	-121.715926 °	
DWR ID	DWR_ST0001_04_f_2017_1					
Comment Code						
Inspector Comment						
Levee Evaluation Comments						
Description:						
Site ID No:250						
Site Designation:LMA-58						
Repair Type: Erosion						
Rating:Area of Concern						
Field Date:6/2/2017						
Notes: training levee end slope where it keys into channel /access ramp erosion

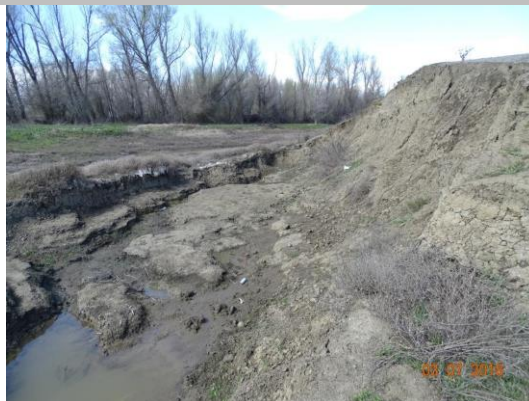
Photo 1 of 4 : SP_2018_ST0001_261_3_20180308_00006.jpg

LM Start	2.26	Rating **	A/W	Issue No.	3
LM End	2.26	Issue Type +	Ma	Location *	WS
Category	Earthen Levee			GPS Latitude/Longitude	
				Start	End
Item	Erosion / Bank Caving			38.695416 °	38.695416 °
				-121.715943 °	-121.715943 °
DWR ID	DWR_ST0001_04_s_2017_3				
Comment Code					
E2 : Schedule repair of erosion site prior to the next inspection.					
Inspector Comment					
Scour on waterside levee slope at end of Unit 04 levee. There is no visible active erosion at this time, however future high water events will likely cause further erosion into the levee prism.

View of scour on waterside levee slope at the end of Unit 4. Spring 2018.

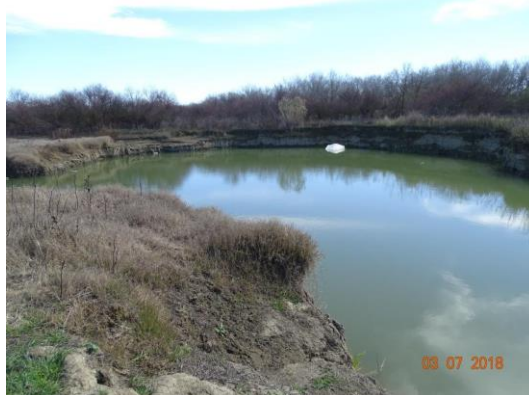
Photo 2 of 4 : SP_2018_ST0001_261_3_20180308_00007.jpg

LM Start	2.26	Rating **	A/W	Issue No.	3 (cont)	
LM End	2.26	Issue Type +	Ma	Location *	WS	
Category	Earthen Levee			GPS Latitude/Longitude		
				Start	End	
Item	Erosion / Bank Caving			38.695416 °	38.695416 °	
				-121.715943 °	-121.715943 °	
DWR ID	DWR_ST0001_04_s_2017_3					
Comment Code						
E2 : Schedule repair of erosion site prior to the next inspection.						
Inspector Comment						
Scour on waterside levee slope at end of Unit 04 levee. There is no visible active erosion at this time, however future high water events will likely cause further erosion into the levee prism.

View of newly scoured pond adjacent to the levee. Spring 2018.

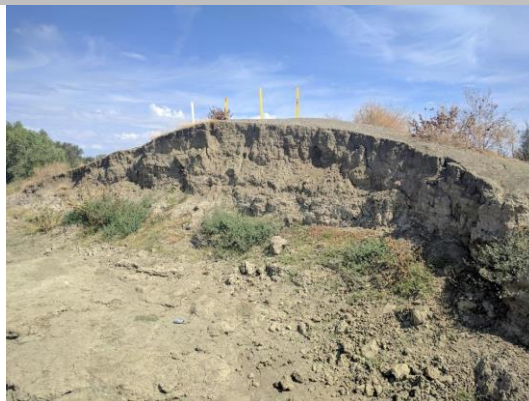
Photo 3 of 4 : SP_2018_ST0001_261_3_20180306_00004.jpg

View of scour at the end of the Training Levee. Ramp is inaccessible at this time. Fall 2017.

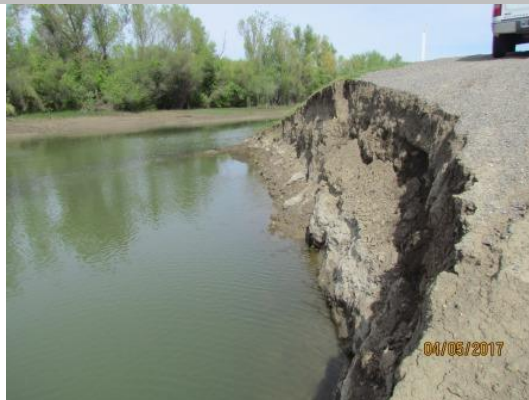
Photo 4 of 4 : SP_2018_ST0001_261_3_20180306_00005.jpg

Scour on waterside levee slope at end of Unit 04 levee. Spring 2017.
