**Flood Control Project Maintenance  
Levee Inspections**

## Maintenance Issue Types Only, Levee Inspection Report By Mile - Spring 2019

### Sacramento Maintenance Yard Cache Creek

Waterway	Bank	Unit Miles	Inspection Start/End	Inspector
Unit No. 01 North Levee	Left	11.69	04/23/2019 04/23/2019	Zach Jojola

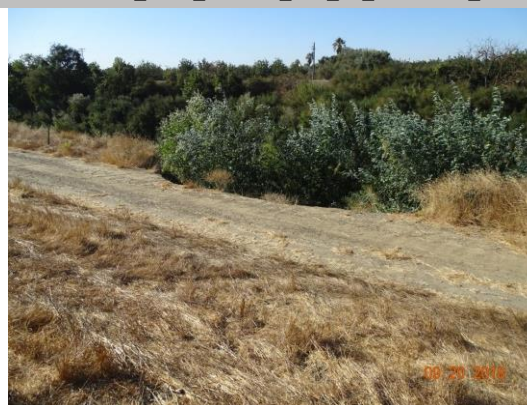
Photo 1 of 3 : SP\_2019\_ST0001\_259\_30\_20190304\_00023.jpg

LM Start	2.57	Rating **	A/W	Issue No.	30
LM End	2.61	Issue Type +	Ma	Location *	WS
Category	Supplemental			GPS Latitude/Longitude	
				Start	End
Item	2017 USACE Erosion Survey, DRAFT			38.732836 °	38.732685 °
				-121.797893 °	-121.797154 °
DWR ID	DWR_ST0001_01_f_2018_30				
Comment Code					
Inspector Comment					
2017 Site ID: CHC 2.4 L					
Status: Critical					
2017 Field Notes: No observed change.					
Site History: Site identified as CRITICAL in 2002. 2006 - Currently constructing a setback levee. New failures present and extensive. Downstream end of the setback levee did not extend far enough. Upstream end was repaired. 2007 - DWR repaired with a setback levee, but the levee did not go far enough downstream. 2012 - New cracks observed. 2013 - Fresh erosion on upper bank.					
DWR Inspector Comment: No observed changes in erosion. Spring 2019.

View of erosion on the waterside toe road. Fall 2018.

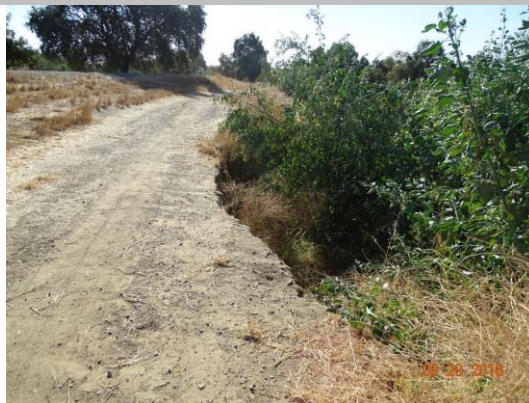
Photo 2 of 3 : SP\_2019\_ST0001\_259\_30\_20190304\_00024.jpg

LM Start	2.57	Rating **	A/W	Issue No.	30 (cont)
LM End	2.61	Issue Type +	Ma	Location *	WS
Category	Supplemental			GPS Latitude/Longitude	
				Start	End
Item	2017 USACE Erosion Survey, DRAFT			38.732836 °	38.732685 °
				-121.797893 °	-121.797154 °
DWR ID	DWR_ST0001_01_f _ 2018_30				
Comment Code					
Inspector Comment					
2017 Site ID: CHC 2.4 L Status: Critical 2017 Field Notes: No observed change. Site History: Site identified as CRITICAL in 2002. 2006 - Currently constructing a setback levee. New failures present and extensive. Downstream end of the setback levee did not extend far enough. Upstream end was repaired. 2007 - DWR repaired with a setback levee, but the levee did not go far enough downstream. 2012 - New cracks observed. 2013 - Fresh erosion on upper bank.					
DWR Inspector Comment: No observed changes in erosion. Spring 2019.

Additional view of the erosion, facing downstream. Fall 2018.

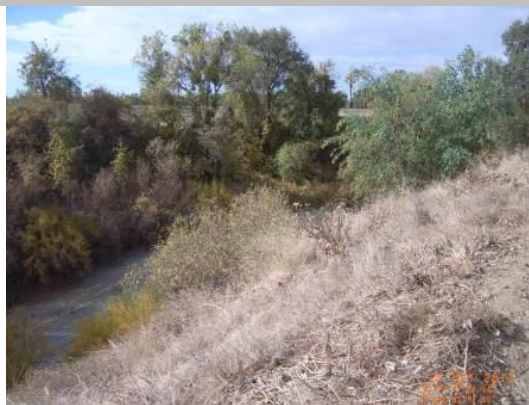
Photo 3 of 3 : SP\_2019\_ST0001\_259\_30\_20190304\_00025.jpg

USACE 2013 Photo #1

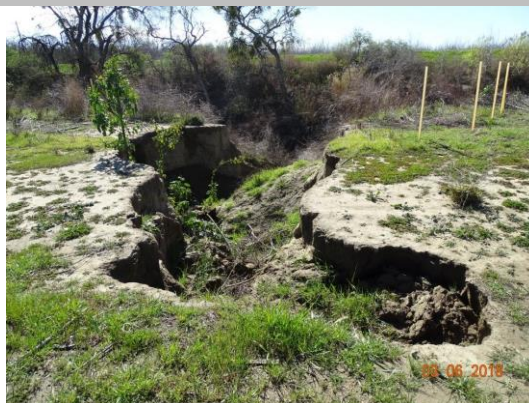
Photo 1 of 5 : SP\_2019\_ST0001\_259\_62\_20190304\_00041.jpg

LM Start	2.84	Rating **	A/W	Issue No.	62
LM End	2.84	Issue Type +	Ma	Location *	WS
Category	Earthen Levee			GPS Latitude/Longitude	
				Start	End
Item	Erosion / Bank Caving			38.734514 °	38.734514 °
				-121.793418 °	-121.793418 °
DWR ID	DWR_ST0001_01_s_2018_62				
Comment Code					
E1 : Note and monitor erosion site.					
Inspector Comment					
Erosion is occurring on the waterside berm and toe road.

View of erosion on toe road, looking towards Cache Creek. Spring 2018.

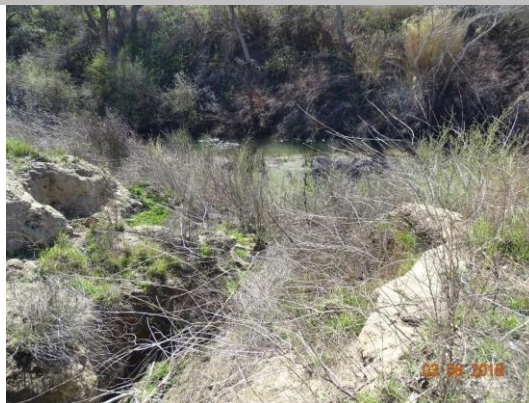
Photo 3 of 5 : SP\_2019\_ST0001\_259\_62\_20190304\_00043.jpg

LM Start	2.84	Rating **	A/W	Issue No.	62 (cont)	
LM End	2.84	Issue Type +	Ma	Location *	WS	
Category	Earthen Levee			GPS Latitude/Longitude		
				Start		End
Item	Erosion / Bank Caving			38.734514 °		38.734514 °
				-121.793418 °		-121.793418 °
DWR ID	DWR_ST0001_01_s_2018_62					
Comment Code						
E1 : Note and monitor erosion site.						
Inspector Comment						
Erosion is occurring on the waterside berm and toe road.

Downslope view of erosion, facing Cache Creek. Spring 2018.

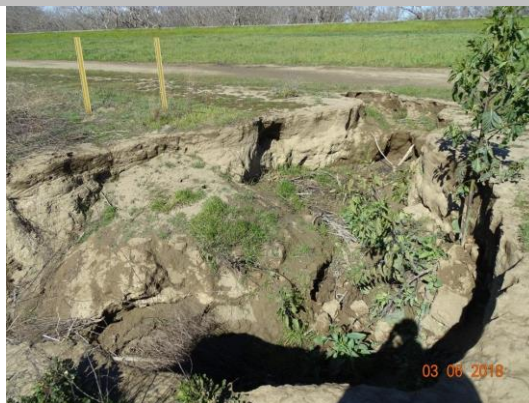
Photo 4 of 5 : SP\_2019\_ST0001\_259\_62\_20190304\_00044.jpg

Additional view of erosion, looking northwest. Spring 2018.

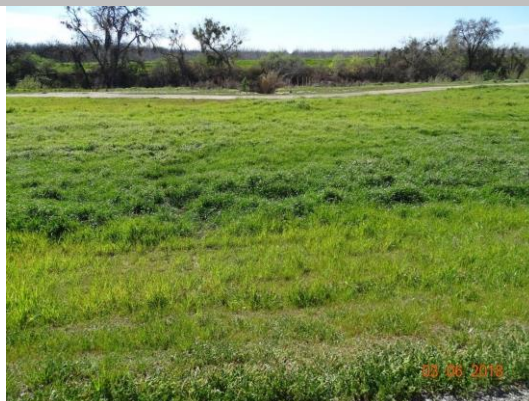
Photo 5 of 5 : SP\_2019\_ST0001\_259\_62\_20190304\_00045.jpg

View of erosion from levee crown, facing Cache Creek. Fall 2018.

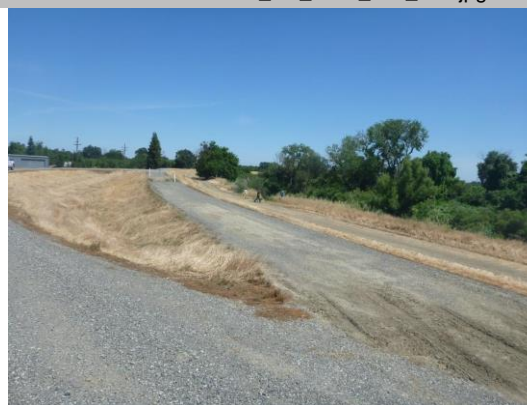
Photo 1 of 3 : LEVAL\_SP\_2019\_249\_954.jpg

LM Start	4.22	Rating **	A/W	Issue No.	34
LM End	4.23	Issue Type +	Ma	Location *	WS
Category	Supplemental			GPS Latitude/Longitude	
				Start	End
Item	2017 Storm Damage			38.727207 °	38.727187 °
				-121.775521 °	-121.775450 °
DWR ID	DWR_ST0001_01_f _ 2017_34				
Comment Code					
Inspector Comment					
Levee Evaluation Comments					
Description:					
Site ID No:249					
Site Designation:LMA-57					
Repair Type: Erosion					
Rating:Area of Concern					
Field Date:6/2/2017					
Notes: setback levee site; remaining berm greater than 86 feet, no section taken, photo only.

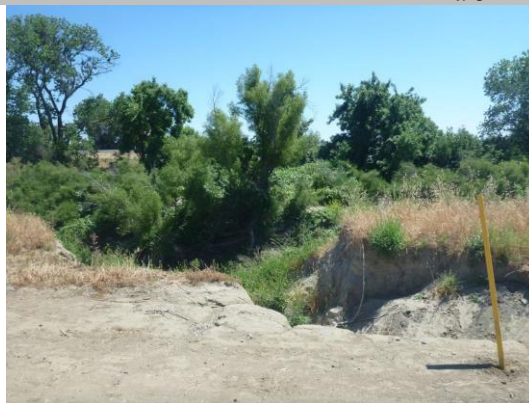
Photo 2 of 3 : LEVAL\_SP\_2019\_249\_959.jpg

LM Start	4.22	Rating **	A/W	Issue No.	34 (cont)
LM End	4.23	Issue Type +	Ma	Location *	WS
Category	Supplemental			GPS Latitude/Longitude	
				Start	End
Item	2017 Storm Damage			38.727207 °	38.727187 °
				-121.775521 °	-121.775450 °
DWR ID	DWR_ST0001_01_f_2017_34				
Comment Code					
Inspector Comment					
Levee Evaluation Comments					
Description:					
Site ID No:249					
Site Designation:LMA-57					
Repair Type: Erosion					
Rating:Area of Concern					
Field Date:6/2/2017					
Notes: setback levee site; remaining berm greater than 86 feet, no section taken, photo only.

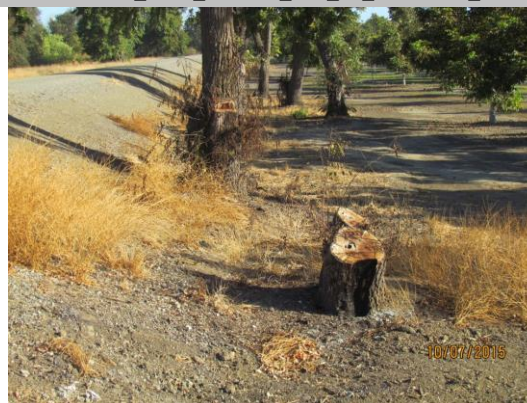
Photo 1 of 1 : SP\_2019\_ST0001\_260\_10\_20190304\_00010.jpg

LM Start	0.18	Rating **	N	Issue No.	10
LM End	0.18	Issue Type +	Ma	Location *	LS
Category	Earthen Levee			GPS Latitude/Longitude	
				Start	End
Item	Trim / Thin Trees			38.729560 °	38.729560 °
				-121.805231 °	-121.805231 °
DWR ID	DWR_ST0001_02_f_2015_10				
Comment Code					
T5 : Tree stumps.					
Inspector Comment					
The stump is located at the levee toe.

View of the tree stump at the landward side of the levee looking downstream. Fall 2015.

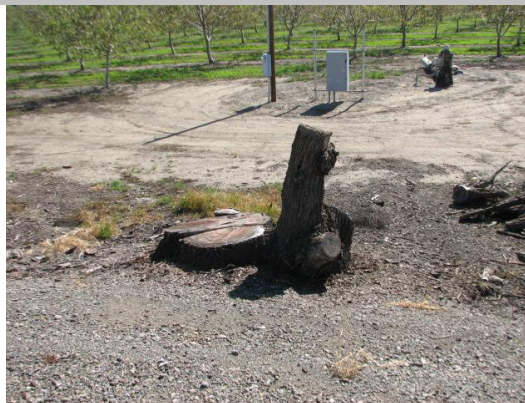
Photo 1 of 1 : SP\_2019\_ST0001\_260\_6\_20190304\_00006.jpg

LM Start	0.27	Rating **	N	Issue No.	6
LM End	0.27	Issue Type +	Ma	Location *	LS
Category	Earthen Levee			GPS Latitude/Longitude	
				Start	End
Item	Trim / Thin Trees			38.730723 °	38.730723 °
				-121.804972 °	-121.804972 °
DWR ID	DWR_ST0001_02_s_2014_6				
Comment Code					
T5 : Tree stumps.					
Inspector Comment					
A large black walnut tree stump is at the toe of the levee

View of large black walnut tree stump is at the landside toe. Spring 2014

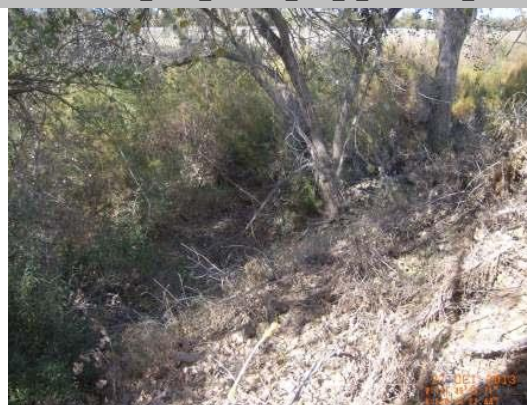
Photo 1 of 1 : SP\_2019\_ST0001\_260\_2\_20190304\_00001.jpg

LM Start	3.53	Rating **	A/W	Issue No.	2
LM End	3.60	Issue Type +	Ma	Location *	WS
Category	Supplemental			GPS Latitude/Longitude	
				Start	End
Item	2017 USACE Erosion Survey, DRAFT			38.722138 °	38.723294 °
				-121.759736 °	-121.759588 °
DWR ID	DWR_ST0001_02_f_2018_2				
Comment Code					
Inspector Comment					
2017 Site ID: CHC 3.5 R					
Status: Eroding					
2017 Field Notes: Significant amount of debris along bank.					
Site History: 2010 - Large slump on the upper berm, a tree has recently slid down the slope. 2011 - Large slump and new erosion. 2012 - Slightly steeper slopes and cracks observed.

USACE 2013 Photo #1

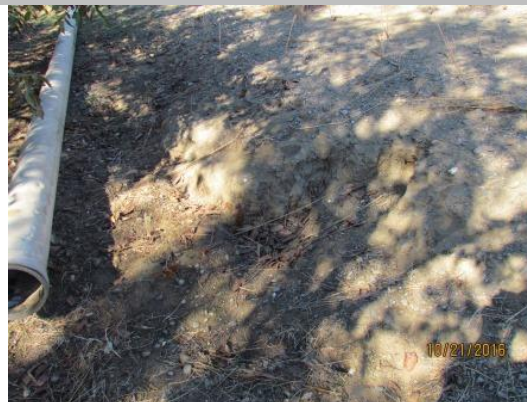
Photo 1 of 1 : SP\_2019\_ST0001\_260\_4\_20190304\_00004.jpg

LM Start	4.42	Rating **	A/W	Issue No.	4
LM End	4.42	Issue Type +	Ma	Location *	LS
Category	Earthen Levee			GPS Latitude/Longitude	
				Start	End
Item	Erosion / Bank Caving			38.726840 °	38.726840 °
				-121.747228 °	-121.747228 °
DWR ID	DWR_ST0001_02_f_2016_4				
Comment Code					
E1 : Note and monitor erosion site.					
Inspector Comment					
There is erosion on the landside slope near the levee toe. It does not appear to pose a significant threat. Recommend monitoring.

Erosion on LS levee slope toward the toe. Fall 2016.

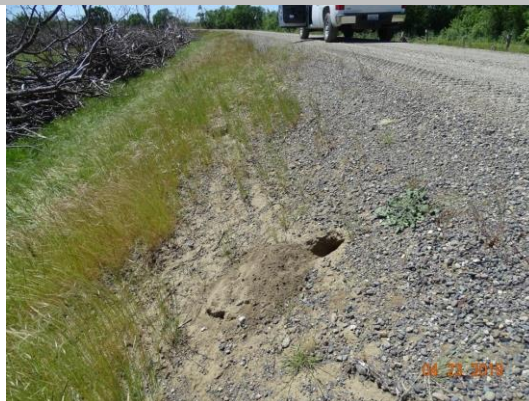
Photo 1 of 1 : SP\_2019\_ST0001\_260\_30\_20190422\_00024.jpg

LM Start	4.44	Rating **	U	Issue No.	30
LM End	4.44	Issue Type +	Ma	Location *	LS
Category	Earthen Levee			GPS Latitude/Longitude	
				Start	End
Item	Animal Control			38.726908 °	38.726908 °
				-121.746833 °	-121.746833 °
DWR ID	DWR_ST0001_02_s_2019_30				
Comment Code					
A1 : Exterminate rodents and backfill and compact or grout burrows.					
Inspector Comment					
There are large rodent holes on the landside slope.

View of rodent holes on the landside slope. Spring 2019.

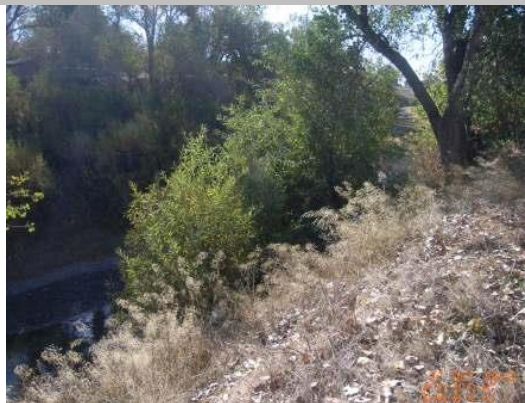
USACE 2013 Photo #1

LM Start	5.33	Rating **	A/W	Issue No.	11
LM End	5.37	Issue Type +	Ma	Location *	WS
Category	Supplemental			GPS Latitude/Longitude	
				Start	End
Item	2017 USACE Erosion Survey, DRAFT			38.722933 °	38.723467 °
				-121.760561 °	-121.760436 °
DWR ID	DWR_ST0001_02_f_2018_11				
Comment Code					
Inspector Comment					
2017 Site ID: CHC 5.4 L Status: Eroding 2017 Field Notes: Site continues to erode due to recent high storm events. Site History: 2009 - Erosion into the levee slope. 2010 - Minor new erosion. 2011 - New erosion and a freshly fallen tree. 2012 - New animal holes and slightly steeper slopes. 2013 - New tree popout and 2 feet of erosion along the top bank.

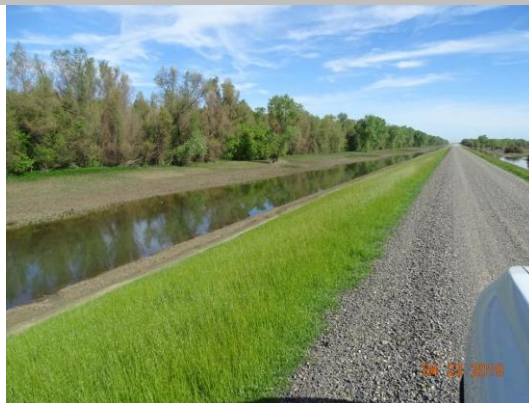
Photo 1 of 1 : SP\_2019\_ST0001\_261\_4\_20190424\_00008.jpg

LM Start	0.03	Rating **	M	Issue No.	4
LM End	2.23	Issue Type +	Ma	Location *	WS
Category	Earthen Levee			GPS Latitude/Longitude	
				Start	End
Item	Vegetation			38.726981 °	38.695860 °
				-121.717821 °	-121.715921 °
DWR ID	DWR_ST0001_04_s_2019_4				
Comment Code					
V1 : Control annual grass and weeds on the levee slopes and easements.					
Inspector Comment

View of vegetation on the waterside slope. Spring 2019.

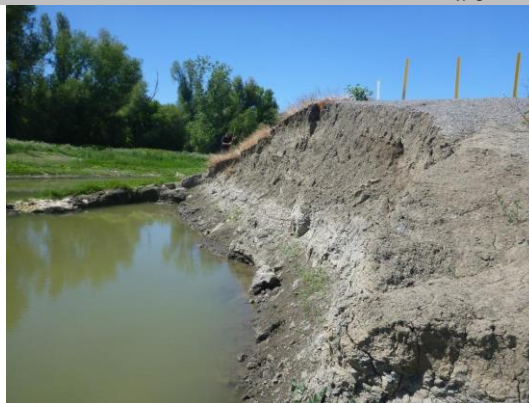
Photo 1 of 3 : LEVAL\_SP\_2019\_250\_962.jpg

LM Start	2.26	Rating **	M	Issue No.	1 (cont)	
LM End	2.26	Issue Type +	Ma	Location *		
Category	Supplemental			GPS Latitude/Longitude		
				Start	End	
Item	2017 Storm Damage			38.695424 °	38.695253 °	
				-121.715914 °	-121.715926 °	
DWR ID	DWR_ST0001_04_f_2017_1					
Comment Code						
Inspector Comment						
Levee Evaluation Comments						
Description:						
Site ID No:250						
Site Designation:LMA-58						
Repair Type: Erosion						
Rating:Area of Concern						
Field Date:6/2/2017						
Notes: training levee end slope where it keys into channel /access ramp erosion. No change as of fall 2018 inspection.

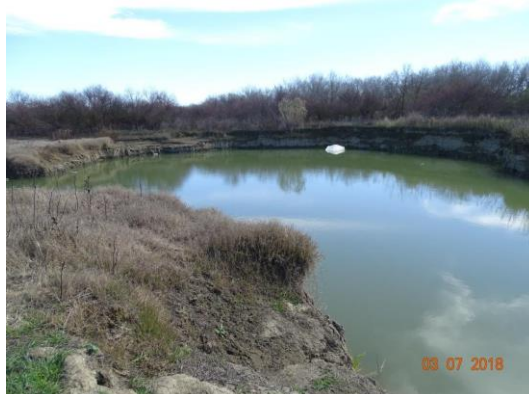
Photo 2 of 4 : SP\_2019\_ST0001\_261\_3\_20190304\_00005.jpg

LM Start	2.26	Rating **	A/W	Issue No.	3 (cont)	
LM End	2.26	Issue Type +	Ma	Location *	WS	
Category	Earthen Levee			GPS Latitude/Longitude		
				Start		End
Item	Erosion / Bank Caving			38.695416 °		38.695416 °
				-121.715943 °		-121.715943 °
DWR ID	DWR_ST0001_04_s_2017_3					
Comment Code						
E2 : Schedule repair of erosion site prior to the next inspection.						
Inspector Comment						
Scour on waterside levee slope at end of Unit 04 levee. There is no visible active erosion at this time, however future high water events will likely cause further erosion into the levee prism.

View of newly scoured pond adjacent to the levee. Spring 2018.

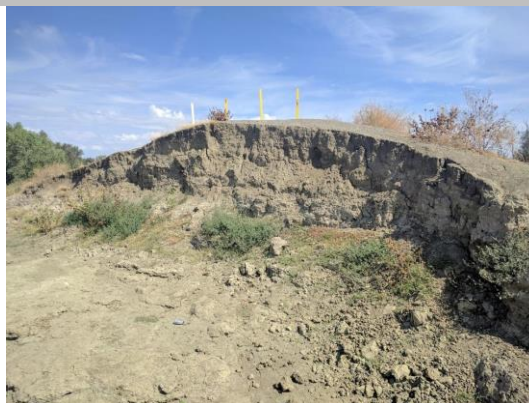
Photo 3 of 4 : SP\_2019\_ST0001\_261\_3\_20190304\_00006.jpg

View of scour at the end of the Training Levee. Ramp is inaccessible at this time. Fall 2017.
