**Flood Control Project Maintenance  
Levee Inspections**

**Maintenance Issue Types Only, Levee Inspection Report By Mile - Spring 2020**

**Sacramento Maintenance Yard Cache Creek**

Waterway	Bank	Unit Miles	Inspection Start/End	Inspector
Unit No. 01 North Levee	Left	11.69	03/10/2020 03/10/2020	Zach Jojola

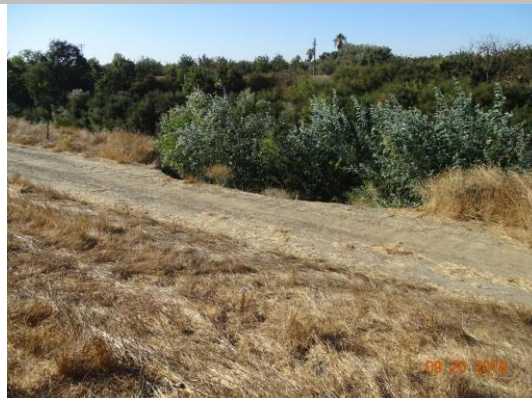
Photo 1 of 3 : SP\_2020\_ST0001\_259\_30\_20200228\_00022.jpg

LM Start	2.57	Rating **	A/W	Issue No.	30
LM End	2.61	Issue Type +	Ma	Location *	WS
Category	Supplemental			GPS Latitude/Longitude	
				Start	End
Item	2017 USACE Erosion Survey			38.732836 °	38.732685 °
				-121.797893 °	-121.797154 °
DWR ID	DWR_ST0001_01_f_2018_30

2017 Site ID: CHC 2.4 L  
Status: Critical  
2017 Field Notes: No observed change.  
Site History: Site identified as CRITICAL in 2002. 2006 - Currently constructing a setback levee. New failures present and extensive. Downstream end of the setback levee did not extend far enough. Upstream end was repaired. 2007 - DWR repaired with a setback levee, but the levee did not go far enough downstream. 2012 - New cracks observed. 2013 - Fresh erosion on upper bank.

View of erosion on the waterside toe road. Fall 2018.

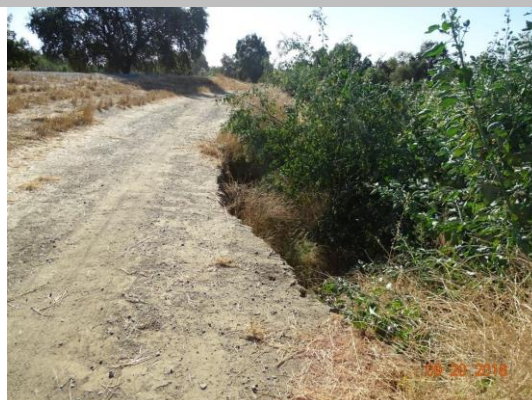
Photo 2 of 3 : SP\_2020\_ST0001\_259\_30\_20200228\_00023.jpg

Additional view of the erosion, facing downstream. Fall 2018.

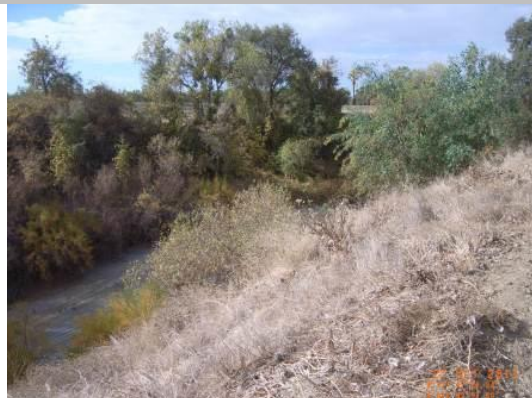
Photo 3 of 3 : SP\_2020\_ST0001\_259\_30\_20200228\_00024.jpg

USACE 2013 Photo #1

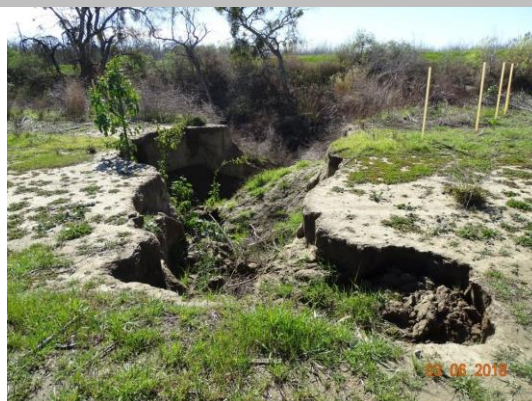
Photo 1 of 5 : SP\_2020\_ST0001\_259\_62\_20200228\_00038.jpg

Erosion is occurring on the waterside berm and toe road.

View of erosion on toe road, looking towards Cache Creek. Spring 2018.

E1 : Note and monitor erosion site.

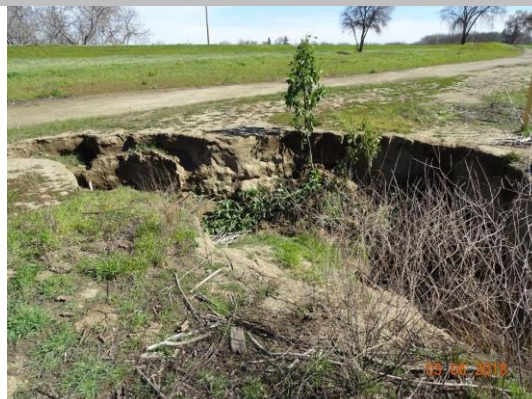
Photo 2 of 5 : SP\_2020\_ST0001\_259\_62\_20200228\_00039.jpg

View of erosion looking towards the landside levee slope, facing northeast. Spring 2018.

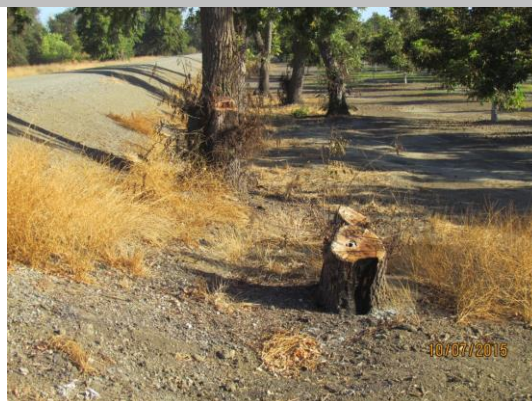
Photo 1 of 1 : SP\_2020\_ST0001\_260\_10\_20200228\_00009.jpg

LM Start	0.18	Rating **	N	Issue No.	10
LM End	0.18	Issue Type +	Ma	Location *	LS
Category	Earthen Levee			GPS Latitude/Longitude	
				Start	End
Item	Trim / Thin Trees			38.729560 °	38.729560 °
				-121.805231 °	-121.805231 °
DWR ID	DWR_ST0001_02_f_2015_10				
Comment Code					
T5 : Tree stumps.					
Inspector Comment					
The stump is located at the levee toe.

View of the tree stump at the landward side of the levee looking downstream. Fall 2015.

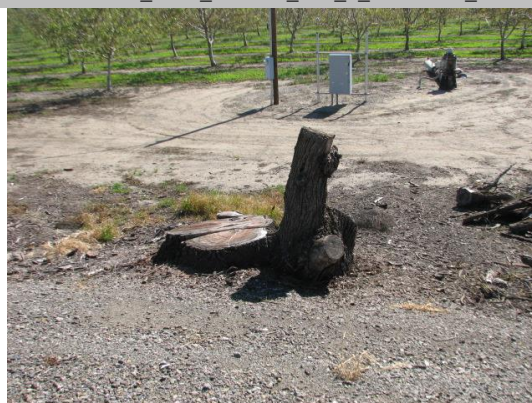
Photo 1 of 1 : SP\_2020\_ST0001\_260\_6\_20200228\_00006.jpg

LM Start	0.27	Rating **	N	Issue No.	6
LM End	0.27	Issue Type +	Ma	Location *	LS
Category	Earthen Levee			GPS Latitude/Longitude	
				Start	End
Item	Trim / Thin Trees			38.730723 °	38.730723 °
				-121.804972 °	-121.804972 °
DWR ID	DWR_ST0001_02_s_2014_6				
Comment Code					
T5 : Tree stumps.					
Inspector Comment					
A large black walnut tree stump is at the toe of the levee

View of large black walnut tree stump is at the landside toe. Spring 2014

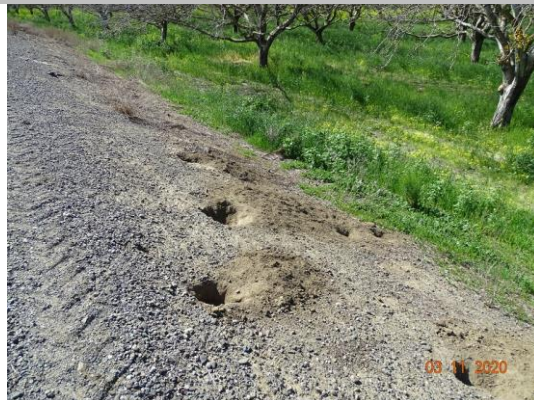
Photo 1 of 1 : SP\_2020\_ST0001\_260\_43\_20200313\_00025.jpg

LM Start	1.59	Rating **	U	Issue No.	43
LM End	1.59	Issue Type +	Ma	Location *	LS
Category	Earthen Levee			GPS Latitude/Longitude	
				Start	End
Item	Animal Control			38.731842 °	38.731842 °
				-121.786177 °	-121.786177 °
DWR ID	DWR_ST0001_02_s_2020_43				
Comment Code					
A3 : No rodents visible, but rodent burrows visible; need to backfill and compact or grout burrows.					
Inspector Comment					
Large rodent holes on the landside slope.

View of rodent holes on the landside slope. Spring 2020.

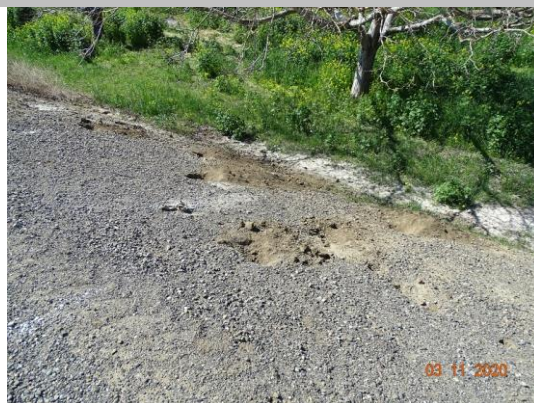
Photo 1 of 1 : SP\_2020\_ST0001\_260\_42\_20200313\_00024.jpg

LM Start	1.65	Rating **	U	Issue No.	42
LM End	1.65	Issue Type +	Ma	Location *	LS
Category	Earthen Levee			GPS Latitude/Longitude	
				Start	End
Item	Animal Control			38.730995 °	38.730995 °
				-121.786229 °	-121.786229 °
DWR ID	DWR_ST0001_02_s_2020_42				
Comment Code					
A3 : No rodents visible, but rodent burrows visible; need to backfill and compact or grout burrows.					
Inspector Comment					
Large rodent holes on the landside slope.

View of rodent holes on the landside slope. Spring 2020.

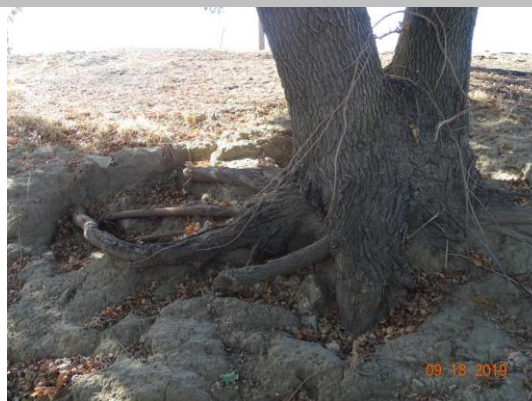
Photo 1 of 1 : SP\_2020\_ST0001\_260\_18\_20200228\_00017.jpg

LM Start	3.09	Rating **	M	Issue No.	18
LM End	3.09	Issue Type +	Ma	Location *	WS
Category	Earthen Levee			GPS Latitude/Longitude	
				Start	End
Item	Erosion / Bank Caving			38.720557 °	38.720557 °
				-121.764575 °	-121.764575 °
DWR ID	DWR_ST0001_02_f_2019_18				
Comment Code					
E2 : Schedule repair of erosion site prior to the next inspection.					
Inspector Comment					
There is erosion around tree roots. Recommend backfilling.

View of the erosion around the tree. Fall 2019.

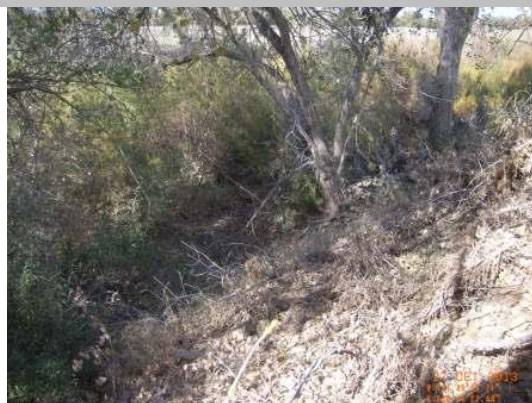
Photo 1 of 1 : SP\_2020\_ST0001\_260\_2\_20200228\_00001.jpg

LM Start	3.53	Rating **	A/W	Issue No.	2
LM End	3.60	Issue Type +	Ma	Location *	WS
Category	Supplemental			GPS Latitude/Longitude	
				Start	End
Item	2017 USACE Erosion Survey			38.722138 °	38.723294 °
				-121.759736 °	-121.759588 °
DWR ID	DWR_ST0001_02_f_2018_2				
Comment Code					
Inspector Comment					
2017 Site ID: CHC 3.5 R					
Status: Eroding					
2017 Field Notes: Significant amount of debris along bank.					
Site History: 2010 - Large slump on the upper berm, a tree has recently slid down the slope. 2011 - Large slump and new erosion. 2012 - Slightly steeper slopes and cracks observed.

USACE 2013 Photo #1

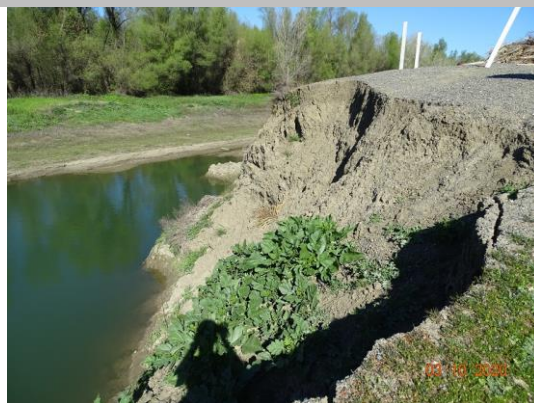
Photo 1 of 2 : SP\_2020\_ST0001\_261\_3\_20200313\_00008.jpg

LM Start	2.26	Rating **	M	Issue No.	3
LM End	2.26	Issue Type +	Ma	Location *	WS
Category	Earthen Levee			GPS Latitude/Longitude	
				Start	End
Item	Erosion / Bank Caving			38.695416 °	38.695416 °
				-121.715943 °	-121.715943 °
DWR ID	DWR_ST0001_04_s_2017_3				
Comment Code					
E2 : Schedule repair of erosion site prior to the next inspection.					
Inspector Comment					
Scour on waterside levee slope at end of Unit 04 levee. There is no visible active erosion at this time, however future high water events will likely cause further erosion into the levee prism.					
Site ID No:250					
Site Designation:LMA-58

View of scour at the end of the levee unit. Spring 2020.

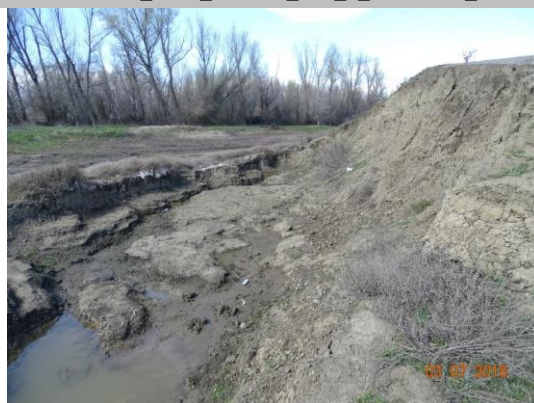
Photo 2 of 2 : SP\_2020\_ST0001\_261\_3\_20200228\_00004.jpg

View of scour on waterside levee slope at the end of Unit 4. Spring 2018.
