**Flood Control Project Maintenance
Levee Inspections**

Maintenance Issue Types Only, Levee Inspection Report By Mile - Spring 2021

Sacramento Maintenance Yard Cache Creek

Waterway	Bank	Unit Miles	Inspection Start/End	Inspector
Unit No. 01 North Levee	Left	11.69	03/09/2021 03/09/2021	Zach Jojola

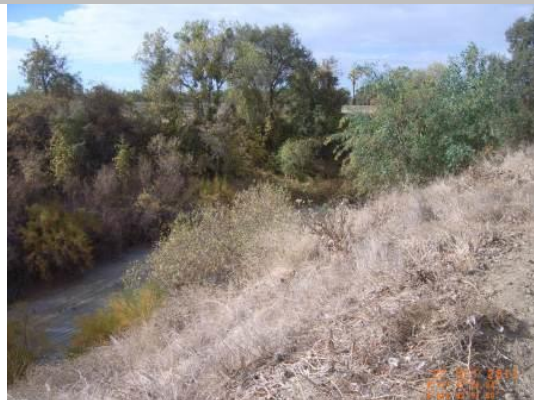
Photo 3 of 3 : SP_2021_ST0001_259_30_20210308_00020.jpg

USACE 2013 Photo #1

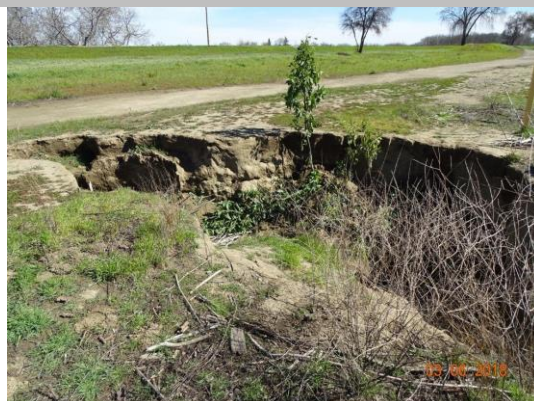
Photo 1 of 2 : SP_2021_ST0001_259_62_20210308_00035.jpg

E1 : Note and monitor erosion site.

Erosion is occurring on the waterside berm and toe road. Approximately 120 feet from the landside toe and not within the prism.

View of erosion looking towards the landside levee slope, facing northeast. Spring 2018.

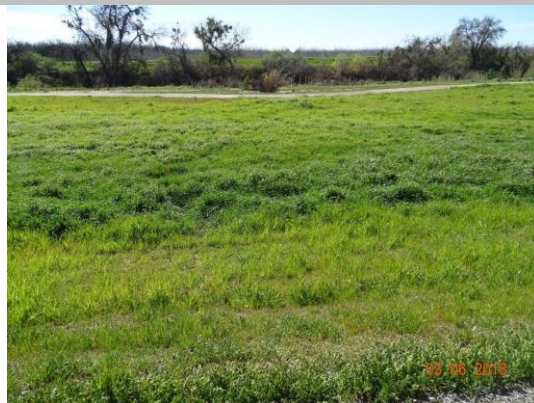
Photo 2 of 2 : SP_2021_ST0001_259_62_20210308_00037.jpg

View of erosion from levee crown, facing Cache Creek. Fall 2018.

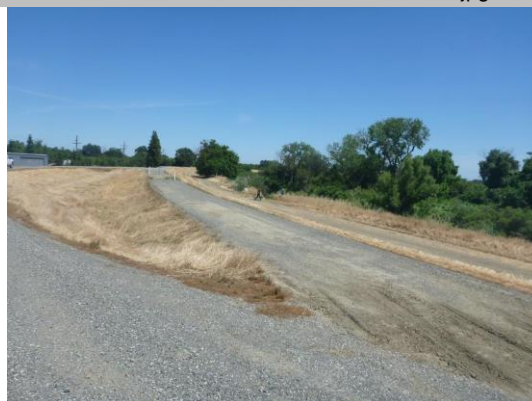
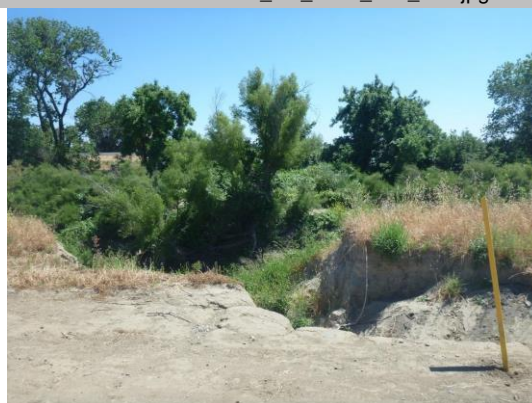
LM Start	4.22	Rating **	A/W	Issue No.	34
LM End	4.23	Issue Type +	Ma	Location *	WS
Category	Earthen Levee			GPS Latitude/Longitude	
				Start	End
Item	Erosion / Bank Caving			38.727207 °	38.727187 °
				-121.775521 °	-121.775450 °
DWR ID	LMA-57				
Comment Code					
E1 : Note and monitor erosion site.					
Inspector Comment					
Erosion is occurring on the waterside berm and toe road. Approximately 80 feet from the landside toe and not within the prism.					
Site ID No:249					
Site Designation:LMA-57

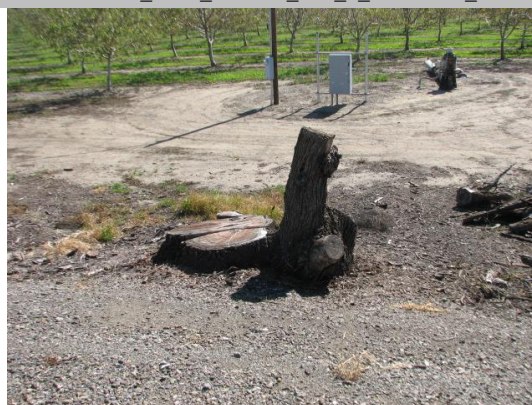
Photo 1 of 1 : SP_2021_ST0001_260_6_20210308_00004.jpg

LM Start	0.27	Rating **	N	Issue No.	6
LM End	0.27	Issue Type +	Ma	Location *	LS
Category	Earthen Levee			GPS Latitude/Longitude	
				Start	End
Item	Trim / Thin Trees			38.730723 °	38.730723 °
				-121.804972 °	-121.804972 °
DWR ID	DWR_ST0001_02_s_2014_6				
Comment Code					
T5 : Tree stumps.					
Inspector Comment					
A large black walnut tree stump is at the toe of the levee.

View of large black walnut tree stump is at the landside toe. Spring 2014

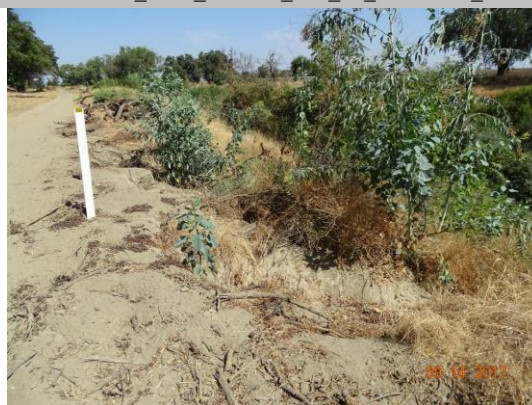
Photo 1 of 1 : SP_2021_ST0001_260_16_20210308_00010.jpg

LM Start	1.60	Rating **	A/W	Issue No.	16
LM End	1.60	Issue Type +	Ma	Location *	WS
Category	Earthen Levee			GPS Latitude/Longitude	
				Start	End
Item	Erosion / Bank Caving			38.731659 °	38.731577 °
				-121.785931 °	-121.785936 °
DWR ID	ST1-01				
Comment Code					
E1 : Note and monitor erosion site.					
Inspector Comment					
Erosion is on the bank and is starting to cut into the WS toe road. Approximately 55 feet from the landside toe.					
Site ID No:181					
Site Designation:ST1-01

View of storm damage site on waterside berm. Does not appear to be within the levee prism at this time. Fall 2017.

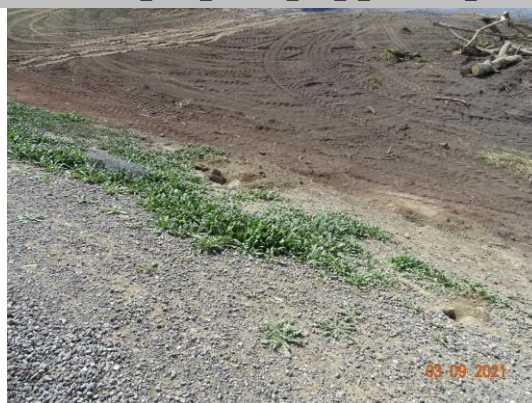
Photo 1 of 1 : SP_2021_ST0001_260_4_20210310_00017.jpg

LM Start	1.68	Rating **	M	Issue No.	4
LM End	1.68	Issue Type +	Ma	Location *	LS
Category	Earthen Levee			GPS Latitude/Longitude	
				Start	End
Item	Animal Control			38.730507 °	38.730507 °
				-121.785972 °	-121.785972 °
DWR ID	DWR_ST0001_02_s_2021_4				
Comment Code					
A3 : No rodents visible, but rodent burrows visible; need to backfill and compact or grout burrows.					
Inspector Comment					
Rodent holes are on the landside slope.

View of rodent holes on the landside slope. Spring 2021.

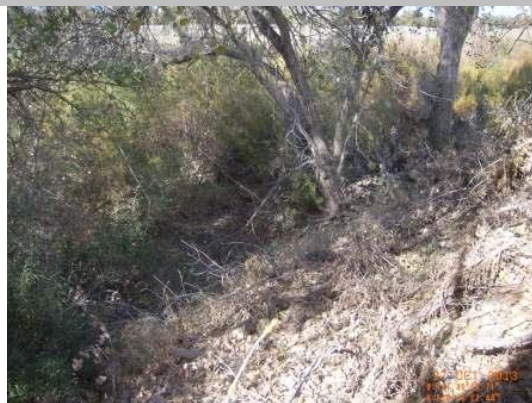
Photo 1 of 1 : SP_2021_ST0001_260_2_20210308_00001.jpg

LM Start	3.53	Rating **	A/W	Issue No.	2
LM End	3.60	Issue Type +	Ma	Location *	WS
Category	Supplemental			GPS Latitude/Longitude	
				Start	End
Item	2017 USACE Erosion Survey			38.722138 °	38.723294 °
				-121.759736 °	-121.759588 °
DWR ID	DWR_ST0001_02_f_2018_2				
Comment Code					
Inspector Comment					
2017 Site ID: CHC 3.5 R					
Status: Eroding					
2017 Field Notes: Significant amount of debris along bank.					
Site History: 2010 - Large slump on the upper berm, a tree has recently slid down the slope. 2011 - Large slump and new erosion. 2012 - Slightly steeper slopes and cracks observed.

USACE 2013 Photo #1

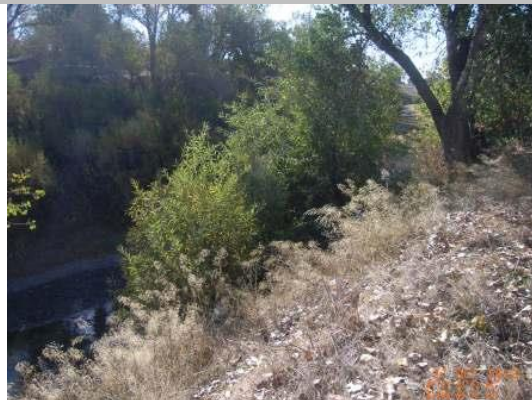
Photo 1 of 1 : SP_2021_ST0001_260_11_20210308_00008.jpg

LM Start	5.33	Rating **	A/W	Issue No.	11
LM End	5.37	Issue Type +	Ma	Location *	WS
Category	Supplemental			GPS Latitude/Longitude	
				Start	End
Item	2017 USACE Erosion Survey			38.722933 °	38.723467 °
				-121.760561 °	-121.760436 °
DWR ID	DWR_ST0001_02_f_2018_11				
Comment Code					
Inspector Comment					
2017 Site ID: CHC 5.4 L Status: Eroding 2017 Field Notes: Site continues to erode due to recent high storm events. Site History: 2009 - Erosion into the levee slope. 2010 - Minor new erosion. 2011 - New erosion and a freshly fallen tree. 2012 - New animal holes and slightly steeper slopes. 2013 - New tree popout and 2 feet of erosion along the top bank.

USACE 2013 Photo #1

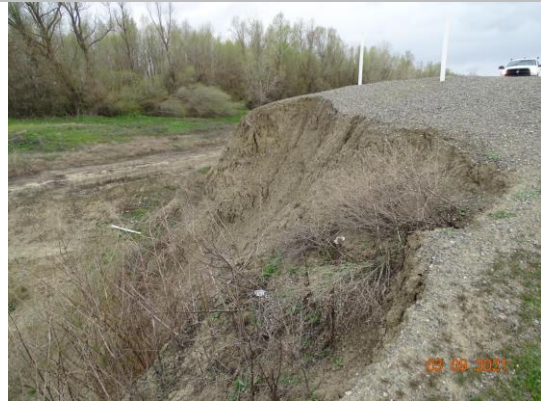
Photo 1 of 1 : SP_2021_ST0001_261_3_20210310_00001.jpg

LM Start	2.26	Rating **	M	Issue No.	3
LM End	2.26	Issue Type +	Ma	Location *	WS
Category	Earthen Levee			GPS Latitude/Longitude	
				Start	End
Item	Erosion / Bank Caving			38.695416 °	38.695416 °
				-121.715943 °	-121.715943 °
DWR ID	DWR_ST0001_04_s_2017_3				
Comment Code					
E2 : Schedule repair of erosion site prior to the next inspection.					
Inspector Comment					
Scour on waterside levee slope at end of Unit 04 levee where previous access ramp was located. There is no visible active erosion at this time, however future high water events will likely cause further erosion into the levee prism.					
Site ID No:250					
Site Designation:LMA-58

View of erosion at previous access ramp. Spring 2021.
