**Flood Control Project Maintenance
Levee Inspections**

Maintenance Issue Types Only, Levee Inspection Report By Mile - Spring 2022

Sacramento Maintenance Yard Cache Creek

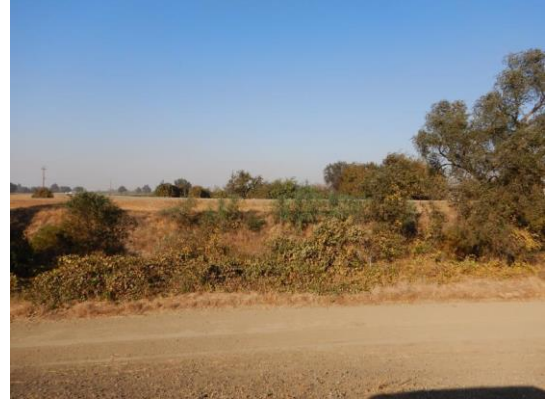
Photo 1 of 1 : SP_2022_ST0001_259_30_20220308_00017.jpg

LM Start	2.57	Rating **	A/W	Issue No.	30
LM End	2.61	Issue Type +	Ma	Location *	WS
Category	Supplemental			GPS Latitude/Longitude	
				Start	End
Item	2018 USACE Erosion Survey			38.732836 °	38.732685 °
				-121.797893 °	-121.797154 °
DWR ID	DWR_ST0001_01_s _ 2022_30				
Comment Code					
Inspector Comment					
2018 Site ID: CHC 2.4 L					
Status: Critical					
2018 Field Notes: No observed change.					
Site History: Site identified as CRITICAL in 2002. 2006 - Currently constructing a setback levee. New failures present and extensive. Downstream end of the setback levee did not extend far enough. Upstream end was repaired. 2007 - DWR repaired with a setback levee, but the levee did not go far enough downstream. 2012 - New cracks observed. 2013 - Fresh erosion on upper bank.

USACE 2018 Erosion Photo #1

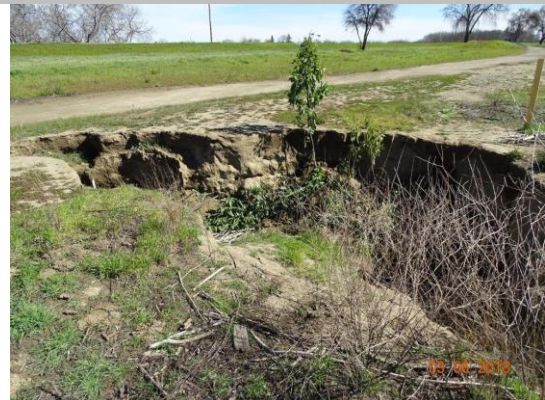
Photo 1 of 2 : SP_2022_ST0001_259_62_20220308_00028.jpg

LM Start	2.84	Rating **	A/W	Issue No.	62
LM End	2.84	Issue Type +	Ma	Location *	WS
Category	Earthen Levee			GPS Latitude/Longitude	
				Start	End
Item	Erosion / Bank Caving			38.734514 °	38.734514 °
				-121.793418 °	-121.793418 °
DWR ID	DWR_ST0001_01_s _ 2022_62				
Comment Code					
E1 : Note and monitor erosion site.					
Inspector Comment					
Erosion is occurring on the waterside berm and toe road. Approximately 120 feet from the landside toe and not within the prism.

View of erosion looking towards the landside levee slope, facing northeast. Spring 2018.

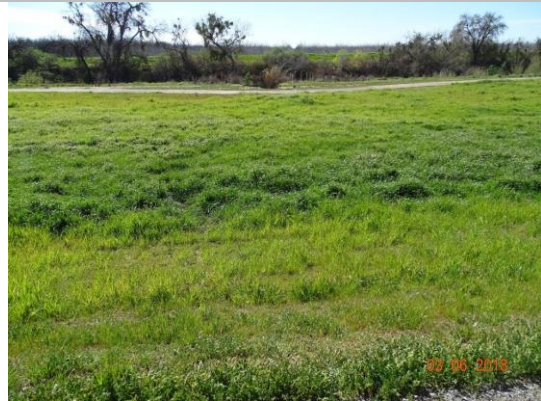
Photo 2 of 2 : SP_2022_ST0001_259_62_20220308_00029.jpg

View of erosion from levee crown, facing Cache Creek. Fall 2018.

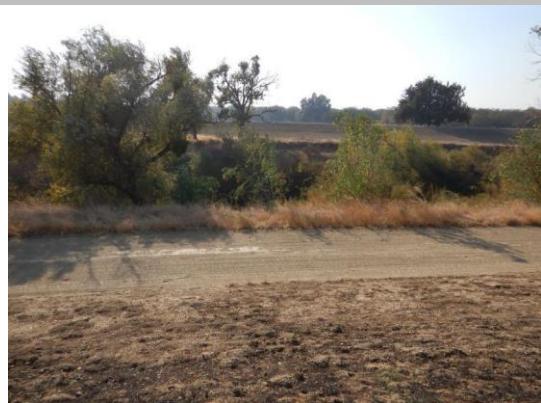
Photo 1 of 2 : SP_2022_ST0001_259_41_20220308_00023.jpg

LM Start	3.71	Rating **	A/W	Issue No.	41
LM End	3.74	Issue Type +	Ma	Location *	WS
Category	Supplemental			GPS Latitude/Longitude	
				Start	End
Item	2018 USACE Erosion Survey			38.729664 °	38.729322 °
				-121.784222 °	-121.783842 °
DWR ID	DWR_ST0001_01_s_ 2022_41

USACE 2018 Erosion Photo #1

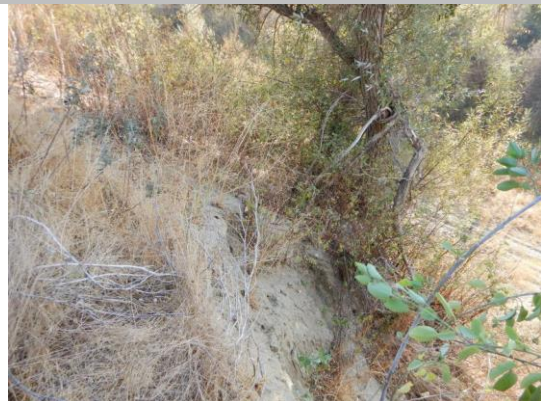
Photo 2 of 2 : SP_2022_ST0001_259_41_20220308_00024.jpg

USACE 2018 Erosion Photo #2

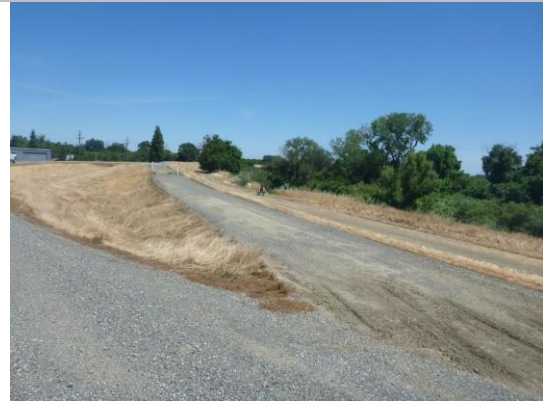
Photo 1 of 2 : LEVAL_SP_2022_249_954.jpg

LM Start	4.22	Rating **	A/W	Issue No.	34
LM End	4.23	Issue Type +	Ma	Location *	WS
Category	Earthen Levee			GPS Latitude/Longitude	
				Start	End
Item	Erosion / Bank Caving			38.727207 °	38.727187 °
				-121.775521 °	-121.775450 °
DWR ID	LMA-57				
Comment Code					
E1 : Note and monitor erosion site.					
Inspector Comment					
Erosion is occurring on the waterside berm and toe road. Approximately 80 feet from the landside toe and not within the prism.					
Site ID No:249					
Site Designation:LMA-57

View of toe road where erosion is located.

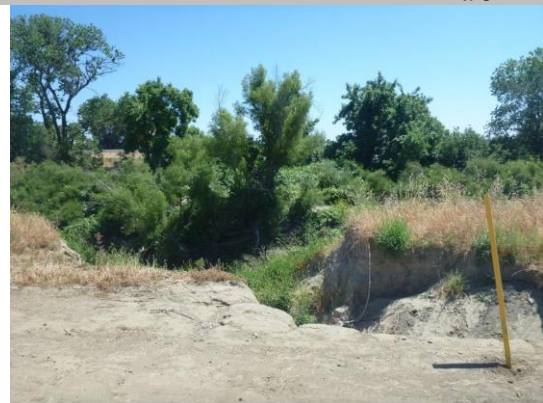
Photo 2 of 2 : LEVAL_SP_2022_249_959.jpg

View of erosion near waterside toe road.

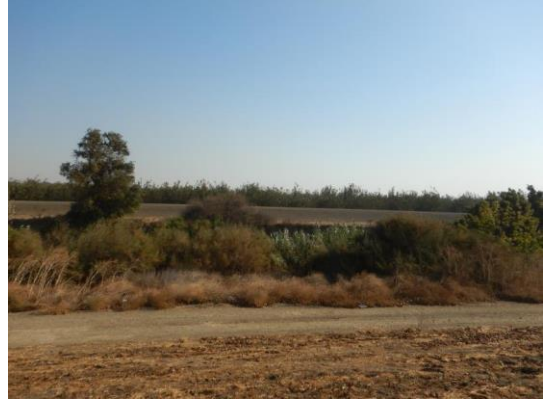
Photo 1 of 2 : SP_2022_ST0001_260_2_20220308_00002.jpg

LM Start	0.90	Rating **	A/W	Issue No.	2
LM End	0.92	Issue Type +	Ma	Location *	WS
Category	Supplemental			GPS Latitude/Longitude	
				Start	End
Item	2018 USACE Erosion Survey			38.732678 °	38.732903 °
				-121.795347 °	-121.795017 °
DWR ID	DWR_ST0001_02_s_2022_2				
Comment Code					
Inspector Comment					
2018 Site ID: CHC 0.9 R					
Status: Eroding New					
2018 Field Notes: Vertical eroding bank slope.					
Site History:

USACE 2018 Erosion Photo #1

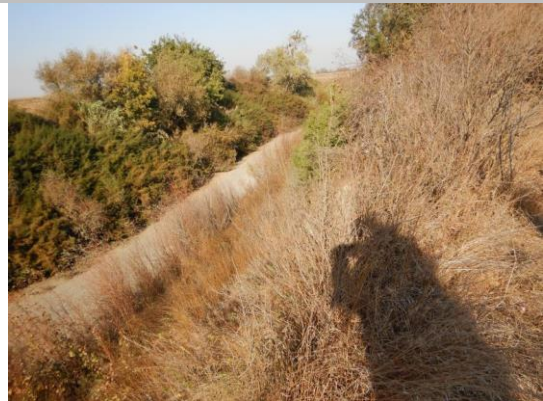
Photo 2 of 2 : SP_2022_ST0001_260_2_20220308_00003.jpg

USACE 2018 Erosion Photo #2

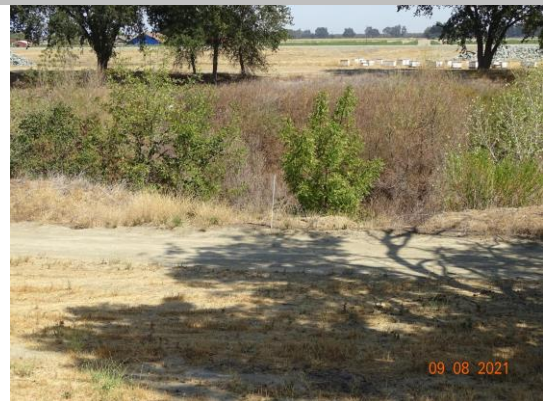
Photo 1 of 1 : SP_2022_ST0001_260_16_20220308_00010.jpg

LM Start	1.60	Rating **	A/W	Issue No.	16
LM End	1.60	Issue Type +	Ma	Location *	WS
Category	Earthen Levee			GPS Latitude/Longitude	
				Start	End
Item	Erosion / Bank Caving			38.731659 °	38.731577 °
				-121.785931 °	-121.785936 °
DWR ID	ST1-01				
Comment Code					
E1 : Note and monitor erosion site.					
Inspector Comment					
Erosion is on the bank and is starting to cut into the WS toe road. Approximately 55 feet from the landside toe.					
Site ID No:181					
Site Designation:ST1-01

View of erosion on waterside toe road. Fall 2021.

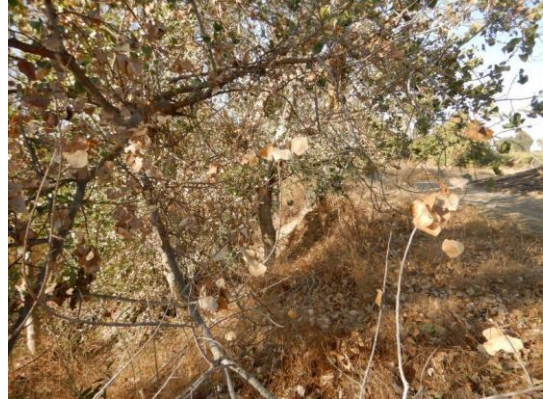
Photo 1 of 2 : SP_2022_ST0001_260_11_20220308_00006.jpg

LM Start	3.53	Rating **	A/W	Issue No.	11
LM End	3.60	Issue Type +	Ma	Location *	WS
Category	Supplemental			GPS Latitude/Longitude	
				Start	End
Item	2018 USACE Erosion Survey			38.722138 °	38.723294 °
				-121.759736 °	-121.759588 °
DWR ID	DWR_ST0001_02_s_2022_11				
Comment Code					
Inspector Comment					
2018 Site ID: CHC 3.5 R					
Status: Eroding					
2018 Field Notes: No observed change.					
Site History: 2010 - Large slump on the upper berm, a tree has recently slid down the slope. 2011 - Large slump and new erosion. 2012 - Slightly steeper slopes and cracks observed. 2017 - Significant amount of debris along bank.

USACE 2018 Erosion Photo #1

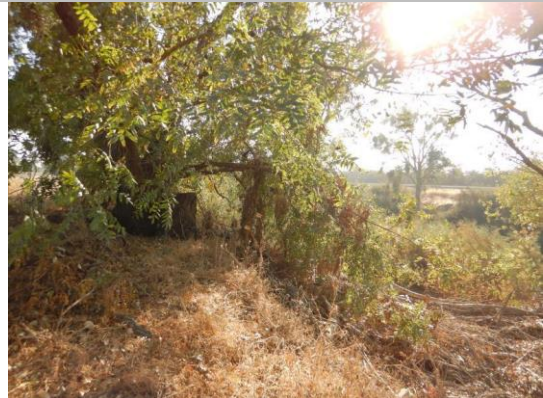
Photo 2 of 2 : SP_2022_ST0001_260_11_20220308_00007.jpg

USACE 2018 Erosion Photo #2

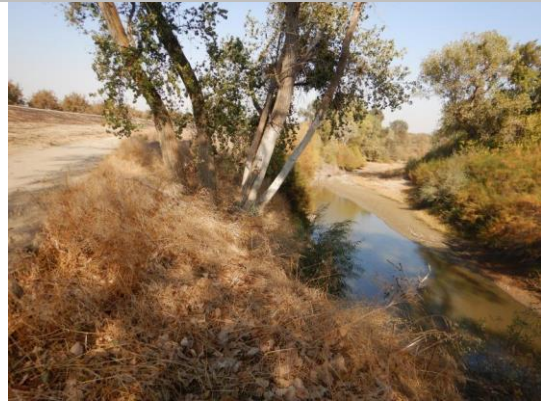
Photo 1 of 2 : SP_2022_ST0001_260_27_20220308_00014.jpg

2018 Site ID: CHC 5.4 L
 Status: Eroding
 2018 Field Notes: No observed change.
 Site History: 2009 - Erosion into the levee slope. 2010 - Minor new erosion. 2011 - New erosion and a freshly fallen tree. 2012 - New animal holes and slightly steeper slopes. 2013 - New tree popout and 2 feet of erosion along the top bank. 2017 - Site continues to erode due to the high 2017 storm event.

USACE 2018 Erosion Photo #1

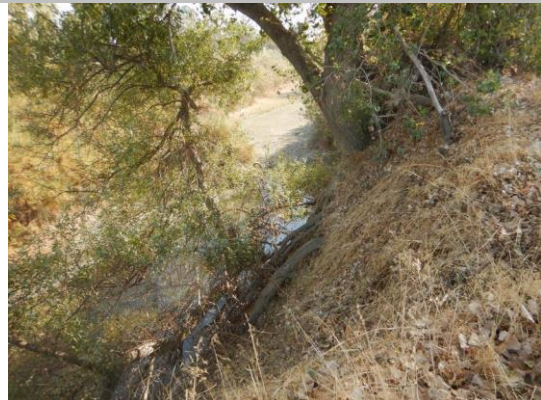
Photo 2 of 2 : SP_2022_ST0001_260_27_20220308_00015.jpg

USACE 2018 Erosion Photo #2

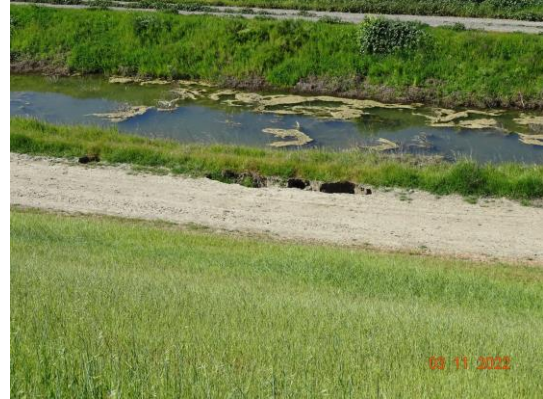
Photo 1 of 1 : SP_2022_ST0001_260_19_20220314_00035.jpg

LM Start	9.39	Rating **	A/W	Issue No.	19
LM End	9.39	Issue Type +	Ma	Location *	LS
Category	Earthen Levee			GPS Latitude/Longitude	
				Start	End
Item	Slope Stability			38.679198 °	38.679198 °
				-121.710895 °	-121.710895 °
DWR ID	DWR_ST0001_02_s_2022_19				
Comment Code					
S1 : Repair slope instability.					
Inspector Comment					
Sinkhole on landside toe road near irrigation ditch. Recommend monitoring.

View of sinkhole on the landside toe road near irrigation ditch. Spring 2022.

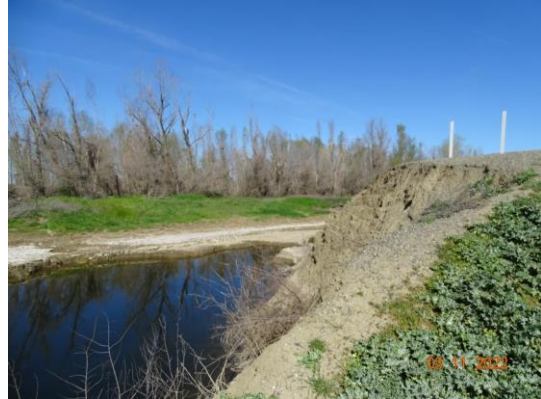
Photo 1 of 1 : SP_2022_ST0001_261_3_20220314_00002.jpg

LM Start	2.26	Rating **	M	Issue No.	3
LM End	2.26	Issue Type +	Ma	Location *	WS
Category	Earthen Levee			GPS Latitude/Longitude	
				Start	End
Item	Erosion / Bank Caving			38.695416 °	38.695416 °
				-121.715943 °	-121.715943 °
DWR ID	DWR_ST0001_04_s_2017_3				
Comment Code					
E2 : Schedule repair of erosion site prior to the next inspection.					
Inspector Comment					
Scour on waterside levee slope at end of Unit 04 levee where previous access ramp was located. There is no visible active erosion at this time, however future high water events will likely cause further erosion into the levee prism.					
Site ID No:250					
Site Designation:LMA-58

View of erosion at the end of the levee unit. Spring 2022.
