**Flood Control Project Maintenance  
Levee Inspections**

**Maintenance Issue Types Only, Levee Inspection Report By Mile - Spring 2023**

**Sacramento Maintenance Yard Cache Creek**

Waterway	Bank	Unit Miles	Inspection Start/End	Inspector
Unit No. 01 North Levee	Left	11.69	04/03/2023 04/03/2023	Zach Jojola

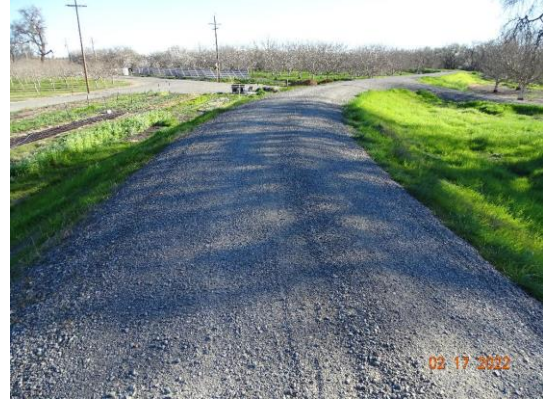
Photo 1 of 3 : UCIP\_SP\_2023\_72495\_108477.jpg

Comment Code						
Inspector Comment						
DS_ID:16271 FS_ID:72495 EP_NO: 10192 Repair Type: Non-Urgent EVAL Issue: Crossing Status: Indicator Found UCIP Comments: 02/17/2022 Record updated from No Action Needed to Non-Urgent. Concrete pipes are visible inside concrete riser on waterside. Unable to confirm that pipe is crossing new levee setback. Geophysical results did not confirm presence of pipe through levee. Record will remain in UCIP's inspection records until future Levee Improvement Project can confirm no crossing was found through the levee. No permit has been identified authorizing pipe. Crossing appears abandoned. Concrete debris, abandoned CMP riser at riverbank. Pipe was crossing old levee at angle. (O.Yakimov - DWR UCIP) 11/16/2018 There is a concrete standpipe and no other pipes connected to this standpipe. The standpipe is located between setback levee and the old levee. No other structure or pipe found. (Ted Skidgel - Sac Yard) FIELD_STRUCT_DESC: 24-inch corrugated metal drainage pipe through the levee, 6 feet below the crown. Slide gate in a concrete riser on the waterside (WS) shoulder. Plate welded on the waterside end. Well, pump, and discharge box on the landside (LS). (24-inch steel pipe [HLM 1.17] authorized under Automatic Board Order (ABO) issued as Permit No. 10192, 1974 - Harry H. and Jane Dewey). [Additional Reference(s): DWR Levee Log, 1993 (HLM 1.17), listed as abandoned 24-inch pipe. USACE Sacramento O&M Manual 126, November 1961, (HLM 1.17)]. USACE As-Built Drawing No. 50-04-3227, January 1960, Sheet 3, STA 215+50]. FS Date: 2/17/2022 9:28:04 AM

Top of Levee: View of levee crown looking downstream

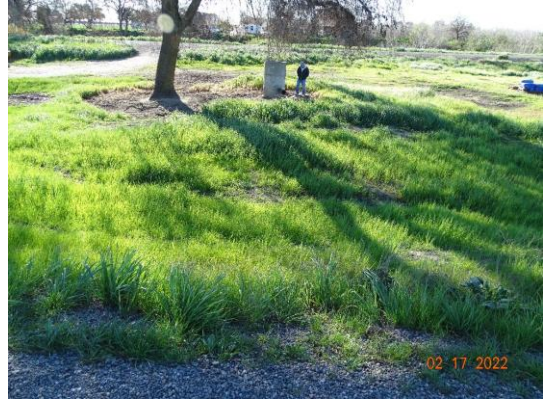
Photo 2 of 3 : UCIP\_SP\_2023\_72495\_108479.jpg

Water-Side: View of levee slope looking from crown

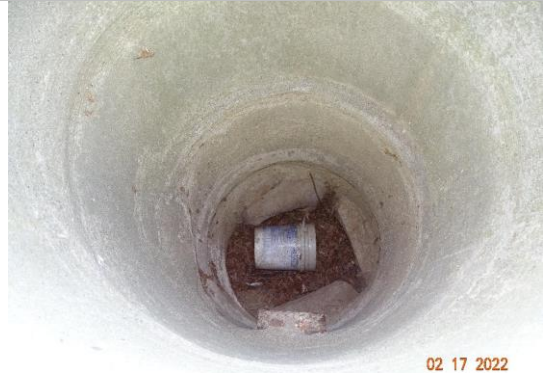
Photo 3 of 3 : UCIP\_SP\_2023\_72495\_108480.jpg

Water-Side: Concrete pipes inside concrete standpipe

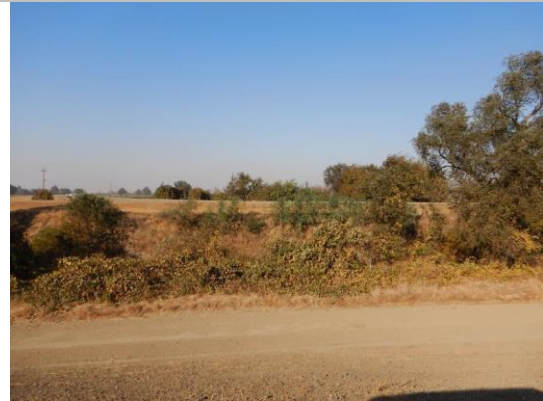
Photo 1 of 1 : SP\_2023\_ST0001\_259\_30\_20230403\_00017.jpg

LM Start	2.57	Rating **	A/W	Issue No.	30
LM End	2.61	Issue Type +	Ma	Location *	WS
Category	Supplemental			GPS Latitude/Longitude	
				Start	End
Item	2018 USACE Erosion Survey			38.732836°	38.732685°
				-121.797893°	-121.797154°
DWR ID	DWR_ST0001_01_s_2022_30				
Comment Code					
Inspector Comment					
2018 Site ID: CHC 2.4 L					
Status: Critical					
2018 Field Notes: No observed change.					
Site History: Site identified as CRITICAL in 2002. 2006 - Currently constructing a setback levee. New failures present and extensive. Downstream end of the setback levee did not extend far enough. Upstream end was repaired. 2007 - DWR repaired with a setback levee, but the levee did not go far enough downstream. 2012 - New cracks observed. 2013 - Fresh erosion on upper bank.

USACE 2018 Erosion Photo #1

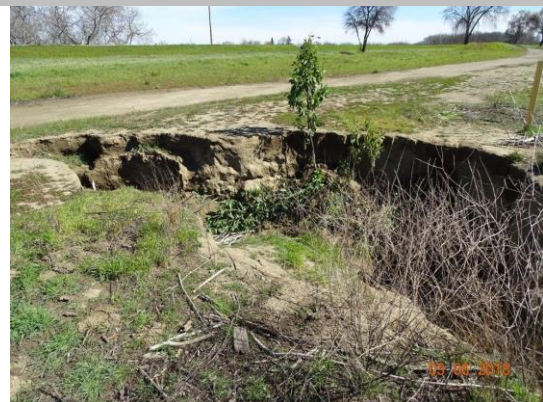
Photo 1 of 2 : SP\_2023\_ST0001\_259\_62\_20230403\_00027.jpg

LM Start	2.84	Rating **	A/W	Issue No.	62
LM End	2.84	Issue Type +	Ma	Location *	WS
Category	Earthen Levee			GPS Latitude/Longitude	
				Start	End
Item	Erosion / Bank Caving			38.734514°	38.734514°
				-121.793418°	-121.793418°
DWR ID	DWR_ST0001_01_s_2022_62				
Comment Code					
E1 : Note and monitor erosion site.					
Inspector Comment					
Erosion is occurring on the waterside berm and toe road. Approximately 120 feet from the landside toe and not within the prism.

View of erosion looking towards the landside levee slope, facing northeast. Spring 2018.

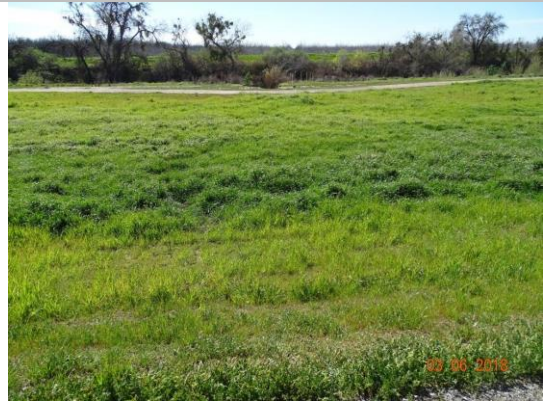
Photo 2 of 2 : SP\_2023\_ST0001\_259\_62\_20230403\_00028.jpg

View of erosion from levee crown, facing Cache Creek. Fall 2018.

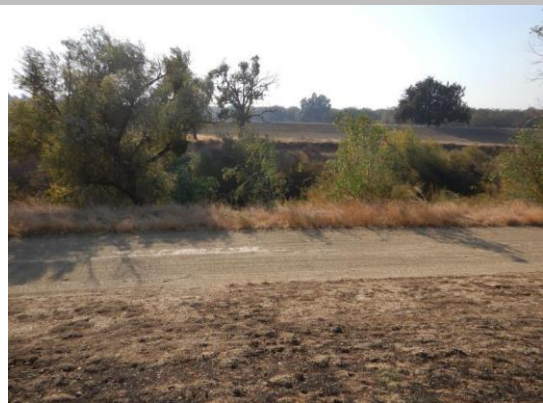
Photo 1 of 2 : SP\_2023\_ST0001\_259\_41\_20230403\_00023.jpg

LM Start	3.71	Rating **	A/W	Issue No.	41
LM End	3.74	Issue Type +	Ma	Location *	WS
Category	Supplemental			GPS Latitude/Longitude	
				Start	End
Item	2018 USACE Erosion Survey			38.729664°	38.729322°
				-121.784222°	-121.783842°
DWR ID	DWR_ST0001_01_s_2022_41				
Comment Code					
Inspector Comment					
2018 Site ID: CHC 3.6 L					
Status: Eroding New					
2018 Field Notes: Erosion of entire bank slope. Possible tree popout.					
Slumping cracks along berm.					
Site History:

USACE 2018 Erosion Photo #1

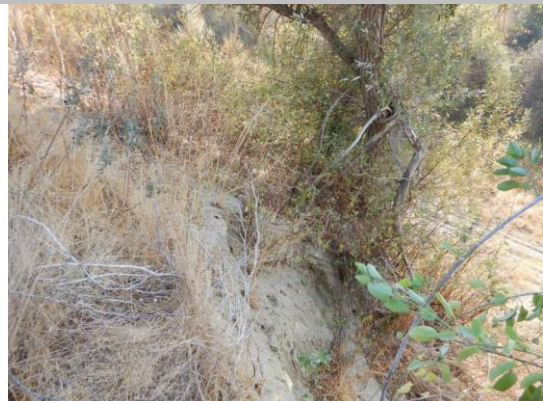
Photo 2 of 2 : SP\_2023\_ST0001\_259\_41\_20230403\_00024.jpg

USACE 2018 Erosion Photo #2

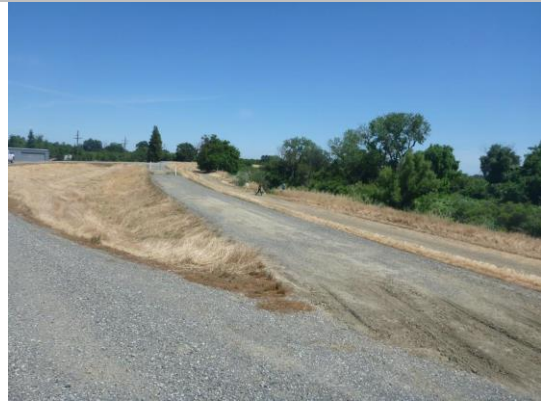
Photo 1 of 2 : LEVAL\_SP\_2023\_249\_954.jpg

LM Start	4.22	Rating **	A/W	Issue No.	34
LM End	4.23	Issue Type +	Ma	Location *	WS
Category	Earthen Levee			GPS Latitude/Longitude	
				Start	End
Item	Erosion / Bank Caving			38.727207°	38.727187°
				-121.775521°	-121.775450°
DWR ID	LMA-57				
Comment Code					
E1 : Note and monitor erosion site.					
Inspector Comment					
Erosion is occurring on the waterside berm and toe road. Approximately 80 feet from the landside toe and not within the prism.					
Site ID No:249					
Site Designation:LMA-57

View of toe road where erosion is located.

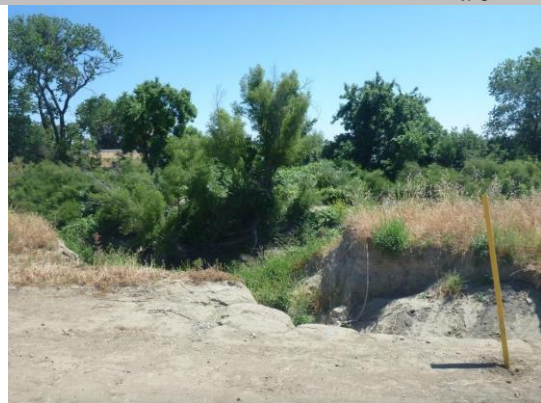
Photo 2 of 2 : LEVAL\_SP\_2023\_249\_959.jpg

View of erosion near waterside toe road.

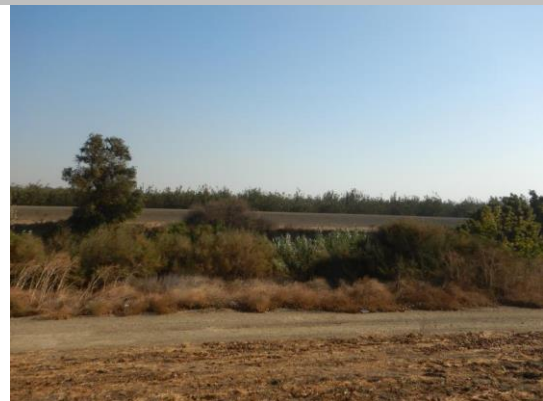
Photo 1 of 2 : SP\_2023\_ST0001\_260\_2\_20230403\_00002.jpg

LM Start	0.90	Rating **	A/W	Issue No.	2
LM End	0.92	Issue Type +	Ma	Location *	WS
Category	Supplemental			GPS Latitude/Longitude	
				Start	End
Item	2018 USACE Erosion Survey			38.732678°	38.732903°
				-121.795347°	-121.795017°
DWR ID	DWR_ST0001_02_f_2022_2				
Comment Code					
Inspector Comment					
2018 Site ID: CHC 0.9 R					
Status: Eroding New					
2018 Field Notes: Vertical eroding bank slope.					
Site History:

USACE 2018 Erosion Photo #1

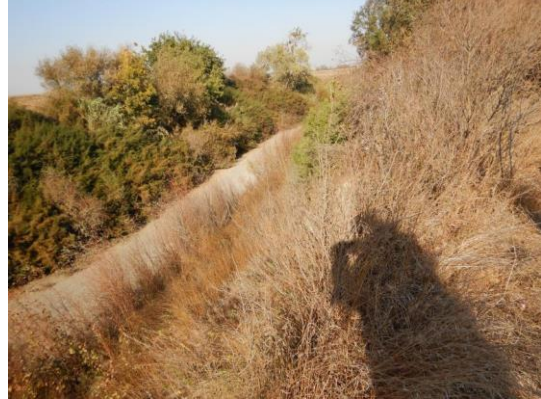
Photo 2 of 2 : SP\_2023\_ST0001\_260\_2\_20230403\_00003.jpg

USACE 2018 Erosion Photo #2

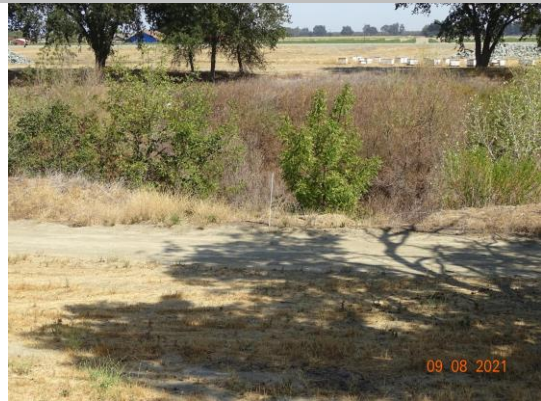
Photo 1 of 1 : SP\_2023\_ST0001\_260\_16\_20230403\_00009.jpg

Erosion is on the bank and is starting to cut into the WS toe road.

View of erosion on waterside toe road. Fall 2021.

E1 : Note and monitor erosion site.

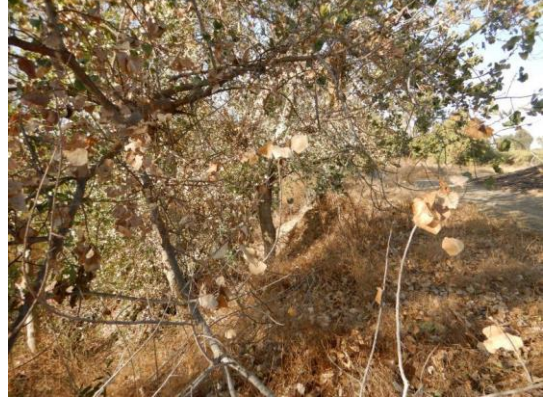
Photo 1 of 2 : SP\_2023\_ST0001\_260\_11\_20230403\_00006.jpg

LM Start	3.53	Rating **	A/W	Issue No.	11
LM End	3.60	Issue Type +	Ma	Location *	WS
Category	Supplemental			GPS Latitude/Longitude	
				Start	End
Item	2018 USACE Erosion Survey			38.722138°	38.723294°
				-121.759736°	-121.759588°
DWR ID	DWR_ST0001_02_s_2022_11				
Comment Code					
Inspector Comment					
2018 Site ID: CHC 3.5 R					
Status: Eroding					
2018 Field Notes: No observed change.					
Site History: 2010 - Large slump on the upper berm, a tree has recently slid down the slope. 2011 - Large slump and new erosion. 2012 - Slightly steeper slopes and cracks observed. 2017 - Significant amount of debris along bank.

USACE 2018 Erosion Photo #1

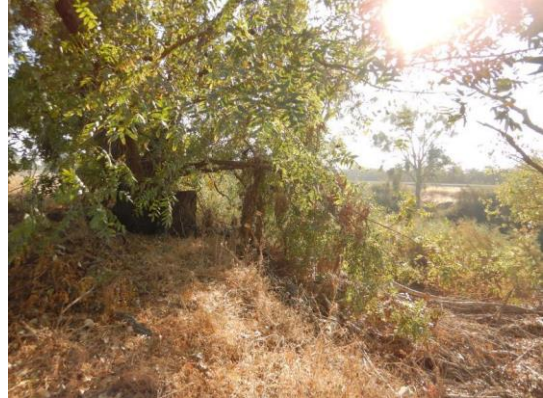
Photo 2 of 2 : SP\_2023\_ST0001\_260\_11\_20230403\_00007.jpg

USACE 2018 Erosion Photo #2

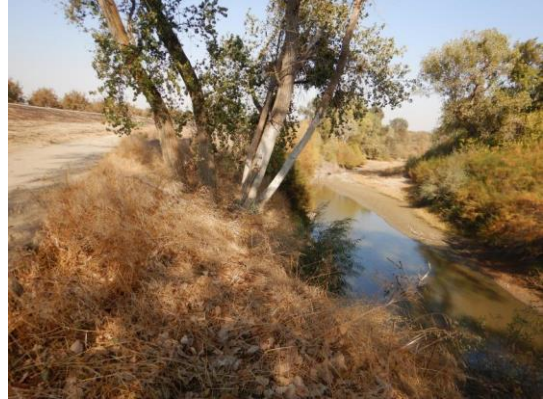
Photo 1 of 2 : SP\_2023\_ST0001\_260\_27\_20230403\_00013.jpg

LM Start	5.33	Rating **	A/W	Issue No.	27
LM End	5.37	Issue Type +	Ma	Location *	WS
Category	Supplemental			GPS Latitude/Longitude	
				Start	End
Item	2018 USACE Erosion Survey			38.722933°	38.723467°
				-121.760561°	-121.760436°
DWR ID	DWR_ST0001_02_s_2022_27				
Comment Code					
Inspector Comment					
2018 Site ID: CHC 5.4 L					
Status: Eroding					
2018 Field Notes: No observed change.					
Site History: 2009 - Erosion into the levee slope. 2010 - Minor new erosion. 2011 - New erosion and a freshly fallen tree. 2012 - New animal holes and slightly steeper slopes. 2013 - New tree pop out and 2 feet of erosion along the top bank. 2017 - Site continues to erode due to the high 2017 storm event.

USACE 2018 Erosion Photo #1

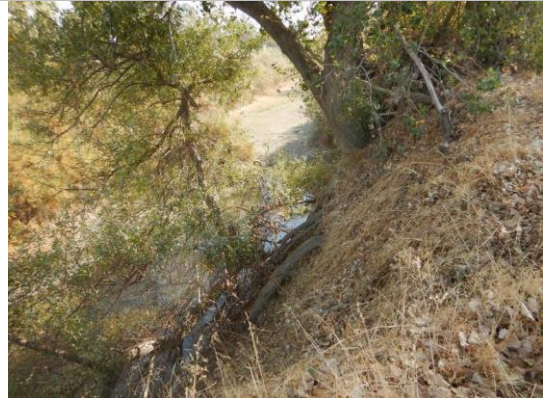
Photo 2 of 2 : SP\_2023\_ST0001\_260\_27\_20230403\_00014.jpg

USACE 2018 Erosion Photo #2

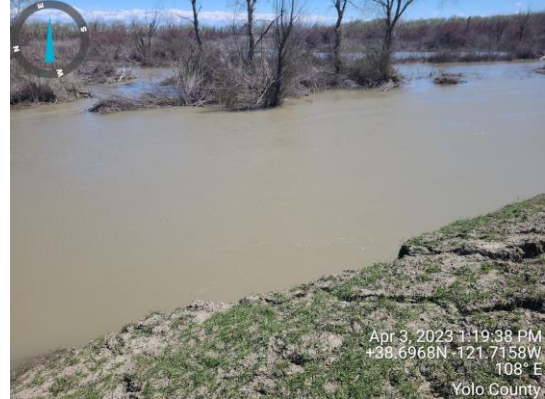
Photo 1 of 1 : SP\_2023\_ST0001\_261\_3\_20230404\_00002.jpg

LM Start	2.17	Rating **	U	Issue No.	3
LM End	2.17	Issue Type +	Ma	Location *	LS
Category	Earthen Levee			GPS Latitude/Longitude	
				Start	End
Item	Erosion / Rills			38.696745°	38.696745°
				-121.715850°	-121.715850°
DWR ID	DWR_ST0001_04_s_2023_3				
Comment Code					
E5 : Schedule repair of rills prior to the next inspection.					
Inspector Comment					
There are rills and bank erosion on the landside toe.

View of erosion on the landside slope and toe. Spring 2023.
