**Flood Control Project Maintenance
Levee Inspections**

Maintenance Issue Types Only, Levee Inspection Report By Mile - Spring 2024

Sacramento Maintenance Yard Cache Creek

Waterway	Bank	Unit Miles	Inspection Start/End	Inspector
Unit No. 01 North Levee	Left	11.69	04/04/2024 04/04/2024	Zach Jojola

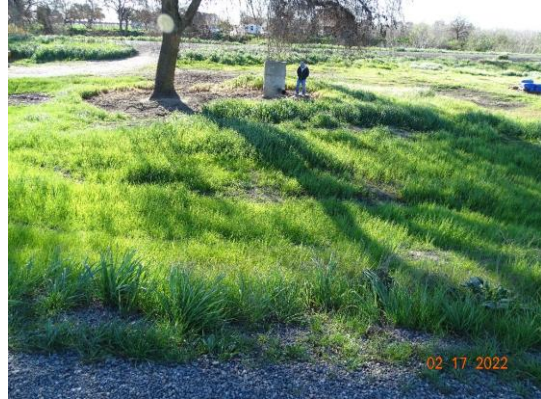
Photo 2 of 3 : UCIP_SP_2024_72495_108479.jpg

Water-Side: View of levee slope looking from crown

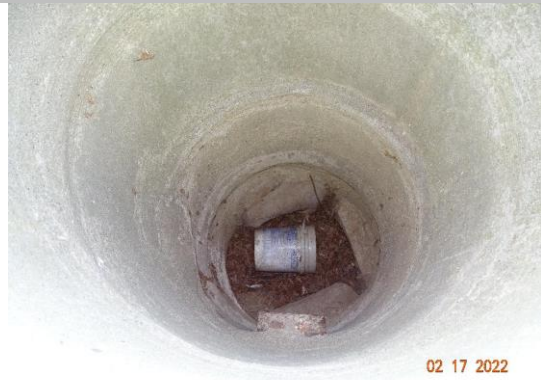
Photo 3 of 3 : UCIP_SP_2024_72495_108480.jpg

Comment Code						
Inspector Comment						
DS_ID:16271 FS_ID:72495 EP_NO: 10192 Repair Type: Non-Urgent EVAL Issue: Crossing Status: Indicator Found UCIP Comments: 02/17/2022 Record updated from No Action Needed to Non-Urgent. Concrete pipes are visible inside concrete riser on waterside. Unable to confirm that pipe is crossing new levee setback. Geophysical results did not confirm presence of pipe through levee. Record will remain in UCIP's inspection records until future Levee Improvement Project can confirm no crossing was found through the levee. No permit has been identified authorizing pipe. Crossing appears abandoned. Concrete debris, abandoned CMP riser at riverbank. Pipe was crossing old levee at angle. (O.Yakimov - DWR UCIP) 11/16/2018 There is a concrete standpipe and no other pipes connected to this standpipe. The standpipe is located between setback levee and the old levee. No other structure or pipe found. (Ted Skidgel - Sac Yard) FIELD_STRUCT_DESC: 24-inch corrugated metal drainage pipe through the levee, 6 feet below the crown. Slide gate in a concrete riser on the waterside (WS) shoulder. Plate welded on the waterside end. Well, pump, and discharge box on the landside (LS). (24-inch steel pipe [HLM 1.17] authorized under Automatic Board Order (ABO) issued as Permit No. 10192, 1974 - Harry H. and Jane Dewey). [Additional Reference(s): DWR Levee Log, 1993 (HLM 1.17), listed as abandoned 24-inch pipe. USACE Sacramento O&M Manual 126, November 1961, (HLM 1.17)]. USACE As-Built Drawing No. 50-04-3227, January 1960, Sheet 3, STA 215+50]. FS Date: 2/17/2022 9:28:04 AM

Water-Side: Concrete pipes inside concrete standpipe

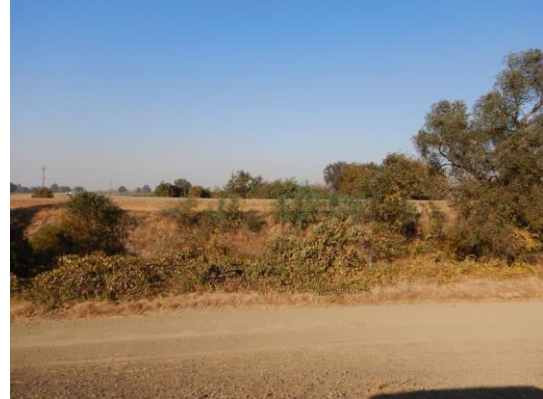
Photo 1 of 1 : SP_2024_ST0001_259_30_20240306_00016.jpg

LM Start	2.57	Rating **	A/W	Issue No.	30
LM End	2.61	Issue Type +	Ma	Location *	WS
Category	Supplemental			GPS Latitude/Longitude	
				Start	End
Item	2018 USACE Erosion Survey			38.732836°	38.732685°
				-121.797893°	-121.797154°
DWR ID	DWR_ST0001_01_s _ 2022_30				
Comment Code					
Inspector Comment					
2018 Site ID: CHC 2.4 L					
Status: Critical					
2018 Field Notes: No observed change.					
Site History: Site identified as CRITICAL in 2002. 2006 - Currently constructing a setback levee. New failures present and extensive. Downstream end of the setback levee did not extend far enough. Upstream end was repaired. 2007 - DWR repaired with a setback levee, but the levee did not go far enough downstream. 2012 - New cracks observed. 2013 - Fresh erosion on upper bank.

USACE 2018 Erosion Photo #1

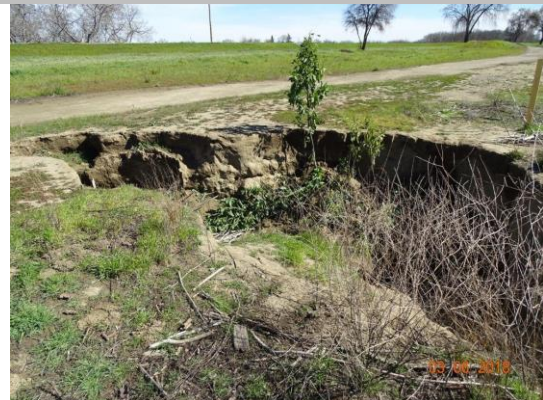
Photo 1 of 2 : SP_2024_ST0001_259_62_20240306_00032.jpg

LM Start	2.84	Rating **	A/W	Issue No.	62
LM End	2.84	Issue Type +	Ma	Location *	WS
Category	Earthen Levee			GPS Latitude/Longitude	
				Start	End
Item	Erosion / Bank Caving			38.734514°	38.734514°
				-121.793418°	-121.793418°
DWR ID	DWR_ST0001_01_s _ 2022_62				
Comment Code					
E1 : Note and monitor erosion site.					
Inspector Comment					
Erosion is occurring on the waterside berm and toe road. Approximately 120 feet from the landside toe and not within the prism.

View of erosion looking towards the landside levee slope, facing northeast. Spring 2018.

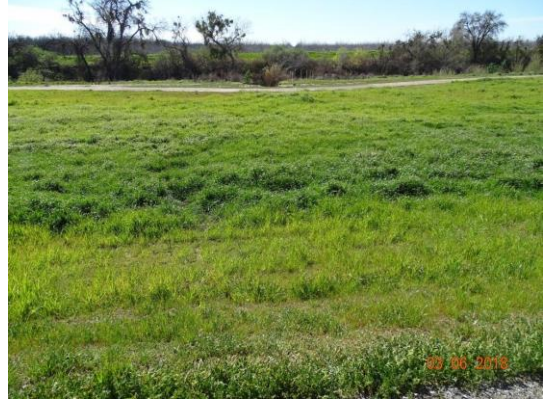
Photo 2 of 2 : SP_2024_ST0001_259_62_20240306_00033.jpg

View of erosion from levee crown, facing Cache Creek. Fall 2018.

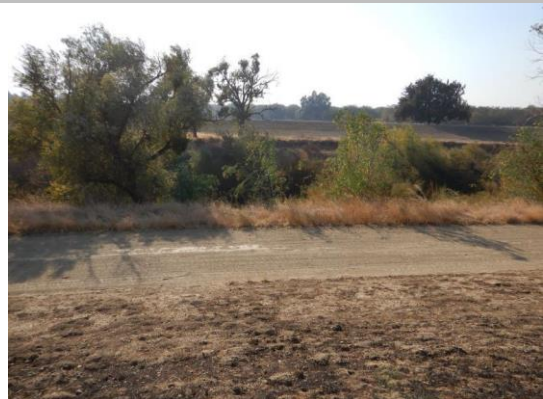
Photo 1 of 2 : SP_2024_ST0001_259_41_20240306_00025.jpg

LM Start	3.71	Rating **	A/W	Issue No.	41
LM End	3.74	Issue Type +	Ma	Location *	WS
Category	Supplemental			GPS Latitude/Longitude	
				Start	End
Item	2018 USACE Erosion Survey			38.729664°	38.729322°
				-121.784222°	-121.783842°
DWR ID	DWR_ST0001_01_s_2022_41				
Comment Code					
Inspector Comment					
2018 Site ID: CHC 3.6 L					
Status: Eroding New					
2018 Field Notes: Erosion of entire bank slope. Possible tree popout.					
Slumping cracks along berm.					
Site History:

USACE 2018 Erosion Photo #1

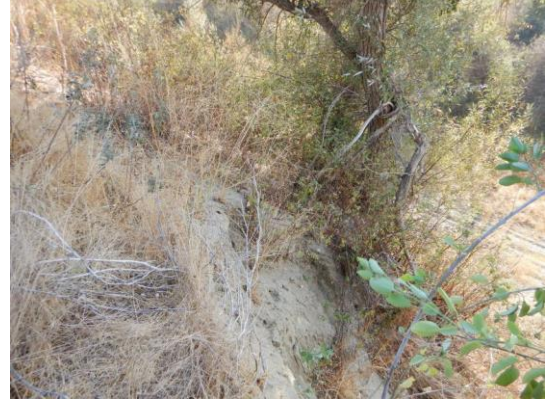
Photo 2 of 2 : SP_2024_ST0001_259_41_20240306_00026.jpg

USACE 2018 Erosion Photo #2

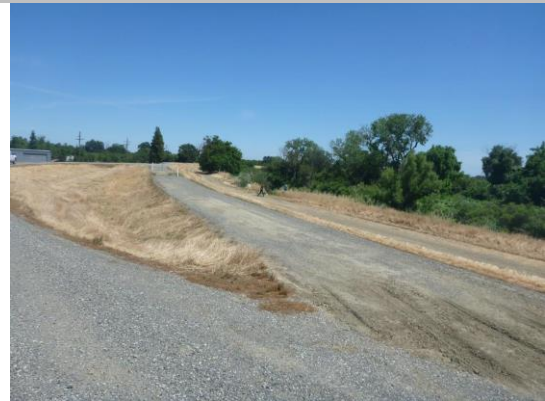
Photo 1 of 2 : LEVAL_SP_2024_249_954.jpg

Erosion is occurring on the waterside berm and toe road. Approximately 80 feet from the landside toe and not within the prism.

View of toe road where erosion is located.

E1 : Note and monitor erosion site.

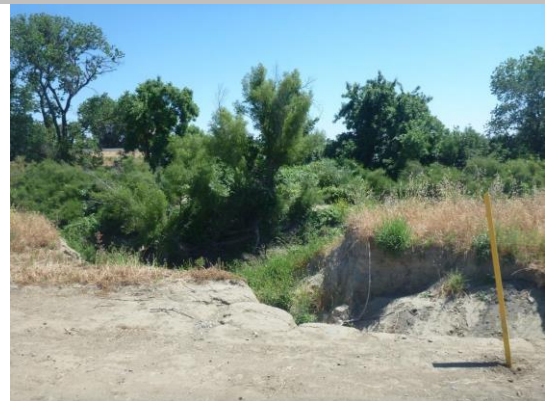
Photo 2 of 2 : LEVAL_SP_2024_249_959.jpg

View of erosion near waterside toe road.

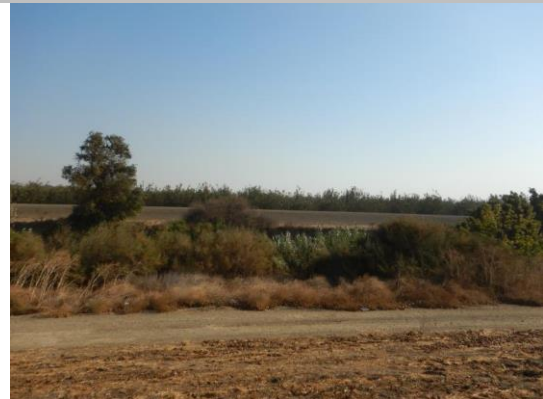
Photo 1 of 2 : SP_2024_ST0001_260_2_20240306_00002.jpg

LM Start	0.90	Rating **	A/W	Issue No.	2
LM End	0.92	Issue Type +	Ma	Location *	WS
Category	Supplemental			GPS Latitude/Longitude	
				Start	End
Item	2018 USACE Erosion Survey			38.732678°	38.732903°
				-121.795347°	-121.795017°
DWR ID	DWR_ST0001_02_f_2022_2				
Comment Code					
Inspector Comment					
2018 Site ID: CHC 0.9 R					
Status: Eroding New					
2018 Field Notes: Vertical eroding bank slope.					
Site History:

USACE 2018 Erosion Photo #1

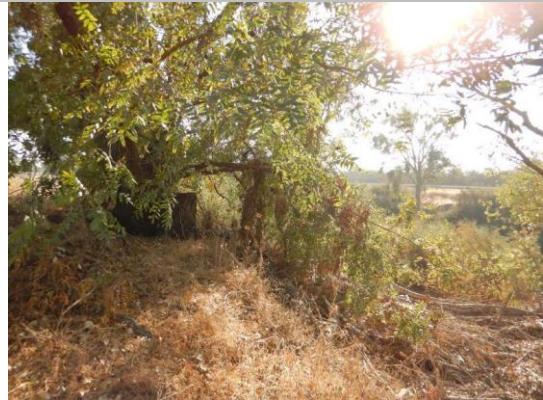
Photo 2 of 2 : SP_2024_ST0001_260_11_20240306_00009.jpg

LM Start	3.53	Rating **	A/W	Issue No.	11
LM End	3.60	Issue Type +	Ma	Location *	WS
Category	Supplemental			GPS Latitude/Longitude	
				Start	End
Item	2018 USACE Erosion Survey			38.722138°	38.723294°
				-121.759736°	-121.759588°
DWR ID	DWR_ST0001_02_s_2022_11				
Comment Code					
Inspector Comment					
2018 Site ID: CHC 3.5 R					
Status: Eroding					
2018 Field Notes: No observed change.					
Site History: 2010 - Large slump on the upper berm, a tree has recently slid down the slope. 2011 - Large slump and new erosion. 2012 - Slightly steeper slopes and cracks observed. 2017 - Significant amount of debris along bank.

USACE 2018 Erosion Photo #2

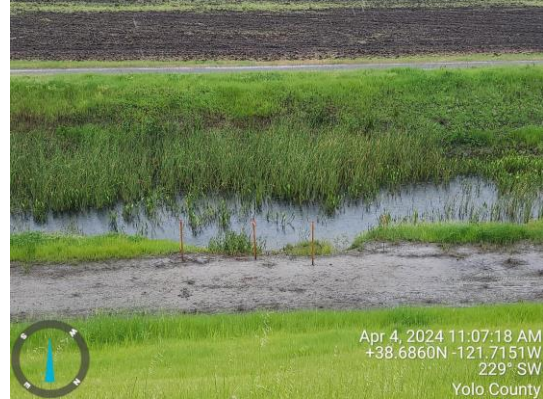
Photo 1 of 1 : SP_2024_ST0001_260_7_20240404_00022.jpg

LM Start	8.86	Rating **	A/W	Issue No.	7
LM End	8.86	Issue Type +	Ma	Location *	LS
Category	Earthen Levee			GPS Latitude/Longitude	
				Start	End
Item	Erosion / Bank Caving			38.685990°	38.685990°
				-121.715176°	-121.715176°
DWR ID	DWR_ST0001_02_s_2024_7				
Comment Code					
E1 : Note and monitor erosion site.					
Inspector Comment					
Erosion on landside toe road. Recommend monitoring.

View of erosion on the landside toe road. Spring 2024.

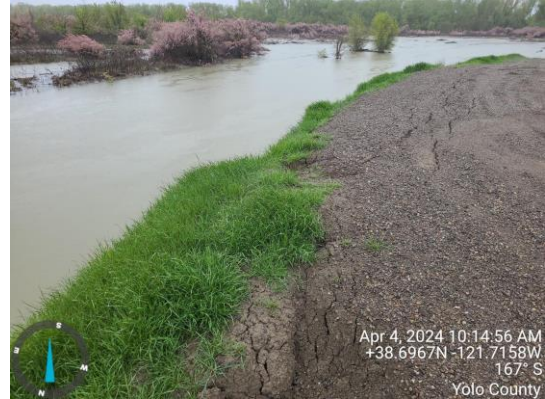
Photo 1 of 2 : SP_2024_ST0001_261_3_20240404_00003.jpg

LM Start	2.17	Rating **	M	Issue No.	3
LM End	2.17	Issue Type +	Ma	Location *	LS
Category	Earthen Levee			GPS Latitude/Longitude	
				Start	End
Item	Erosion / Rills			38.696745°	38.696745°
				-121.715850°	-121.715850°
DWR ID	DWR_ST0001_04_s_2023_3				
Comment Code					
E5 : Schedule repair of rills prior to the next inspection.					
Inspector Comment					
There are rills and bank erosion on the landside toe. Active sloughing on the landside hinge point.

View of settlement on the landside hinge point. Spring 2024.

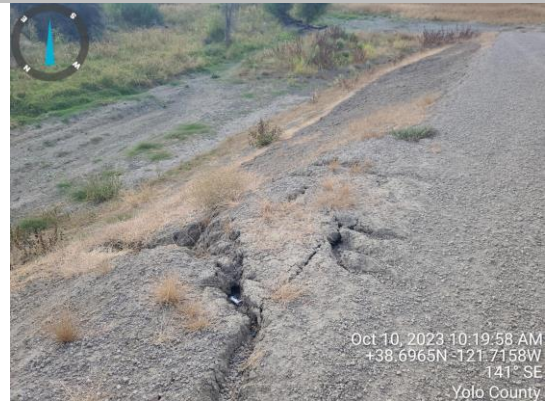
Photo 2 of 2 : SP_2024_ST0001_261_3_20240306_00002.jpg

View of erosion on the landside slope and toe. Fall 2023.
