**Flood Control Project Maintenance
Levee Inspections**
LMA District Cover Sheet
Spring 2014 Levee Inspection Results

Sutter Maintenance Yard East Levee Sutter Bypass

Spring 2014 Levee Inspection Results

Waterway	Bank	Unit Miles
Unit No. 01 Sutter Bypass Levee	Left	22.12

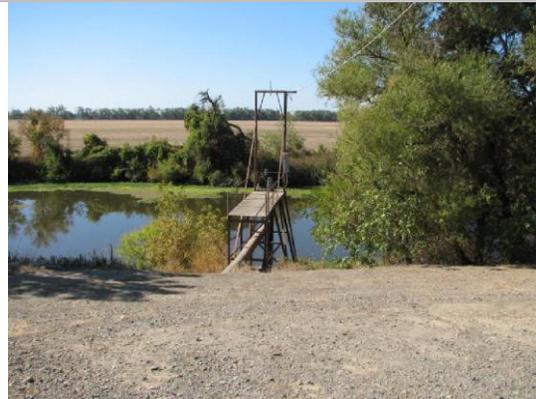
Photo 1 of 1 : UCIP_3528.jpg

LM Start	1.13	Rating **	M	Issue No.	477
LM End	1.13	Issue Type +	En	Location *	LS
Category	Supplemental			GPS Latitude/Longitude	
				Start	End
Item	DWR UCIP Field Study			39.140868 °	39.140868 °
				-121.816644 °	-121.816644 °
DWR ID	DWR_ST0002_01_s_2014_477				
Action/Comments					
Inspector Comments: FS_ID:23550 EP_NO: 10932 Repair Type: Crossing Status: UCIP Comments: Pier has no walkway to access pump on pier. This is not necessarily an issue 5/22/2013 24in. cmp riser on WS shoulder is full of garbage and dirt and should be cleaned out to inspect siphon breaker 0/30/2013 24in. cmp riser was pulled out of levee and there is no sign of a siphon breaker on WS shoulder. FIELD_STRUCT_DESC: 16-inch steel pipe through the levee, 6.3 feet below the crown. Vertical pump mounted on a steel structure on the bank. Siphon breaker in a 24-inch corrugated metal pipe riser on the waterward slope. Concrete distribution box on the landward side. JP on WS shoulder. Original Equipment in O+M. Replaced under (App. 10932-Nall) Hand drawings available in permit. FS Date: 11/4/2013 1:10:00 PM

Pump on metal pier on WS slope.

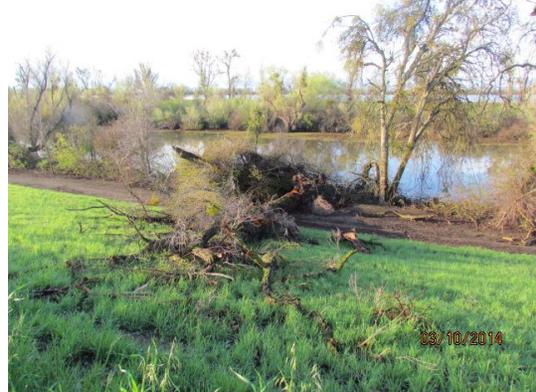
Photo 1 of 1 : rduffey_s_20140317_111.jpg

LM Start	1.91	Rating **	M	Issue No.	489
LM End	1.91	Issue Type +	En	Location *	WS
Category	Earthen Levee			GPS Latitude/Longitude	
				Start	End
Item	Encroachments			39.134447 °	39.134447 °
				-121.805071 °	-121.805071 °
DWR ID	DWR_ST0002_01_s_2014_489				
Action/Comments					
Tree or limb

View of the downed tree on the waterside slope.

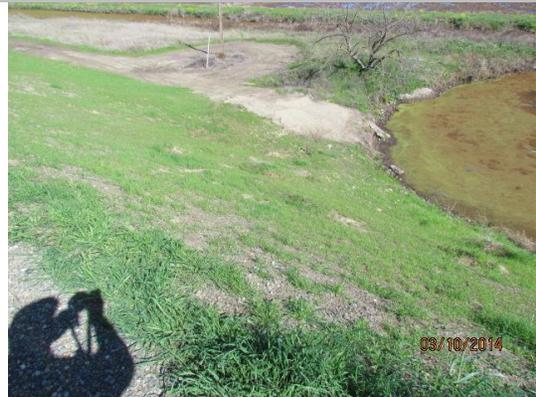
Photo 1 of 1 : rduffey_s_20140317_112.jpg

LM Start	3.60	Rating **	M	Issue No.	7
LM End	3.60	Issue Type +	Ma	Location *	LS
Category	Earthen Levee			GPS Latitude/Longitude	
				Start	End
Item	Animal Control			39.120422 °	39.120422 °
				-121.779907 °	-121.779907 °
DWR ID	DWR_ST0002_01_f_2012_7				
Action/Comments					
No rodents visible, but rodent burrows visible; need to backfill and compact or grout burrows.

View of the rodent activity along landside slope.

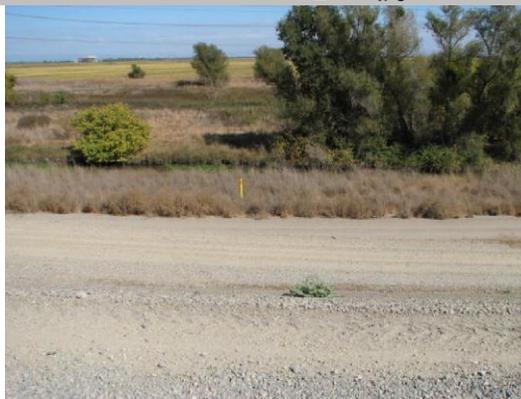
Photo 1 of 1 : UCIP_3535.jpg

LM Start	10.44	Rating **	M	Issue No.	478
LM End	10.44	Issue Type +	En	Location *	LS
Category	Supplemental			GPS Latitude/Longitude	
				Start	End
Item	DWR UCIP Field Study			39.033517 °	39.033517 °
				-121.728925 °	-121.728925 °
DWR ID	DWR_ST0002_01_s_2014_478				
Action/Comments					
Inspector Comments: FS_ID:23577 EP_NO: 14455 Repair Type: Crossing Status: UCIP Comments: 5/22/2013 Carsonite marker on WS shoulder is broken and should be replaced 10/30/2013 Same as last inspection. FIELD_STRUCT_DESC: 3 of 3. 4.5-inch Natural gas pipelines through the levee installed 2 feet below the crown. Pipes were paced in same trench 1-foot apart. Gasline markers on LS toe and WS shoulder. Design drawings available in the permit. FS Date: 11/4/2013 1:44:26 PM

Gasline markers on LS toe.

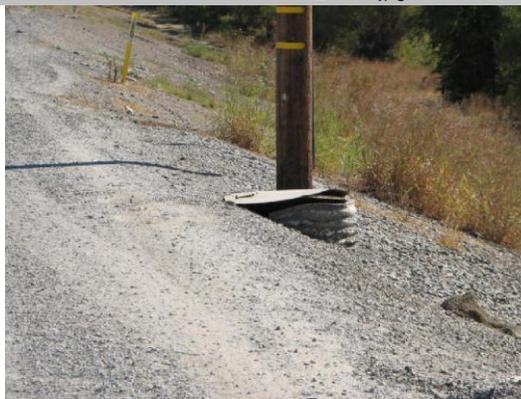
Photo 1 of 1 : UCIP_3542.jpg

LM Start	11.01	Rating **	M	Issue No.	483
LM End	11.01	Issue Type +	En	Location *	WS
Category	Supplemental			GPS Latitude/Longitude	
				Start	End
Item	DWR UCIP Field Study			39.025560 °	39.025560 °
				-121.726846 °	-121.726846 °
DWR ID	DWR_ST0002_01_s_2014_483				
Action/Comments					
Inspector Comments: FS_ID:23589 EP_NO: 3165 Repair Type: Crossing Status: UCIP Comments: Need to determine type of abandonment 5/22/2013 Same as last inspection. FIELD_STRUCT_DESC: 10-inch drainage pipe through the levee, 2.0 feet below the crown. Siphon breaker in a 36-inch CM pipe riser on the waterward shoulder. Flap gate on the waterward end. (App. 3165 - DWR). Minimalistic design drawings available. FS Date: 11/4/2013 1:54:13 PM

Siphon breaker in 36-inch CMP riser on WS shoulder. Pipe visible at siphon breaker.

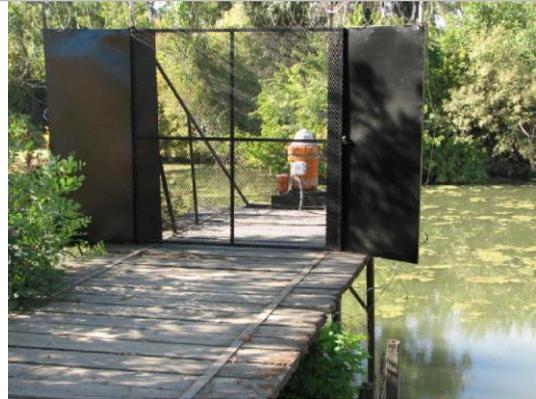
Photo 1 of 1 : UCIP_3543.jpg

LM Start	13.54	Rating **	M	Issue No.	485
LM End	13.54	Issue Type +	En	Location *	WS
Category	Supplemental			GPS Latitude/Longitude	
				Start	End
Item	DWR UCIP Field Study			38.991808 °	38.991808 °
				-121.711512 °	-121.711512 °
DWR ID	DWR_ST0002_01_s_2014_485				
Action/Comments					
Inspector Comments: FS_ID:23592 EP_NO: N/A Repair Type: Crossing Status: UCIP Comments: Verify work (if any) was done to replace original equipment with inspected 5/23/2013 Same as last inspection 10/30/2013 Same as last inspection. FIELD_STRUCT_DESC: 18-inch pipe through the levee, 5.5 feet below the crown. Pipe measures 16-inches at pump and on LS outlet. Siphon breaker in a 16-inch corrugated metal pipe riser on the landward slope. Pump on pile structure in the channel. Meter and pole on the bank. Originally included in O+M manual. FS Date: 11/4/2013 1:56:06 PM

Pump on Pier structure on WS toe.

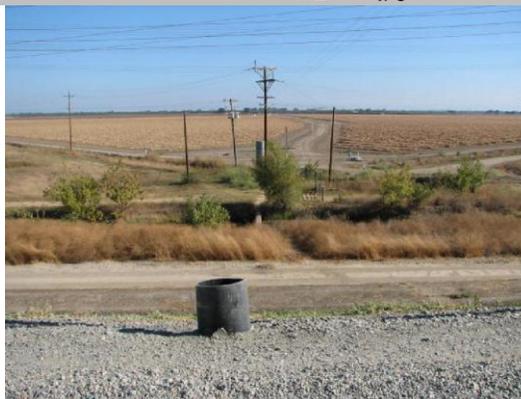
Photo 1 of 1 : UCIP_3548.jpg

LM Start	14.70	Rating **	M	Issue No.	486
LM End	14.70	Issue Type +	En	Location *	WS
Category	Supplemental			GPS Latitude/Longitude	
				Start	End
Item	DWR UCIP Field Study			38.981286 °	38.981286 °
				-121.694958 °	-121.694958 °
DWR ID	DWR_ST0002_01_s_2014_486				
Action/Comments					
Inspector Comments: FS_ID:23593 EP_NO: 1674 Repair Type: Crossing Status: UCIP Comments: Pipe exposed on WS toe at road and heavy oil usage that may be a problem at pump on pie5/23/2013 Same as last inspection10/30/2013 Same as last inspection. FIELD_STRUCT_DESC: 24-inch steel pipe through the levee, 4.0 feet below the crown. Siphon breaker in an 18-inch PVC pipe riser on the landward shoulder. 24-inch concrete standpipe in field on the landward side. Vertical pump on a steel pile structure in the channel. (App. 1674 - Etchevery). Minimal design drawings available. FS Date: 11/4/2013 1:56:46 PM

Siphon breaker in PVC standpipe on LS shoulder and Concrete riser in adjacent field.

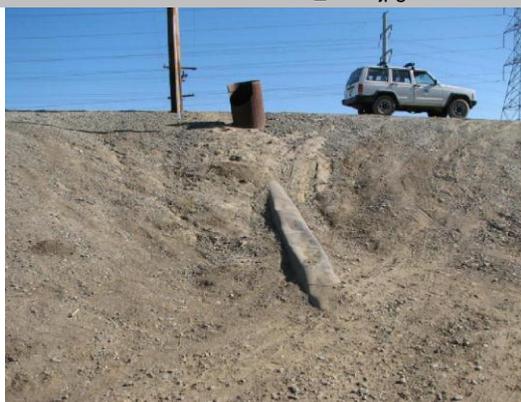
Photo 1 of 1 : UCIP_3551.jpg

LM Start	14.91	Rating **	M	Issue No.	487
LM End	14.91	Issue Type +	En	Location *	WS
Category	Supplemental			GPS Latitude/Longitude	
				Start	End
Item	DWR UCIP Field Study			38.979377 °	38.979377 °
				-121.691929 °	-121.691929 °
DWR ID	DWR_ST0002_01_s_2014_487				
Action/Comments					
Inspector Comments: FS_ID:23594 EP_NO: N/A Repair Type: Crossing Status: UCIP Comments: Pipe has not been abandoned properly. It should be removed from the levee section5/23/2013 Same as last inspection10/30/2013 Same as last inspection. FIELD_STRUCT_DESC: 16-inch steel pipe through the levee, 3.5 feet below the crown. Siphon breakers in 30-inch steel risers on both WS and LS shoulders. Vertical pump on pile structure in stream (removed). FS Date: 11/4/2013 1:57:26 PM

Crushed pipe on WS slope.

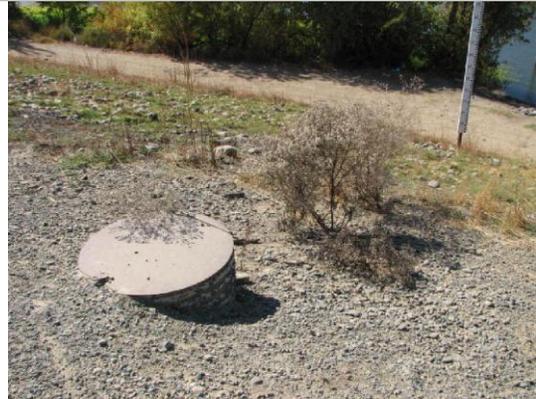
Photo 1 of 1 : UCIP_3555.jpg

LM Start	19.46	Rating **	M	Issue No.	488
LM End	19.46	Issue Type +	En	Location *	WS
Category	Supplemental			GPS Latitude/Longitude	
				Start	End
Item	DWR UCIP Field Study			38.932423 °	38.932423 °
				-121.635085 °	-121.635085 °
DWR ID	DWR_ST0002_01_s_2014_488				
Action/Comments					
Inspector Comments: FS_ID:23612 EP_NO: 3165 Repair Type: Crossing Status: UCIP Comments: Need to determine type of abandonment 5/23/2013 Same as last inspection 10/30/2013 Same as last inspection. FIELD_STRUCT_DESC: 10-inch drainage pipe through the levee, 4.0 feet below the crown. Siphon breaker in 36-inch corrugated metal pipe riser on the waterward shoulder. Flap gate on the waterward end. (App. 3165 - DWR) FS Date: 11/4/2013 2:12:39 PM

36-inch CMP riser on WS shoulder.
