**Flood Control Project Maintenance  
Levee Inspections**  
**LMA District Cover Sheet**  
**Spring 2016 Levee Inspection Results**

**Sutter Maintenance Yard East Levee Sutter Bypass**

**Levee Inspection Report By Mile - Spring 2016**

Waterway	Bank	Unit Miles	Inspection Start/End	Inspector
Unit No. 01 Sutter Bypass Levee	Left	21.68	03/23/2016 03/23/2016	Keith Millard

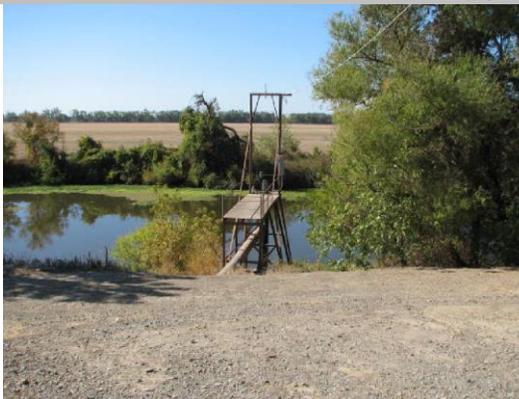
Photo 1 of 2 : UCIP\_SP\_2016\_48182\_64805.jpg

LM Start	<b>1.12</b>	Rating **	M	Issue No.	<b>48</b>
LM End	<b>1.12</b>	Issue Type +	En	Location *	N/A
Category	Supplemental			GPS Latitude/Longitude	
				Start	End
Item	DWR UCIP Field Study			39.140868 °	39.140868 °
				-121.816644 °	-121.816644 °
DWR ID

FS\_ID:48182  
 DS\_ID:16862  
 EP\_NO: 10932  
 Repair Type: Non-Urgent  
 Crossing Status: Found  
 UCIP Comments: 4/18/2016 CMP riser is still knocked out of place and a siphon breaker cannot be found.5/7/2015 24in. cmp riser and siphon breaker were not found on the WS shoulder.11/12/2014 Same as last inspection.5/13/2014 Same as last inspection.10/30/2013 24in. cmp riser was pulled out of levee and there is no sign of a siphon breaker on WS shoulder.5/22/2013 24in. cmp riser on WS shoulder is full of garbage and dirt and should be cleaned out to inspect siphon breaker.10/8/2012 Pier has no walkway to access pump on pier. This is not necessarily an issue.  
 FIELD\_STRUCT\_DESC: 16-inch steel irrigation pipe through the levee, 6.3 feet below the crown. Vertical pump mounted on a steel structure on the bank. Siphon breaker in a 24-inch corrugated metal pipe riser on the waterside (WS) slope. Concrete distribution box on the landside (LS). Power and communication joint pole (JP) on WS shoulder. Original equipment in O&M. Hand drawings available in permit. Replaced under (Original O&M entry removed in 1975 and replaced under Permit No. 10932, 1976-Edward Nall) [Additional Reference(s): DWR Levee Log, 2005. USACE Sacramento O&M Manual 315, May 1953 (Station 1094+80)].

Pump on metal pier on WS slope.

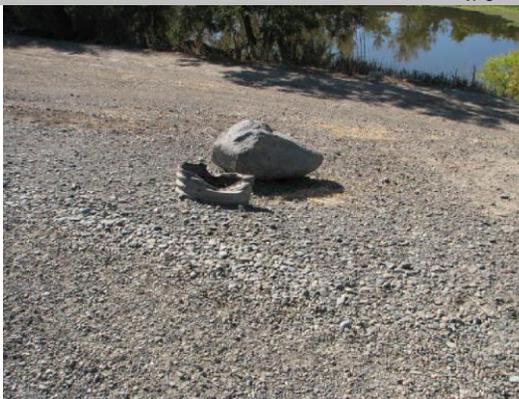
Photo 2 of 2 : UCIP\_SP\_2016\_48182\_64804.jpg

24-inch CMP riser on WS slope.

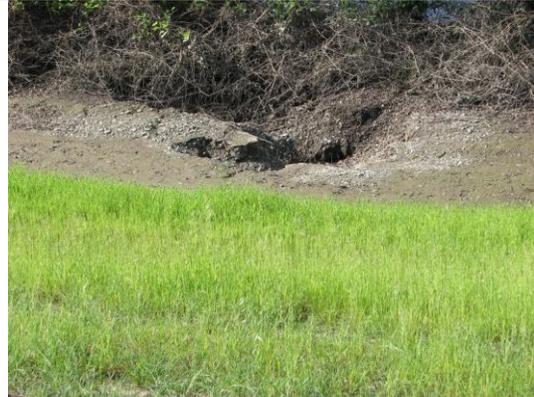
Photo 1 of 1 : SP\_2016\_ST0002\_450\_27\_20160405\_00039.jpg

LM Start	<b>1.57</b>	Rating **	U	Issue No.	<b>27</b>
LM End	<b>1.57</b>	Issue Type +	Ma	Location *	WS
Category	Earthen Levee		GPS Latitude/Longitude		
			Start	End	
Item	Erosion / Bank Caving		39.136984 °	39.136984 °	
			-121.809686 °	-121.809686 °	
DWR ID	DWR_ST0002_01_s_2016_27				
Comment Code					
E2 : Schedule repair of erosion site prior to the next inspection.					
Inspector Comment					
Active erosion of the waterside toe road migrating towards levee.

Erosion rut

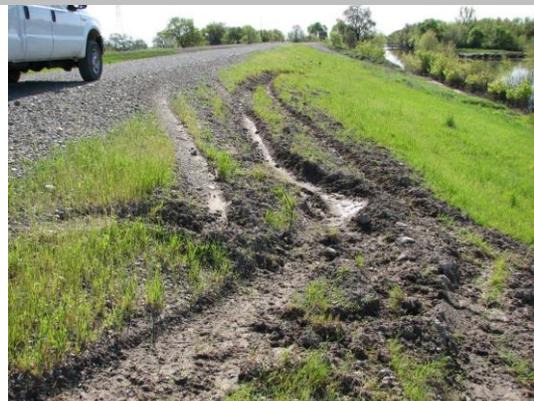
Photo 1 of 1 : SP\_2016\_ST0002\_450\_28\_20160405\_00040.jpg

LM Start	<b>4.14</b>	Rating **	M	Issue No.	<b>28</b>
LM End	<b>4.14</b>	Issue Type +	Ma	Location *	WS
Category	Earthen Levee		GPS Latitude/Longitude		
			Start	End	
Item	Slope Stability		39.115232 °	39.115232 °	
			-121.770963 °	-121.770963 °	
DWR ID	DWR_ST0002_01_s_2016_28				
Comment Code					
S3 : Repair the levee slope damaged by vehicle traffic and prevent access where possible.					
Inspector Comment					
Vehicle traffic on slope has deep ruts and ponding of water.

Tire ruts

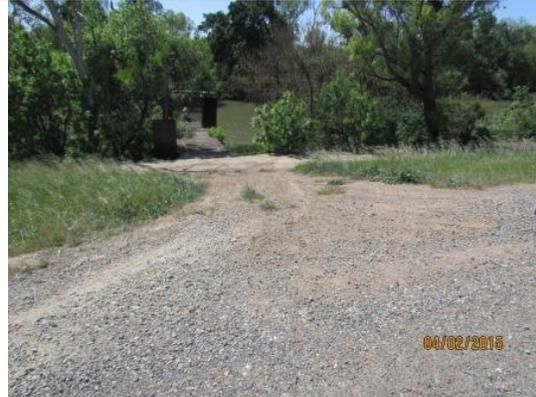
Photo 1 of 1 : SP\_2016\_ST0002\_450\_25\_20160316\_00005.jpg

LM Start	<b>5.20</b>	Rating **	A/W	Issue No.	<b>25</b>
LM End	<b>5.20</b>	Issue Type +	Ma	Location *	WS
Category	Earthen Levee			GPS Latitude/Longitude	
				Start	End
Item	Slope Stability			39.103313 °	39.103313 °
				-121.758813 °	-121.758813 °
DWR ID	DWR_ST0002_01_s_2015_25				
Comment Code					
S3 : Repair the levee slope damaged by vehicle traffic and prevent access where possible.					
Inspector Comment					
Repair the vehicle erosion along the waterside slope.

View of the vehicle erosion along the waterside slope.

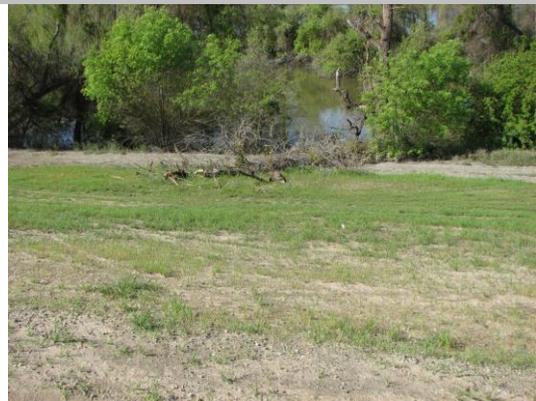
Photo 1 of 1 : SP\_2016\_ST0002\_450\_31\_20160405\_00041.jpg

LM Start	<b>6.60</b>	Rating **	M	Issue No.	<b>31</b>
LM End	<b>6.60</b>	Issue Type +	Ma	Location *	WS
Category	Earthen Levee			GPS Latitude/Longitude	
				Start	End
Item	Trim / Thin Trees			39.084236 °	39.084236 °
				-121.749914 °	-121.749914 °
DWR ID	DWR_ST0002_01_s_2016_31				
Comment Code					
T3 : Trim and thin trees to allow visibility of the ground and room to flood fight.					
Inspector Comment					
Fallen dead tree on waterside levee slope.

Downed tree on slope

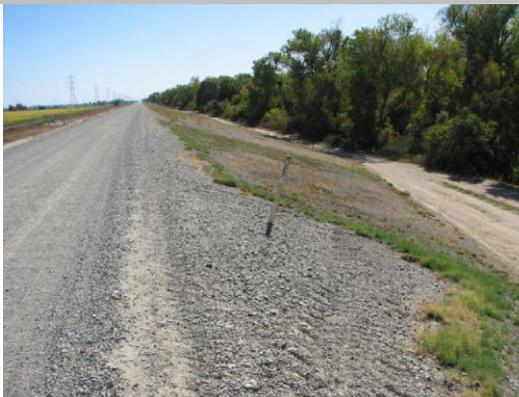
Photo 1 of 2 : UCIP\_SP\_2016\_48204\_65213.jpg

Item	DWR UCIP Field Study			39.072292 °	39.072292 °
				-121.744907 °	-121.744907 °
DWR ID					
Comment Code					
Inspector Comment					
FS_ID:48204 DS_ID:19985 EP_NO: N/A Repair Type: Non-Urgent Crossing Status: Found UCIP Comments: 4/18/2016 Crossing appears in good condition. No noticeable issues to report.5/7/2015 Crossing is in good condition. No noticeable issues to report.11/12/2014 Same as last inspection.5/13/2014 Same as last inspection.10/30/2013 Same as last inspection.5/22/2013 Same as last inspection.10/8/2012 No Permit identified for crossing. FIELD_STRUCT_DESC: Gas-line crosses levee at unknown depth. Carsonite sign on waterside (WS) shoulder and at landside (LS) toe across toe ditch. Line is owned by Calpine Pipeline Company. No permit has been identified since crossing was field discovered in 2012. FS Date: 4/22/2016 9:04:00 AM

Gasline marker on WS shoulder.

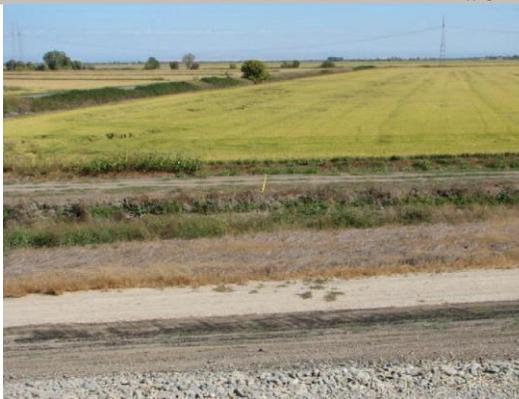
Photo 2 of 2 : UCIP\_SP\_2016\_48204\_65212.jpg

Gasline marker on LS toe east of ditch.

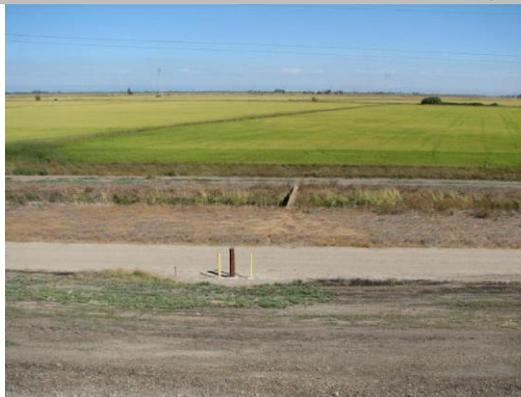
Photo 1 of 2 : UCIP\_SP\_2016\_48205\_65215.jpg

Item	DWR UCIP Field Study			39.062976 °	39.062976 °
				-121.741027 °	-121.741027 °
DWR ID					
Comment Code					
Inspector Comment					
FS_ID:48205 DS_ID:19984 EP_NO: N/A Repair Type: Non-Urgent Crossing Status: Found UCIP Comments: 4/18/2016 Crossing appears in good condition. No noticeable issues to report.5/7/2015 Crossing is in good condition. No noticeable issues to report.11/12/2014 Same as last inspection.5/13/2014 Same as last inspection.10/30/2013 Same as last inspection.5/22/2013 Same as last inspection.10/8/2012 No permit or purpose identified for this crossing. FIELD_STRUCT_DESC: 2.5-inch steel pipe bored under the levee at unknown depth. Pipe has locked cap on landside (LS) toe. Steel I-beam stream crossing on LS toe mark location of pipe. Waterside (WS) marker of pipe crossing is not identified. No permit has been identified since crossing was field discovered in 2012. FS Date: 4/22/2016 9:08:00 AM

Pipe at steel i-beam crossing in ditch at LS toe.

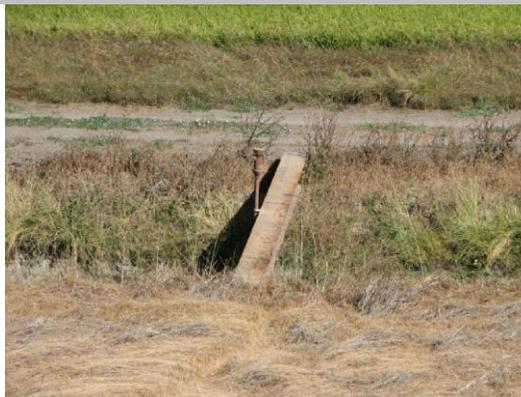
Photo 2 of 2 : UCIP\_SP\_2016\_48205\_65214.jpg

Pipe at steel i-beam crossing in ditch at LS toe.

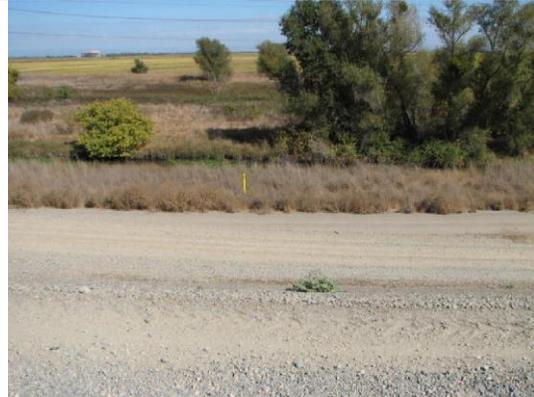
Photo 1 of 2 : UCIP\_SP\_2016\_48208\_65219.jpg

Item	DWR UCIP Field Study			39.033519 °	39.033519 °
				-121.728926 °	-121.728926 °
DWR ID					
Comment Code					
Inspector Comment					
<p>FS_ID:48208                  DS_ID:16899                  EP_NO: 14455                  Repair Type: Urgent                  Crossing Status: Indicator Found                  UCIP Comments: 4/18/2016 Gas line was damaged at the WS berm due to a farmer getting his tractor stuck. Gas company is aware of the damage and will be doing repairs sometime this summer. Damage should not affect the integrity of the levee.5/7/2015 Marker on WS broken.11/12/2014 Same as last inspection.5/13/2014 Same as last inspection.10/30/2013 Same as last inspection.5/22/2013 Carsonite marker on WS shoulder is broken and should be replaced.                  FIELD_STRUCT_DESC: 2 of 3. 4.5-inch steel natural gas pipeline through the levee, 2 feet below the crown. Pipes were paced in same trench 1-foot apart. Gasline markers on landside (LS) toe and waterside (WS) shoulder. Design drawings available in the permit. (Permit No. 14455, 1986-Depco, Inc.)                  FS Date: 4/22/2016 9:39:00 AM</p>

Gasline markers on LS toe.

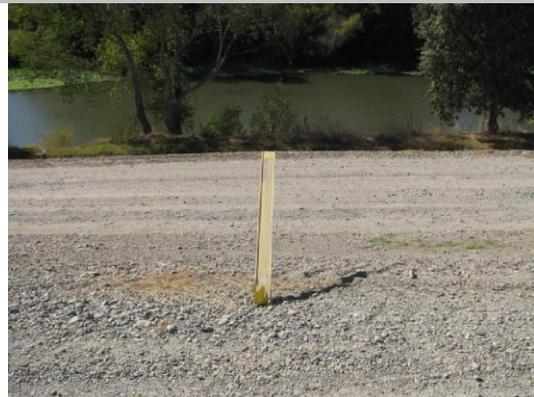
Photo 2 of 2 : UCIP\_SP\_2016\_48208\_65218.jpg

Gasline markers on WS shoulder.

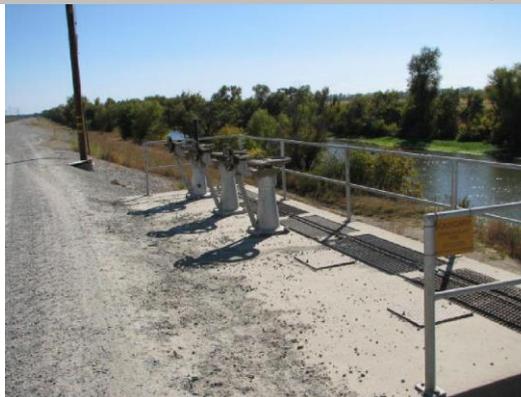
Photo 1 of 2 : UCIP\_SP\_2016\_48216\_65251.jpg

FS\_ID:48216  
 DS\_ID:16871  
 EP\_NO: N/A  
 Repair Type: Non-Urgent  
 Crossing Status: Found  
 UCIP Comments: 4/18/2016 Abandoned crossing but no noticeable issues seen with it.5/7/2015 Abandoned crossing but no noticeable issues with it.11/12/2014 Same as last inspection.5/13/2014 Same as last inspection.10/30/2013 Same as last inspection.5/22/2013 Same as last inspection.10/8/2012 Need to determine type of abandonment.  
 FIELD\_STRUCT\_DESC: \*ABANDONED\* [Pumping Plant No. 2] 1 of 5. 4-foot by 6-foot concrete drainage culvert through the levee, 31.5 feet below the crown. Wood flap gate and concrete headwall on the waterside (WS) end. Wooden steps on the landside (LS) slope. Concrete steps on the WS end. [Additional Reference(s): DWR Levee Log, 2005. USACE Sacramento O&M Manual 315, May 1953 (Station 582+19)]  
 FS Date: 4/22/2016 9:47:00 AM

Slide gates on WS shoulder

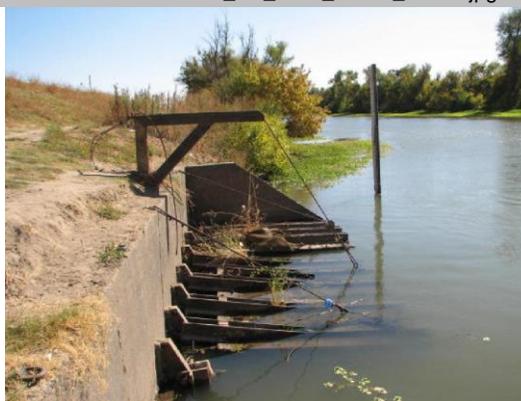
Photo 2 of 2 : UCIP\_SP\_2016\_48216\_65250.jpg

Flap gates on WS toe.

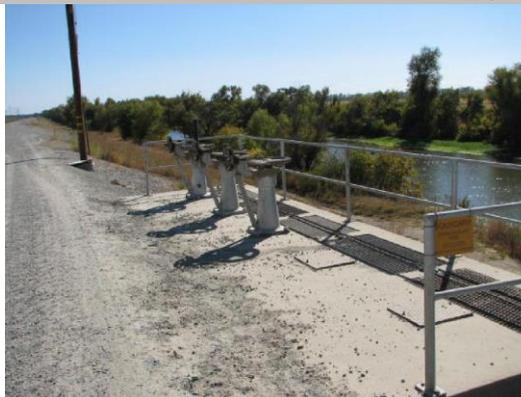
Photo 1 of 2 : UCIP\_SP\_2016\_48217\_65254.jpg

FS\_ID:48217  
 DS\_ID:16906  
 EP\_NO: N/A  
 Repair Type: Non-Urgent  
 Crossing Status: Found  
 UCIP Comments: 4/18/2016 Abandoned crossing but no noticeable issues seen with it.5/7/2015 Abandoned crossing but no noticeable issues to report.11/12/2014 Same as last inspection.5/13/2014 Same as last inspection.10/30/2013 Same as last inspection.5/22/2013 Same as last inspection.10/8/2012 Determine type of abandonment.  
 FIELD\_STRUCT\_DESC: \*ABANDONED\* [Pumping Plant No. 2] 2 of 5. 4-foot by 6-foot concrete drainage culvert through the levee, 31.5 feet below the crown. Wood flap gate and concrete headwall on the waterside (WS) end. Wooden steps on the landside (LS) slope. Concrete steps on the WS end. [Additional Reference(s): DWR Levee Log, 2005. USACE Sacramento O&M Manual 315, May 1953 (Station 582+19)]  
 FS Date: 4/22/2016 9:48:00 AM

Slide gates on WS shoulder.

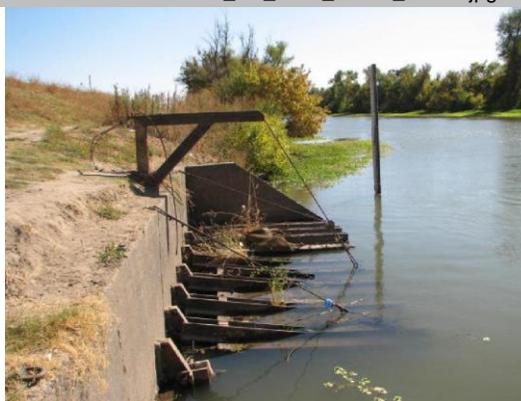
Photo 2 of 2 : UCIP\_SP\_2016\_48217\_65253.jpg

Flap gates on WS toe.

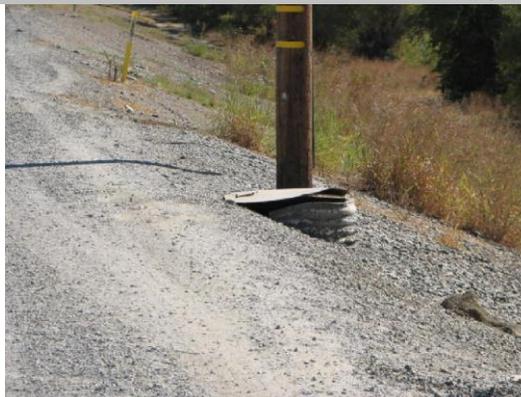
Photo 1 of 1 : UCIP\_SP\_2016\_48221\_65264.jpg

Item	DWR UCIP Field Study			39.025560 °	39.025560 °
				-121.726846 °	-121.726846 °
DWR ID					
Comment Code					
Inspector Comment					
FS_ID:48221 DS_ID:16872 EP_NO: 3165 Repair Type: Non-Urgent Crossing Status: Found UCIP Comments: 4/18/2016 Abandoned crossing but no noticeable issues to report.5/7/2015 Abandoned crossing. No noticeable issues to report.11/12/2014 Same as last inspection.5/13/2014 Same as last inspection.10/30/2013 Same as last inspection.5/22/2013 Same as last inspection.10/8/2012 Need to determine type of abandonment. FIELD_STRUCT_DESC: 10-inch drainage pipe through the levee, 2.0 feet below the crown. Siphon breaker in a 36-inch corrugated metal pipe (CMP) riser on the waterside (WS) shoulder. Flap gate on the WS end. Minimalistic design drawings available. (Permit No. 3165, 1959-State of California Department of Water Resources [DWR]). [Additional Reference(s): DWR Levee Log, 2005]. FS Date: 4/22/2016 10:06:00 AM

Siphon breaker in 36-inch CMP riser on WS shoulder. Pipe visible at siphon breaker.

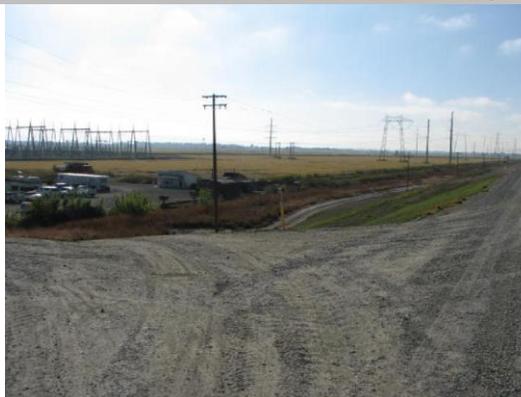
Photo 1 of 2 : UCIP\_SP\_2016\_48222\_65266.jpg

Item	DWR UCIP Field Study			39.025310 °	39.025310 °
				-121.726770 °	-121.726770 °
DWR ID					
Comment Code					
Inspector Comment					
FS_ID:48222 DS_ID:19986 EP_NO: N/A Repair Type: Non-Urgent Crossing Status: Indicator Found UCIP Comments: 4/18/2016 Crossing appears in good condition. No noticeable issues to report.5/7/2015 Crossing is in good condition. No noticeable issues to report.11/12/2014 Same as last inspection.5/13/2014 Same as last inspection.10/30/2013 Same as last inspection.5/22/2013 Same as last inspection.10/9/2012 No permit identified for crossing. FIELD_STRUCT_DESC: Gas-line crosses levee at unknown depth. Carsonite sign on both landside (LS) and waterside (WS) shoulder. Line is owned by Calpine Pipeline Company. No permit has been identified since crossing was field discovered in 2012. FS Date: 4/22/2016 10:13:00 AM

Gasline marker on LS shoulder.

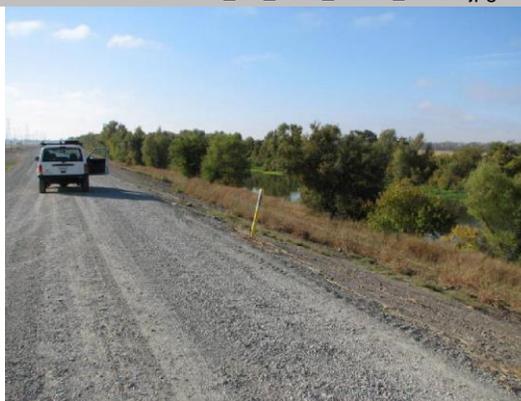
Photo 2 of 2 : UCIP\_SP\_2016\_48222\_65265.jpg

Gasline marker on WS shoulder.

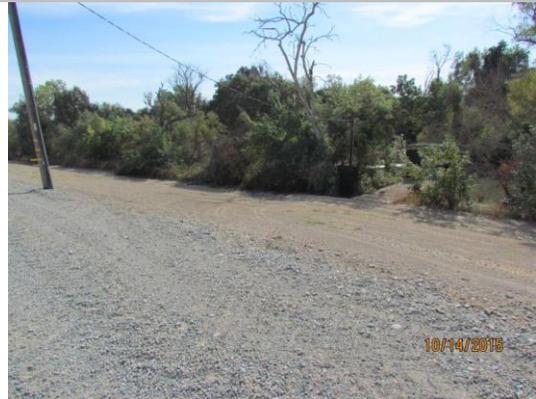
Photo 1 of 1 : SP\_2016\_ST0002\_450\_23\_20160316\_00004.jpg

LM Start	<b>13.34</b>	Rating **	A/W	Issue No.	<b>23</b>
LM End	<b>13.34</b>	Issue Type +	Ma	Location *	WS
Category	Earthen Levee			GPS Latitude/Longitude	
				Start	End
Item	Slope Stability			38.991857 °	38.991857 °
				-121.711555 °	-121.711555 °
DWR ID	DWR_ST0002_01_s_2015_23				
Comment Code					
S3 : Repair the levee slope damaged by vehicle traffic and prevent access where possible.					
Inspector Comment					
Repair the erosion along the waterside slope.

View of the vehicle erosion along the slope.

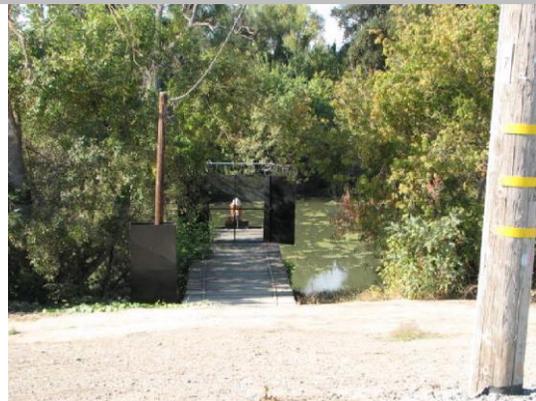
Photo 1 of 2 : UCIP\_SP\_2016\_48224\_65302.jpg

Item	DWR UCIP Field Study			38.991808 °	38.991808 °
				-121.711512 °	-121.711512 °
DWR ID					
Comment Code					
Inspector Comment					
FS_ID:48224 DS_ID:16873 EP_NO: N/A Repair Type: Non-Urgent Crossing Status: Found UCIP Comments: 4/18/2016 Crossing appears in good condition. No noticeable issues to report.5/7/2015 Crossing is in good condition. No noticeable issues to report.11/12/2014 Same as last inspection.5/14/2014 Same as last inspection.10/30/2013 Same as last inspection.5/23/2013 Same as last inspection.10/9/2012 Verify work (if any) was done to replace original equipment with inspector. FIELD_STRUCT_DESC: 18-inch irrigation pipe through the levee, 5.5 feet below the crown. Pipe measures 16-inches at pump and on landside (LS) outlet. Siphon breaker in a 16-inch corrugated metal pipe (CMP) riser on the LS slope. Pump on pile structure in the channel. Meter and pole on the waterside (WS). [Additional Reference(s): DWR Levee Log, 2005. USACE Sacramento O&M Manual 315, May 1953 (Station 449+15)] FS Date: 4/22/2016 10:16:00 AM

Pump on Pier on WS toe.

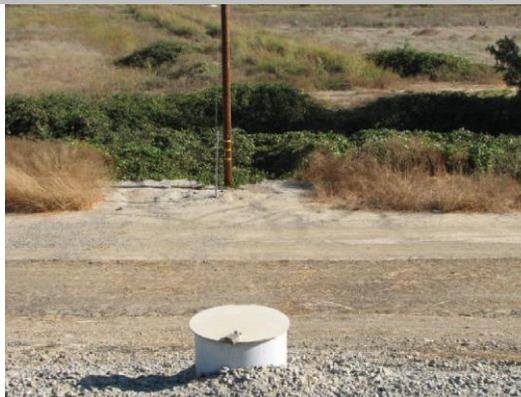
Photo 2 of 2 : UCIP\_SP\_2016\_48224\_65301.jpg

Siphon Breaker in 16-inch steel riser on LS shoulder.

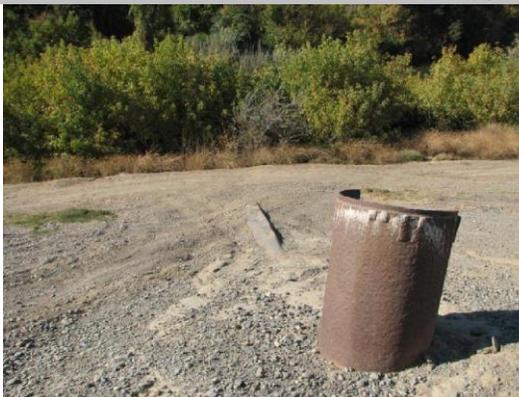
Photo 1 of 2 : UCIP\_SP\_2016\_48226\_65314.jpg

Item	DWR UCIP Field Study			38.979377 °	38.979377 °
				-121.691929 °	-121.691929 °
DWR ID					
Comment Code					
Inspector Comment					
FS_ID:48226 DS_ID:16875 EP_NO: N/A Repair Type: Non-Urgent Crossing Status: Found UCIP Comments: 4/18/2016 Abandoned crossing.5/7/2015 Abandoned crossing. Needs to be properly abandoned.11/12/2014 Same as last inspection.5/14/2014 Same as last inspection.10/30/2013 Same as last inspection.5/23/2013 Same as last inspection.10/9/2012 Pipe has not been abandoned properly. It should be removed from the levee section. FIELD_STRUCT_DESC: 16-inch steel irrigation pipe through the levee, 3.5 feet below the crown. Siphon breakers in 30-inch steel risers on both waterside (WS) and landside (LS) shoulders. Vertical pump on pile structure in stream (removed). [Additional Reference(s): DWR Levee Log, 2005. USACE Sacramento O&M Manual 315, May 1953 (Station 377+10)]. FS Date: 4/22/2016 10:18:00 AM

Pipe on WS slope exposed and crushed below 30-inch steel riser.

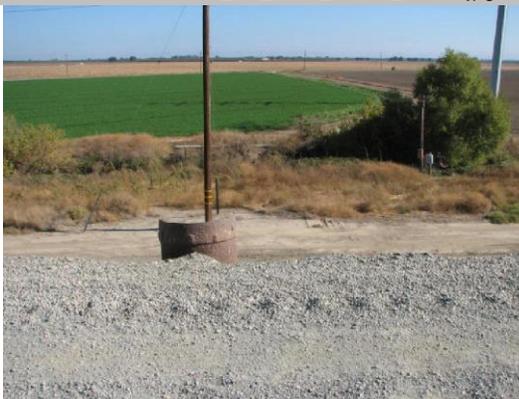
Photo 2 of 2 : UCIP\_SP\_2016\_48226\_65313.jpg

Steel riser on LS shoulder.

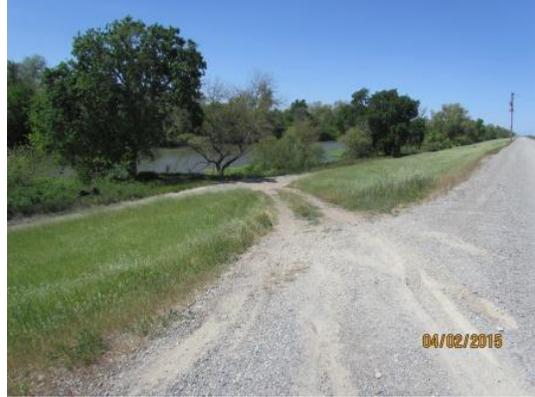
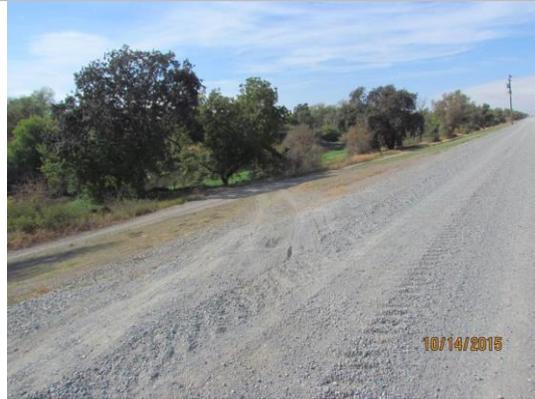
LM Start	<b>17.60</b>	Rating **	M	Issue No.	<b>21</b>
LM End	<b>17.60</b>	Issue Type +	Ma	Location *	WS
Category	Earthen Levee		GPS Latitude/Longitude		
			Start	End	
Item	Slope Stability		38.949965 °	38.949965 °	
			-121.653823 °	-121.653823 °	
DWR ID	DWR_ST0002_01_s_2015_21				
Comment Code					
S3 : Repair the levee slope damaged by vehicle traffic and prevent access where possible.					
Inspector Comment					
Repair the vehicle erosion along the waterside slope.

View of the vehicle erosion along the waterside slope.

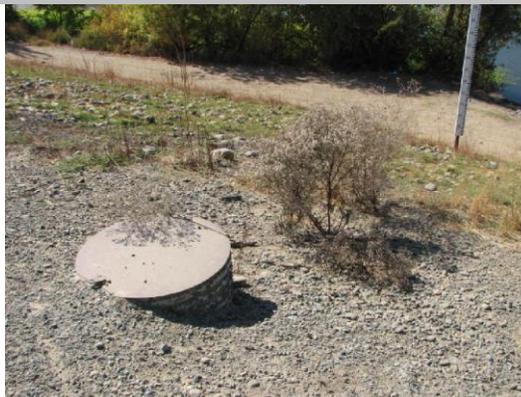
Photo 1 of 1 : UCIP\_SP\_2016\_48238\_65334.jpg

Item	DWR UCIP Field Study			38.932423 °	38.932423 °
				-121.635085 °	-121.635085 °
DWR ID					
Comment Code					
Inspector Comment					
FS_ID:48238 DS_ID:16878 EP_NO: 3165 Repair Type: Non-Urgent Crossing Status: Found UCIP Comments: 4/18/2015 Abandoned crossing. No noticeable issues to report.5/7/2015 Abandoned crossing. No noticeable issues to report.11/12/2014 Same as last inspection.5/14/2014 Same as last inspection.10/30/2013 Same as last inspection.5/23/2013 Same as last inspection.10/9/2012 Need to determine type of abandonment. FIELD_STRUCT_DESC: 10-inch steel drainage pipe through the levee, 4.0 feet below the crown. Siphon breaker in 36-inch corrugated metal pipe (CMP) riser on the waterside (WS) shoulder. Flap gate on the WS end. (Permit No. 3165, 1959- State of California Department of Water Resources [DWR]) [Additional Reference(s): DWR Levee Log, 2005]. FS Date: 4/22/2016 10:52:00 AM

36-inch CMP riser on WS shoulder.

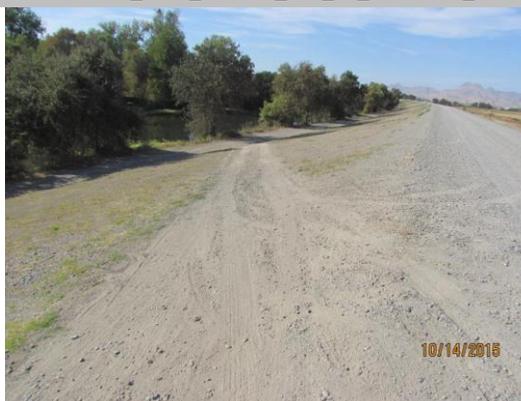
Photo 1 of 1 : SP\_2016\_ST0002\_450\_29\_20160316\_00006.jpg

LM Start	<b>20.02</b>	Rating **	M	Issue No.	<b>29</b>
LM End	<b>20.02</b>	Issue Type +	Ma	Location *	WS
Category	Earthen Levee			GPS Latitude/Longitude	
				Start	End
Item	Slope Stability			38.922678 °	38.922678 °
				-121.625890 °	-121.625890 °
DWR ID	DWR_ST0002_01_f_2015_29				
Comment Code					
S3 : Repair the levee slope damaged by vehicle traffic and prevent access where possible.					
Inspector Comment					
Repair the erosion along the waterside slope.

View of the vehicle erosion along the waterside slope.

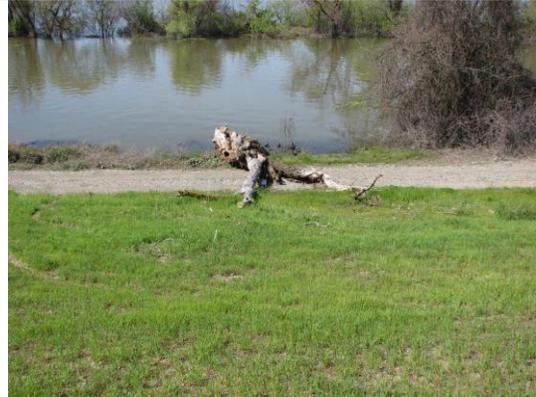
Photo 1 of 1 : SP\_2016\_ST0002\_450\_33\_20160405\_00043.jpg

Downed tree obstructing access

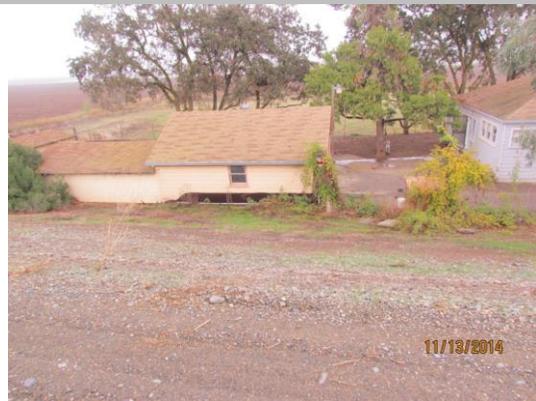
Photo 1 of 1 : SP\_2016\_ST0002\_450\_10\_20160316\_00001.jpg

LM Start	<b>20.34</b>	Rating **	U	Issue No.	<b>10</b>
LM End	<b>20.34</b>	Issue Type +	En	Location *	LS
Category	Earthen Levee		GPS Latitude/Longitude		
			Start	End	
Item	Encroachments		38.918147 °	38.918147 °	
			-121.624545 °	-121.624545 °	
DWR ID	DWR_ST0002_01_s_2012_10				
Comment Code					
BU : Building					
Inspector Comment

View of the house next to the toe of the levee.
