**Flood Control Project Maintenance
Levee Inspections**

Maintenance Issue Types Only, Levee Inspection Report By Mile - Fall 2014

Sutter Maintenance Yard East Levee Sutter Bypass

Waterway	Bank	Unit Miles	Inspection Start/End	Inspector
Unit No. 01 Sutter Bypass Levee	Left	21.67	11/13/2014 11/13/2014	Bob Duffey

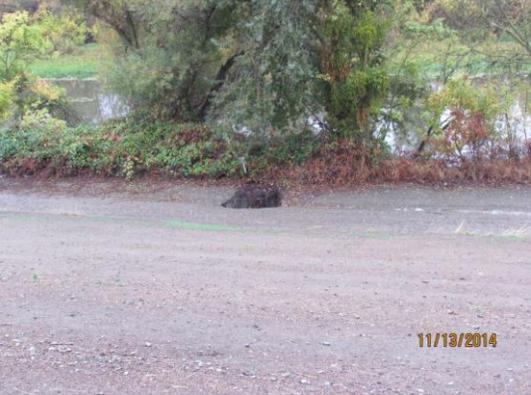
Photo 1 of 1 : FA_2014_ST0002_450_22_20141113_00003.jpg

LM Start	1.60	Rating **	U	Issue No.	22
LM End	1.60	Issue Type +	Ma	Location *	WS
Category	Earthen Levee		GPS Latitude/Longitude		
			Start	End	
Item	Erosion / Bank Caving		39.137025 °	39.137025 °	
			-121.809713 °	-121.809713 °	
DWR ID	DWR_ST0002_01_f_2014_22				
Action/Comments					
Schedule repair of erosion site prior to the next inspection. Inspector Comments: The beaver hole needs to be repaired.

View of the beaver hole at the toe of the levee.

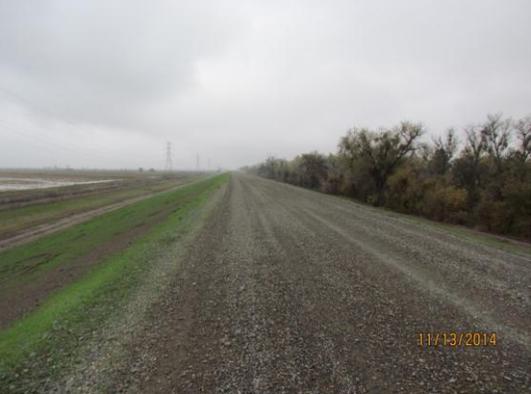
Photo 1 of 1 : FA_2014_ST0002_450_23_20141113_00009.jpg

LM Start	6.22	Rating **	A	Issue No.	23
LM End	6.22	Issue Type +	Ma	Location *	LS
Category	Earthen Levee		GPS Latitude/Longitude		
			Start	End	
Item	Vegetation		39.090835 °	39.090835 °	
			-121.752755 °	-121.752755 °	
DWR ID	DWR_ST0002_01_f_2014_23				
Action/Comments					
Control annual grass and weeds on the levee slopes and easements.

View of no vegetation on both slopes.
