**Flood Control Project Maintenance  
Levee Inspections**

**Maintenance Issue Types Only, Levee Inspection Report By Mile - Fall 2015**

**Sutter Maintenance Yard East Levee Sutter Bypass**

Waterway	Bank	Unit Miles	Inspection Start/End	Inspector
Unit No. 01 Sutter Bypass Levee	Left	21.68	10/14/2015 10/14/2015	Bob Duffey

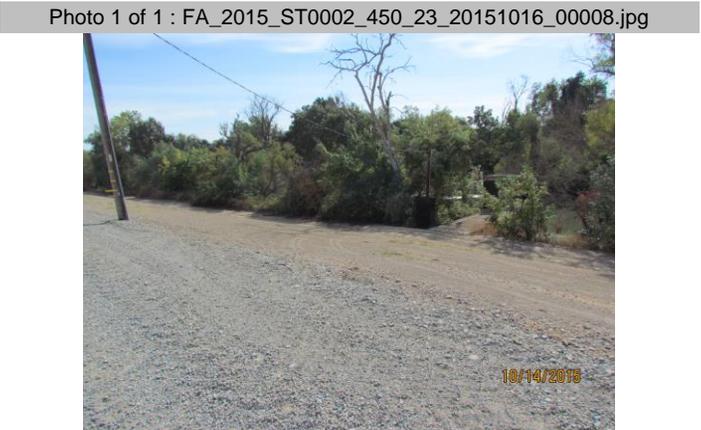
LM Start	<b>13.34</b>	Rating **	M	Issue No.	<b>23</b>
LM End	<b>13.34</b>	Issue Type +	Ma	Location *	WS
Category	Earthen Levee		GPS Latitude/Longitude		
			Start	End	
Item	Slope Stability		38.991857 °	38.991857 °	
			-121.711555 °	-121.711555 °	
DWR ID	DWR_ST0002_01_s_ 2015_23				
Action/Comments					
Repair the levee slope damaged by vehicle traffic and prevent access where possible. Inspector Comments: Repair the erosion along the waterside slope.

View of the vehicle erosion along the slope.

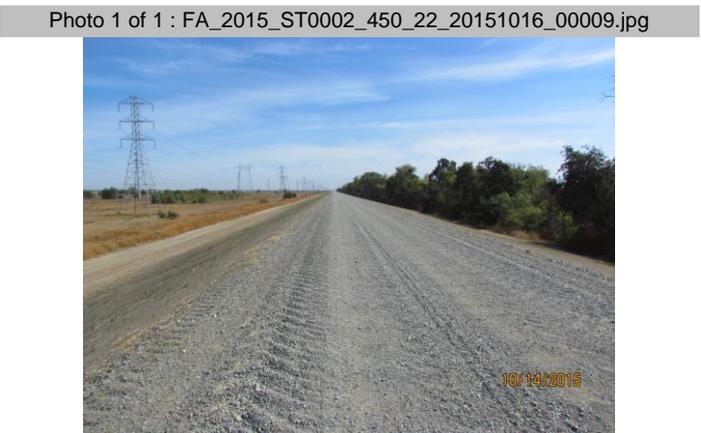
LM Start	<b>13.57</b>	Rating **	A	Issue No.	<b>22</b>
LM End	<b>13.57</b>	Issue Type +	Ma	Location *	LS
Category	Earthen Levee		GPS Latitude/Longitude		
			Start	End	
Item	Vegetation		38.989703 °	38.989703 °	
			-121.708392 °	-121.708392 °	
DWR ID	DWR_ST0002_01_f_ 2015_22				
Action/Comments					
Control annual grass and weeds on the levee slopes and easements. Inspector Comments: Sutter Yard burned and dragged the levee slopes.

View of both slopes with no vegetation.

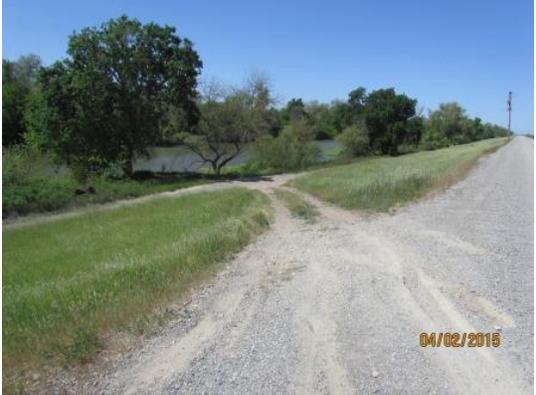
Photo 1 of 2 : FA\_2015\_ST0002\_450\_21\_20150910\_00002.jpg

LM Start	<b>17.60</b>	Rating **	M	Issue No.	<b>21</b>
LM End	<b>17.60</b>	Issue Type +	Ma	Location *	WS
Category	Earthen Levee		GPS Latitude/Longitude		
			Start	End	
Item	Slope Stability		38.949965 °	38.949965 °	
			-121.653823 °	-121.653823 °	
DWR ID	DWR_ST0002_01_s_2015_21				
Action/Comments					
Repair the levee slope damaged by vehicle traffic and prevent access where possible. Inspector Comments: Repair the vehicle erosion along the waterside slope.

View of the vehicle erosion along the waterside slope.

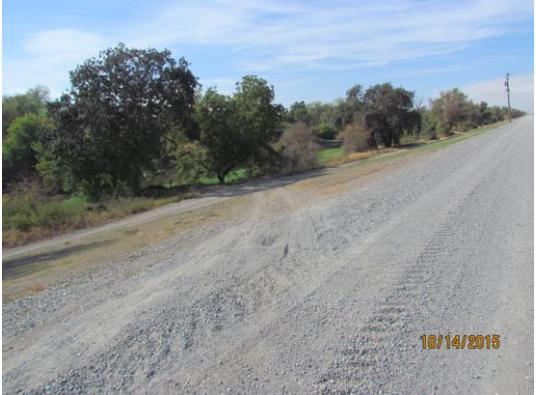
Photo 2 of 2 : FA\_2015\_ST0002\_450\_21\_20151016\_00011.jpg

View of the vehicle erosion along the waterside slope.

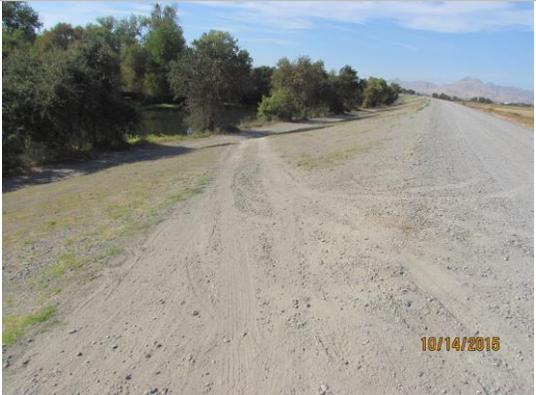
Photo 1 of 1 : FA\_2015\_ST0002\_450\_29\_20151016\_00012.jpg

LM Start	<b>20.02</b>	Rating **	M	Issue No.	<b>29</b>
LM End	<b>20.02</b>	Issue Type +	Ma	Location *	WS
Category	Earthen Levee		GPS Latitude/Longitude		
			Start	End	
Item	Slope Stability		38.922678 °	38.922678 °	
			-121.625890 °	-121.625890 °	
DWR ID	DWR_ST0002_01_f_2015_29				
Action/Comments					
Repair the levee slope damaged by vehicle traffic and prevent access where possible. Inspector Comments: Repair the erosion along the waterside slope.

View of the vehicle erosion along the waterside slope.
