**Flood Control Project Maintenance  
Levee Inspections**

**Maintenance Issue Types Only, Levee Inspection Report By Mile - Spring 2015**

**Sutter Maintenance Yard East Levee Sutter Bypass**

Waterway	Bank	Unit Miles	Inspection Start/End	Inspector
Unit No. 01 Sutter Bypass Levee	Left	21.77	04/02/2015 04/02/2015	Bob Duffey

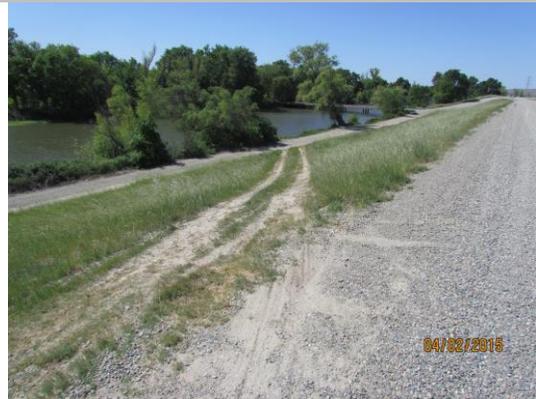
Photo 1 of 1 : SP\_2015\_ST0002\_450\_28\_20150406\_00005.jpg

LM Start	<b>4.46</b>	Rating **	M	Issue No.	<b>28</b>
LM End	<b>4.46</b>	Issue Type +	Ma	Location *	WS
Category	Earthen Levee			GPS Latitude/Longitude	
				Start	End
Item	Slope Stability			39.112042 °	39.112042 °
				-121.766687 °	-121.766687 °
DWR ID	DWR_ST0002_01_s_2015_28				
Action/Comments					
Repair the levee slope damaged by vehicle traffic and prevent access where possible. Inspector Comments: Repair the vehicle erosion along the the waterside slope.

View of the vehicle erosion along the waterside slope.

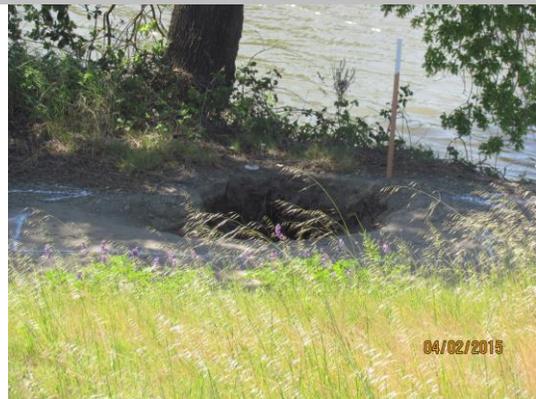
Photo 1 of 1 : SP\_2015\_ST0002\_450\_27\_20150406\_00006.jpg

LM Start	<b>4.78</b>	Rating **	M	Issue No.	<b>27</b>
LM End	<b>4.78</b>	Issue Type +	Ma	Location *	WS
Category	Earthen Levee			GPS Latitude/Longitude	
				Start	End
Item	Erosion / Bank Caving			39.108427 °	39.108427 °
				-121.762910 °	-121.762910 °
DWR ID	DWR_ST0002_01_s_2015_27				
Action/Comments					
Schedule repair of erosion site prior to the next inspection. Inspector Comments: Repair the beaver hole at the waterside toe.

View of the beaver hole along the waterside toe.

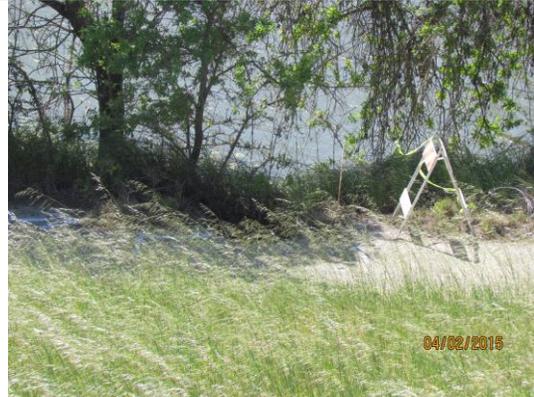
Photo 1 of 1 : SP\_2015\_ST0002\_450\_26\_20150406\_00007.jpg

LM Start	<b>4.95</b>	Rating **	M	Issue No.	<b>26</b>
LM End	<b>4.95</b>	Issue Type +	Ma	Location *	WS
Category	Earthen Levee			GPS Latitude/Longitude	
				Start	End
Item	Erosion / Bank Caving			39.106428 °	39.106428 °
				-121.761150 °	-121.761150 °
DWR ID	DWR_ST0002_01_s_ 2015_26				
Action/Comments					
Schedule repair of erosion site prior to the next inspection. Inspector Comments: Repair the beaver hole at the waterside toe.

View of the beaver hole at the waterside toe.

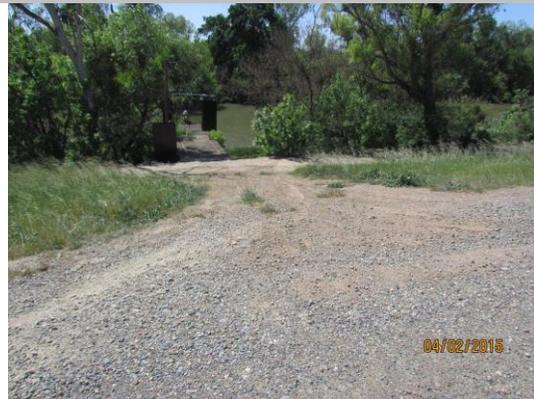
Photo 1 of 1 : SP\_2015\_ST0002\_450\_25\_20150406\_00008.jpg

LM Start	<b>5.20</b>	Rating **	M	Issue No.	<b>25</b>
LM End	<b>5.20</b>	Issue Type +	Ma	Location *	WS
Category	Earthen Levee			GPS Latitude/Longitude	
				Start	End
Item	Slope Stability			39.103313 °	39.103313 °
				-121.758813 °	-121.758813 °
DWR ID	DWR_ST0002_01_s_ 2015_25				
Action/Comments					
Repair the levee slope damaged by vehicle traffic and prevent access where possible. Inspector Comments: Repair the vehicle erosion along the waterside slope.

View of the vehicle erosion along the waterside slope.

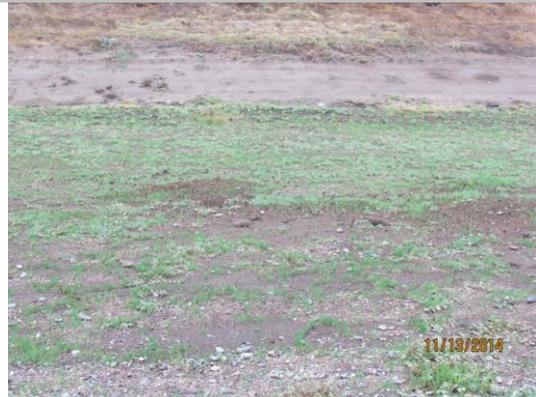
Photo 1 of 1 : SP\_2015\_ST0002\_450\_24\_20150310\_00003.jpg

LM Start	<b>16.23</b>	Rating **	A/W	Issue No.	<b>24</b>
LM End	<b>16.23</b>	Issue Type +	Ma	Location *	LS
Category	Earthen Levee		GPS Latitude/Longitude		
			Start	End	
Item	Animal Control		38.965188 °	38.965188 °	
			-121.670365 °	-121.670365 °	
DWR ID	DWR_ST0002_01_f_2014_24				
Action/Comments					
No rodents visible, but rodent burrows visible; need to backfill and compact or grout burrows.

View of the rodent holes on the landside slope.

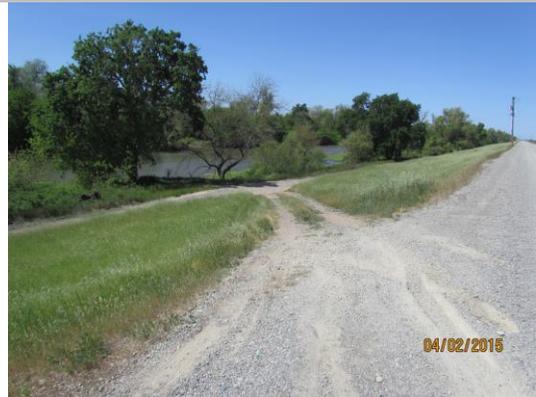
Photo 1 of 1 : SP\_2015\_ST0002\_450\_21\_20150406\_00009.jpg

LM Start	<b>17.60</b>	Rating **	M	Issue No.	<b>21</b>
LM End	<b>17.60</b>	Issue Type +	Ma	Location *	WS
Category	Earthen Levee		GPS Latitude/Longitude		
			Start	End	
Item	Slope Stability		38.949965 °	38.949965 °	
			-121.653823 °	-121.653823 °	
DWR ID	DWR_ST0002_01_s_2015_21				
Action/Comments					
Repair the levee slope damaged by vehicle traffic and prevent access where possible. Inspector Comments: Repair the vehicle erosion along the waterside slope.

View of the vehicle erosion along the waterside slope.
