**Flood Control Project Maintenance  
Levee Inspections**  
**LMA District Cover Sheet**  
**Spring 2012 Levee Inspection Results**

**Sutter Maintenance Yard East Levee Sacramento River**

**Levee Inspection Report By Mile - Spring 2012**

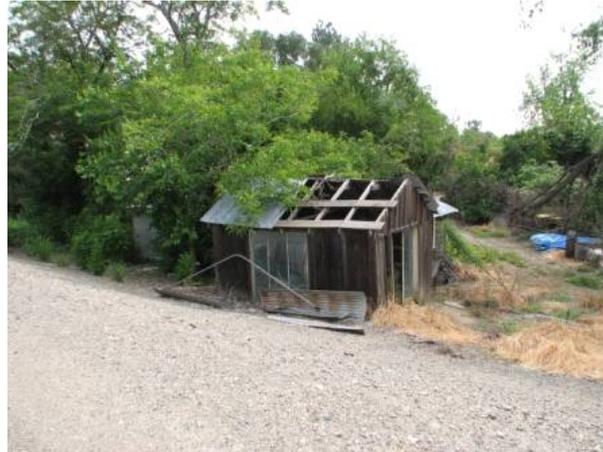
Levee Mile Report Line	4
Start Levee Mile	0.08
End Levee Mile	0.14
Location	Water Side
Category	Earthen Levee
Item	Encroachments
View of a old building next to the landside toe.	
rduffey_s_20120312_484.jpg

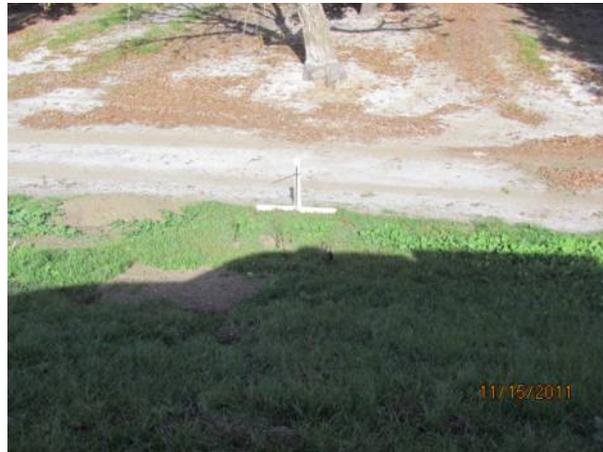
Levee Mile Report Line	6
Start Levee Mile	2.05
End Levee Mile	2.05
Location	Land Side
Category	Earthen Levee
Item	Animal Control
View of the rodent holes & bait station.	
rduffey_s_20120312_485.jpg

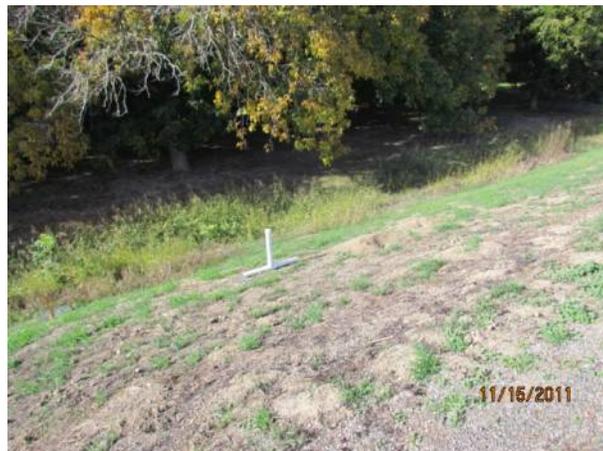
Levee Mile Report Line	7
Start Levee Mile	3.03
End Levee Mile	3.03
Location	Water Side
Category	Earthen Levee
Item	Animal Control
View of the rodent holes & bait station.	
rduffey_s_20120312_492.jpg

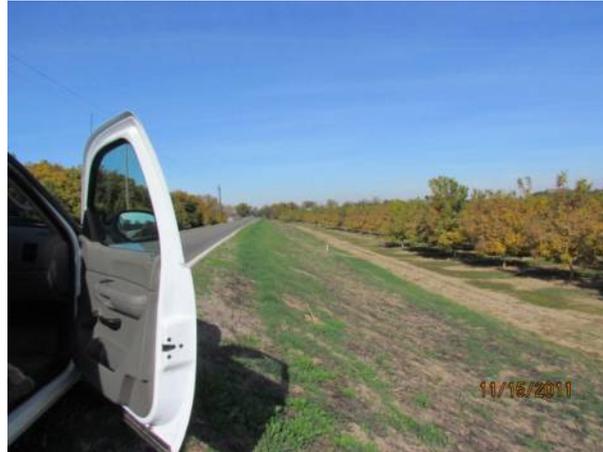
Levee Mile Report Line	8
Start Levee Mile	3.06
End Levee Mile	3.12
Location	Land Side
Category	Earthen Levee
Item	Animal Control
View of the rodent holes & bait station.	
rduffey_s_20120312_493.jpg

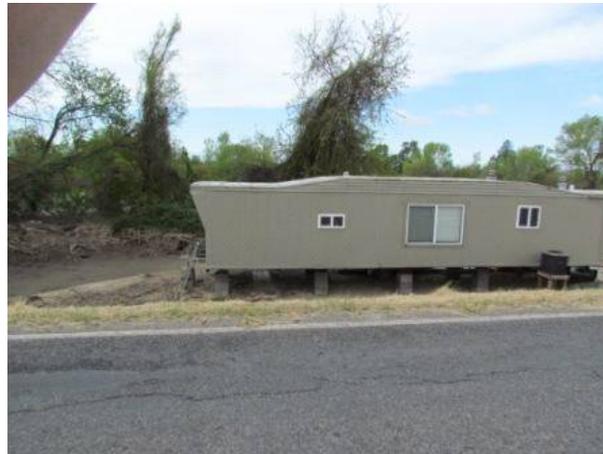
Levee Mile Report Line	9
Start Levee Mile	4.19
End Levee Mile	4.19
Location	Water Side
Category	Earthen Levee
Item	Encroachments
View of the trailer next to the W/S toe.	
rduffey_s_20120312_487.jpg

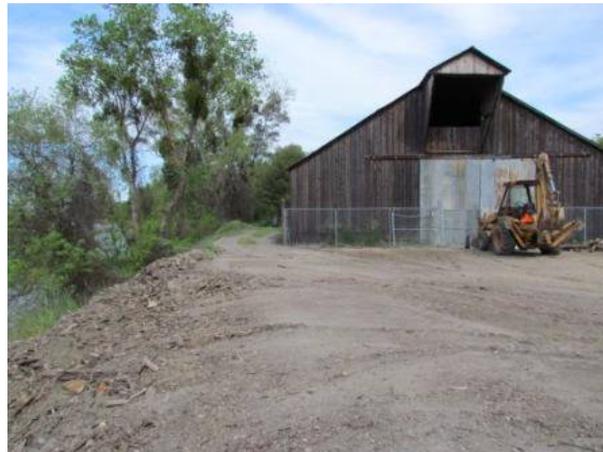
Levee Mile Report Line	10
Start Levee Mile	4.66
End Levee Mile	4.84
Location	Crown
Category	Earthen Levee
Item	Encroachments
View of the barn on the large crown of the levee.	
rduffey_s_20120312_488.jpg

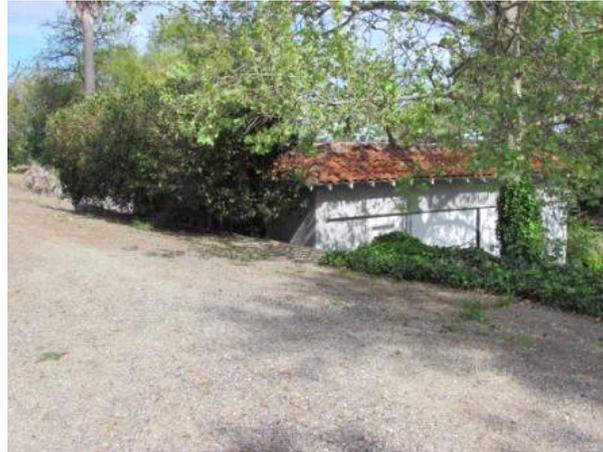
Levee Mile Report Line	11
Start Levee Mile	4.81
End Levee Mile	4.81
Location	Land Side
Category	Earthen Levee
Item	Encroachments

View of the building next to the L/S toe.

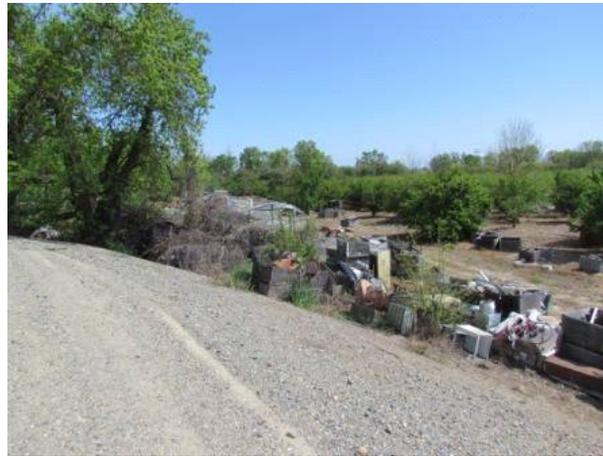
Levee Mile Report Line	15
Start Levee Mile	6.42
End Levee Mile	6.42
Location	Land Side
Category	Earthen Levee
Item	Encroachments

View of the material & garbage along the toe.

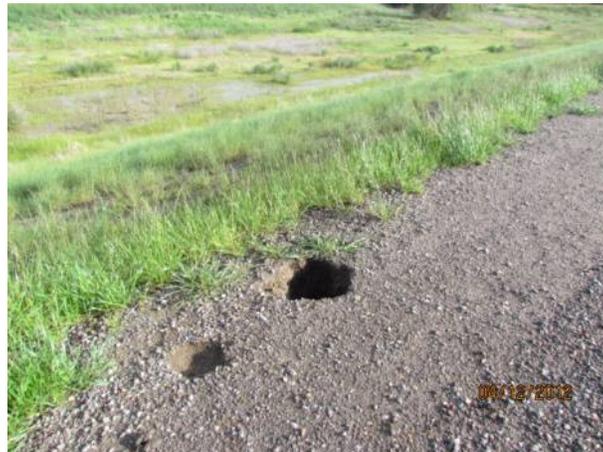
Levee Mile Report Line	16
Start Levee Mile	6.71
End Levee Mile	6.71
Location	Water Side
Category	Earthen Levee
Item	Slope Stability

View of the erosion along the slope of the new setback levee.

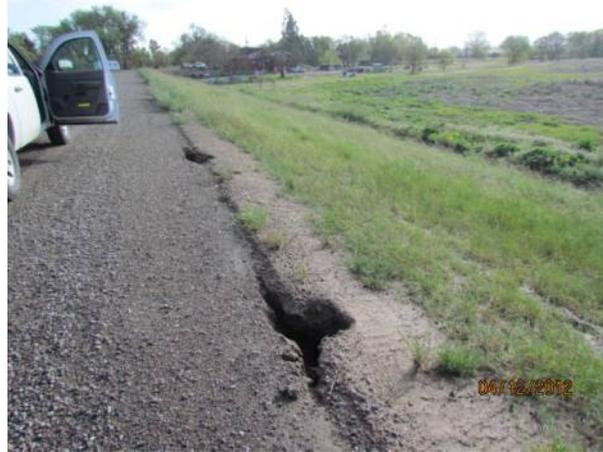
Levee Mile Report Line	17
Start Levee Mile	6.76
End Levee Mile	6.76
Location	Land Side
Category	Earthen Levee
Item	Slope Stability

View of the erosion along the slope of the new setback levee.

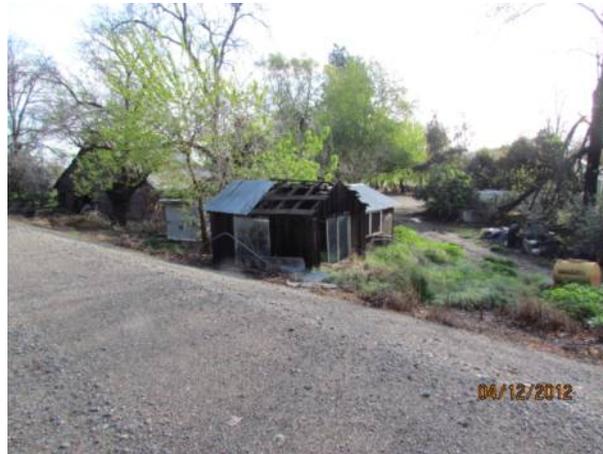
Levee Mile Report Line	18
Start Levee Mile	8.76
End Levee Mile	8.76
Location	Land Side
Category	Earthen Levee
Item	Encroachments

View of the building next to the toe of the levee.

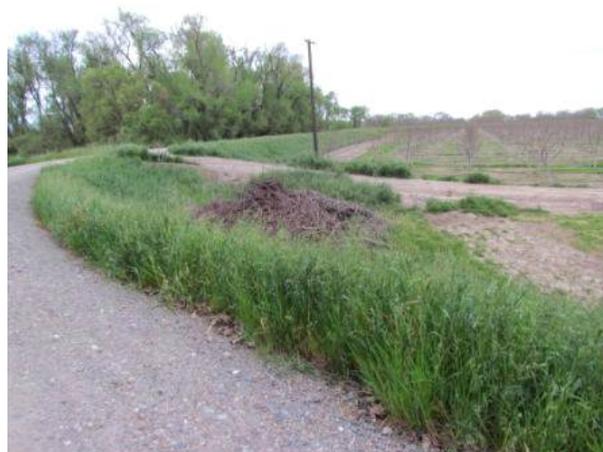
Levee Mile Report Line	19
Start Levee Mile	9.23
End Levee Mile	9.23
Location	Land Side
Category	Earthen Levee
Item	Encroachments

View of the prunings along the L/S toe.

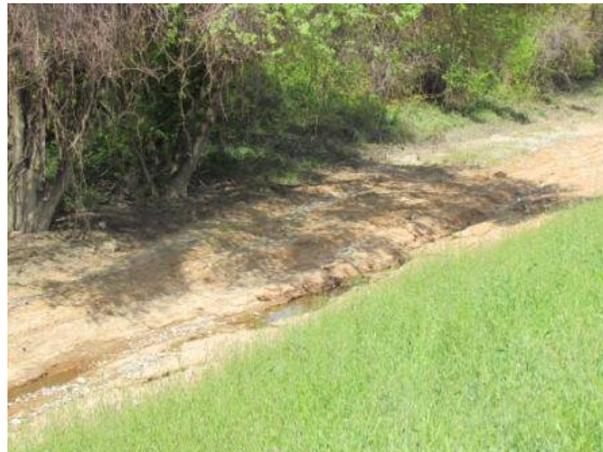
Levee Mile Report Line	27
Start Levee Mile	13.47
End Levee Mile	13.66
Location	Water Side
Category	Earthen Levee
Item	Erosion / Bank Caving
View of the erosion along the W/S toe.	
rduffey_s_20120312_486.jpg

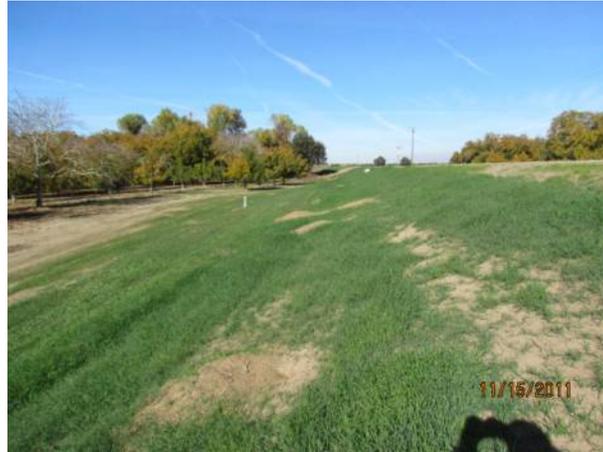
Levee Mile Report Line	28
Start Levee Mile	13.87
End Levee Mile	13.87
Location	Water Side
Category	Earthen Levee
Item	Animal Control
View of the rodents hole along the W/S slope.	
rduffey_s_20120312_494.jpg

DWR ID: DWR_ST0003_01_s_2012_9									
28	13.87	13.87	Earthen Levee	Animal Control	WS Ma	A3 : No rodents visible, but rodent burrows visible; need to backfill and compact or grout burrows.	39.313415 ° -122.012947 °	39.313415 ° -122.012947 °	25 Y
DWR ID: DWR_ST0003_01_s_2012_25

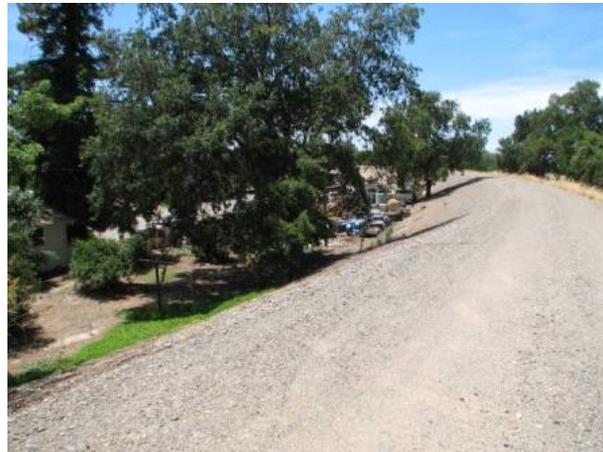
Levee Mile Report Line	31
Start Levee Mile	18.04
End Levee Mile	18.18
Location	Land Side
Category	Earthen Levee
Item	Encroachments
View of the equipment and trees next to the landside toe of the levee.	
rduffey_s_20120312_489.jpg

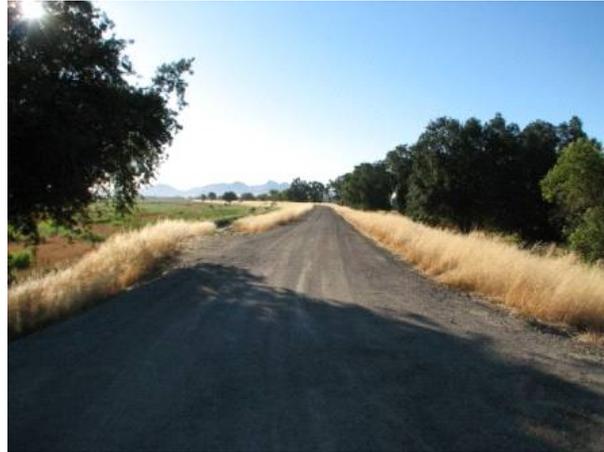
Levee Mile Report Line	4
Start Levee Mile	0.01
End Levee Mile	0.01
Location	Land Side
Category	Earthen Levee
Item	Vegetation

View of the elderberries along the landside toe of the levee.

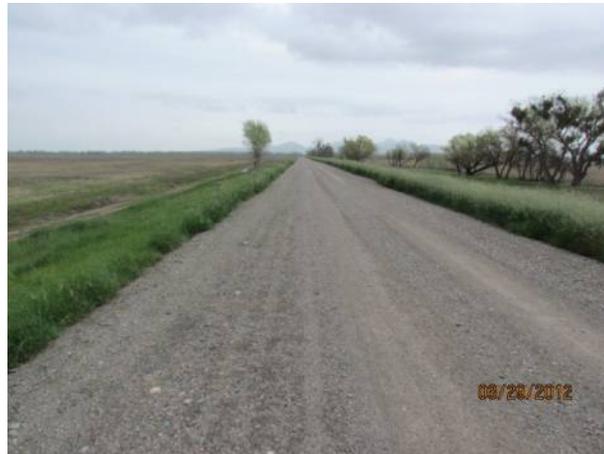
Levee Mile Report Line	5
Start Levee Mile	0.50
End Levee Mile	0.50
Location	Land Side
Category	Earthen Levee
Item	Vegetation

View of the grasses on both slope.

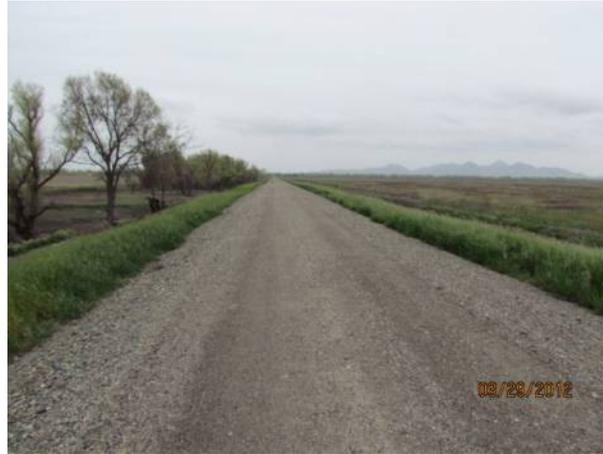
View of the grasses on both slope.

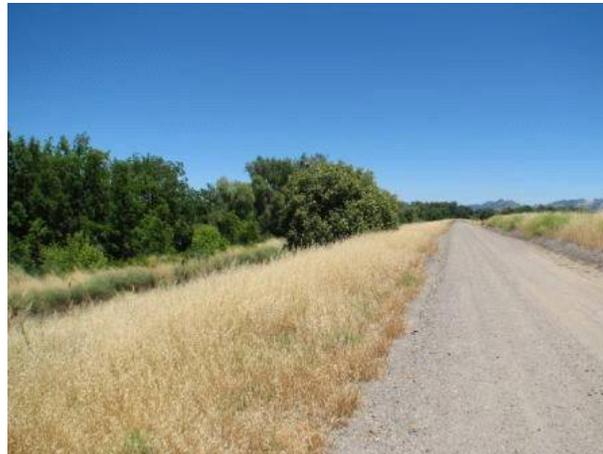
Levee Mile Report Line	2
Start Levee Mile	1.98
End Levee Mile	1.98
Location	Land Side
Category	Earthen Levee
Item	Vegetation

View of the elderberries along the landside toe of the levee.

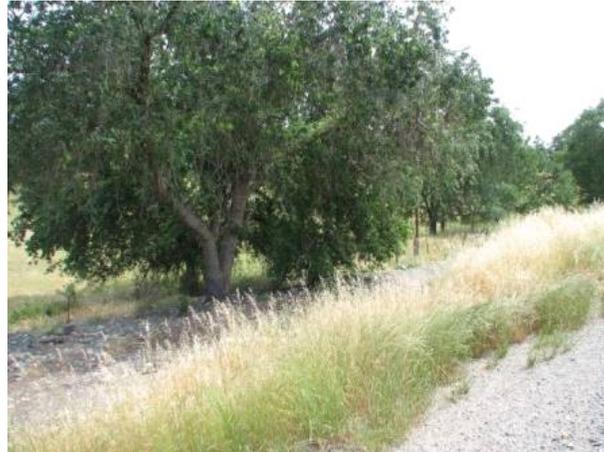
View of a Elderberries bush by the waterside toe.

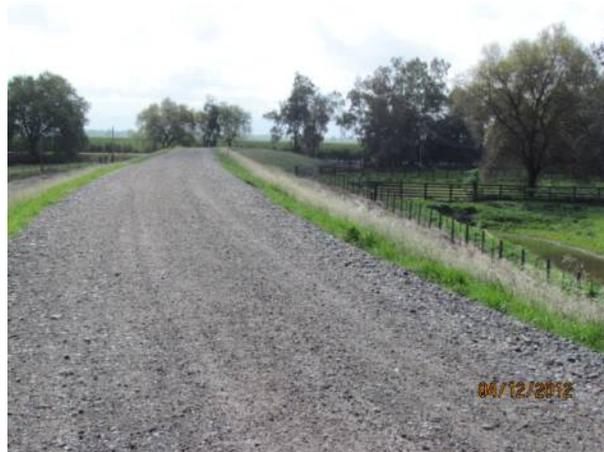
Levee Mile Report Line	2
Start Levee Mile	0.12
End Levee Mile	0.12
Location	Land Side
Category	Earthen Levee
Item	Vegetation

View of the grass on both slopes.

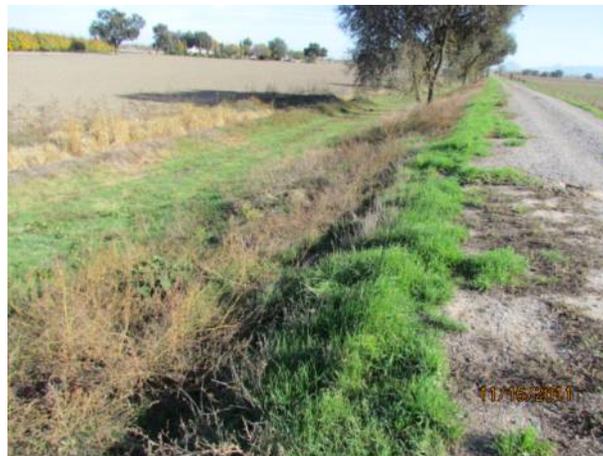
Levee Mile Report Line	2
Start Levee Mile	0.85
End Levee Mile	0.85
Location	Land Side
Category	Earthen Levee
Item	Animal Control
View of the rodents hole along the L/S slope.	
rduffey_s_20120312_507.jpg

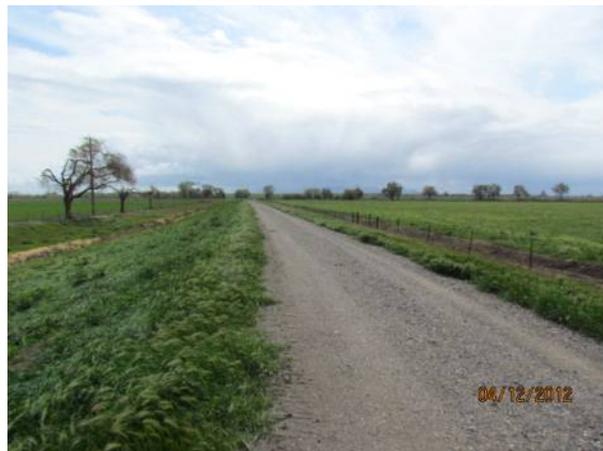
Levee Mile Report Line	6
Start Levee Mile	1.24
End Levee Mile	1.24
Location	Land Side
Category	Earthen Levee
Item	Vegetation
View of the grass on both slopes.	
rduffey_s_20120430_599.jpg
