**Flood Control Project Maintenance
Levee Inspections
LMA District Cover Sheet
Spring 2015 Levee Inspection Results**

Sutter Maintenance Yard East Levee Sacramento River

Spring 2015 Levee Inspection Results

Levee Inspection Report By Mile - Spring 2015

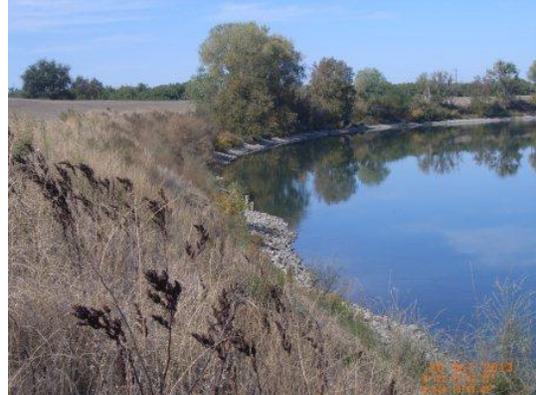
Photo 1 of 1 : SP_2015_ST0003_264_27_20150310_00011.jpg

LM Start	0.00	Rating **	M	Issue No.	27
LM End	11.41	Issue Type +	Ma	Location *	WS
Category	Supplemental			GPS Latitude/Longitude	
				Start	End
Item	USACE Erosion Survey			39.266315 °	39.265730 °
				-122.020682 °	-122.014925 °
DWR ID	DWR_ST0003_01_f_2014_27				
Action/Comments					
Inspector Comments: 2009 - Slump in the middle of the section has left a vertical section on the bank. 2010 - Old cobble site unraveling, site extended downstream. 2013: No observed changes. [2013 Site ID: SAC_151-0_R]

USACE 2013 Photo #1

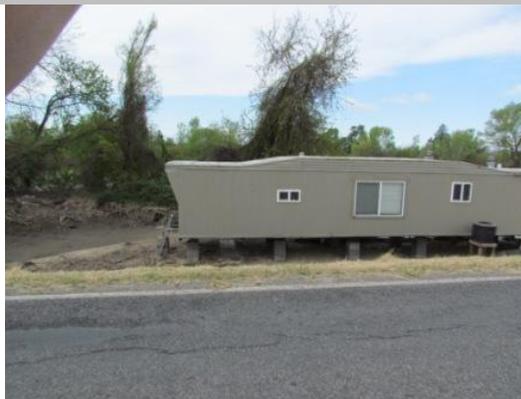
Photo 1 of 1 : SP_2015_ST0003_264_11_20150310_00004.jpg

LM Start	4.26	Rating **	M	Issue No.	11
LM End	4.26	Issue Type +	En	Location *	WS
Category	Earthen Levee			GPS Latitude/Longitude	
				Start	End
Item	Encroachments			39.208935 °	39.208935 °
				-121.985310 °	-121.985310 °
DWR ID	DWR_ST0003_01_s_ 2012_11				
Action/Comments					
Building

View of the trailer next to the W/S toe.

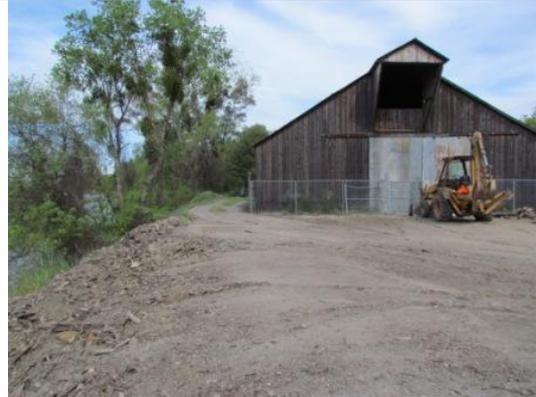
Photo 1 of 1 : SP_2015_ST0003_264_12_20150310_00005.jpg

LM Start	4.72	Rating **	U	Issue No.	12
LM End	4.72	Issue Type +	En	Location *	CR
Category	Earthen Levee		GPS Latitude/Longitude		
			Start	End	
Item	Encroachments		39.213265 °	39.213265 °	
			-121.991672 °	-121.991672 °	
DWR ID	DWR_ST0003_01_s_2012_12				
Action/Comments					
Building

View of the barn on the large crown of the levee.

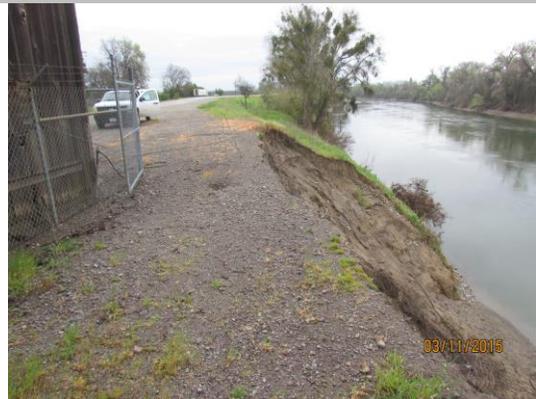
Photo 1 of 1 : SP_2015_ST0003_264_15_20150406_00022.jpg

LM Start	4.72	Rating **	M	Issue No.	15
LM End	4.72	Issue Type +	Ma	Location *	WS
Category	Earthen Levee		GPS Latitude/Longitude		
			Start	End	
Item	Slope Stability		39.213271 °	39.213271 °	
			-121.991676 °	-121.991676 °	
DWR ID	DWR_ST0003_01_s_2013_15				
Action/Comments					
Repair slope instability. Inspector Comments: The erosion needs to be repaired.

View of the erosion along the waterside slope.

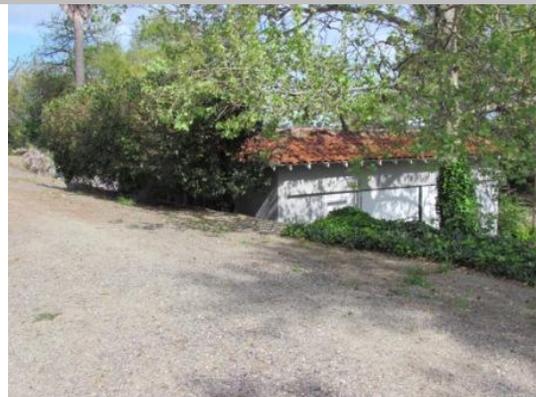
Photo 1 of 1 : SP_2015_ST0003_264_20_20150310_00008.jpg

LM Start	4.84	Rating **	U	Issue No.	20
LM End	4.84	Issue Type +	En	Location *	LS
Category	Earthen Levee		GPS Latitude/Longitude		
			Start	End	
Item	Encroachments		39.214168 °	39.214168 °	
			-121.993515 °	-121.993515 °	
DWR ID	DWR_ST0003_01_s_2012_20				
Action/Comments					
Building

View of the building next to the L/S toe.

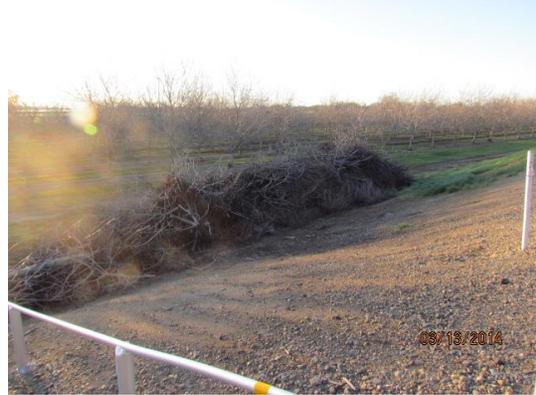
Photo 1 of 1 : SP_2015_ST0003_264_53_20150310_00016.jpg

LM Start	6.38	Rating **	M	Issue No.	53
LM End	6.38	Issue Type +	En	Location *	N/A
Category	Earthen Levee			GPS Latitude/Longitude	
				Start	End
Item	Encroachments			39.223563 °	39.223563 °
				-121.999048 °	-121.999048 °
DWR ID	DWR_ST0003_01_s_2014_53				
Action/Comments					
Prunings

View of the prunings along the landside toe.

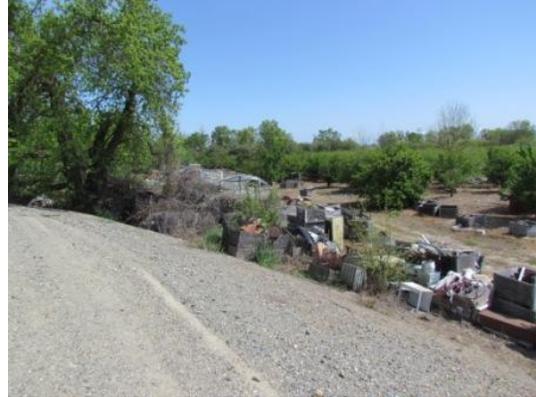
Photo 1 of 1 : SP_2015_ST0003_264_21_20150310_00009.jpg

LM Start	6.48	Rating **	M	Issue No.	21
LM End	6.49	Issue Type +	Ma	Location *	LS
Category	Earthen Levee			GPS Latitude/Longitude	
				Start	End
Item	Encroachments			39.224982 °	39.225013 °
				-121.998600 °	-121.998585 °
DWR ID	DWR_ST0003_01_s_2012_21				
Action/Comments					
Material

View of the material & garbage along the toe.

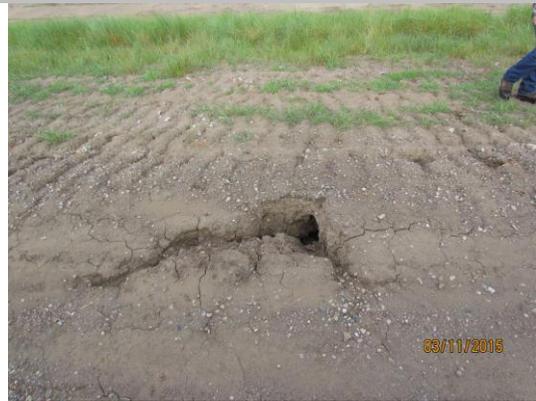
Photo 1 of 1 : SP_2015_ST0003_264_14_20150406_00023.jpg

LM Start	6.78	Rating **	U	Issue No.	14
LM End	6.78	Issue Type +	Ma	Location *	WS
Category	Earthen Levee			GPS Latitude/Longitude	
				Start	End
Item	Erosion / Bank Caving			39.228535 °	39.228535 °
				-121.998330 °	-121.998330 °
DWR ID	DWR_ST0003_01_s_2015_14				
Action/Comments					
Schedule repair of erosion site prior to the next inspection. Inspector Comments: The erosion along the waterside slope needs to be repaired.

View of the erosion along the waterside slope.

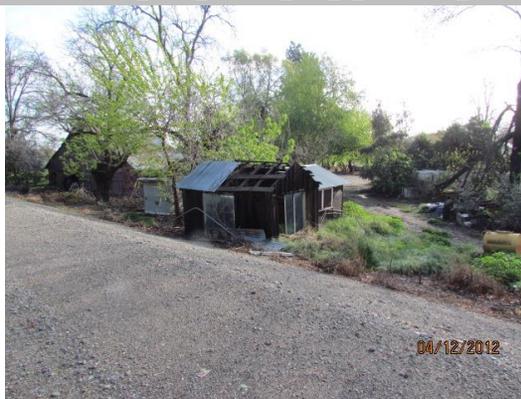
Photo 1 of 1 : SP_2015_ST0003_264_2_20150310_00001.jpg

LM Start	8.75	Rating **	U	Issue No.	2
LM End	8.75	Issue Type +	En	Location *	LS
Category	Earthen Levee			GPS Latitude/Longitude	
				Start	End
Item	Encroachments			39.252260 °	39.252260 °
				-121.997721 °	-121.997721 °
DWR ID	DWR_ST0003_01_s_2012_2				
Action/Comments					
Building

View of the building next to the toe of the levee.

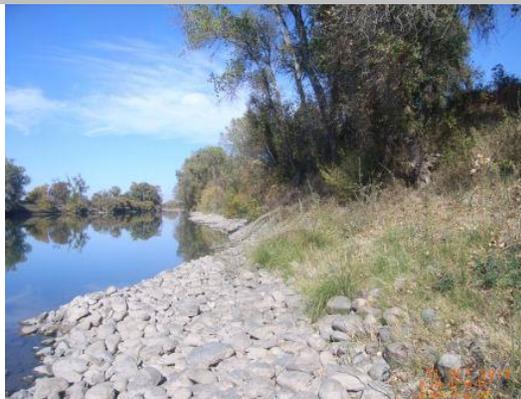
Photo 1 of 1 : SP_2015_ST0003_264_28_20150310_00012.jpg

LM Start	11.51	Rating **	M	Issue No.	28
LM End	11.79	Issue Type +	Ma	Location *	WS
Category	Supplemental			GPS Latitude/Longitude	
				Start	End
Item	USACE Erosion Survey			39.279910 °	39.283853 °
				-122.018221 °	-122.016113 °
DWR ID	DWR_ST0003_01_f_2014_28				
Action/Comments					
Inspector Comments: 2008 - Large rotational/mass failure in the bank with tree slump. 2009 - Minimal new erosion, the tree is leaning further into the river. 2011 - Site extended downstream. 2012 - Minor new erosion and tree roots are further exposed. 2013: No observed changes. [2013 Site ID: SAC_152-6_L]

USACE 2013 Photo #1

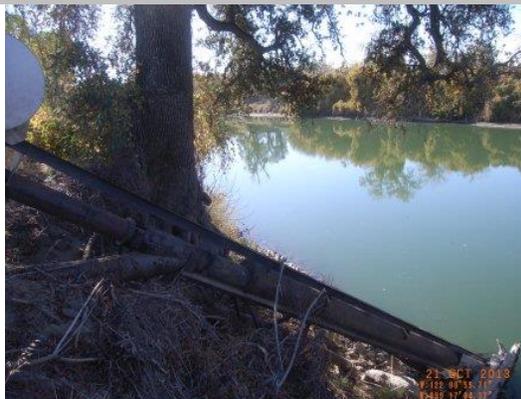
Photo 1 of 1 : SP_2015_ST0003_264_29_20150310_00013.jpg

LM Start	11.85	Rating **	M	Issue No.	29
LM End	11.90	Issue Type +	Ma	Location *	WS
Category	Supplemental			GPS Latitude/Longitude	
				Start	End
Item	USACE Erosion Survey			39.284568 °	39.285298 °
				-122.015690 °	-122.015208 °
DWR ID	DWR_ST0003_01_f_2014_29				
Action/Comments					
Inspector Comments: 2006 - Large rotational/mass failure in the bank with tree slump. Tough clayey toe material. 2007 - Site is between stone revetments with a pump station at the downstream end. 2010 - Erosion is into the levee toe. 2011 - Minor new erosion. 2012 - Minor new erosion. 2013: No observed changes. [2013 Site ID: SAC_152-8_L]

USACE 2013 Photo #1

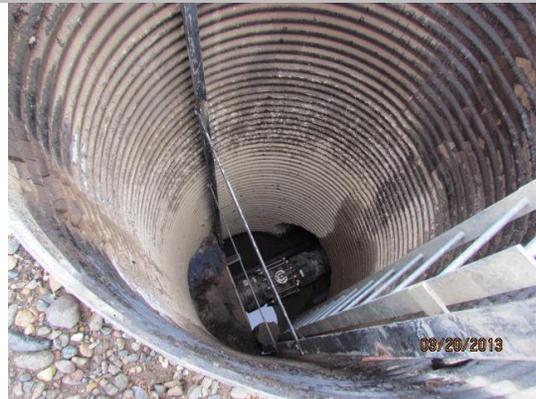
Photo 1 of 1 : SP_2015_ST0003_264_25_20150310_00010.jpg

LM Start	14.56	Rating **	U	Issue No.	25
LM End	14.56	Issue Type +	En	Location *	WS
Category	Earthen Levee			GPS Latitude/Longitude	
				Start	End
Item	Encroachments			39.322254 °	39.322254 °
				-122.015985 °	-122.015985 °
DWR ID	DWR_ST0003_01_s_ 2013_25				
Action/Comments					
Pipe

View of the unauthorized pipe placed inside the drain pipe.

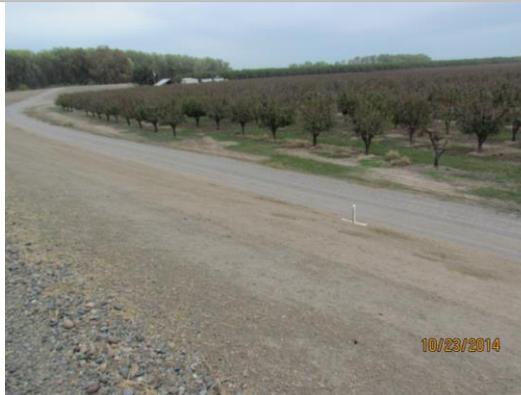
Photo 1 of 1 : SP_2015_ST0003_264_56_20150310_00018.jpg

View of the rodent holes on the landside slope.

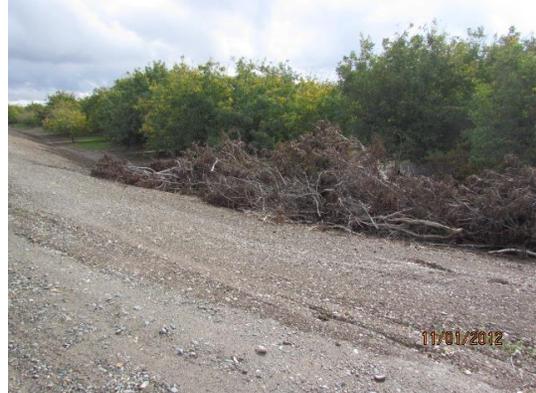
Photo 1 of 1 : SP_2015_ST0003_264_36_20150310_00015.jpg

View of the brush pile along the landside toe.

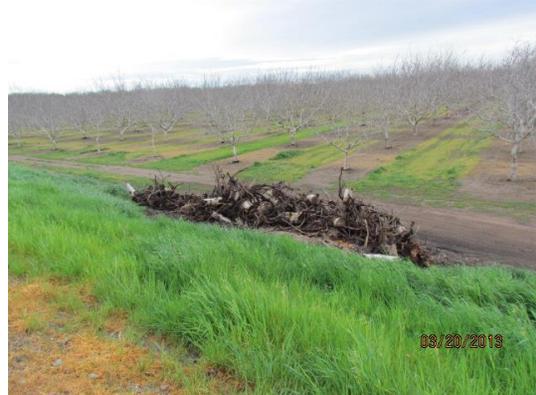
Photo 1 of 1 : SP_2015_ST0003_264_30_20150310_00014.jpg

LM Start	17.42	Rating **	M	Issue No.	30
LM End	17.42	Issue Type +	En	Location *	LS
Category	Earthen Levee		GPS Latitude/Longitude		
			Start	End	
Item	Encroachments		39.351311 °	39.351311 °	
			-122.009409 °	-122.009409 °	
DWR ID	DWR_ST0003_01_s_2013_30				
Action/Comments					
Prunings

View of the walnut orchard stumps along the landside toe.

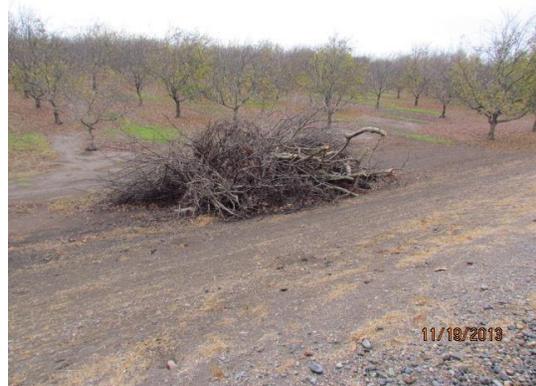
Photo 1 of 1 : SP_2015_ST0003_264_136_20150310_00021.jpg

LM Start	17.43	Rating **	M	Issue No.	136
LM End	17.43	Issue Type +	En	Location *	LS
Category	Earthen Levee		GPS Latitude/Longitude		
			Start	End	
Item	Encroachments		39.351447 °	39.351447 °	
			-122.009385 °	-122.009385 °	
DWR ID	DWR_ST0003_01_f_2013_136				
Action/Comments					
Prunings

View of the prunings at the toe of the levee.

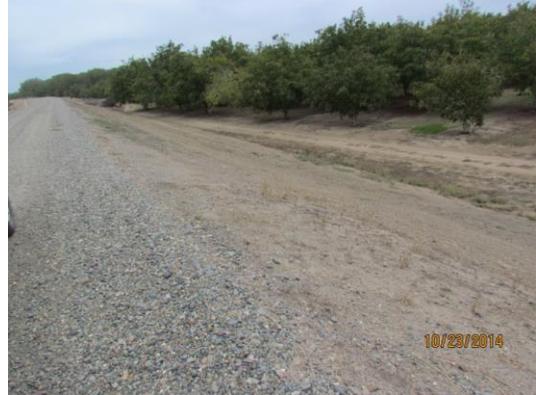
Photo 1 of 1 : SP_2015_ST0003_264_57_20150310_00019.jpg

View of the rodent holes on the landside slope.

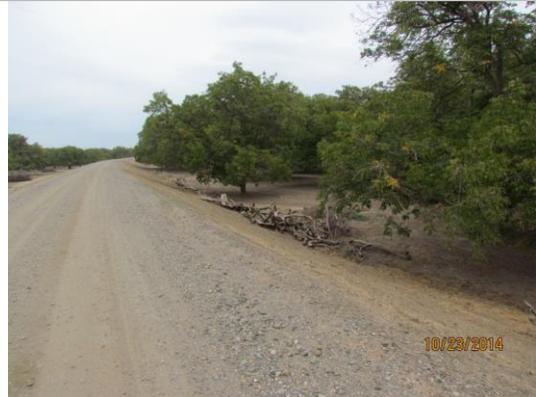
Photo 1 of 1 : SP_2015_ST0003_264_58_20150310_00020.jpg

LM Start	17.67	Rating **	M	Issue No.	58
LM End	17.74	Issue Type +	En	Location *	LS
Category	Earthen Levee		GPS Latitude/Longitude		
			Start	End	
Item	Encroachments		39.354862 °	39.355885 °	
			-122.009292 °	-122.009030 °	
DWR ID	DWR_ST0003_01_f_2014_58				
Action/Comments					
Firewood

View of the firewood along the landside slope.

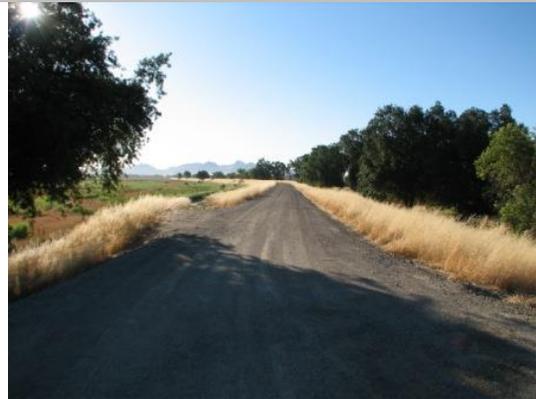
Photo 1 of 1 : SP_2015_ST0003_265_1_20150310_00001.jpg

View of the elderberries along the landside toe of the levee.

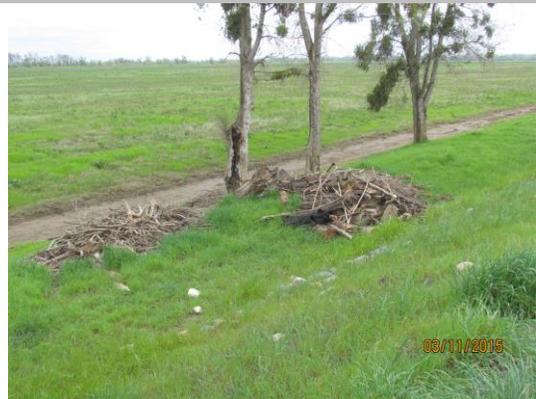
Photo 1 of 1 : SP_2015_ST0003_265_2_20150406_00002.jpg

LM Start	0.60	Rating **	M	Issue No.	2
LM End	0.60	Issue Type +	En	Location *	WS
Category	Earthen Levee		GPS Latitude/Longitude		
			Start	End	
Item	Encroachments		39.231402 °	39.231402 °	
			-121.984845 °	-121.984845 °	
DWR ID	DWR_ST0003_02_s_2015_2				
Action/Comments					
Debris

View of the debris along the waterside toe.

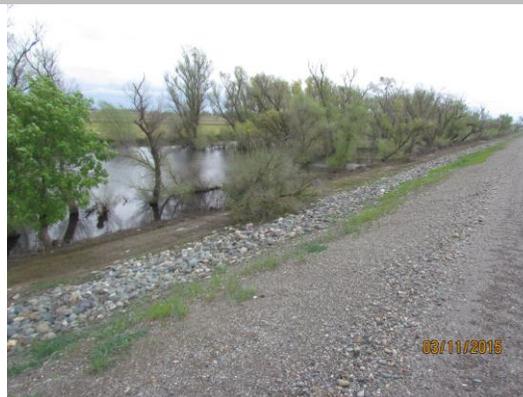
Photo 1 of 1 : SP_2015_ST0003_266_1_20150406_00002.jpg

View of the tree along the waterside toe.

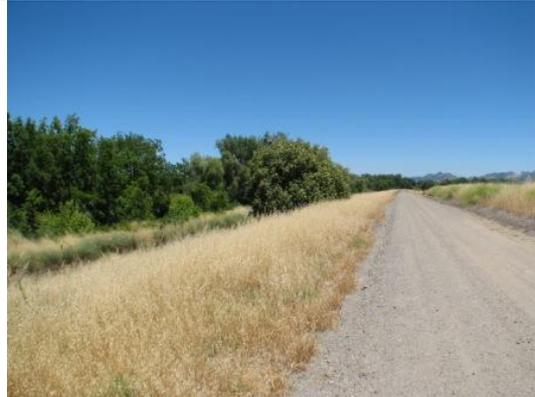
Photo 1 of 1 : SP_2015_ST0003_266_10_20150310_00001.jpg

View of the elderberries along the landside toe of the levee.

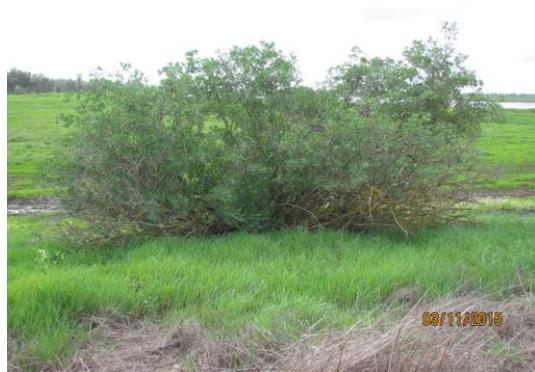
Photo 1 of 1 : SP_2015_ST0003_266_2_20150406_00003.jpg

LM Start	2.13	Rating **	M	Issue No.	2
LM End	2.13	Issue Type +	Ma	Location *	WS
Category	Earthen Levee		GPS Latitude/Longitude		
			Start	End	
Item	Vegetation		39.244925 °	39.244925 °	
			-121.962072 °	-121.962072 °	
DWR ID	DWR_ST0003_03_s_2015_2				
Action/Comments					
Elderberries are blocking visibility and flood fight capability.

View of the elderberry along the waterside slope.

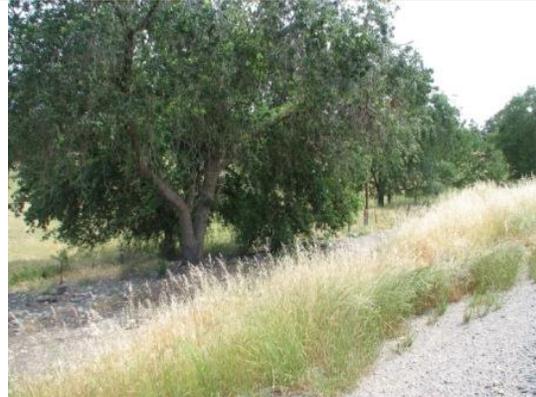
Photo 1 of 1 : SP_2015_ST0003_267_2_20150310_00001.jpg

View of an elderberry bush by the waterside toe.

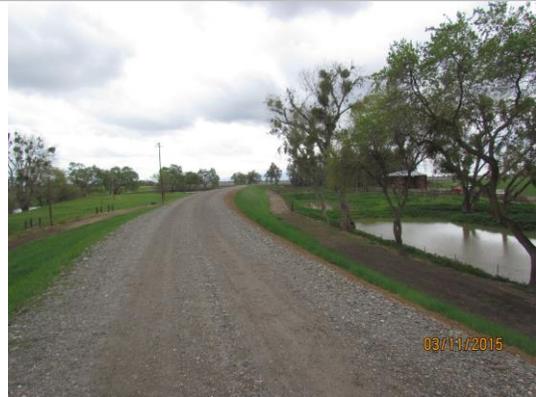
Photo 1 of 1 : SP_2015_ST0003_267_1_20150406_00002.jpg

LM Start	0.10	Rating **	A	Issue No.	1
LM End	0.10	Issue Type +	Ma	Location *	LS
Category	Earthen Levee			GPS Latitude/Longitude	
				Start	End
Item	Vegetation				
DWR ID	DWR_ST0003_04_s_2015_1				
Action/Comments					
Control annual grass and weeds on the levee slopes and easements.

View of the native grasses on both slopes.

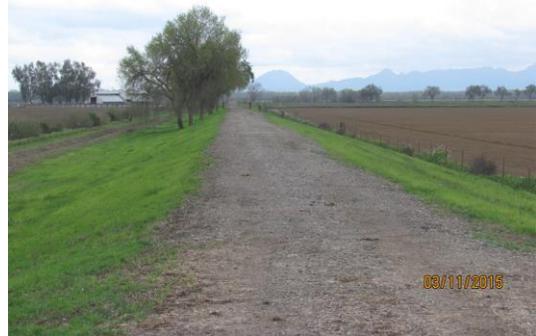
Photo 1 of 1 : SP_2015_ST0003_268_1_20150406_00001.jpg

View of the native grasses on both slopes.
