**Flood Control Project Maintenance  
Levee Inspections**

**Maintenance Issue Types Only, Levee Inspection Report By Mile - Fall 2015**

**Sutter Maintenance Yard East Levee Sacramento River**

Waterway	Bank	Unit Miles	Inspection Start/End	Inspector
Unit No. 01 Sacramento River	Left	19.85	09/16/2015 09/16/2015	Bob Duffey

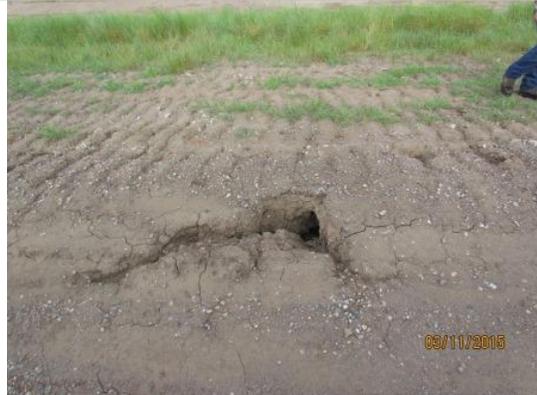
Photo 1 of 1 : FA\_2015\_ST0003\_264\_14\_20150910\_00005.jpg

LM Start	<b>6.78</b>	Rating **	U	Issue No.	<b>14</b>
LM End	<b>6.78</b>	Issue Type +	Ma	Location *	WS
Category	Earthen Levee		GPS Latitude/Longitude		
			Start	End	
Item	Erosion / Bank Caving		39.228535 °	39.228535 °	
			-121.998330 °	-121.998330 °	
DWR ID	DWR_ST0003_01_s_2015_14				
Action/Comments					
Schedule repair of erosion site prior to the next inspection. Inspector Comments: The erosion along the waterside slope needs to be repaired.

View of the erosion along the waterside slope.

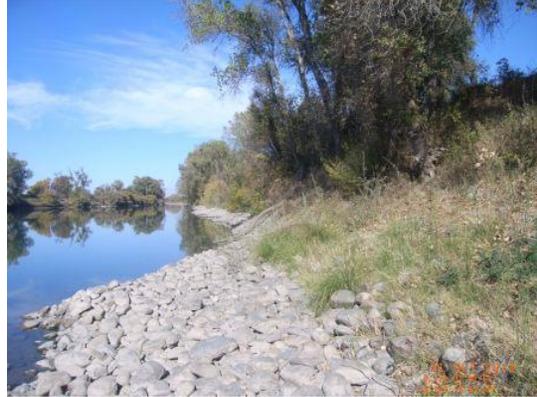
Photo 1 of 1 : USACE2013A\_SAC\_152-6\_L\_8.jpg

LM Start	<b>11.53</b>	Rating **	M	Issue No.	<b>8</b>
LM End	<b>11.79</b>	Issue Type +	Ma	Location *	WS
Category	Supplemental			GPS Latitude/Longitude	
				Start	End
Item	2015 USACE Erosion Survey, DRAFT			39.279910 °	39.283853 °
				-122.018221 °	-122.016113 °
DWR ID					
Action/Comments					
Inspector Comments: 2008 - Large rotational/mass failure in the bank with tree slump. 2009 - Minimal new erosion, the tree is leaning further into the river. 2011 - Site extended downstream. 2012 - Minor new erosion and tree roots are further exposed. 2015: Last observed in 2013. [2015 Site ID: SAC_152-6_L]

USACE 2013 Photo #1

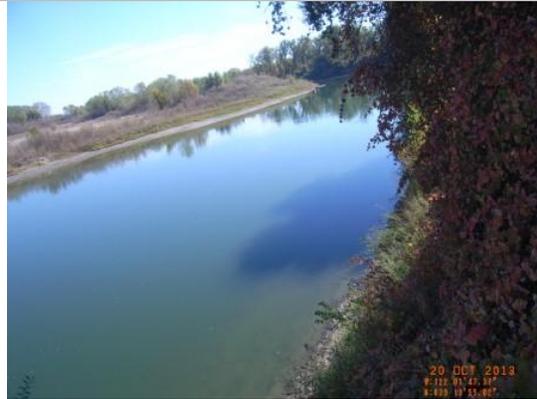
Photo 1 of 1 : USACE2013A\_SAC\_157-7\_R\_4.jpg

LM Start	<b>11.85</b>	Rating **	M	Issue No.	<b>1</b>
LM End	<b>11.90</b>	Issue Type +	Ma	Location *	WS
Category	Supplemental			GPS Latitude/Longitude	
				Start	End
Item	2015 USACE Erosion Survey, DRAFT			39.331447 °	39.332716 °
				-122.029440 °	-122.029953 °
DWR ID					
Action/Comments					
Inspector Comments: 2004 - Slowly eroding but near vertical with no vegetation to hold it. 2005 - Erosion is close to levee toe but not into the levee section yet. 2010 - Some new toe scour. 2015: Last observed in 2013. [2015 Site ID: SAC_157-7_R]

USACE 2013 Photo #1

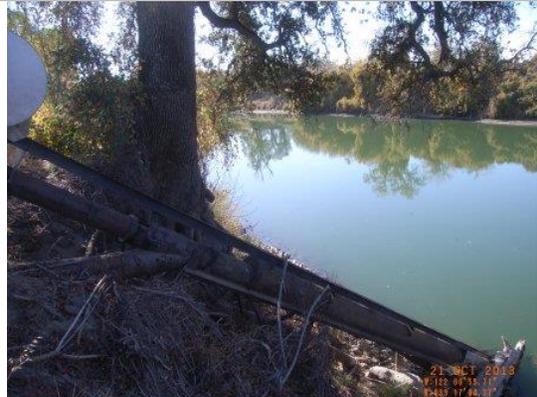
Photo 1 of 1 : USACE2013A\_SAC\_152-8\_L\_1.jpg

LM Start	<b>11.85</b>	Rating **	M	Issue No.	<b>13</b>
LM End	<b>11.90</b>	Issue Type +	Ma	Location *	WS
Category	Supplemental			GPS Latitude/Longitude	
				Start	End
Item	2015 USACE Erosion Survey, DRAFT			39.284568 °	39.285298 °
				-122.015690 °	-122.015208 °
DWR ID					
Action/Comments					
Inspector Comments: 2006 - Large rotational/mass failure in the bank with tree slump. Tough clayey toe material. 2007 - Site is between stone revetments with a pump station at the downstream end. 2010 - Erosion is into the levee toe. 2011 - Minor new erosion. 2012 - Minor new erosion. 2015: Last observed in 2013. [2015 Site ID: SAC_152-8_L]

USACE 2013 Photo #1

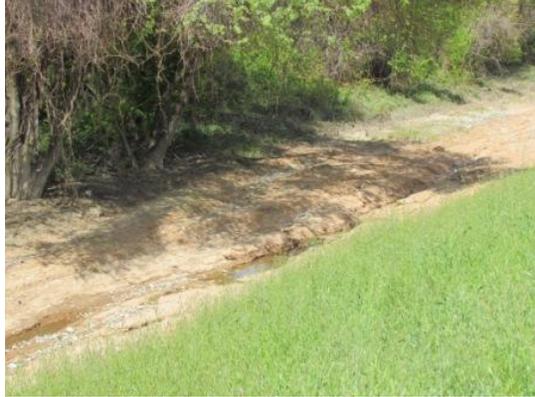
Photo 1 of 1 : FA\_2015\_ST0003\_264\_9\_20150910\_00002.jpg

LM Start	<b>13.47</b>	Rating **	M	Issue No.	<b>9</b>
LM End	<b>13.66</b>	Issue Type +	Ma	Location *	WS
Category	Earthen Levee		GPS Latitude/Longitude		
			Start	End	
Item	Erosion / Bank Caving		39.307448 °	39.310231 °	
			-122.013037 °	-122.012912 °	
DWR ID	DWR_ST0003_01_s_ 2012_9				
Action/Comments					
Note and monitor erosion site.

View of the erosion along the W/S toe.

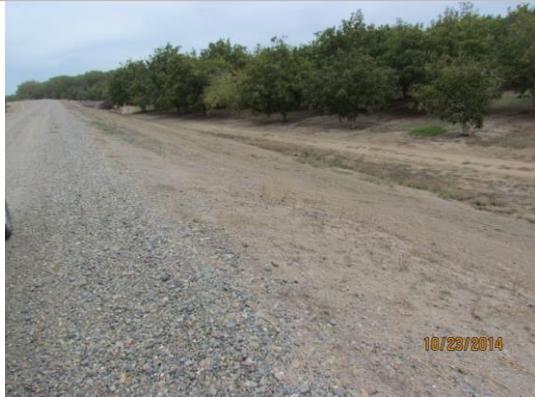
Photo 1 of 1 : FA\_2015\_ST0003\_264\_57\_20150910\_00019.jpg

LM Start	<b>17.44</b>	Rating **	M	Issue No.	<b>57</b>
LM End	<b>17.44</b>	Issue Type +	Ma	Location *	LS
Category	Earthen Levee		GPS Latitude/Longitude		
			Start	End	
Item	Animal Control		39.351553 °	39.351553 °	
			-122.009388 °	-122.009388 °	
DWR ID	DWR_ST0003_01_f_ 2014_57				
Action/Comments					
No rodents visible, but rodent burrows visible; need to backfill and compact or grout burrows. Inspector Comments: Repair the rodent hole along the landside slope

View of the rodent holes on the landside slope.

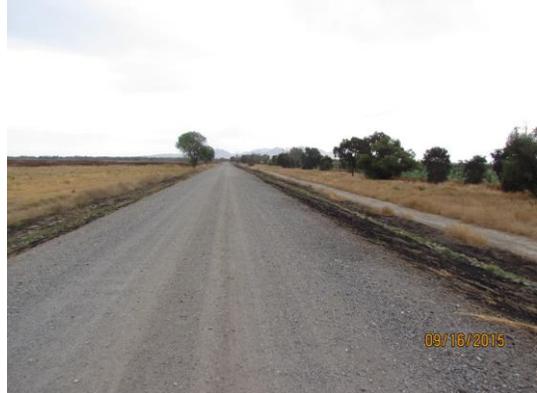
Photo 1 of 1 : FA\_2015\_ST0003\_265\_3\_20151013\_00003.jpg

LM Start	<b>0.38</b>	Rating **	A	Issue No.	<b>3</b>
LM End	<b>0.38</b>	Issue Type +	Ma	Location *	LS
Category	Earthen Levee		GPS Latitude/Longitude		
			Start	End	
Item	Vegetation		39.231365 °	39.231365 °	
			-121.988935 °	-121.988935 °	
DWR ID	DWR_ST0003_02_f_2015_3				
Action/Comments					
Control annual grass and weeds on the levee slopes and easements. Inspector Comments: Sutter Yard burned and dragged both slopes.

View of the levee slope with no vegetation.

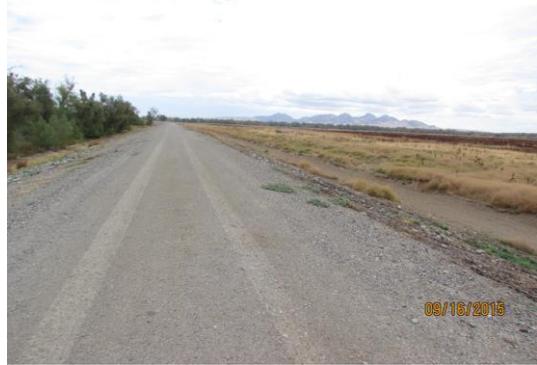
Photo 1 of 1 : FA\_2015\_ST0003\_266\_3\_20151013\_00005.jpg

LM Start	<b>0.71</b>	Rating **	A	Issue No.	<b>3</b>
LM End	<b>0.71</b>	Issue Type +	Ma	Location *	WS
Category	Earthen Levee		GPS Latitude/Longitude		
			Start	End	
Item	Vegetation		39.237768 °	39.237768 °	
			-121.981307 °	-121.981307 °	
DWR ID	DWR_ST0003_03_f_2015_3				
Action/Comments					
Control annual grass and weeds on the levee slopes and easements. Inspector Comments: Sutter Yard burned and dragged both slopes.

View of the levee slopes with no vegetation.

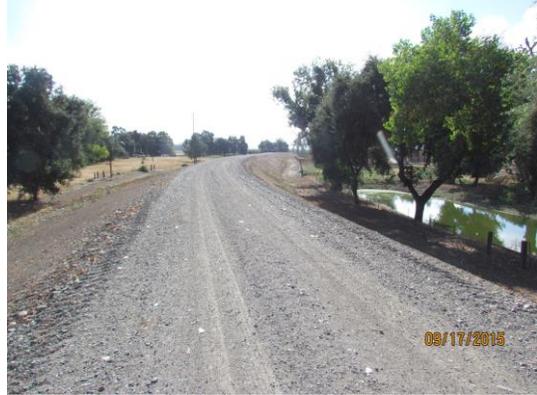
Photo 1 of 1 : FA\_2015\_ST0003\_267\_1\_20151013\_00002.jpg

LM Start	<b>0.08</b>	Rating **	A	Issue No.	<b>1</b>
LM End	<b>0.08</b>	Issue Type +	Ma	Location *	LS
Category	Earthen Levee		GPS Latitude/Longitude		
			Start	End	
Item	Vegetation		39.337897 °	39.337897 °	
			-122.020677 °	-122.020677 °	
DWR ID	DWR_ST0003_04_f_2015_1				
Action/Comments					
Control annual grass and weeds on the levee slopes and easements. Inspector Comments: Sutter Yard Burned and dragged both slopes.

View of the levee slope with no vegetation.

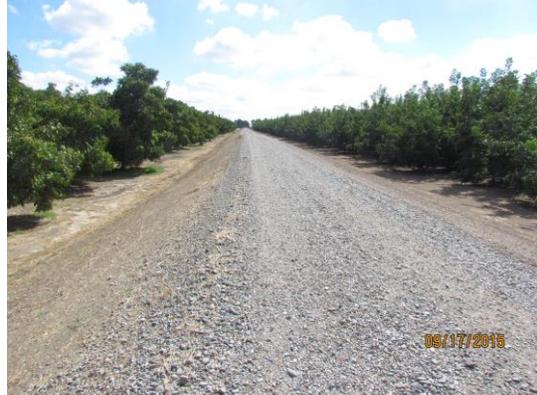
Photo 1 of 1 : FA\_2015\_ST0003\_268\_1\_20151013\_00001.jpg

LM Start	<b>0.36</b>	Rating **	A	Issue No.	<b>1</b>
LM End	<b>0.36</b>	Issue Type +	Ma	Location *	LS
Category	Earthen Levee		GPS Latitude/Longitude		
			Start	End	
Item	Vegetation		39.343158 °	39.343158 °	
			-122.016377 °	-122.016377 °	
DWR ID	DWR_ST0003_05_f_2015_1				
Action/Comments					
Control annual grass and weeds on the levee slopes and easements. Inspector Comments: Sutter Yard Burned and dragged both slopes.

View of the levee slopes with no vegetation.
