**Flood Control Project Maintenance  
Levee Inspections**

**Maintenance Issue Types Only, Levee Inspection Report By Mile - Spring 2015**

**Sutter Maintenance Yard East Levee Sacramento River**

Waterway	Bank	Unit Miles	Inspection Start/End	Inspector
Unit No. 01 Sacramento River	Left	20.31	03/11/2015 03/11/2015	Bob Duffey

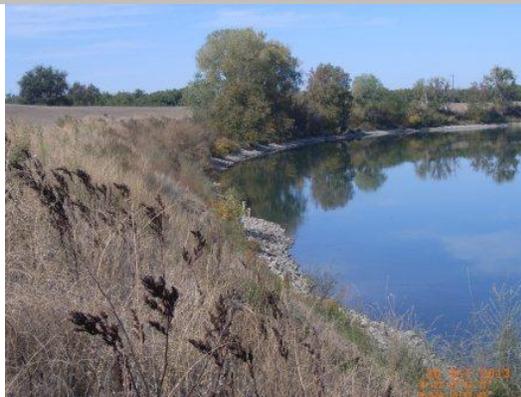
Photo 1 of 1 : SP\_2015\_ST0003\_264\_27\_20150310\_00011.jpg

LM Start	<b>0.00</b>	Rating **	M	Issue No.	<b>27</b>
LM End	<b>11.41</b>	Issue Type +	Ma	Location *	WS
Category	Supplemental			GPS Latitude/Longitude	
				Start	End
Item	USACE Erosion Survey			39.266315 °	39.265730 °
				-122.020682 °	-122.014925 °
DWR ID	DWR_ST0003_01_f_2014_27				
Action/Comments					
Inspector Comments: 2009 - Slump in the middle of the section has left a vertical section on the bank. 2010 - Old cobble site unraveling, site extended downstream. 2013: No observed changes. [2013 Site ID: SAC_151-0_R]

USACE 2013 Photo #1

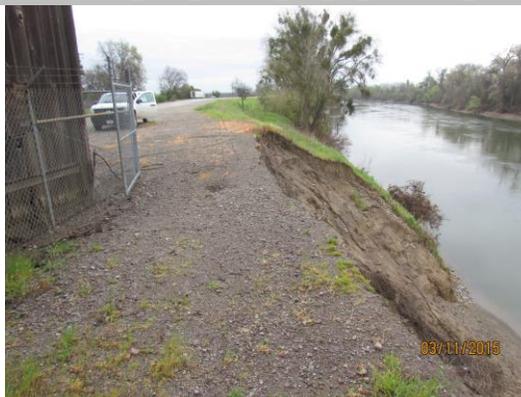
Photo 1 of 1 : SP\_2015\_ST0003\_264\_15\_20150406\_00022.jpg

LM Start	<b>4.72</b>	Rating **	M	Issue No.	<b>15</b>
LM End	<b>4.72</b>	Issue Type +	Ma	Location *	WS
Category	Earthen Levee			GPS Latitude/Longitude	
				Start	End
Item	Slope Stability			39.213271 °	39.213271 °
				-121.991676 °	-121.991676 °
DWR ID	DWR_ST0003_01_s_2013_15				
Action/Comments					
Repair slope instability. Inspector Comments: The erosion needs to be repaired.

View of the erosion along the waterside slope.

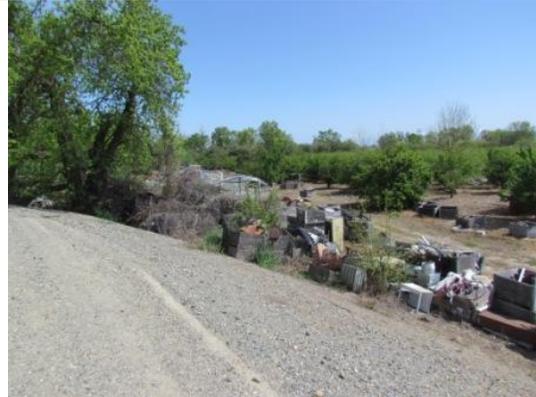
Photo 1 of 1 : SP\_2015\_ST0003\_264\_21\_20150310\_00009.jpg

LM Start	<b>6.48</b>	Rating **	M	Issue No.	<b>21</b>
LM End	<b>6.49</b>	Issue Type +	Ma	Location *	LS
Category	Earthen Levee		GPS Latitude/Longitude		
			Start	End	
Item	Encroachments		39.224982 °	39.225013 °	
			-121.998600 °	-121.998585 °	
DWR ID	DWR_ST0003_01_s_2012_21				
Action/Comments					
Material

View of the material & garbage along the toe.

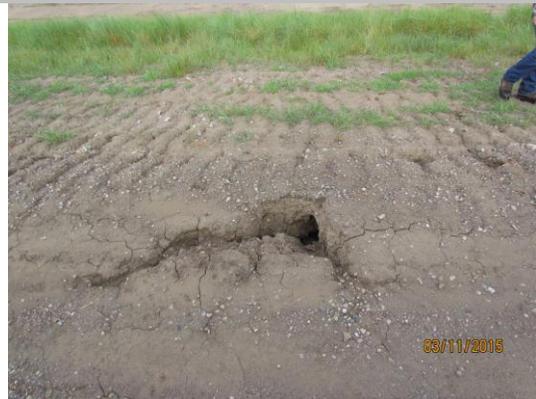
Photo 1 of 1 : SP\_2015\_ST0003\_264\_14\_20150406\_00023.jpg

LM Start	<b>6.78</b>	Rating **	U	Issue No.	<b>14</b>
LM End	<b>6.78</b>	Issue Type +	Ma	Location *	WS
Category	Earthen Levee		GPS Latitude/Longitude		
			Start	End	
Item	Erosion / Bank Caving		39.228535 °	39.228535 °	
			-121.998330 °	-121.998330 °	
DWR ID	DWR_ST0003_01_s_2015_14				
Action/Comments					
Schedule repair of erosion site prior to the next inspection. Inspector Comments: The erosion along the waterside slope needs to be repaired.

View of the erosion along the waterside slope.

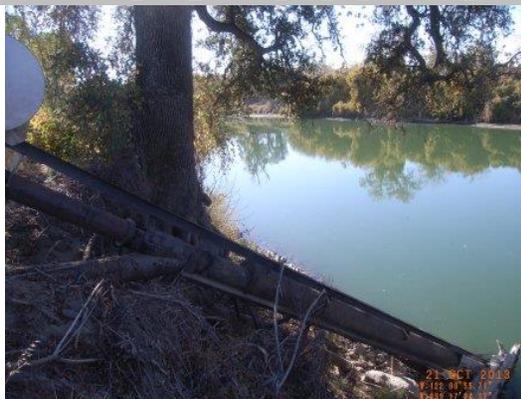
Photo 1 of 1 : SP\_2015\_ST0003\_264\_29\_20150310\_00013.jpg

LM Start	<b>11.85</b>	Rating **	M	Issue No.	<b>29</b>
LM End	<b>11.90</b>	Issue Type +	Ma	Location *	WS
Category	Supplemental			GPS Latitude/Longitude	
				Start	End
Item	USACE Erosion Survey			39.284568 °	39.285298 °
				-122.015690 °	-122.015208 °
DWR ID	DWR_ST0003_01_f_2014_29				
Action/Comments					
Inspector Comments: 2006 - Large rotational/mass failure in the bank with tree slump. Tough clayey toe material. 2007 - Site is between stone revetments with a pump station at the downstream end. 2010 - Erosion is into the levee toe. 2011 - Minor new erosion. 2012 - Minor new erosion. 2013: No observed changes. [2013 Site ID: SAC_152-8_L]

USACE 2013 Photo #1

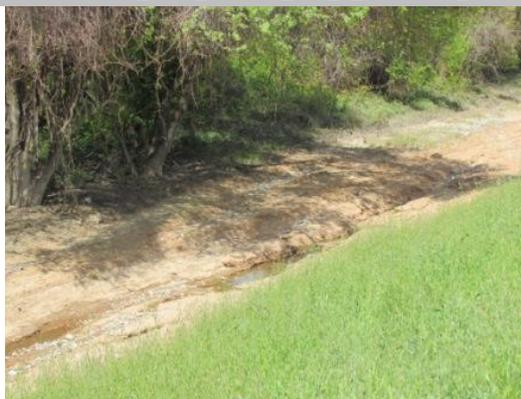
Photo 1 of 1 : SP\_2015\_ST0003\_264\_9\_20150310\_00003.jpg

LM Start	<b>13.47</b>	Rating **	M	Issue No.	<b>9</b>
LM End	<b>13.66</b>	Issue Type +	Ma	Location *	WS
Category	Earthen Levee			GPS Latitude/Longitude	
				Start	End
Item	Erosion / Bank Caving			39.307448 °	39.310231 °
				-122.013037 °	-122.012912 °
DWR ID	DWR_ST0003_01_s_2012_9				
Action/Comments					
Note and monitor erosion site.

View of the erosion along the W/S toe.

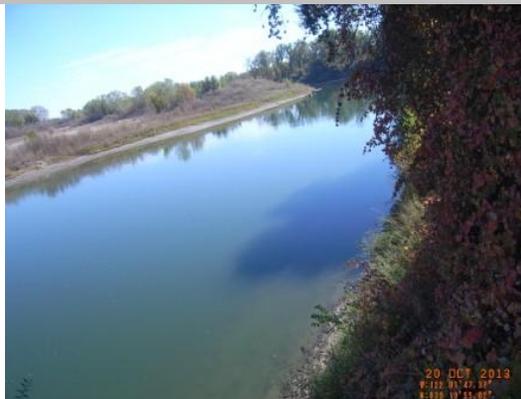
Photo 1 of 1 : SP\_2015\_ST0003\_264\_55\_20150310\_00017.jpg

LM Start	<b>15.53</b>	Rating **	M	Issue No.	<b>55</b>
LM End	<b>15.53</b>	Issue Type +	Ma	Location *	WS
Category	Supplemental			GPS Latitude/Longitude	
				Start	End
Item	USACE Erosion Survey			39.331447 °	39.332716 °
				-122.029440 °	-122.029953 °
DWR ID	DWR_ST0003_01_f_2014_55				
Action/Comments					
Inspector Comments: 2004 - Slowly eroding but near vertical with no vegetation to hold it. 2005 - Erosion is close to levee toe but not into the levee section yet. 2010 - Some new toe scour. 2013: No observed changes. [2013 Site ID: SAC_157-7_R]

USACE 2013 Photo #1

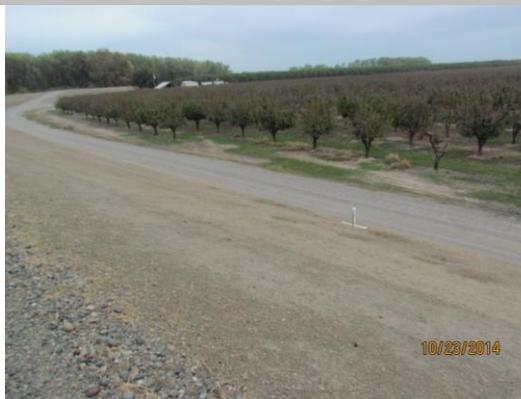
Photo 1 of 1 : SP\_2015\_ST0003\_264\_56\_20150310\_00018.jpg

LM Start	<b>16.21</b>	Rating **	A/W	Issue No.	<b>56</b>
LM End	<b>16.21</b>	Issue Type +	Ma	Location *	LS
Category	Earthen Levee			GPS Latitude/Longitude	
				Start	End
Item	Animal Control			39.342948 °	39.342948 °
				-122.024263 °	-122.024263 °
DWR ID	DWR_ST0003_01_f_2014_56				
Action/Comments					
No rodents visible, but rodent burrows visible; need to backfill and compact or grout burrows.

View of the rodent holes on the landside slope.

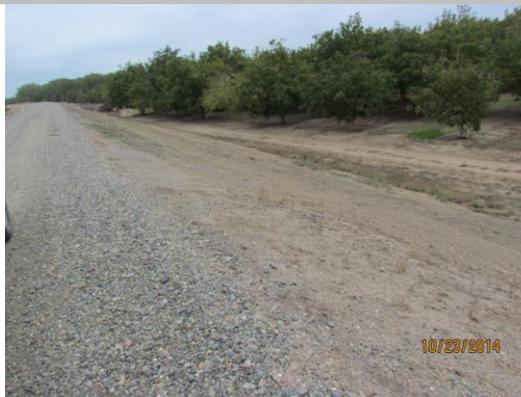
Photo 1 of 1 : SP\_2015\_ST0003\_264\_57\_20150310\_00019.jpg

LM Start	<b>17.44</b>	Rating **	M	Issue No.	<b>57</b>
LM End	<b>17.44</b>	Issue Type +	Ma	Location *	LS
Category	Earthen Levee			GPS Latitude/Longitude	
				Start	End
Item	Animal Control			39.351553 °	39.351553 °
				-122.009388 °	-122.009388 °
DWR ID	DWR_ST0003_01_f_2014_57				
Action/Comments					
No rodents visible, but rodent burrows visible; need to backfill and compact or grout burrows.

View of the rodent holes on the landside slope.

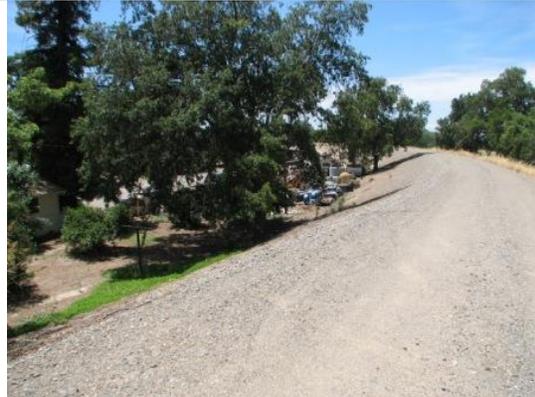
Photo 1 of 1 : SP\_2015\_ST0003\_264\_16\_20150310\_00007.jpg

LM Start	<b>18.01</b>	Rating **	M	Issue No.	<b>16</b>
LM End	<b>18.15</b>	Issue Type +	Ma	Location *	LS
Category	Earthen Levee		GPS Latitude/Longitude		
			Start	End	
Item	Encroachments		39.359188 °	39.359980 °	
			-122.006878 °	-122.004517 °	
DWR ID	DWR_ST0003_01_s_2012_16				
Action/Comments					
Equipment

View of the equipment and trees next to the landside toe of the levee.

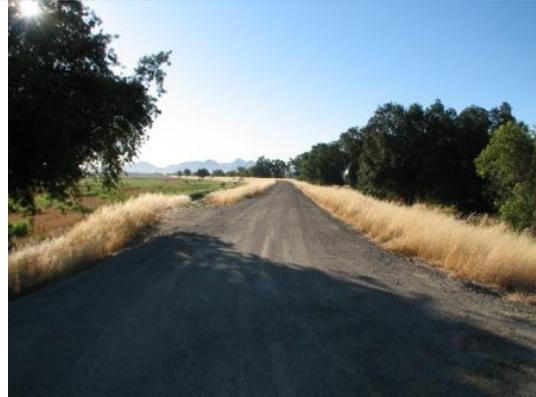
Photo 1 of 1 : SP\_2015\_ST0003\_265\_1\_20150310\_00001.jpg

LM Start	<b>0.02</b>	Rating **	M	Issue No.	<b>1</b>
LM End	<b>0.02</b>	Issue Type +	Ma	Location *	LS
Category	Earthen Levee		GPS Latitude/Longitude		
			Start	End	
Item	Vegetation		39.232058 °	39.232058 °	
			-121.995514 °	-121.995514 °	
DWR ID	DWR_ST0003_02_s_2012_1				
Action/Comments					
Elderberries are blocking visibility and flood fight capability.

View of the elderberries along the landside toe of the levee.
