**Flood Control Project Maintenance
Levee Inspections**
LMA District Cover Sheet
Spring 2010 Levee Inspection Results

Sutter Maintenance Yard East Levee Sacramento River

Levee Inspection Report By Mile - Spring 2010

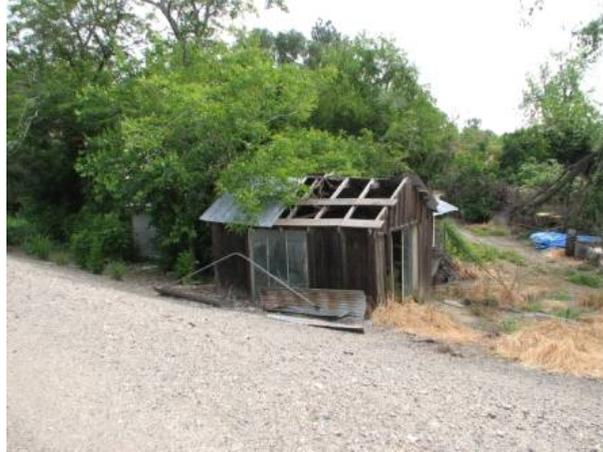
| rduffey_s_20100622_072.jpg | |

| LMIR No | Levee Mile | | Category | Item | Location | Rating | Action/Comment | GPS Latitude/Longitude | | Issue No. Photo |
|---|---|---|---|---|---|---|--|---|---|---|
| 1 | 0.08 | 0.14 | Earthen Levee | Encroachments | WS | CO | Buildings | 39.194978 ° -121.937502 ° | 39.195022 ° -121.938563 ° | 3 Y |

| View of a old building next to the landside toe. | |

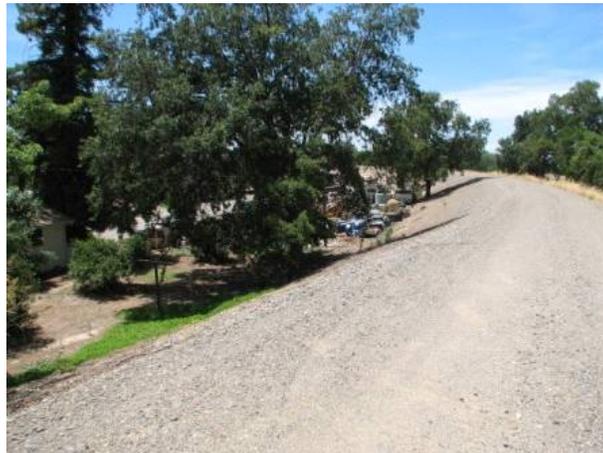
| rduffey_s_20100625_083.jpg | |

| LMIR No | Levee Mile | | Category | Item | Location * | Rating ** | Action/Comment | GPS Latitude/Longitude | | Issue No. Photo |
|---|---|---|---|---|---|---|--|---|---|---|
| 24 | 18.04 | 18.18 | Earthen Levee | Encroachments | LS | M | Equipment | 39.359188 ° -122.006878 ° | 39.359980 ° -122.004517 ° | 16 Y |

| View of the equipment and trees next to the landside toe of the levee. | |

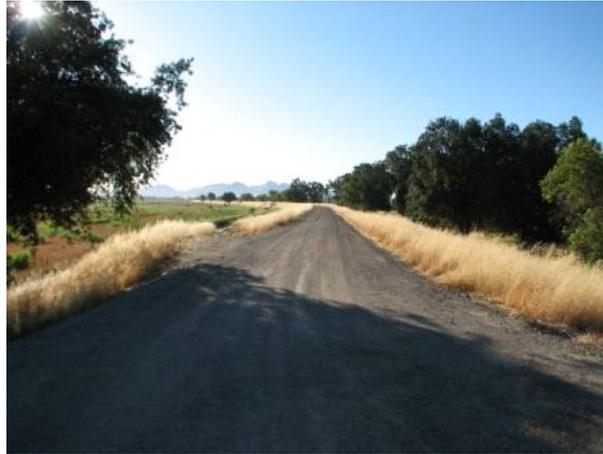
rduffey_s_20100622_067.jpg

| LMIR No | Levee Mile | | Category | Item | Location * | Rating ** | Action/Comment | GPS Latitude/Longitude | | Issue No. Photo |
|---|---|---|---|---|---|---|--|---|---|---|
| 1 | 0.01 | 0.01 | Earthen Levee | Vegetation | LS | M | Elderberries are blocking visibility and flood fight capability. | 39.232058 ° -121.995514 ° | 39.232058 ° -121.995514 ° | 1 Y |

View of the elderberries along the landside toe of the levee.

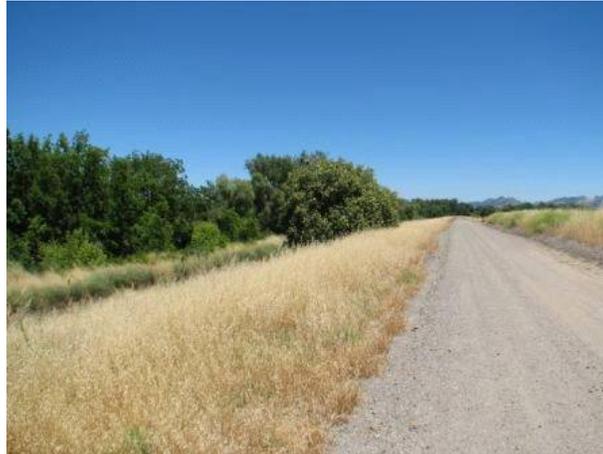
| rduffey_s_20100630_099.jpg | |

| LMIR No | Levee Mile | | Category | Item | Location * | Rating ** | Action/Comment | GPS Latitude/Longitude | | Issue No. Photo |
|---|---|---|---|---|---|---|--|---|---|---|
| 1 | 1.98 | 1.98 | Earthen Levee | Vegetation | LS | M | Elderberries are blocking visibility and flood fight capability. | 39.244888 ° -121.965595 ° | 39.244888 ° -121.965595 ° | 10 Y |

| View of the elderberries along the landside toe of the levee. | |

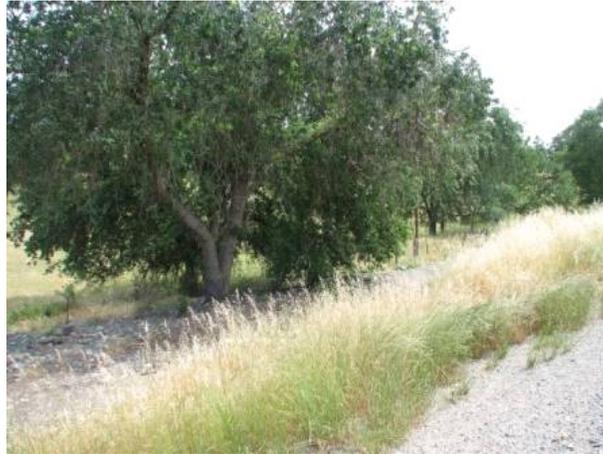
rduffey_s_20100622_073.jpg

| LMIR No | Levee Mile | | Category | Item | Location * | Rating ** | Action/Comment | GPS Latitude/Longitude | | Issue No. Photo |
|---|---|---|---|---|---|---|--|---|---|---|
| 1 | 0.02 | 0.02 | Earthen Levee | Vegetation | WS | M | Elderberries are blocking visibility and flood fight capability. | 39.338141 ° -122.021852 ° | 39.338141 ° -122.021852 ° | 2 Y |

View of a Elderberries bush by the waterside toe.

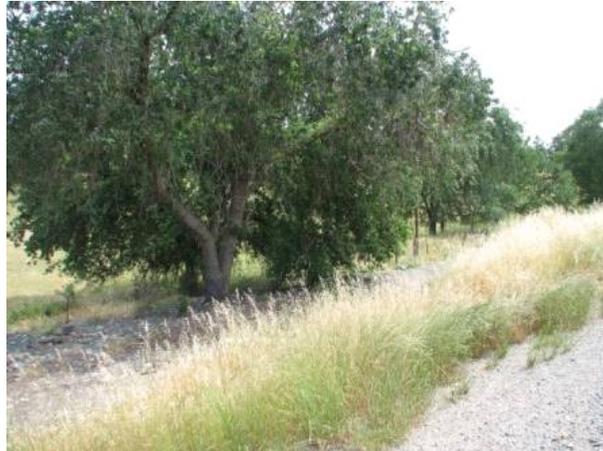
rduffey_s_20100625_084.jpg

View of the elderberry & Oak tree by the waterside toe of the levee.

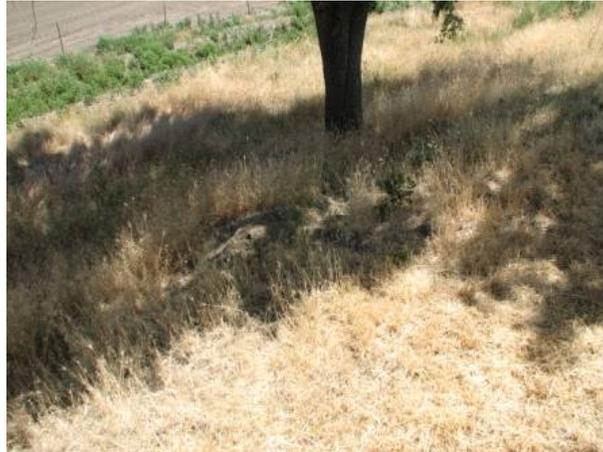
| rduffey_s_20100625_085.jpg | |

| View of the squirrel hole on the landside slope of the levee. | |
