**Flood Control Project Maintenance
Levee Inspections**

Fall 2011 Levee Maintenance Deficiency Summary Report

Sacramento Maintenance Yard East Levee Yolo Bypass

Levee Inspection Report By Mile - Fall 2011

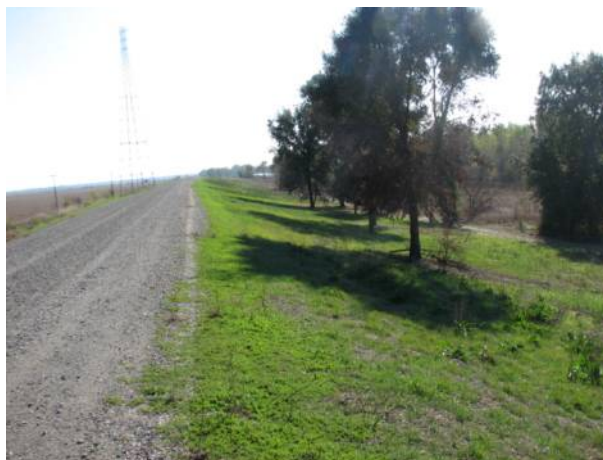
johngw_f_20111116_557.jpg

Levee Mile Report Line	1
Start Levee Mile	0.01
End Levee Mile	2.00
Location	Water Side
Category	Earthen Levee
Item	Vegetation

The vegetation meets all standards. Fall 2011

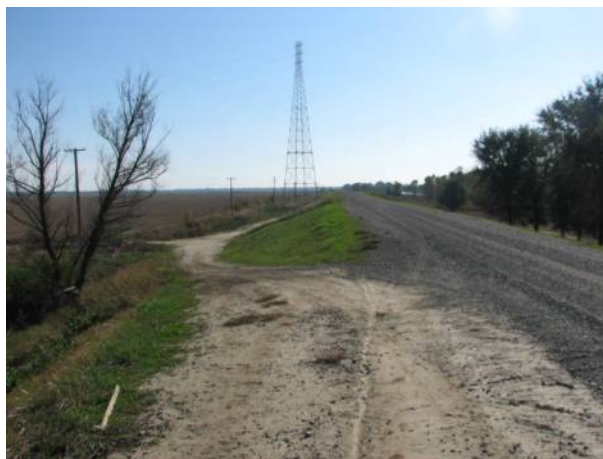
johngw_f_20111116_558.jpg

Levee Mile Report Line	2
Start Levee Mile	0.01
End Levee Mile	2.00
Location	Land Side
Category	Earthen Levee
Item	Vegetation

The vegetation meets all standards. Fall 2011
