**Flood Control Project Maintenance
Levee Inspections**

Fall 2012 Levee Maintenance Deficiency Summary Report

Sacramento Maintenance Yard East Levee Yolo Bypass

Levee Inspection Report By Mile - Fall 2012

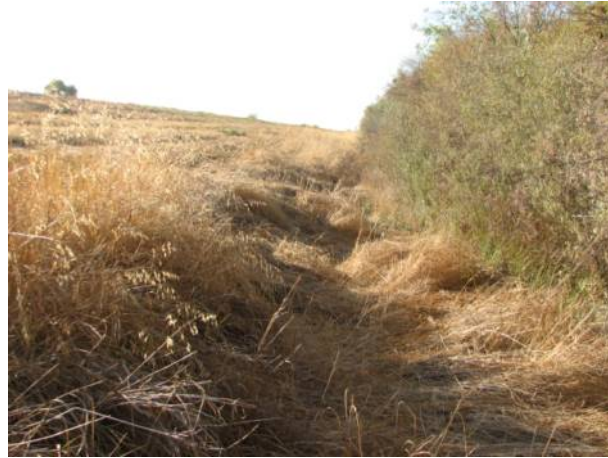
johngw_f_20121022_757.jpg

| LMR No. | Levee Mile | | Category | Item | Location * | Rating ** + | Action/Comment | GPS Latitude/Longitude | | Issue No. Photo |
|---|---|---|---|---|---|---|---|---|---|---|
| 2 | 1.79 | 1.85 | Earthen Levee | Erosion / Bank Caving | WS | M Ma | E1 : Note and monitor erosion site. | 38.739177 ° -121.633892 ° | 38.738305 ° -121.633815 ° | 19 Y |

Erosion at the toe of the waterside levee. Photo fall 2012.

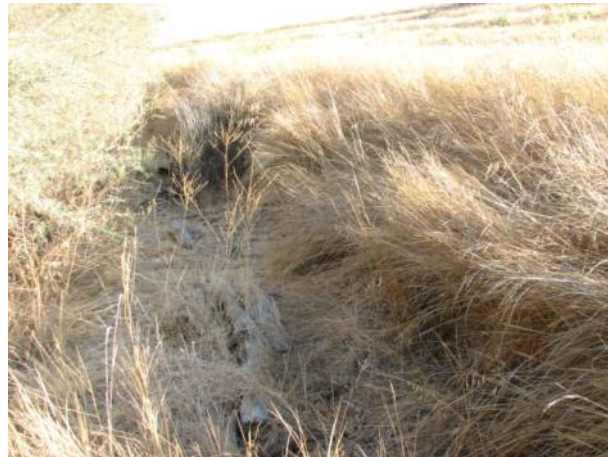
johngw_f_20121022_758.jpg

Another angle of the wave wash damage at the toe. Photo fall 2012.
