**Flood Control Project Maintenance
Levee Inspections**

Fall 2017 Levee Maintenance Deficiency Summary Report

Sacramento Maintenance Yard East Levee Yolo Bypass

Levee Inspection Report By Mile - Fall 2017

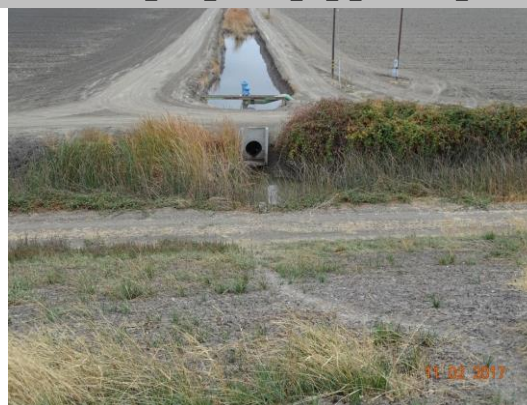
Photo 1 of 3 : FA_2017_ST0004_41_1_20171102_00004.jpg

LM Start	1.51	Rating **	A/W	Issue No.	1
LM End	1.51	Issue Type +	Ob	Location *	LS
Category	Earthen Levee			GPS Latitude/Longitude	
				Start	End
Item	Erosion / Bank Caving			38.743573 °	38.743573 °
				-121.634128 °	-121.634128 °
DWR ID	DWR_ST0004_01_f_2016_1				
Comment Code					
E1 : Note and monitor erosion site.					
Inspector Comment					
Erosion on a side of a ditch toward LS toe caused by water coming out of irrigation canal. Recommend monitoring.

Updated view of erosion on toe road. Fall 2017.

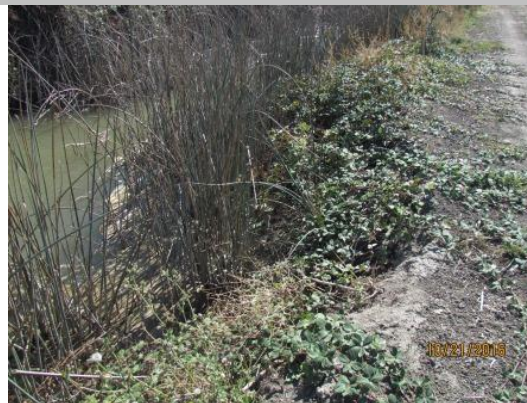
Photo 2 of 3 : FA_2017_ST0004_41_1_20170911_00001.jpg

Irrigation ditch erosion on landward side toward LS levee toe. Fall 2016.

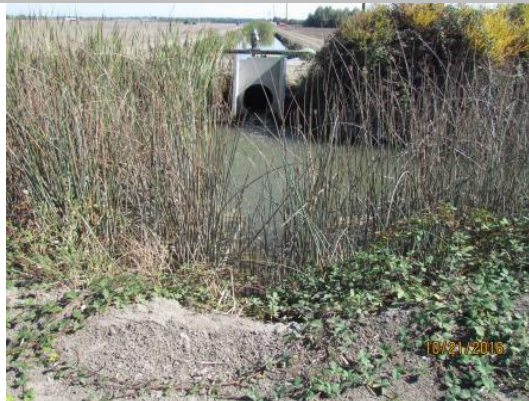
Photo 3 of 3 : FA_2017_ST0004_41_1_20170911_00002.jpg

LM Start	1.51	Rating **	A/W	Issue No.	1 (cont)	
LM End	1.51	Issue Type +	Ob	Location *	LS	
Category	Earthen Levee			GPS Latitude/Longitude		
				Start		End
Item	Erosion / Bank Caving			38.743573 °		38.743573 °
				-121.634128 °		-121.634128 °
DWR ID	DWR_ST0004_01_f_2016_1					
Comment Code						
E1 : Note and monitor erosion site.						
Inspector Comment						
Erosion on a side of a ditch toward LS toe caused by water coming out of irrigation canal. Recommend monitoring.

Irrigation ditch erosion caused by water flowing from perpendicular irrigation canal. Fall 2016.
