**Flood Control Project Maintenance
Levee Inspections**

Fall 2018 Levee Maintenance Deficiency Summary Report

Sacramento Maintenance Yard East Levee Yolo Bypass

Levee Inspection Report By Mile - Fall 2018

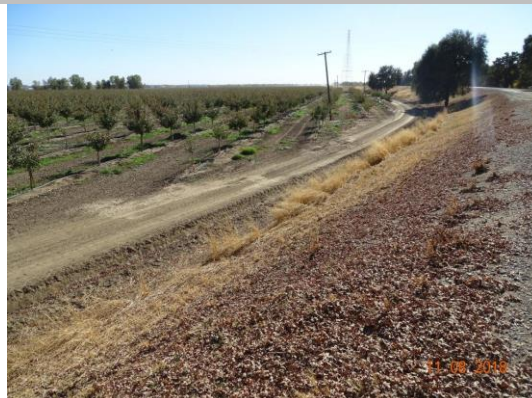
Photo 1 of 1 : FA_2018_ST0004_41_2_20181108_00004.jpg

LM Start	0.01	Rating **	M	Issue No.	2
LM End	0.15	Issue Type +	En	Location *	LS
Category	Earthen Levee			GPS Latitude/Longitude	
				Start	End
Item	Encroachments			38.765181°	38.763164°
				-121.635131°	-121.635438°
DWR ID	DWR_ST0004_01_f_2018_2				
Comment Code					
DT : Ditch					
Inspector Comment					
Landowner has dug irrigation ditch within landside easement.

View of irrigation ditch near the landside toe. Fall 2018.

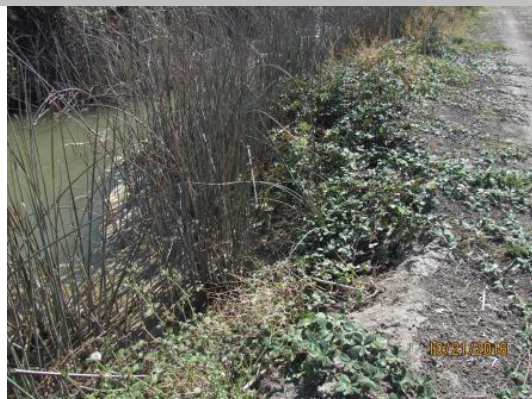
Photo 2 of 3 : FA_2018_ST0004_41_1_20180904_00002.jpg

LM Start	1.51	Rating **	A/W	Issue No.	1
LM End	1.51	Issue Type +	Ob	Location *	LS
Category	Earthen Levee			GPS Latitude/Longitude	
				Start	End
Item	Erosion / Bank Caving			38.743573 °	38.743573 °
				-121.634128 °	-121.634128 °
DWR ID	DWR_ST0004_01_f_2016_1				
Comment Code					
E1 : Note and monitor erosion site.					
Inspector Comment					
Erosion on a side of a ditch toward LS toe caused by water coming out of irrigation canal. Recommend monitoring.

Irrigation ditch erosion on landward side toward LS levee toe. Fall 2016.

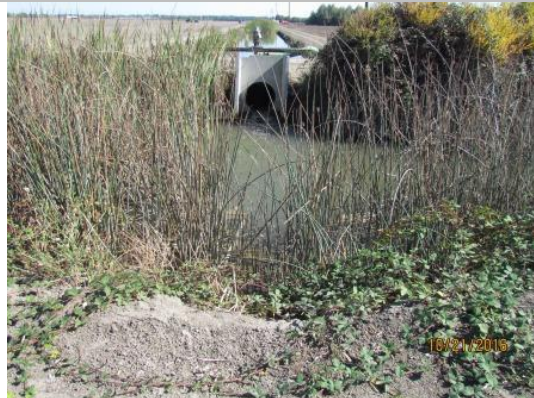
Photo 3 of 3 : FA_2018_ST0004_41_1_20180904_00003.jpg

LM Start	1.51	Rating **	A/W	Issue No.	1 (cont)	
LM End	1.51	Issue Type +	Ob	Location *	LS	
Category	Earthen Levee			GPS Latitude/Longitude		
				Start	End	
Item	Erosion / Bank Caving			38.743573 °	38.743573 °	
				-121.634128 °	-121.634128 °	
DWR ID	DWR_ST0004_01_f_2016_1					
Comment Code						
E1 : Note and monitor erosion site.						
Inspector Comment						
Erosion on a side of a ditch toward LS toe caused by water coming out of irrigation canal. Recommend monitoring.

Irrigation ditch erosion caused by water flowing from perpendicular irrigation canal. Fall 2016.

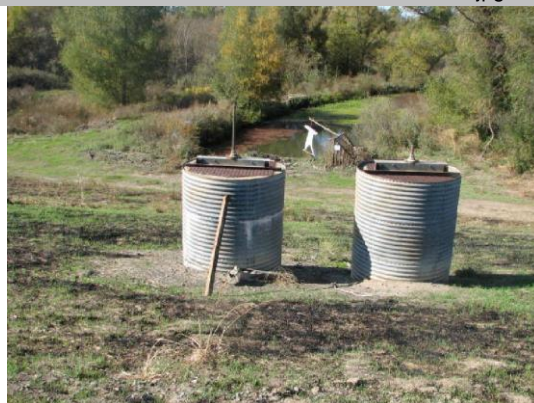
Photo 1 of 3 : UCIP_FA_2018_53253_60261.jpg

Comment Code						
Inspector Comment						
FS_ID:53253						
DS_ID:838						
EP_NO: N/A						
Repair Type: No Action Needed						
Crossing Status: Found						
UCIP Comments: 11/16/17 Ted Skidgel, pipe is closed on w/s and closed on L/S. Mud removed recently from WS pipes.						
FIELD_STRUCT_DESC: 1 of 2: 48-inch corrugated metal drainage pipe through the levee, 28.5 feet below the crown. 30-inch steel pipe sleeved through the 48-inch pipe. Slide gate in a 60-inch pipe riser on the waterside (WS) slope. [Additional Reference(s): DWR Levee Log, 1981. USACE Sacramento O&M Manual 123, August 1955, (Station 382+85)]. No permit or as-built drawing available.						
FS Date: 11/21/2018 8:31:59 AM

Waterside view: overview CMP standpipe and water body

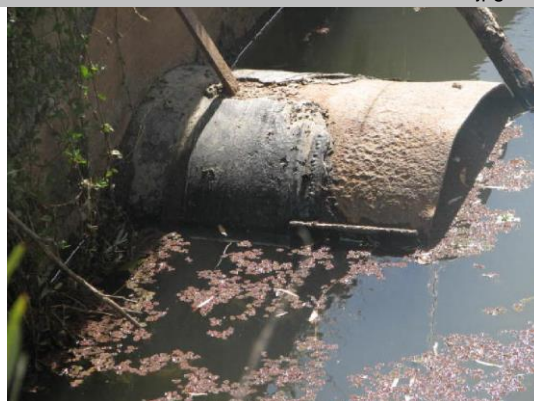
Photo 2 of 3 : UCIP_FA_2018_53253_60260.jpg

Comment Code						
Inspector Comment						
FS_ID:53253 DS_ID:838 EP_NO: N/A Repair Type: No Action Needed Crossing Status: Found UCIP Comments: 11/16/17 Ted Skidgel, pipe is closed on w/s and closed on L/S. Mud removed recently from WS pipes. FIELD_STRUCT_DESC: 1 of 2: 48-inch corrugated metal drainage pipe through the levee, 28.5 feet below the crown. 30-inch steel pipe sleeved through the 48-inch pipe. Slide gate in a 60-inch pipe riser on the waterside (WS) slope. [Additional Reference(s): DWR Levee Log, 1981. USACE Sacramento O&M Manual 123, August 1955, (Station 382+85)]. No permit or as-built drawing available. FS Date: 11/21/2018 8:31:59 AM

Waterside view: steel pipe and concrete headwall

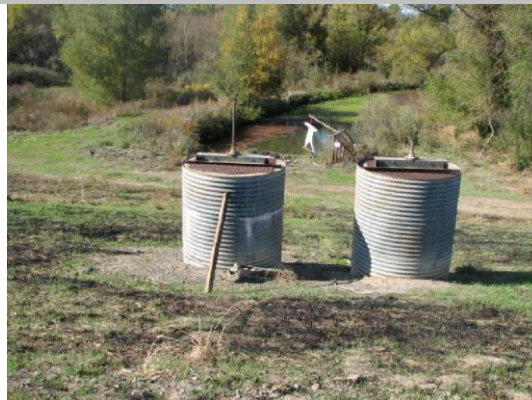
Photo 1 of 3 : UCIP_FA_2018_53254_60269.jpg

LM Start	1.71	Rating **	A/W	Issue No.	7	
LM End	1.71	Issue Type +	Ma	Location *		
Category	Supplemental			GPS Latitude/Longitude		
				Start	End	
Item	DWR UCIP LMA Responsibility			38.740686 °	38.740686 °	
				-121.633979 °	-121.633979 °	
DWR ID	840					
Comment Code						
Inspector Comment						
FS_ID:53254 DS_ID:840 EP_NO: N/A Repair Type: No Action Needed Crossing Status: Found UCIP Comments: FIELD_STRUCT_DESC: 2 of 2: 48-inch corrugated metal drainage pipe through the levee, 28.5 feet below the crown. 30-inch steel pipe sleeved through the 48-inch pipe. Slide gate in a 60-inch pipe riser on the waterside (WS) slope. [Additional Reference(s): DWR Levee Log, 1981. USACE Sacramento O&M Manual 123, August 1955, (Station 382+85)]. No permit or as-built drawing available. FS Date: 11/21/2018 8:34:20 AM

Waterside view: overview of CMP standpipe and water body

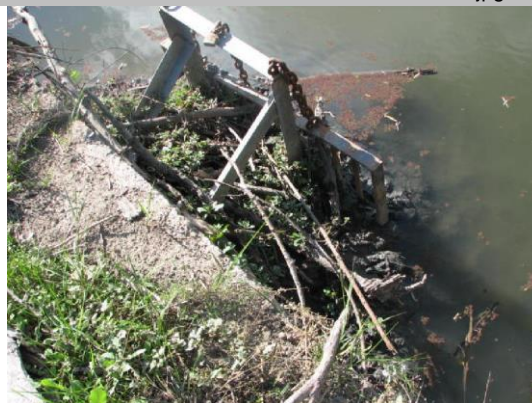
Photo 2 of 3 : UCIP_FA_2018_53254_60268.jpg

Waterside view: mud clogged pipe, trash rack and headwall

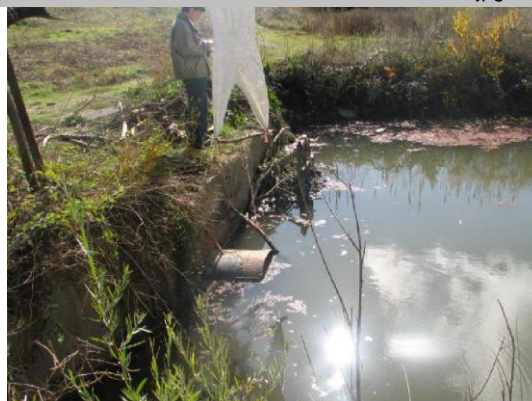
Photo 3 of 3 : UCIP_FA_2018_53254_60267.jpg

LM Start	1.71	Rating **	A/W	Issue No.	7 (cont)	
LM End	1.71	Issue Type +	Ma	Location *		
Category	Supplemental			GPS Latitude/Longitude		
				Start	End	
Item	DWR UCIP LMA Responsibility			38.740686 °	38.740686 °	
				-121.633979 °	-121.633979 °	
DWR ID	840					
Comment Code						
Inspector Comment						
FS_ID:53254						
DS_ID:840						
EP_NO: N/A						
Repair Type: No Action Needed						
Crossing Status: Found						
UCIP Comments:						
FIELD_STRUCT_DESC: 2 of 2: 48-inch corrugated metal drainage pipe through the levee, 28.5 feet below the crown. 30-inch steel pipe sleeved through the 48-inch pipe. Slide gate in a 60-inch pipe riser on the waterside (WS) slope. [Additional Reference(s): DWR Levee Log, 1981. USACE Sacramento O&M Manual 123, August 1955, (Station 382+85)]. No permit or as-built drawing available.						
FS Date: 11/21/2018 8:34:20 AM

Waterside view: overview pipes and headwall
