**Flood Control Project Maintenance
Levee Inspections**

Fall 2019 Levee Maintenance Deficiency Summary Report

Sacramento Maintenance Yard East Levee Yolo Bypass

Levee Inspection Report By Mile - Fall 2019

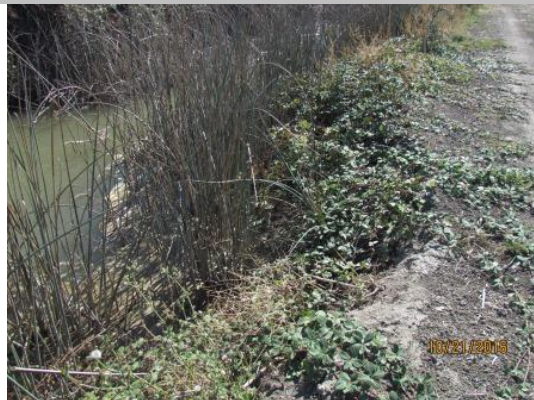
Photo 2 of 3 : FA_2019_ST0004_41_1_20190829_00002.jpg

LM Start	1.51	Rating **	A/W	Issue No.	1 (cont)	
LM End	1.51	Issue Type +	Ob	Location *	LS	
Category	Earthen Levee			GPS Latitude/Longitude		
				Start	End	
Item	Erosion / Bank Caving			38.743573 °	38.743573 °	
				-121.634128 °	-121.634128 °	
DWR ID	DWR_ST0004_01_f_2016_1					
Comment Code						
E1 : Note and monitor erosion site.						
Inspector Comment						
Erosion on a side of a ditch toward LS toe caused by water coming out of irrigation canal. Recommend monitoring.

Irrigation ditch erosion on landward side toward LS levee toe. Fall 2016.

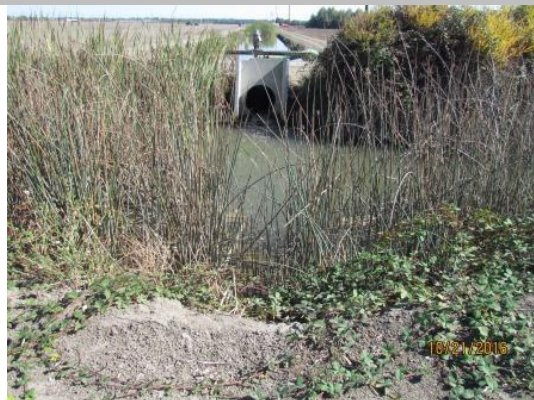
Photo 3 of 3 : FA_2019_ST0004_41_1_20190829_00003.jpg

Irrigation ditch erosion caused by water flowing from perpendicular irrigation canal. Fall 2016.

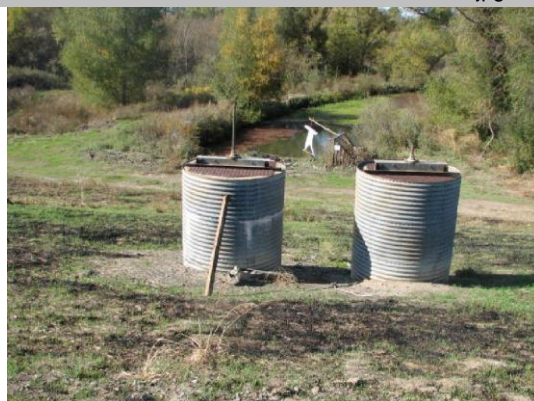
Photo 1 of 3 : UCIP_FA_2019_53253_60261.jpg

Comment Code						
Inspector Comment						
DS_ID:838 FS_ID:53253 EP_NO: N/A Repair Type: No Action Needed Crossing Status: Found UCIP Comments: 11/16/17 Ted Skidgel, pipe is closed on w/s and closed on L/S. Mud removed recently from WS pipes. FIELD_STRUCT_DESC: 1 of 2: 48-inch corrugated metal drainage pipe through the levee, 28.5 feet below the crown. 30-inch steel pipe sleeved through the 48-inch pipe. Slide gate in a 60-inch pipe riser on the waterside (WS) slope. [Additional Reference(s): DWR Levee Log, 1981. USACE Sacramento O&M Manual 123, August 1955, (Station 382+85)]. No permit or as-built drawing available. FS Date: 11/21/2018 8:31:59 AM

Waterside view: overview CMP standpipe and water body

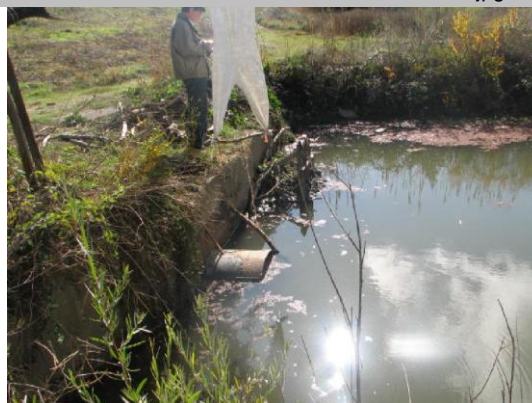
Photo 3 of 3 : UCIP_FA_2019_53253_60259.jpg

Waterside view: overview steel pipes and concrete headwall

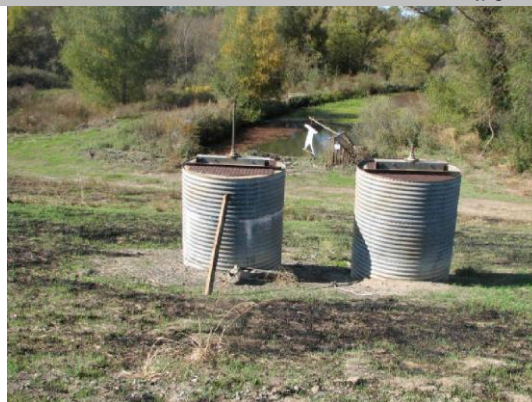
Photo 1 of 3 : UCIP_FA_2019_53254_60269.jpg

LM Start	1.71	Rating **	A/W	Issue No.	10	
LM End	1.71	Issue Type +	Ma	Location *		
Category	Supplemental			GPS Latitude/Longitude		
				Start		End
Item	DRAFT DWR UCIP LMA Responsibility			38.740686 °		38.740686 °
				-121.633979 °		-121.633979 °
DWR ID	840					
Comment Code						
Inspector Comment						
DS_ID:840 FS_ID:53254 EP_NO: N/A Repair Type: No Action Needed Crossing Status: Found UCIP Comments: FIELD_STRUCT_DESC: 2 of 2: 48-inch corrugated metal drainage pipe through the levee, 28.5 feet below the crown. 30-inch steel pipe sleeved through the 48-inch pipe. Slide gate in a 60-inch pipe riser on the waterside (WS) slope. [Additional Reference(s): DWR Levee Log, 1981. USACE Sacramento O&M Manual 123, August 1955, (Station 382+85)]. No permit or as-built drawing available. FS Date: 11/21/2018 8:34:20 AM

Waterside view: overview of CMP standpipe and water body

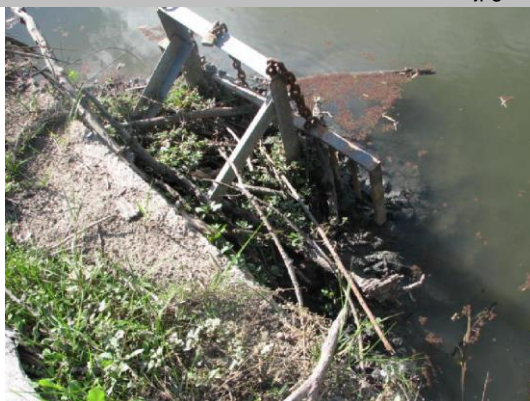
Photo 2 of 3 : UCIP_FA_2019_53254_60268.jpg

Waterside view: mud clogged pipe, trash rack and headwall

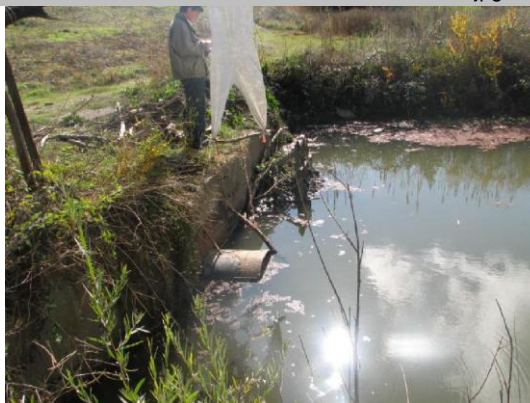
Photo 3 of 3 : UCIP_FA_2019_53254_60267.jpg

Waterside view: overview pipes and headwall
