Flood Control Project Maintenance Levee Inspections

Fall 2020 Levee Maintenance Deficiency Summary Report

Sacramento Maintenance Yard East Levee Yolo Bypass

Levee Inspection Report By Mile - Fall 2020

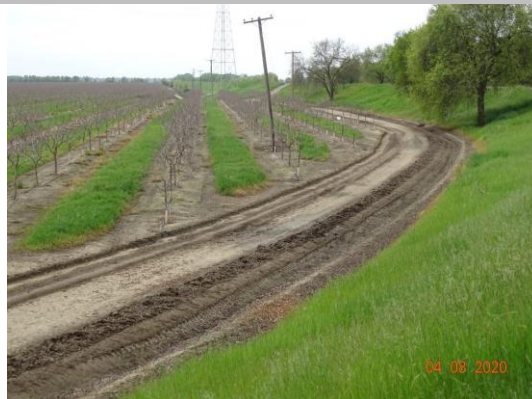
Photo 1 of 1 : FA_2020_ST0004_41_2_20200813_00003.jpg

LM Start	0.01	Rating **	M	Issue No.	2
LM End	0.15	Issue Type +	En	Location *	LS
Category	Earthen Levee			GPS Latitude/Longitude	
				Start	End
Item	Encroachments			38.765181 °	38.763164 °
				-121.635131 °	-121.635438 °
DWR ID	DWR_ST0004_01_f_2018_2				
Comment Code					
DT : Ditch					
Inspector Comment					
Landowner has dug an irrigation ditch within the landside easement.

View of irrigation ditch at landside toe. Spring 2020.

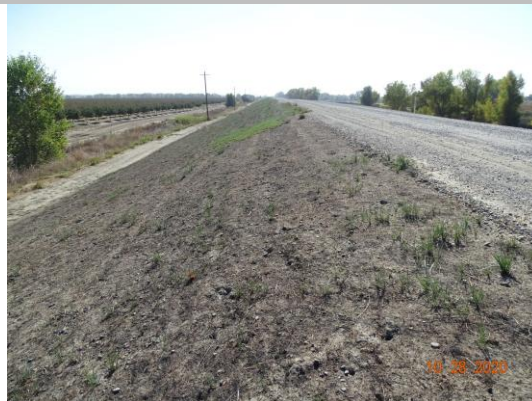
Photo 1 of 1 : FA_2020_ST0004_41_8_20201028_00010.jpg

LM Start	0.48	Rating **	A	Issue No.	8
LM End	0.48	Issue Type +	Ma	Location *	LS
Category	Earthen Levee			GPS Latitude/Longitude	
				Start	End
Item	Vegetation			38.758487 °	38.758487 °
				-121.635137 °	-121.635137 °
DWR ID	DWR_ST0004_01_f_2020_8				
Comment Code					
V1 : Control annual grass and weeds on the levee slopes and easements.					
Inspector Comment					
LMA maintains the vegetation at a high level.

View of maintained landside slope. Fall 2020.

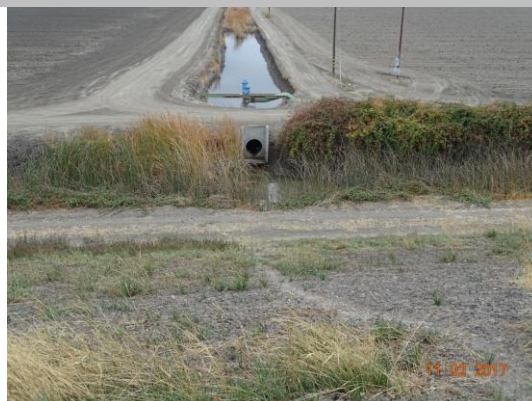
Photo 1 of 2 : FA_2020_ST0004_41_1_20200813_00001.jpg

LM Start	1.51	Rating **	A/W	Issue No.	1
LM End	1.51	Issue Type +	Ma	Location *	LS
Category	Earthen Levee			GPS Latitude/Longitude	
				Start	End
Item	Erosion / Bank Caving			38.743573 °	38.743573 °
				-121.634128 °	-121.634128 °
DWR ID	DWR_ST0004_01_s_2020_1				
Comment Code					
E1 : Note and monitor erosion site.					
Inspector Comment					
Erosion on a side of a ditch toward LS toe caused by water coming out of irrigation canal. Recommend monitoring.

View of erosion on toe road. Fall 2017.

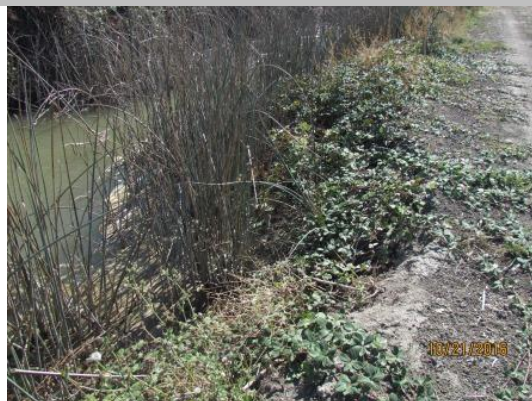
Photo 2 of 2 : FA_2020_ST0004_41_1_20200813_00002.jpg

Irrigation ditch erosion on landward side toward LS levee toe. Fall 2016.

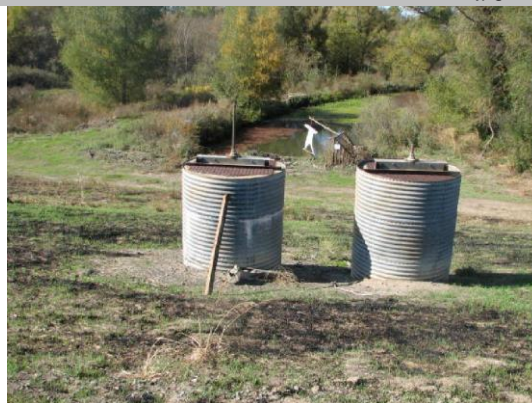
Photo 1 of 3 : UCIP_FA_2020_53253_60261.jpg

DS_ID:838
 FS_ID:53253
 EP_NO: N/A
 Repair Type: No Action Needed
 EVAL Issue:
 Crossing Status: Found
 UCIP Comments: 11/16/17 Ted Skidgel, pipe is closed on w/s and closed on L/S. Mud removed recently from WS pipes.
 FIELD_STRUCT_DESC: 1 of 2: 48-inch corrugated metal drainage pipe through the levee, 28.5 feet below the crown. 30-inch steel pipe sleeved through the 48-inch pipe. Slide gate in a 60-inch pipe riser on the waterside (WS) slope. [Additional Reference(s): DWR Levee Log, 1981. USACE Sacramento O&M Manual 123, August 1955, (Station 382+85)]. No permit or as-built drawing available.
 FS Date: 11/21/2018 8:31:59 AM

Waterside view: overview CMP standpipe and water body

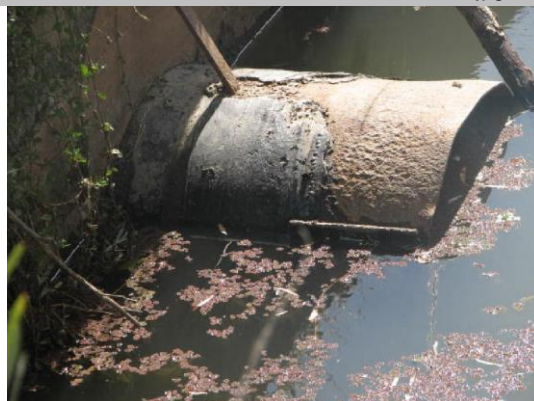
Photo 2 of 3 : UCIP_FA_2020_53253_60260.jpg

Waterside view: steel pipe and concrete headwall

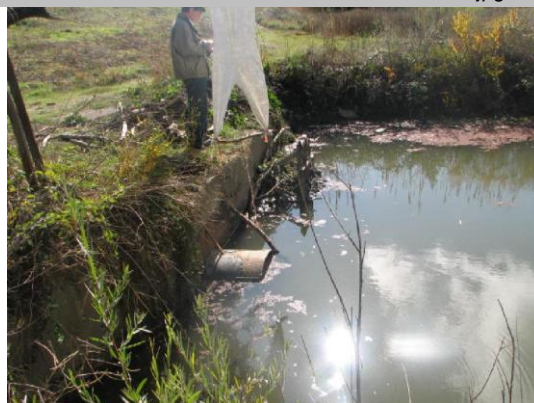
Photo 3 of 3 : UCIP_FA_2020_53253_60259.jpg

Waterside view: overview steel pipes and concrete headwall

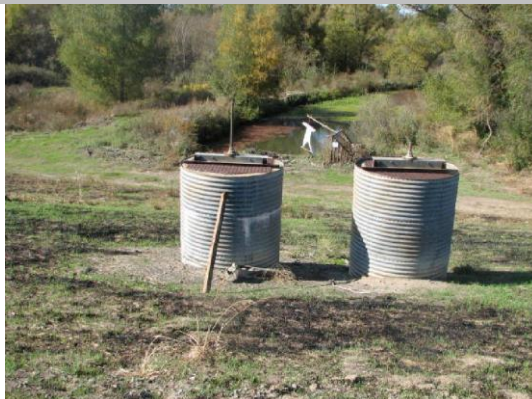
Photo 1 of 3 : UCIP_FA_2020_53254_60269.jpg

LM Start	1.71	Rating **	A/W	Issue No.	10	
LM End	1.71	Issue Type +	Ma	Location *		
Category	Supplemental			GPS Latitude/Longitude		
				Start		End
Item	DWR UCIP LMA Responsibility			38.740686 °	38.740686 °	
				-121.633979 °	-121.633979 °	
DWR ID	840					
Comment Code						
Inspector Comment						
DS_ID:840 FS_ID:53254 EP_NO: N/A Repair Type: No Action Needed EVAL Issue: Crossing Status: Found UCIP Comments: FIELD_STRUCT_DESC: 2 of 2: 48-inch corrugated metal drainage pipe through the levee, 28.5 feet below the crown. 30-inch steel pipe sleeved through the 48-inch pipe. Slide gate in a 60-inch pipe riser on the waterside (WS) slope. [Additional Reference(s): DWR Levee Log, 1981. USACE Sacramento O&M Manual 123, August 1955, (Station 382+85)]. No permit or as-built drawing available. FS Date: 11/21/2018 8:34:20 AM

Waterside view: overview of CMP standpipe and water body

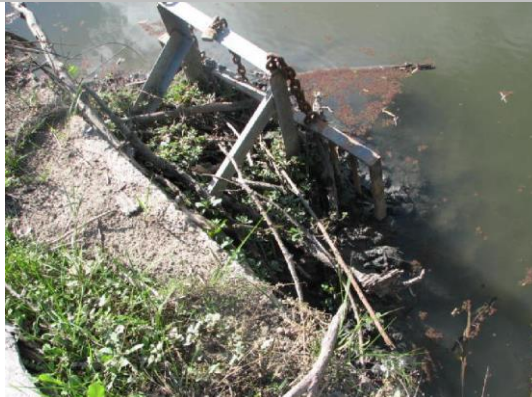
Photo 2 of 3 : UCIP_FA_2020_53254_60268.jpg

Waterside view: mud clogged pipe, trash rack and headwall

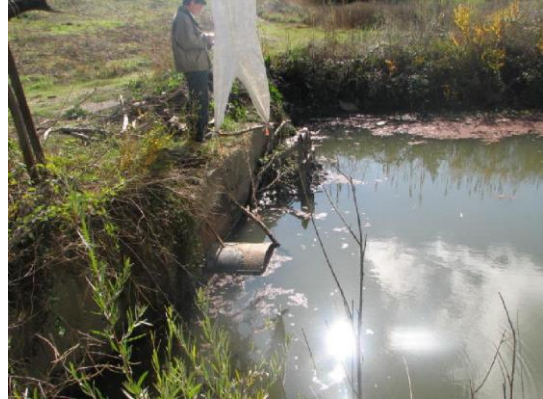
Photo 3 of 3 : UCIP_FA_2020_53254_60267.jpg

Waterside view: overview pipes and headwall
