## Flood Control Project Maintenance Levee Inspections

### Fall 2021 Levee Maintenance Deficiency Summary Report

## Sacramento Maintenance Yard East Levee Yolo Bypass

**Levee Inspection Report By Mile - Fall 2021**

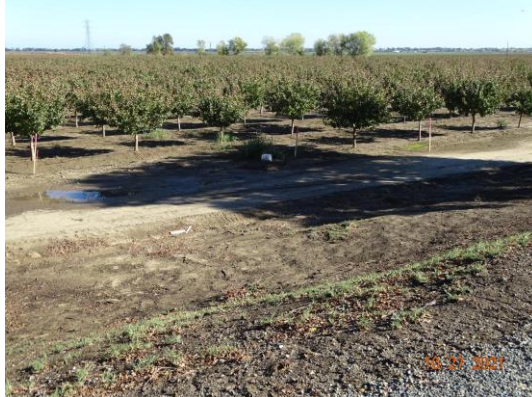
Photo 1 of 1 : FA\_2021\_ST0004\_41\_2\_20211102\_00009.jpg

LM Start	0.07	Rating **	M	Issue No.	2
LM End	0.15	Issue Type +	En	Location *	LS
Category	Earthen Levee			GPS Latitude/Longitude	
				Start	End
Item	Encroachments			38.764385 °	38.763164 °
				-121.635494 °	-121.635438 °
DWR ID	DWR_ST0004_01_f_2018_2				
Comment Code					
DT : Ditch					
Inspector Comment					
Landowner has dug an irrigation ditch within the landside easement.

View of ditch at the landside toe. Fall 2021.

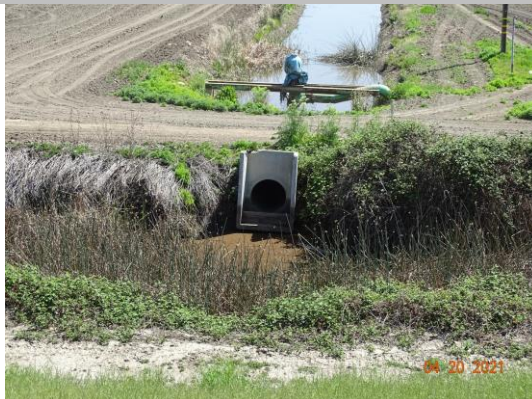
Photo 1 of 1 : FA\_2021\_ST0004\_41\_1\_20210907\_00001.jpg

LM Start	1.51	Rating **	A/W	Issue No.	1
LM End	1.51	Issue Type +	Ma	Location *	LS
Category	Earthen Levee			GPS Latitude/Longitude	
				Start	End
Item	Erosion / Bank Caving			38.743573 °	38.743573 °
				-121.634128 °	-121.634128 °
DWR ID	DWR_ST0004_01_s_2020_1				
Comment Code					
E1 : Note and monitor erosion site.					
Inspector Comment					
Erosion on a side of a ditch toward LS toe caused by water coming out of irrigation canal. Recommend monitoring.

View of erosion on landside irrigation canal. Spring 2021.

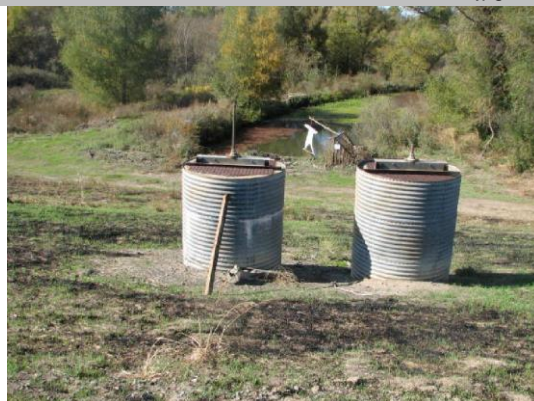
Photo 1 of 3 : UCIP\_FA\_2021\_53253\_60261.jpg

Comment Code						
Inspector Comment						
DS_ID:838						
FS_ID:53253						
EP_NO: N/A						
Repair Type: No Action Needed						
EVAL Issue:						
Crossing Status: Found						
UCIP Comments: 11/16/17 Ted Skidgel, pipe is closed on w/s and closed on L/S. Mud removed recently from WS pipes.						
FIELD_STRUCT_DESC: 1 of 2: 48-inch corrugated metal drainage pipe through the levee, 28.5 feet below the crown. 30-inch steel pipe sleeved through the 48-inch pipe. Slide gate in a 60-inch pipe riser on the waterside (WS) slope. [Additional Reference(s): DWR Levee Log, 1981. USACE Sacramento O&M Manual 123, August 1955, (Station 382+85)]. No permit or as-built drawing available.						
FS Date: 11/21/2018 8:31:59 AM

Waterside view: overview CMP standpipe and water body

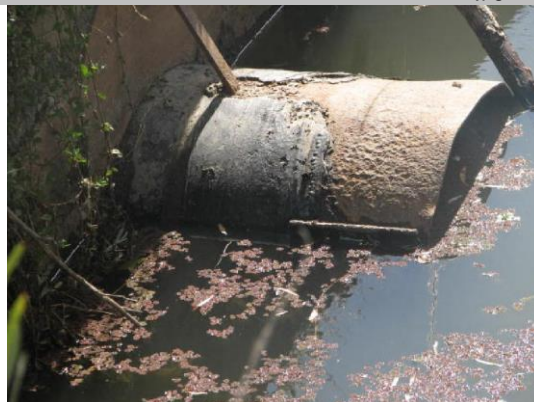
Photo 2 of 3 : UCIP\_FA\_2021\_53253\_60260.jpg

Waterside view: steel pipe and concrete headwall

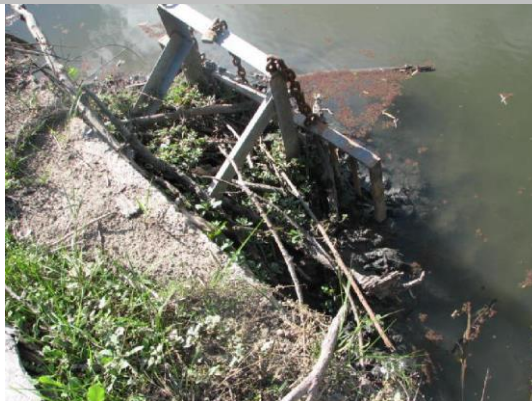
Photo 2 of 3 : UCIP\_FA\_2021\_53254\_60268.jpg

Waterside view: mud clogged pipe, trash rack and headwall

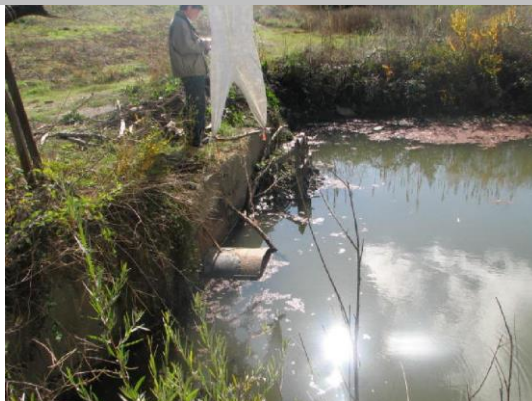
Photo 3 of 3 : UCIP\_FA\_2021\_53254\_60267.jpg

Waterside view: overview pipes and headwall
