**Flood Control Project Maintenance  
Levee Inspections  
Fall 2022 Levee Maintenance Deficiency Summary Report**

**Sacramento River Basin**

**Sacramento Maintenance Yard East Levee Yolo Bypass**

**Levee Inspection Report By Mile - Fall 2022**

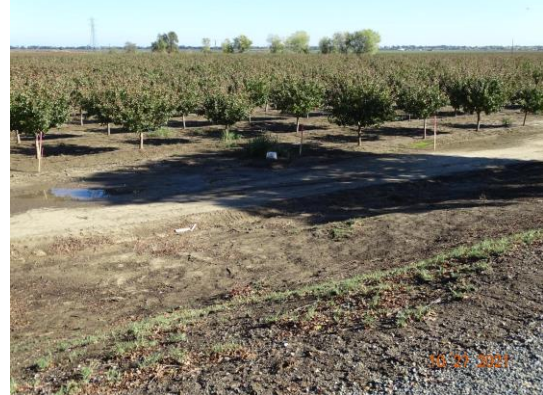
Photo 1 of 1 : FA\_2022\_ST0004\_41\_2\_20220921\_00002.jpg

LM Start	0.07	Rating **	M	Issue No.	2
LM End	0.15	Issue Type +	En	Location *	LS
Category	Earthen Levee			GPS Latitude/Longitude	
				Start	End
Item	Encroachments			38.764385 °	38.763164 °
				-121.635494 °	-121.635438 °
DWR ID	DWR_ST0004_01_f_2018_2				
Comment Code					
DT : Ditch					
Inspector Comment					
Landowner has dug an irrigation ditch within the landside easement.

View of ditch at the landside toe. Fall 2021.

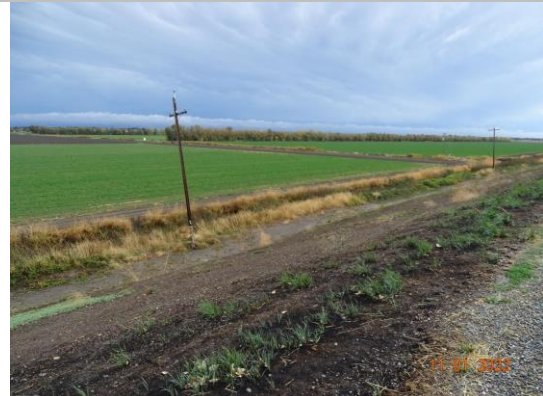
Photo 1 of 1 : FA\_2022\_ST0004\_41\_9\_20221102\_00003.jpg

LM Start	1.42	Rating **	A	Issue No.	9
LM End	1.42	Issue Type +	Ma	Location *	LS
Category	Earthen Levee			GPS Latitude/Longitude	
				Start	End
Item	Vegetation			38.744904 °	38.744904 °
				-121.634219 °	-121.634219 °
DWR ID	DWR_ST0004_01_f_2022_9				
Comment Code					
V1 : Control annual grass and weeds on the levee slopes and easements.					
Inspector Comment					
LMA maintains the vegetation at a high level.

View of maintained landside slope. Fall 2022.

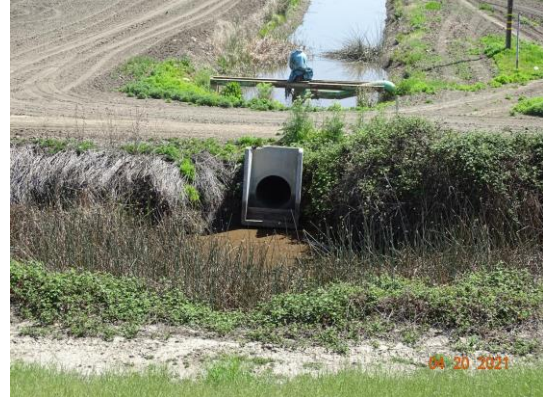
Photo 1 of 1 : FA\_2022\_ST0004\_41\_1\_20220921\_00001.jpg

LM Start	1.51	Rating **	A/W	Issue No.	1
LM End	1.51	Issue Type +	Ma	Location *	LS
Category	Earthen Levee			GPS Latitude/Longitude	
				Start	End
Item	Erosion / Bank Caving			38.743573 °	38.743573 °
				-121.634128 °	-121.634128 °
DWR ID	DWR_ST0004_01_s_2020_1				
Comment Code					
E1 : Note and monitor erosion site.					
Inspector Comment					
Erosion on a side of a ditch toward LS toe caused by water coming out of irrigation canal. Recommend monitoring.

View of erosion on landside irrigation canal. Spring 2021.

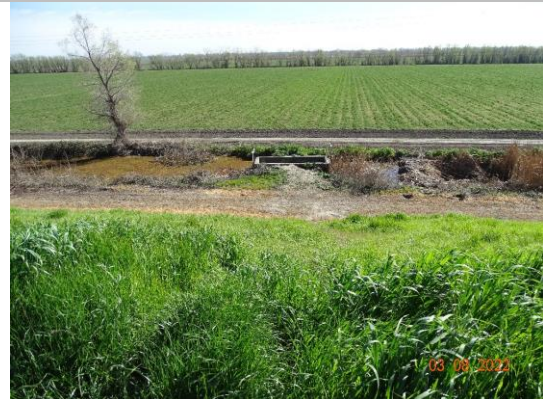
Photo 1 of 3 : UCIP\_FA\_2022\_71979\_106877.jpg

Comment Code						
Inspector Comment						
DS_ID:838 FS_ID:71979 EP_NO: N/A Repair Type: Non-Urgent EVAL Issue: 11, Maintenance Compliance Issue Crossing Status: Found UCIP Comments: 03/08/2022 Record updated from No Action Needed to Non-Urgent. Multiple sinkholes around headwall on waterside. A sinkhole measured 2-feet in diameter and 3-feet deep located on a shoulder of toe road located approximately 20 feet from levee toe in pipe alignment. No permit has been identified authorizing pipe. (O.Yakimov - DWR UCIP) 11/16/2017 Pipe is closed on w/s and closed on L/S. Mud removed recently from WS pipes. (Ted Skidgel - Sac Yard) FIELD_STRUCT_DESC: 1 of 2: 48-inch corrugated metal drainage pipe through the levee, 28.5 feet below the crown. 30-inch steel pipe sleeved through the 48-inch pipe. Slide gate in a 60-inch pipe riser on the waterside (WS) slope. [Additional Reference(s): DWR Levee Log, 1981. USACE Sacramento O&M Manual 123, August 1955, (Station 382+85)]. No permit or as-built drawing available. FS Date: 3/8/2022 3:46:12 PM

Land-Side: View of levee slope looking from crown

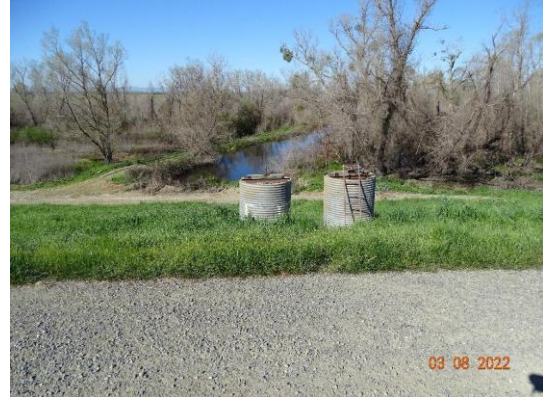
Photo 2 of 3 : UCIP\_FA\_2022\_71979\_106879.jpg

Water-Side: View of levee slope looking from crown. CMP riser on slope

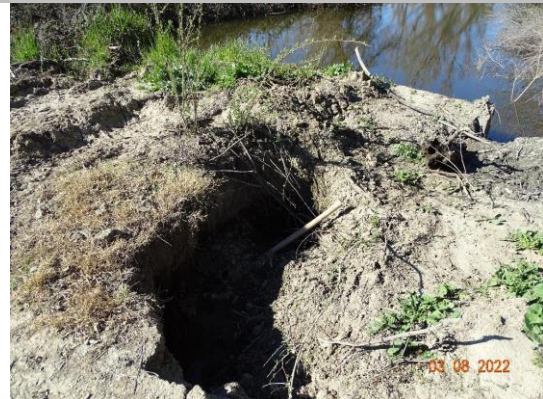
Photo 3 of 3 : UCIP\_FA\_2022\_71979\_106881.jpg

Water-Side: Multiple sinkholes filled with water around headwall

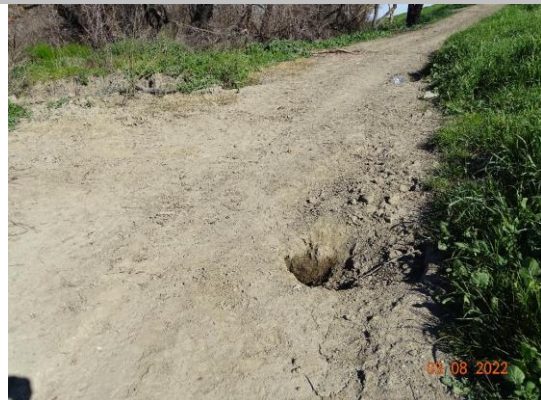
Photo 2 of 3 : UCIP\_FA\_2022\_71980\_106888.jpg

Comment Code					
Inspector Comment					
DS_ID:840 FS_ID:71980 EP_NO: N/A Repair Type: Non-Urgent EVAL Issue: 11, Maintenance Compliance Issue Crossing Status: Found UCIP Comments: 03/08/2022 Record updated from No Action Needed to Non-Urgent. Multiple sinkholes around headwall on waterside. A sinkhole measured 2-feet in diameter and 2-feet deep located on a shoulder of toe road located approximately 20 feet from levee toe in pipe alignment. No permit has been identified authorizing pipe. (O.Yakimov - DWR UCIP)  FIELD_STRUCT_DESC: 2 of 2: 48-inch corrugated metal drainage pipe through the levee, 28.5 feet below the crown. 30-inch steel pipe sleeved through the 48-inch pipe. Slide gate in a 60-inch pipe riser on the waterside (WS) slope. [Additional Reference(s): DWR Levee Log, 1981. USACE Sacramento O&M Manual 123, August 1955, (Station 382+85)]. No permit or as-built drawing available. FS Date: 3/8/2022 3:57:41 PM

Water-Side: Sinkhole at the edge of toe road
