**Flood Control Project Maintenance
Levee Inspections
Fall 2023 Levee Maintenance Deficiency Summary Report**

Sacramento River Basin

Sacramento Maintenance Yard East Levee Yolo Bypass

Levee Inspection Report By Mile - Fall 2023

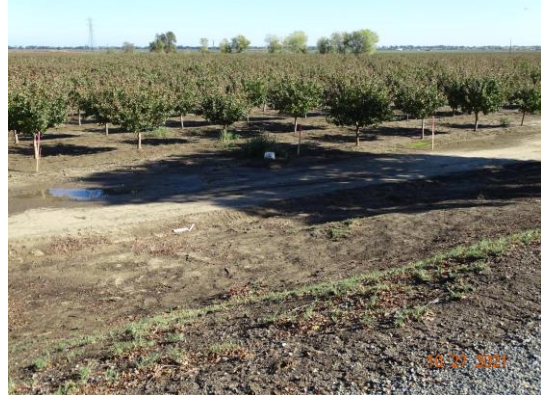
Photo 1 of 1 : FA_2023_ST0004_41_2_20231024_00002.jpg

LM Start	0.07	Rating **	M	Issue No.	2
LM End	0.15	Issue Type +	En	Location *	LS
Category	Earthen Levee			GPS Latitude/Longitude	
				Start	End
Item	Encroachments			38.764385°	38.763164°
				-121.635494°	-121.635438°
DWR ID	DWR_ST0004_01_f_2018_2				
Comment Code					
DT : Ditch					
Inspector Comment					
Landowner has dug an irrigation ditch within the landside easement.

View of ditch at the landside toe. Fall 2021.

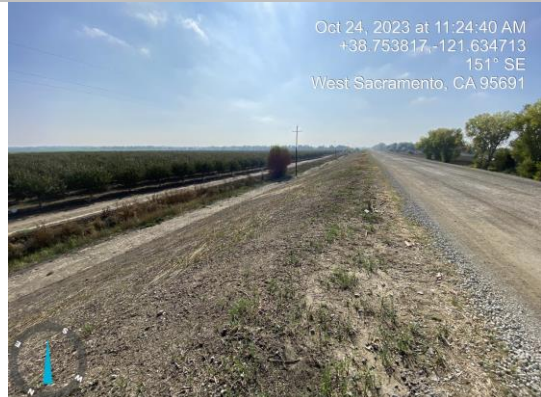
Photo 1 of 1 : FA_2023_ST0004_41_8_20231025_00009.jpg

LM Start	0.80	Rating **	A	Issue No.	8
LM End	0.80	Issue Type +	Ma	Location *	LS
Category	Earthen Levee			GPS Latitude/Longitude	
				Start	End
Item	Vegetation			38.753801°	38.753801°
				-121.634788°	-121.634788°
DWR ID	DWR_ST0004_01_f_2023_8				
Comment Code					
V1 : Control annual grass and weeds on the levee slopes and easements.					
Inspector Comment

View of acceptable vegetation on the landside slope (Fall 2023).

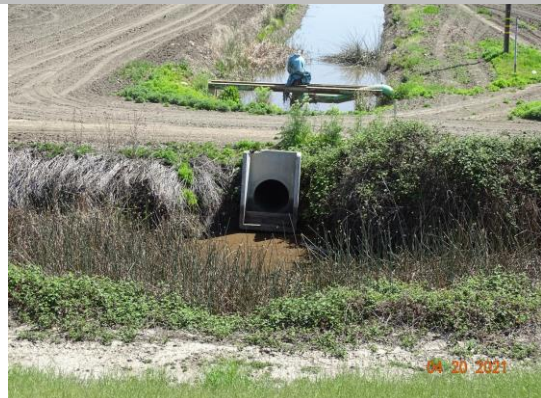
Photo 1 of 1 : FA_2023_ST0004_41_1_20231024_00001.jpg

LM Start	1.51	Rating **	A/W	Issue No.	1
LM End	1.51	Issue Type +	Ma	Location *	LS
Category	Earthen Levee			GPS Latitude/Longitude	
				Start	End
Item	Erosion / Bank Caving			38.743573°	38.743573°
				-121.634128°	-121.634128°
DWR ID	DWR_ST0004_01_s_2020_1				
Comment Code					
E1 : Note and monitor erosion site.					
Inspector Comment					
Erosion on a side of a ditch toward LS toe caused by water coming out of irrigation canal. Recommend monitoring.

View of erosion on landside irrigation canal. Spring 2021.

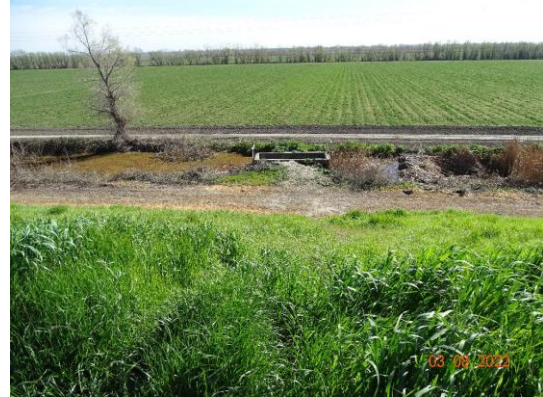
Photo 1 of 3 : UCIP_FA_2023_80055_106877.jpg

Comment Code					
Inspector Comment					
DS_ID:838 FS_ID:80055 EP_NO: N/A Repair Type: Non-Urgent EVAL Issue: 5, Pipe Damage Crossing Status: Found UCIP Comments: 05/23/2023 Record updated from Urgent to Non-Urgent. LoF grade is equal to 5 due to pipe surface damage corrosion, integrity issues are not found. Crossing will be monitored until funding becomes available for rehabilitation. (O.Yakimov - DWR UCIP). 12/15/2022 Record updated from Non-Urgent to Urgent. DMP internal video inspection has LOF of crossing is between 5 and 6. Crossing will be monitored until funding becomes available to address the issues. (O.Yakimov - DWR UCIP) 03/08/2022 Record updated from No Action Needed to Non-Urgent. Multiple sinkholes around headwall on waterside. A sinkhole measured 2-feet in diameter and 3-feet deep located on a shoulder of toe road located approximately 20 feet from levee toe in pipe alignment. No permit has been identified authorizing pipe. (O.Yakimov - DWR UCIP) 11/16/2017 Pipe is closed on w/s and closed on L/S. Mud removed recently from WS pipes. (Ted Skidgel - Sac Yard) FIELD_STRUCT_DESC: 1 of 2: 48-inch corrugated metal drainage pipe through the levee, 28.5 feet below the crown. 30-inch steel pipe sleeved through the 48-inch pipe. Slide gate in a 60-inch pipe riser on the waterside (WS) slope. [Additional Reference(s): DWR Levee Log, 1981. USACE Sacramento O&M Manual 123, August 1955, (Station 382+85)]. No permit or as-built drawing available. FS Date: 3/8/2022 10:33:40 AM

Land-Side: View of levee slope looking from crown

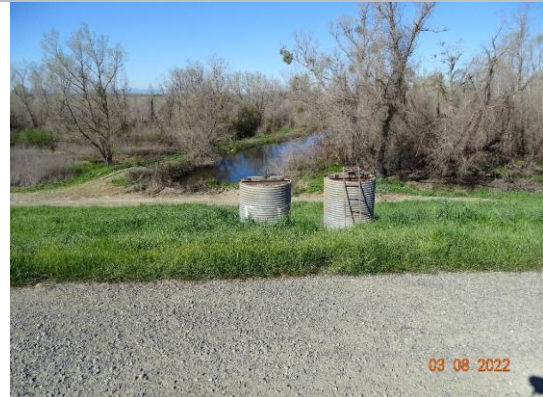
Photo 2 of 3 : UCIP_FA_2023_80055_106879.jpg

Water-Side: View of levee slope looking from crown. CMP riser on slope

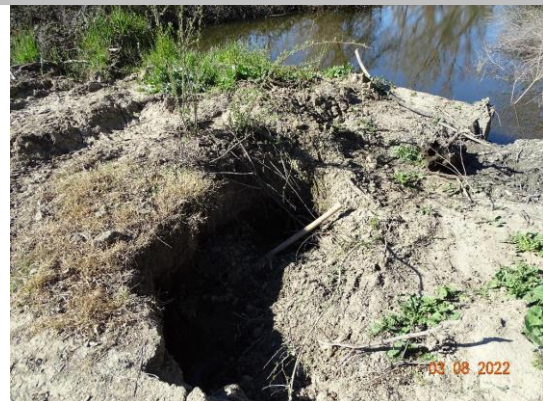
Photo 3 of 3 : UCIP_FA_2023_80055_106881.jpg

Water-Side: Multiple sinkholes filled with water around headwall

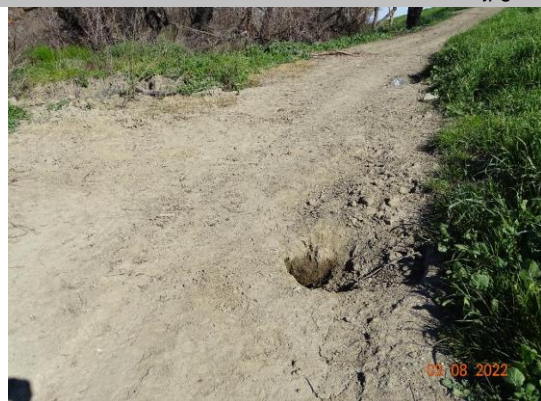
Photo 2 of 3 : UCIP_FA_2023_80056_106888.jpg

Water-Side: Sinkhole at the edge of toe road
