Flood Control Project Maintenance Levee Inspections

Fall 2024 Levee Maintenance Deficiency Summary Report

Sacramento River Basin

Sacramento Maintenance Yard East Levee Yolo Bypass

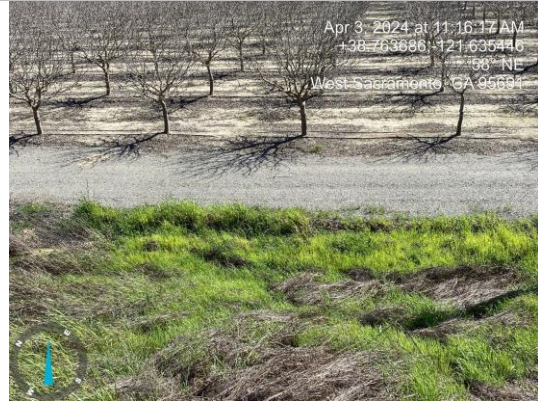
Photo 1 of 1 : FA_2024_ST0004_41_2_20241028_00002.jpg

LM Start	0.07	Rating **	M	Issue No.	2
LM End	0.15	Issue Type +	En	Location *	LS
Category	Earthen Levee			GPS Latitude/Longitude	
				Start	End
Item	Encroachments			38.764385 °	38.763164 °
				-121.635494 °	-121.635438 °
DWR ID	DWR_ST0004_01_f_2018_2				
Comment Code					
DT : Ditch					
Inspector Comment					
Landowner has dug an irrigation ditch within the landside easement.

View of ditch on landside toe (Spring 2024).

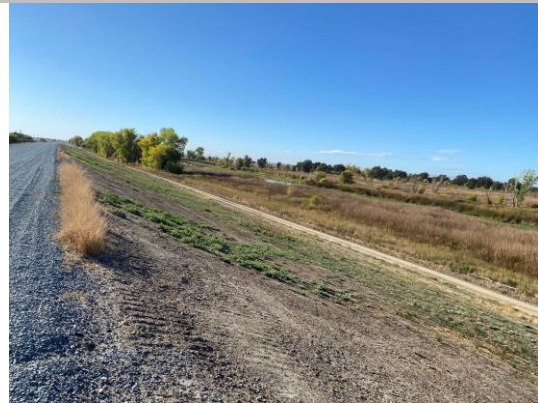
Photo 1 of 1 : FA_2024_ST0004_41_10_20241104_00009.jpg

View of good vegetation on the waterside (Fall 2024).

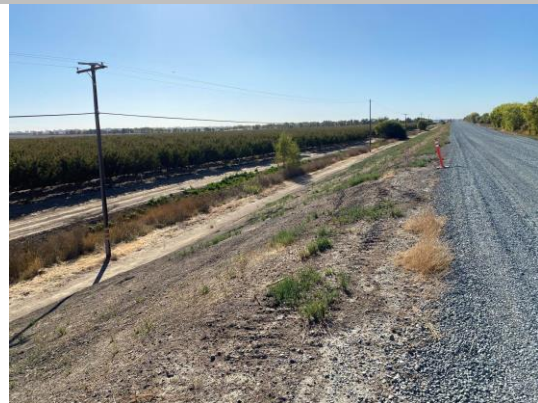
Photo 1 of 1 : FA_2024_ST0004_41_8_20241104_00010.jpg

View of good vegetation on the landside (Fall 2024).

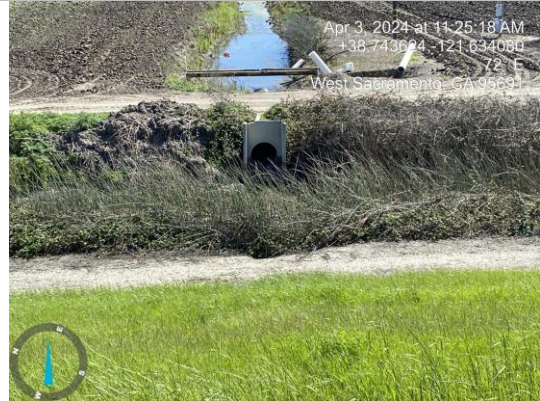
Photo 1 of 1 : FA_2024_ST0004_41_1_20241028_00001.jpg

LM Start	1.51	Rating **	A/W	Issue No.	1
LM End	1.51	Issue Type +	Ma	Location *	LS
Category	Earthen Levee			GPS Latitude/Longitude	
				Start	End
Item	Erosion / Bank Caving			38.743573°	38.743573°
				-121.634128°	-121.634128°
DWR ID	DWR_ST0004_01_s_2024_1				
Comment Code					
E1 : Note and monitor erosion site.					
Inspector Comment					
Erosion on a side of a ditch toward LS toe caused by water coming out of irrigation canal. Recommend monitoring.

View of erosion on landside irrigation canal (Spring 2024).

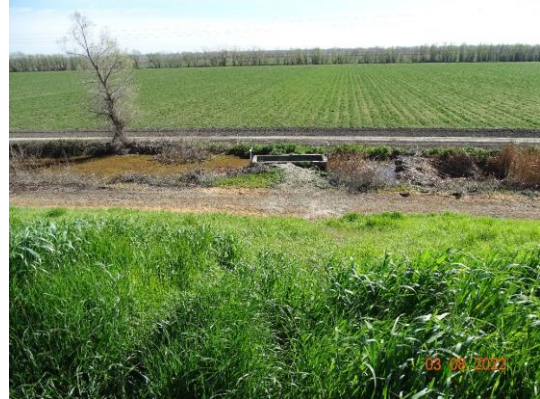
Photo 1 of 3 : UCIP_FA_2024_80055_106877.jpg

Comment Code						
Inspector Comment						
DS_ID:838 FS_ID:80055 EP_NO: N/A Repair Type: Non-Urgent EVAL Issue: 5, Pipe Damage Crossing Status: Found UCIP Comments: 05/23/2023 Record updated from Urgent to Non-Urgent. LoF grade is equal to 5 due to pipe surface damage corrosion, integrity issues are not found. Crossing will be monitored until funding becomes available for rehabilitation. (O.Yakimov - DWR UCIP). 12/15/2022 Record updated from Non-Urgent to Urgent. DMP internal video inspection has LOF of crossing is between 5 and 6. Crossing will be monitored until funding becomes available to address the issues. (O.Yakimov - DWR UCIP) 03/08/2022 Record updated from No Action Needed to Non-Urgent. Multiple sinkholes around headwall on waterside. A sinkhole measured 2-feet in diameter and 3-feet deep located on a shoulder of toe road located approximately 20 feet from levee toe in pipe alignment. No permit has been identified authorizing pipe. (O.Yakimov - DWR UCIP) 11/16/2017 Pipe is closed on w/s and closed on L/S. Mud removed recently from WS pipes. (Ted Skidgel - Sac Yard) FIELD_STRUCT_DESC: 1 of 2: 48-inch corrugated metal drainage pipe through the levee, 28.5 feet below the crown. 30-inch steel pipe sleeved through the 48-inch pipe. Slide gate in a 60-inch pipe riser on the waterside (WS) slope. (Two 48-inch pipes authorized under Permit No. 973, 1944 - Reclamation District 1600). [Additional Reference(s): DWR Levee Log, 1981 (HLM 1.68). USACE Sacramento O&M Manual, Unit 123, August 1955, Revised 17 December 2020, (Station 382+85), listed as two 48-inch pipes. USACE As-Built Drawing No. 50-04-1310, October 1931, Sheet 2, Station 382+85]. FS Date: 3/8/2022 10:33:40 AM

Land-Side: View of levee slope looking from crown

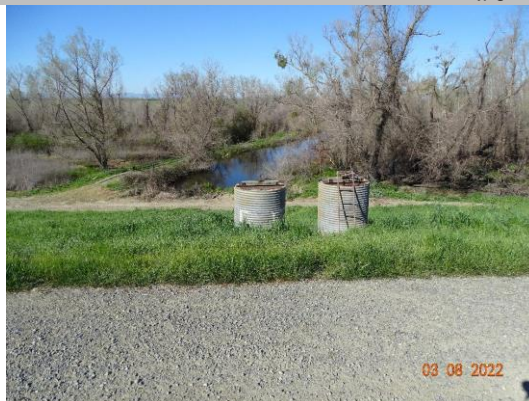
Photo 2 of 3 : UCIP_FA_2024_80055_106879.jpg

Water-Side: View of levee slope looking from crown. CMP riser on slope

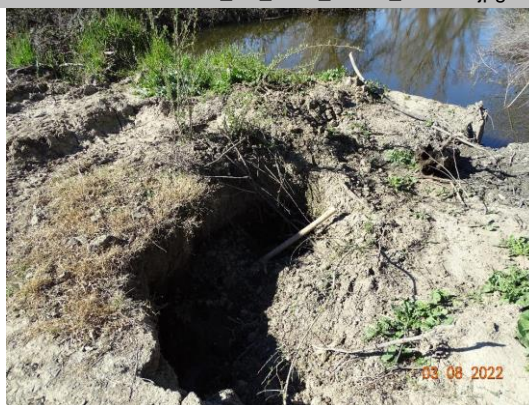
Photo 3 of 3 : UCIP_FA_2024_80055_106881.jpg

Water-Side: Multiple sinkholes filled with water around headwall

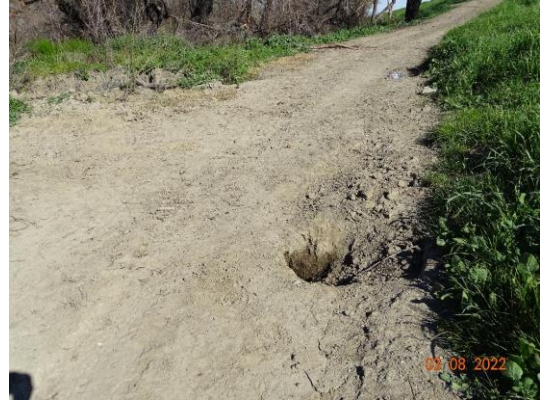
Photo 2 of 3 : UCIP_FA_2024_80056_106888.jpg

Water-Side: Sinkhole at the edge of toe road

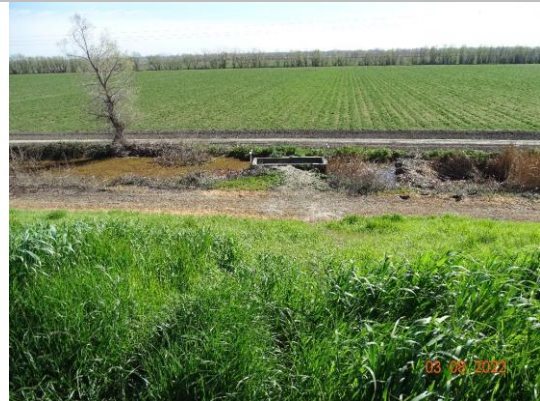
Photo 3 of 3 : UCIP_FA_2024_80056_106884.jpg

Land-Side: View of levee slope looking from crown
