**Flood Control Project Maintenance
Levee Inspections
LMA District Cover Sheet
Spring 2012 Levee Inspection Results**

Sacramento Maintenance Yard East Levee Yolo Bypass

Spring 2012 Levee Inspection Results

Levee Inspection Report By Mile - Spring 2012

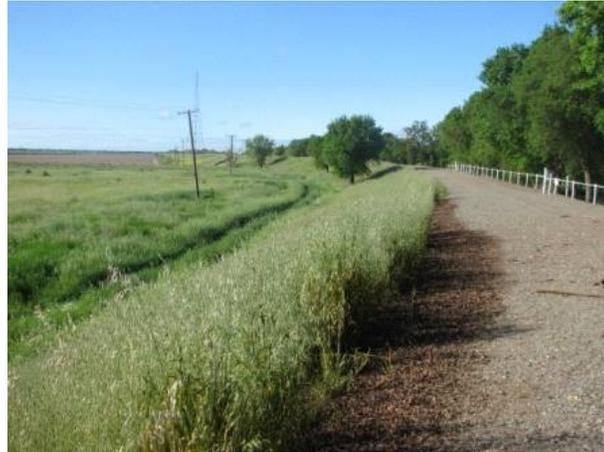
Levee Mile Report Line	1
Start Levee Mile	0.01
End Levee Mile	2.00
Location	Land Side
Category	Earthen Levee
Item	Vegetation
The grasses are taller than 12". Photo taken spring 2012.	
johngw_s_20120430_738.jpg

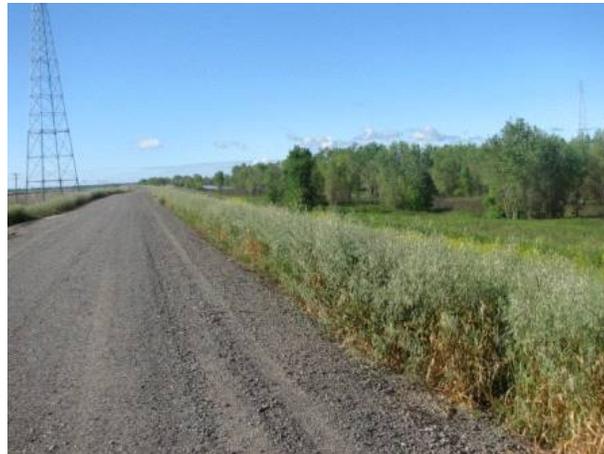
Levee Mile Report Line	2
Start Levee Mile	0.08
End Levee Mile	2.00
Location	Water Side
Category	Earthen Levee
Item	Vegetation
The grasses are taller than 12". Photo taken spring 2012.	
johngw_s_20120430_740.jpg

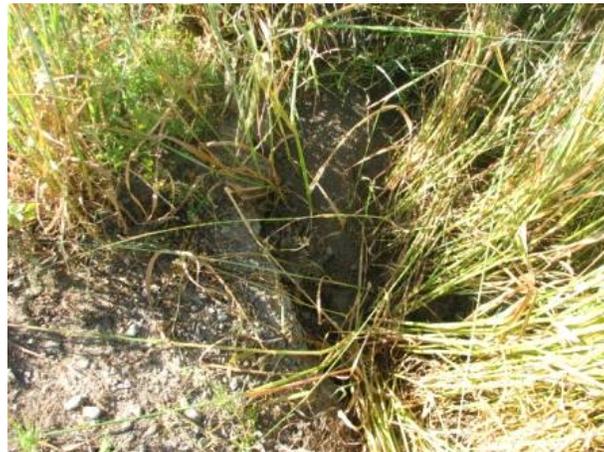
Levee Mile Report Line	3
Start Levee Mile	0.38
End Levee Mile	0.38
Location	Water Side
Category	Earthen Levee
Item	Animal Control
A rodent hole at the shoulder of the crown. Photo taken spring 2012.	
johngw_s_20120430_741.jpg
