**Flood Control Project Maintenance
Levee Inspections**
LMA District Cover Sheet
Spring 2015 Levee Inspection Results

Sacramento Maintenance Yard East Levee Yolo Bypass

Spring 2015 Levee Inspection Results

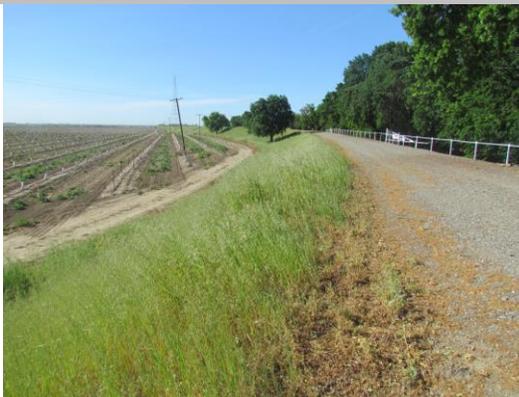
Photo 1 of 1 : SP_2015_ST0004_41_102_20150415_00001.jpg

LM Start	0.01	Rating **	M	Issue No.	102
LM End	2.01	Issue Type +	Ma	Location *	LS
Category	Earthen Levee			GPS Latitude/Longitude	
				Start	End
Item	Vegetation			38.765307 °	°
				-121.635208 °	°
DWR ID	DWR_ST0004_01_s_2015_102				
Action/Comments					
Control annual grass and weeds on the levee slopes and easements.

View of the vegetation on the landward side of the levee looking downstream. Spring 2015.

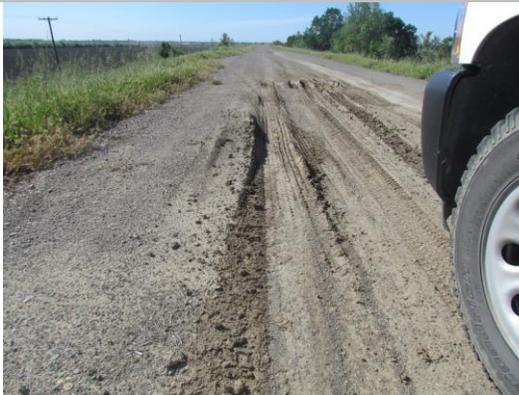
Photo 1 of 1 : SP_2015_ST0004_41_104_20150415_00002.jpg

LM Start	1.68	Rating **	M	Issue No.	104
LM End	2.02	Issue Type +	Ma	Location *	CR
Category	Earthen Levee			GPS Latitude/Longitude	
				Start	End
Item	Crown Surface / Depressions / Rutting			38.741080 °	38.736103 °
				-121.634018 °	-121.633682 °
DWR ID	DWR_ST0004_01_s_2015_104				
Action/Comments					
Add appropriate gravel or road base. Grade and compact.

View of the depression on the crown of the levee looking downstream. Spring 2015.
