**Flood Control Project Maintenance  
Levee Inspections**  
**LMA District Cover Sheet**  
**Spring 2016 Levee Inspection Results**

**Sacramento Maintenance Yard East Levee Yolo Bypass**

**Levee Inspection Report By Mile - Spring 2016**

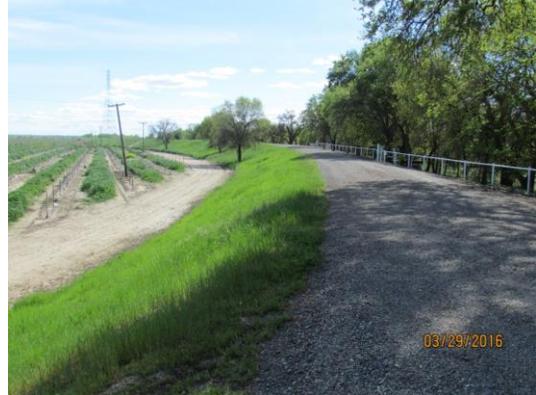
Photo 1 of 1 : SP\_2016\_ST0004\_41\_1\_20160401\_00004.jpg

LM Start	<b>0.00</b>	Rating **	M	Issue No.	<b>1</b>
LM End	<b>2.02</b>	Issue Type +	Ma	Location *	LS
Category	Earthen Levee		GPS Latitude/Longitude		
			Start	End	
Item	Vegetation		38.765317 °	38.736192 °	
			-121.635083 °	-121.633670 °	
DWR ID	DWR_ST0004_01_s_2016_1				
Comment Code					
V1 : Control annual grass and weeds on the levee slopes and easements.					
Inspector Comment

View of the vegetation on the landward side of the levee looking downstream. Spring 2016.

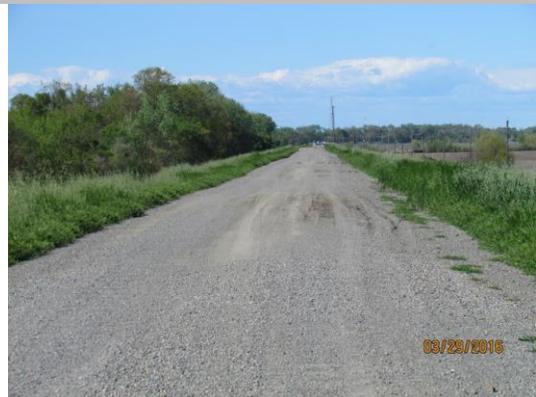
Photo 1 of 1 : SP\_2016\_ST0004\_41\_8\_20160401\_00005.jpg

LM Start	<b>0.27</b>	Rating **	M	Issue No.	<b>8</b>
LM End	<b>2.02</b>	Issue Type +	Ma	Location *	CR
Category	Earthen Levee		GPS Latitude/Longitude		
			Start	End	
Item	Crown Surface / Depressions / Rutting		38.761439 °	38.736191 °	
			-121.635400 °	-121.633670 °	
DWR ID	DWR_ST0004_01_s_2016_8				
Comment Code					
C1 : Add appropriate material and re-grade the levee to bring the crown above the design elevation.					
Inspector Comment

View of the crown of the levee looking upstream. Spring 2016.

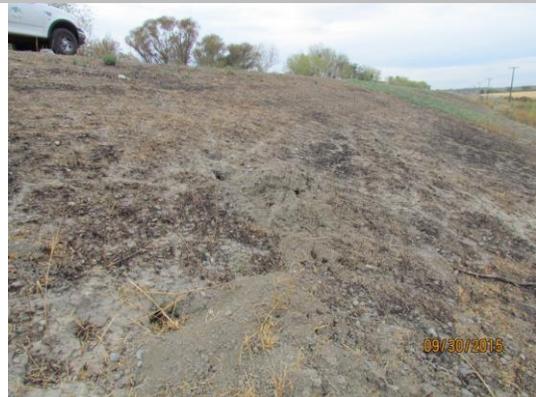
Photo 1 of 1 : SP\_2016\_ST0004\_41\_6\_20160304\_00001.jpg

LM Start	<b>1.65</b>	Rating **	M	Issue No.	<b>6</b>
LM End	<b>1.65</b>	Issue Type +	Ma	Location *	LS
Category	Earthen Levee			GPS Latitude/Longitude	
				Start	End
Item	Animal Control			38.741579 °	38.741579 °
				-121.634007 °	-121.634007 °
DWR ID	DWR_ST0004_01_f_2015_6				
Comment Code					
A3 : No rodents visible, but rodent burrows visible; need to backfill and compact or grout burrows.					
Inspector Comment

View of the rodent holes on the landward side of the levee looking upstream. Fall 2015.
