**Flood Control Project Maintenance  
Levee Inspections**

**Maintenance Issue Types Only, Levee Inspection Report By Mile - Fall 2014**

**Sacramento Maintenance Yard East Levee Yolo Bypass**

Waterway	Bank	Unit Miles	Inspection Start/End	Inspector
Unit No. 01 Yolo Bypass	Left	2.01	11/04/2014 11/04/2014	Clay Thomas

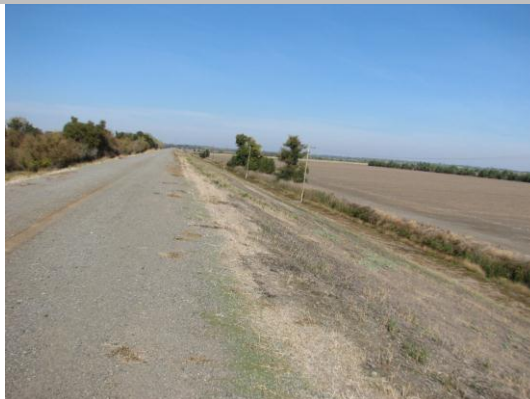
Photo 1 of 1 : FA\_2014\_ST0004\_41\_1\_20141106\_00002.jpg

LM Start	0.01	Rating **	A	Issue No.	1		
LM End	2.00	Issue Type +	Ma	Location *	LS		
Category	Earthen Levee			GPS Latitude/Longitude			
				Start		End	
Item	Vegetation				°		°
					°		°
DWR ID	DWR_ST0004_01_f_2014_1						
Action/Comments							
Control annual grass and weeds on the levee slopes and easements.

Levee mile 1.98, vegetation on levee slopes and crown. Fall 2014.
