**Flood Control Project Maintenance
Levee Inspections**

Maintenance Issue Types Only, Levee Inspection Report By Mile - Fall 2015

Sacramento Maintenance Yard East Levee Yolo Bypass

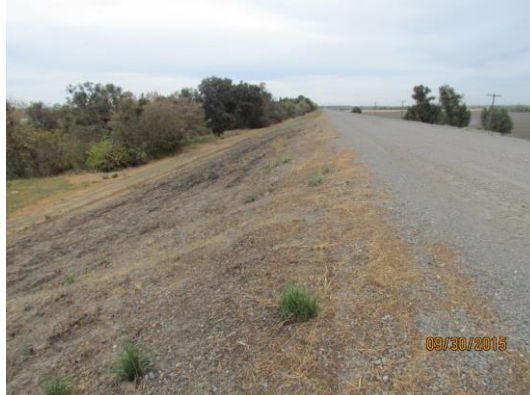
Photo 1 of 1 : FA_2015_ST0004_41_1_20151005_00002.jpg

| Control annual grass and weeds on the levee slopes and easements. Inspector Comments: Vegetation on slope has been burned. | | | | | |

View of the vegetation on the waterward side of the levee looking upstream. Fall 2015.

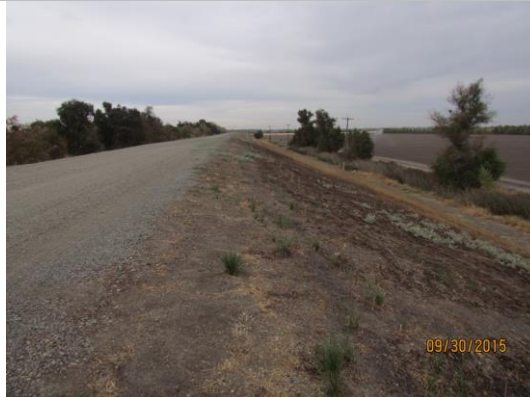
Photo 1 of 1 : FA_2015_ST0004_41_2_20151005_00003.jpg

| Control annual grass and weeds on the levee slopes and easements. Inspector Comments: Vegetation on slope has been burned. | | | | | |

View of the vegetation on the landward side of the levee looking upstream. Fall 2015.

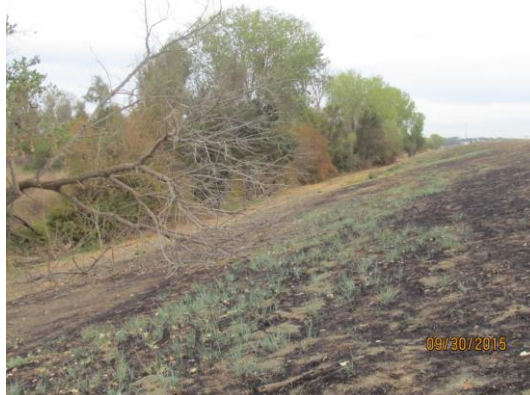
Photo 1 of 2 : FA_2015_ST0004_41_7_20151005_00005.jpg

| Tree or limb | | | | | |

Perspective view of the broken tree on the waterward side of the levee looking upstream. Fall 2015.

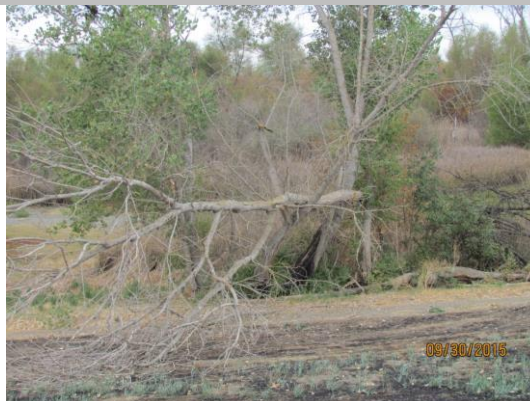
Photo 2 of 2 : FA_2015_ST0004_41_7_20151005_00007.jpg

| Tree or limb | | | | | | |

The tree is broken on the waterward side of the levee. Fall 2015.

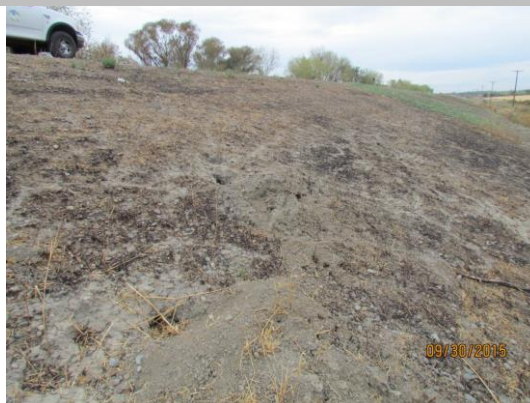
Photo 1 of 1 : FA_2015_ST0004_41_6_20151005_00004.jpg

| No rodents visible, but rodent burrows visible; need to backfill and compact or grout burrows. | | | | | |

View of the rodent holes on the landward side of the levee looking upstream. Fall 2015.
