**Flood Control Project Maintenance
Levee Inspections**

Maintenance Issue Types Only, Levee Inspection Report By Mile - Fall 2016

Sacramento Maintenance Yard East Levee Yolo Bypass

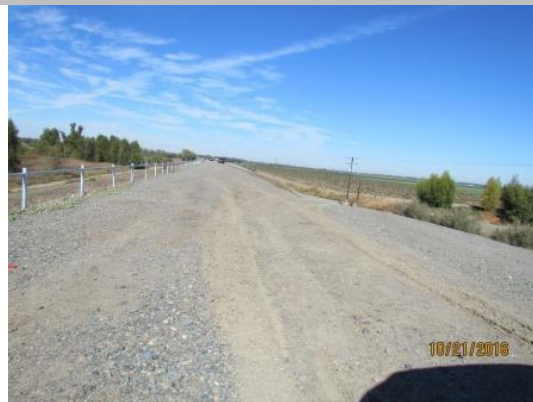
Photo 1 of 1 : FA_2016_ST0004_41_2_20161025_00006.jpg

| Item | Crown Surface / Depressions / Rutting | | 38.749634° | 38.747699° | |

Ruts on levee crown. Fall 2016.

| C2 : Repair depressions or ruts in the crown or slope. | | | | | |

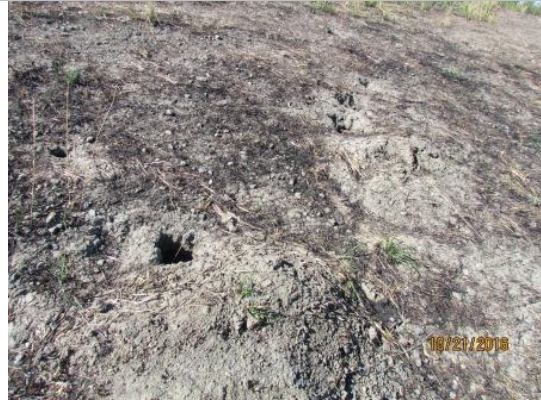
Photo 1 of 2 : FA_2016_ST0004_41_6_20161025_00005.jpg

| Item | Animal Control | | | 38.741579 ° | 38.741579 ° |

Updated view of rodent holes at this site. Fall 2016.

| A3 : No rodents visible, but rodent burrows visible; need to backfill and compact or grout burrows. | | | | | |

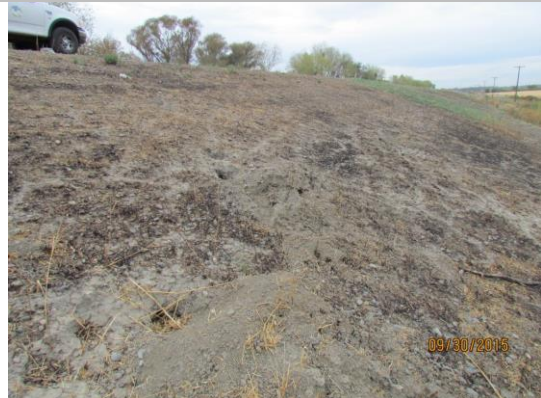
Photo 2 of 2 : FA_2016_ST0004_41_6_20160913_00001.jpg

View of the rodent holes on the landward side of the levee looking upstream. Fall 2015.
